# Arboricultural Report

Tree Survey,  
Arboricultural Impact Assessment &  
Arboricultural Method Statement

**Belgard Square East**  
**Belgard Road and Blessington Road**  
**Tallaght**  
**Dublin 24**

**210812-PD-11-A**

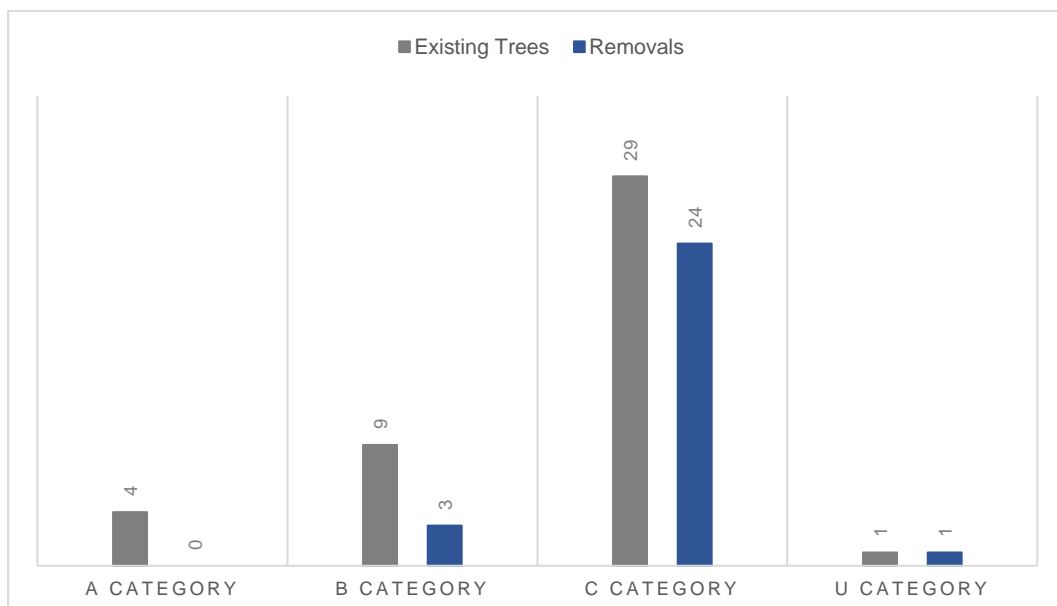
**Figure 3:** Proposed removals in comparison to the total number of survey entries recorded and their category in accordance with BS5837:2012.

- 6.1 **Loss of trees** – To facilitate the proposed development, 23 trees, three groups of trees, and two hedgerows are required to be removed.
- 6.2 Of the 28 survey entries proposed to be removed, three trees are of moderate quality and value (B Category), 24 trees and groups are of low quality and value (C Category), and one tree is of poor quality (U Category).
- 6.3 Full details of the proposed removals are specified within the Tree Work Schedule at Appendix A and are shown on the Tree Removals Plan at Appendix B.

- 6.4 The loss of trees and shrubs located internally within the site will have an insignificant impact on the character and appearance of the local surrounding area due to their low quality and limited public amenity value.
- 6.5 The street trees proposed to be removed are of high public amenity value due to their prominent location and their loss will have an initial visual impact on the local surrounding area.
- 6.6 The proposed development has taken into consideration the trees required to be removed and has included new high-quality tree planting within the site and along the public highway in order to mitigate the loss of trees.
