Title: Stage 1 Road Safety Audit

**Link Road to Clonlara Road, Baldonnell Business Park,
Dublin 22.**

Client: PUNCH Consulting Engineers

Report reference: 1462R01

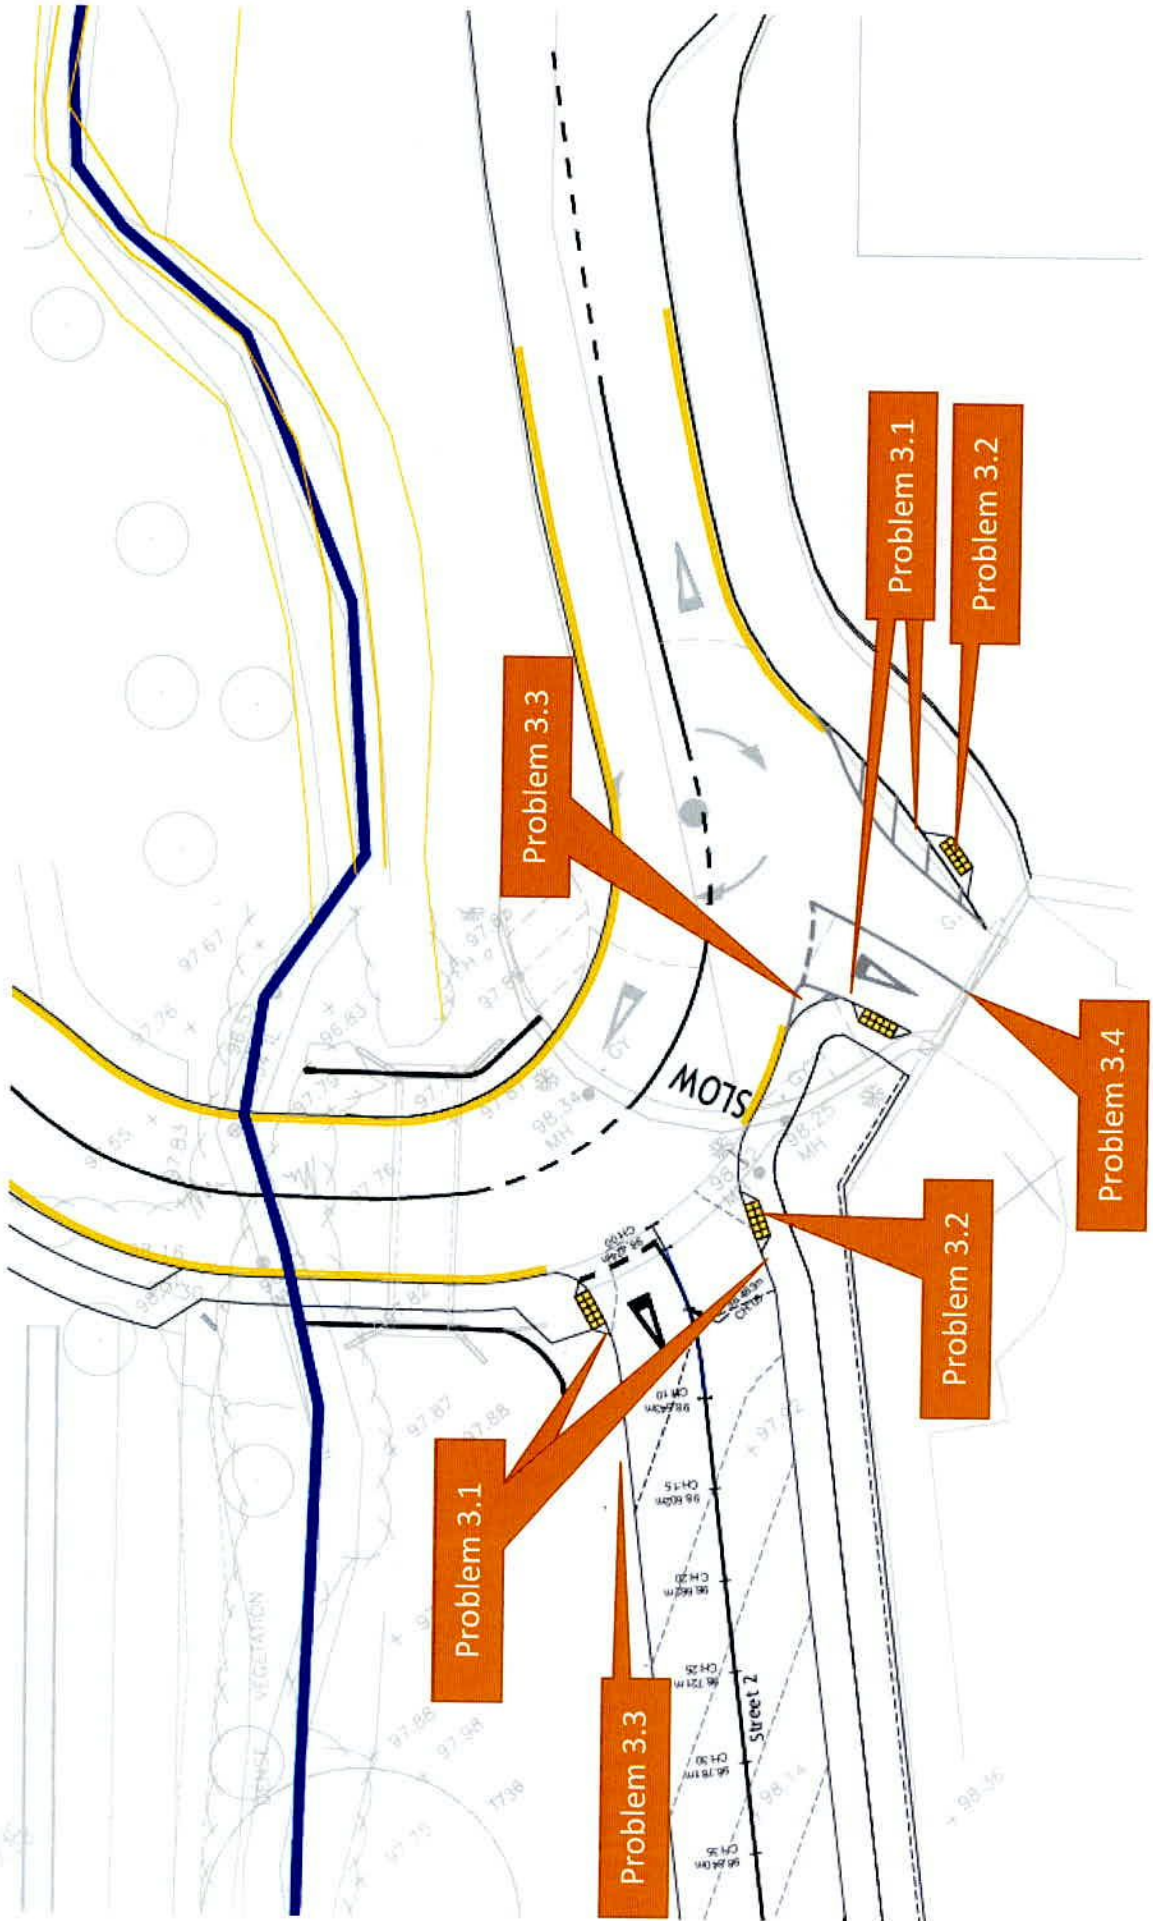
Problem Location Plan.

There is a risk of surface water ponding at the dropped kerbs of the uncontrolled pedestrian crossing points which could lead to slips and falls particularly in icy conditions.

The tactile paving at the uncontrolled crossings do not align on either side of the carriageways. This could lead to blind or partially sighted pedestrians being directed incorrectly as they attempt to cross the carriageway. This could lead to collisions with passing vehicles.

The access roads have Yield control junctions. Yield signs have not been shown on the drawings. Without adequate signage drivers exiting the proposed access road (Street 2) may assume priority if the road markings become faded which could result in side-impact collisions.

It is unclear if a HGV can park outside the Caulfield Transport gated entrance without overhanging the through road. If the trailer overhangs this could lead to side-swipe or rear-end collisions.

Provide gullies immediately upstream of the uncontrolled pedestrian crossings.

It is recommended that the tactile paving be aligned.

It is recommended that Yield signs be provided at both accesses in locations where there is suitable forward visibility for approaching drivers and they are not hazards for pedestrians.

It is recommended that the gate be far enough back so that a HGV driver can pull clear of the carriageway when looking to speak through the intercom to gain access.
