TREE & HEDGEROW SURVEY, ASSESSMENT, MANAGEMENT, MITIGATION & PROTECTION MEASURES

PROPOSED CHANGE OF USE OF RESIDENTIAL UNITS
AT
WESTPARK CRESCENT, GARTERS LANE, SAGGART, Dublin 22

Suites Hotel Management CLG.

July 2022

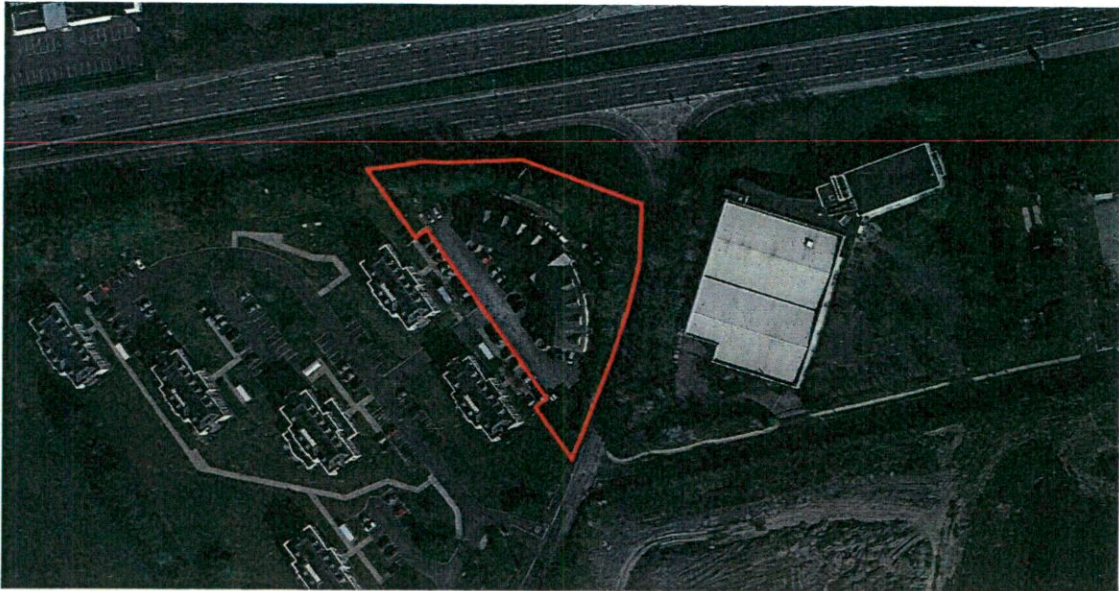
Figure 1 Site plan

4.2 The most prominent trees located on the site are located along the northern boundary with the Nass Road N7 and along the Eastern Boundary with Garters Lane. These trees provide dense visual screening of the exiting development and are a prominent feature of the site and are significant to the wider receiving environment. There are two tree groups located within this boundary and they are Group 1 along the northern boundary and Group 2 along the eastern boundary.
