Title: **STAGE 1 ROAD SAFETY AUDIT**

Hillhouse, Lucan, Proposed Residential Development.

Client: **PMCE**

Report reference: **1495R01**

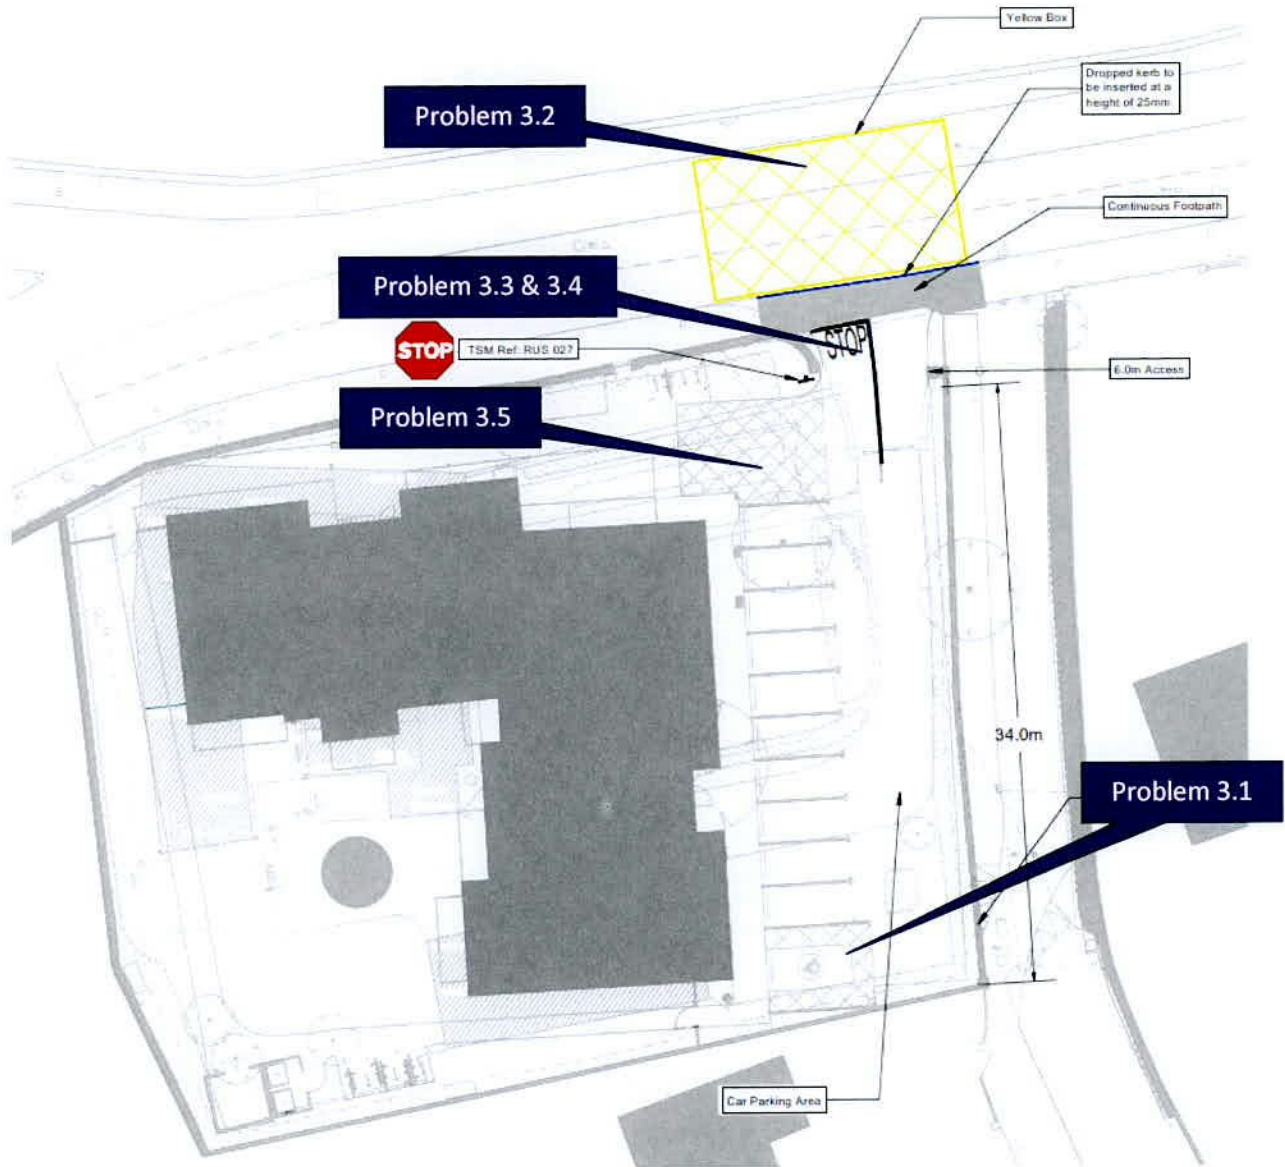
Appendix A – Problem Location Map

It is unclear if there is sufficient space for a user of the disabled parking space to easily enter/exit the parking space given the proximity of the boundary walls. A lack of space could lead to material damage of vehicles.

It is unclear if the proposed yellow box is required on the outbound lane from Lucan on the Lucan Road. If queues of traffic do not form in that direction drivers exiting the development during peak periods of inbound traffic may mistakenly think that they can turn right without checking for oncoming outbound traffic resulting in side-impact or rear-end collisions.

The swept path for the refuse truck has been shown however it is unclear where the bin storage area is to be located. Without a suitable storage area bin left for collection could be hazards for pedestrians especially the mobility impaired.

It is recommended that a swept path analysis be carried out to ensure that sufficient space is available.

It is recommended that the Design Team confirms if outbound queuing takes place and if not, that the yellow box only be provided on the two inbound lanes.

It is recommended that bin be located where they are not a hazard for pedestrians.
