Tree & Hedgerow Survey, Assessment, Management, Mitigation & Protection Measures

**RATHCOOLE AGE-FRIENDLY DEVELOPMENT
TAY LANE, NEWCASTLE ROAD,
RATHCOOLE, DUBLIN 24**

Riverside Projects Limited

AUGUST 2022

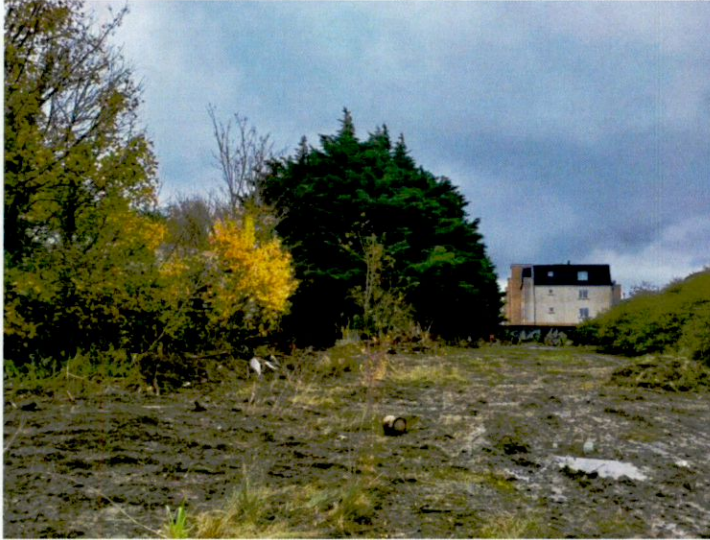
4.2 The site can be characterised by lands formerly occupied by a dwelling structure which has since been demolished and has been vacant for some time. The vacant site is now largely overgrown with dense, self-seeded scrub vegetation which makes a large portion of the site impassable. Access was created and the prominent trees in question could be surveyed.

Fig 2.0 – Site photo facing east.

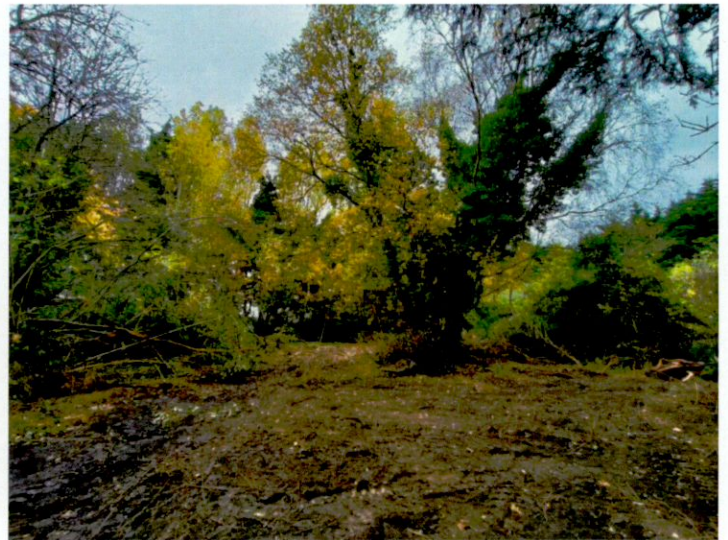
Fig 3.0 – Site A photo facing north east.
