# Arboricultural Report

Tree Survey,  
Arboricultural Impact Assessment &  
Arboricultural Method Statement

**No. 1 Adamstown Boulevard**

**220722-PD-11**

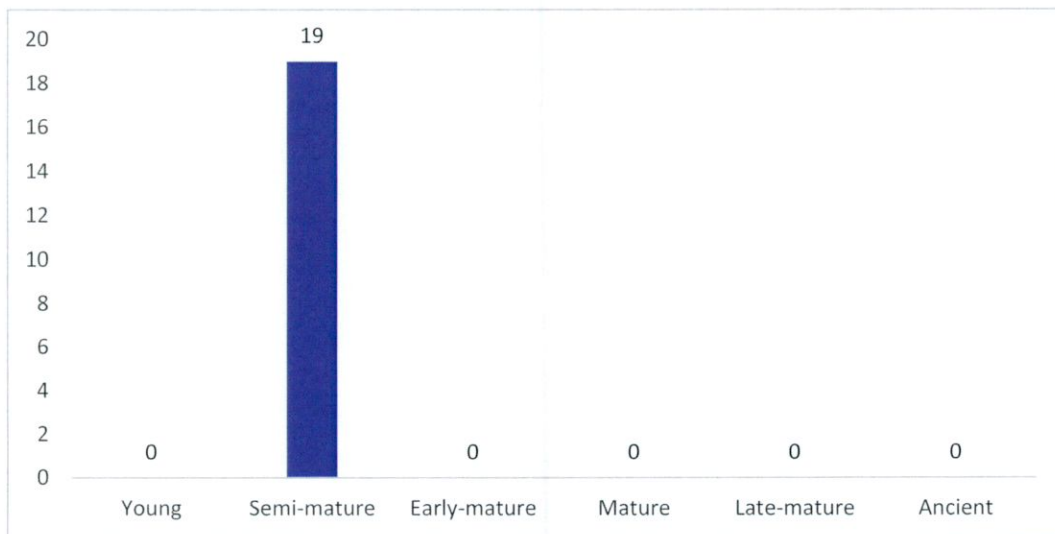
**Figure 1:** All trees and shrubs recorded (19 survey entries) are of a semi-mature age.

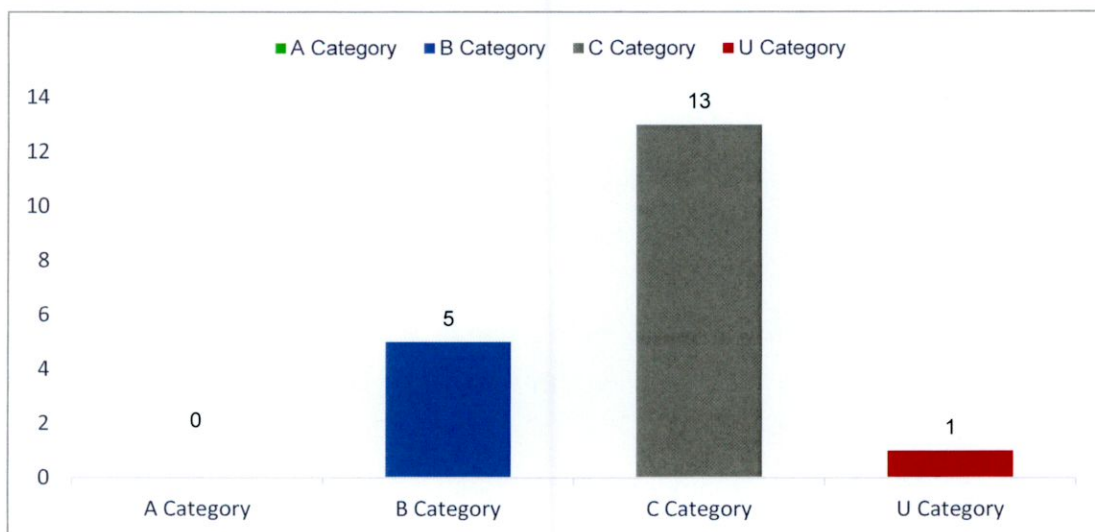
**Figure 2:** Breakdown of BS5837:2012 categories of the 19 survey entries recorded.

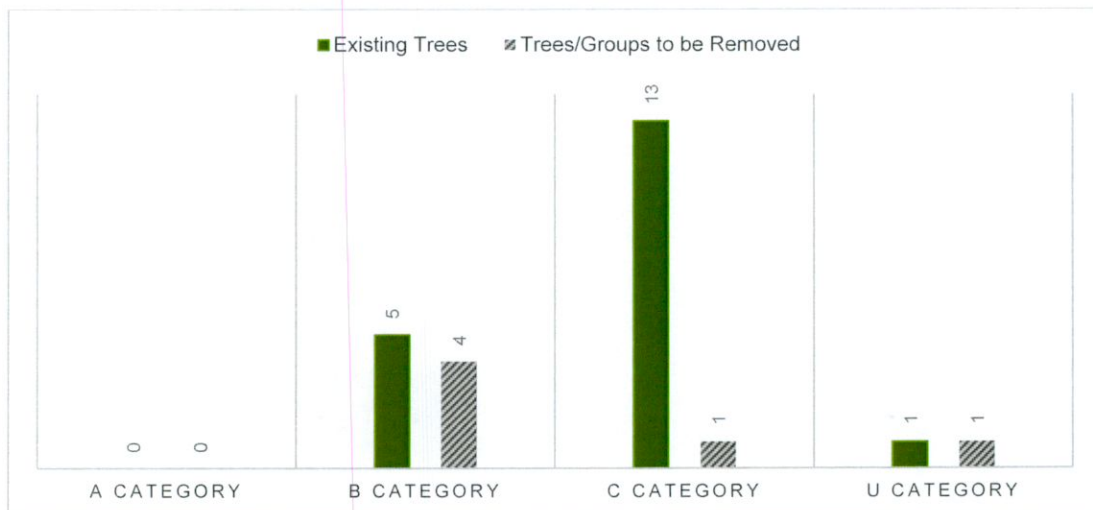
- 6.1 **Loss of trees** – The proposed development will require the removal of four B Category lime trees (T552 to T555) and one C Category mountain ash tree (T567). In addition, one U Category silver birch tree (T558) is required to be removed for arboricultural reasons due to its poor structural condition. The tree contains a longitudinal crack at the base of the main stem and poses a significant risk to public highway users.
- 6.2 Details of proposed tree removals are specified within the Tree Work Schedule at Appendix A and their location within the site is highlighted on the Tree Removals & Protection Plan at Appendix B. A breakdown of tree removals according to their BS5837:2012 category is outlined in Figure 3.

**Figure 3:** Breakdown of tree removals proposed as part of the development.

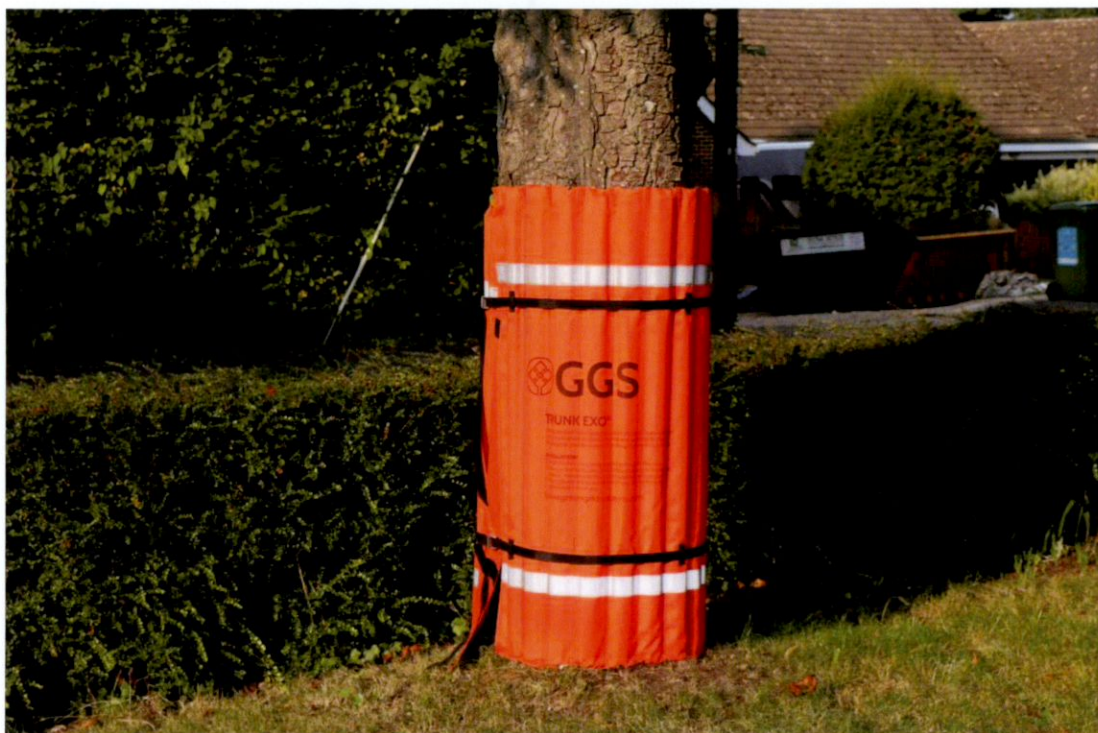
**Photo 4:** Trunk Protecta system as shown by Green Grid Systems.

- 6.5 **Tree protection measures** – Retained trees around the existing building can be successfully protected during the proposed development works by using robust fencing measures which comply with the recommendations outlined within BS 5837:2012. Please refer to the Tree Removals and Protection Plan at Appendix B for a fencing specification.
- 6.6 A stem protection system is required to be installed to safeguard the outer trunk of the lime tree T556 during the proposed alteration works along Adamstown Boulevard. To achieve this, a Trunk Protecta system can be installed (Photo 5).
