CCTV Inspection Report

**DAVID WHITSON
5 LIMEKILN DRIVE,
D12 AP60.**

Job Number: 00037

Greenday Environmental

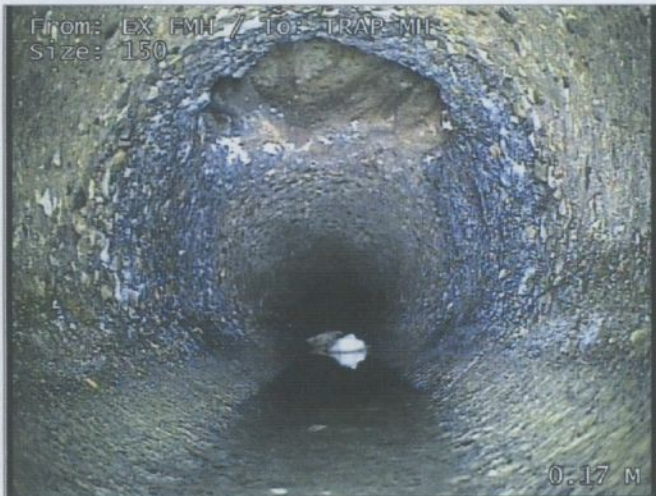
Connection other than junction at 12 o'clock, diameter 100mm

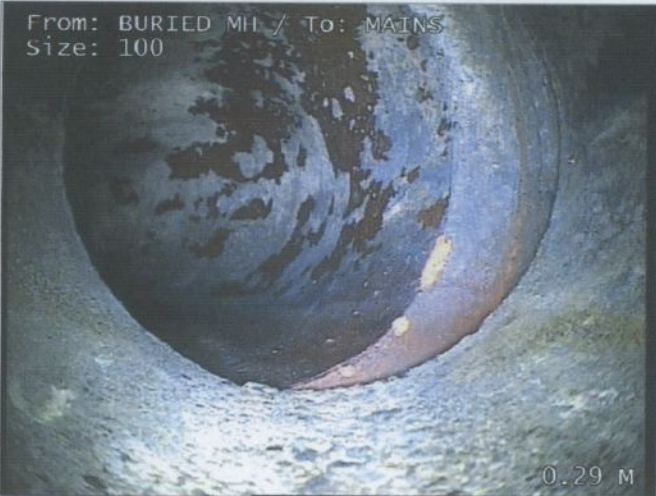
Joint displaced 20mm

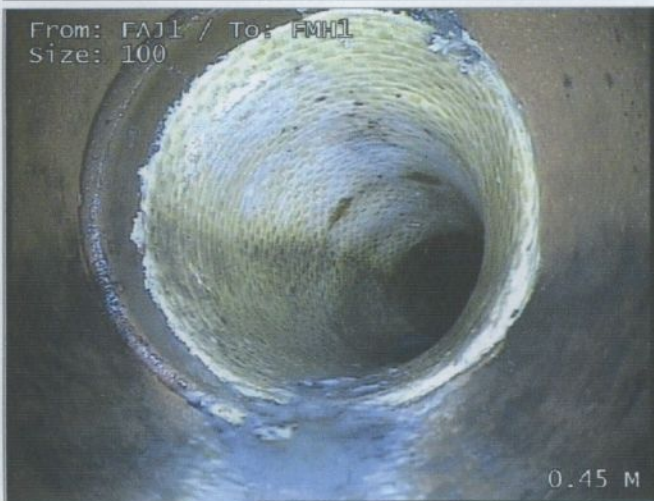
Line of drain/sewer deviates right

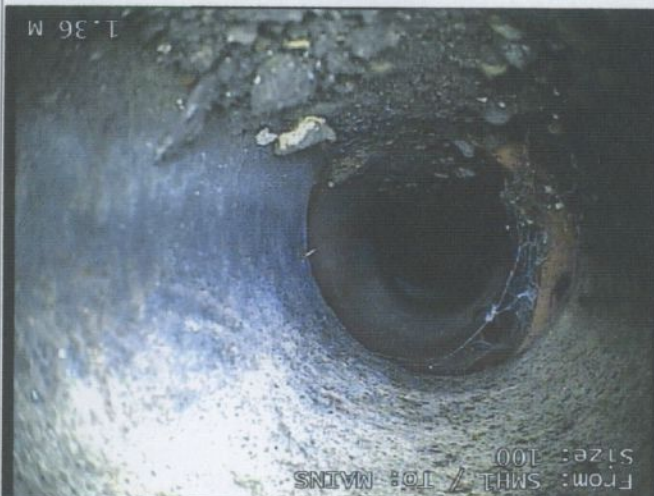
Material of drain/sewer changes to vitrified clay at this point

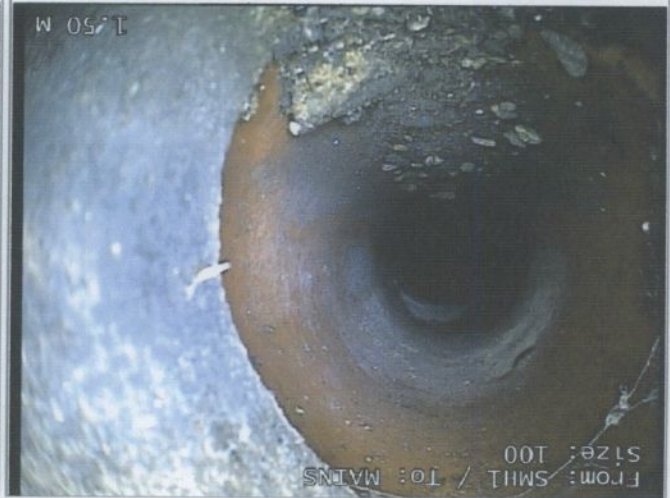
Dimensions of drain/sewer changes to 150mm

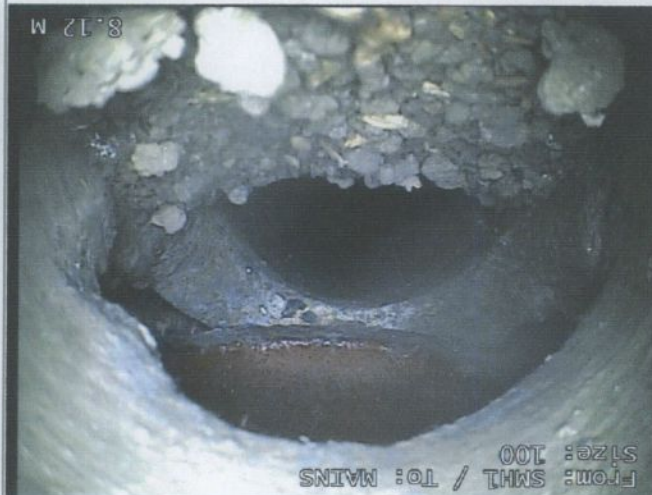
DEC 8.12	Settled deposits hard or compacted 75% cross-sectional area loss	6702508 Service / 4	Service / 4
CX 8.12	Connection defective at 12 o'clock, diameter 100mm	6702510 Comment / 0	Comment / 0
DER 11.36	Settled deposits coarse 30% cross-sectional area loss	6702511 Service / 4	Service / 4
SC 12.10	Dimensions of drain/sewer changes to 150mm	6702512 Comment / 0	Comment / 0
JN 12.64	Junction at 12 o'clock, diameter 100mm	6702513 Comment / 0	Comment / 0
SC 13.10	Dimensions of drain/sewer changes to 100mm	6702515 Comment / 0	Comment / 0
JD 16.79	Joint displaced 10mm	6702516 Structural / 3	Structural / 3
GP 19.81	General photograph taken at this point - Remark: MANHOLE AT 1 LIMEKILN CLOSE	6702517 Comment / 0	Comment / 0
JD 20.60	Joint displaced 25mm	6702518 Structural / 5	Structural / 5
LL 20.69	Line of drain/sewer deviates left	6702519 Comment / 0	Comment / 0
MCVC 20.86	Material of drain/sewer changes to vitrified clay at this point	6702523 Comment / 0	Comment / 0

Settled deposits hard or compacted 75% cross-sectional area loss

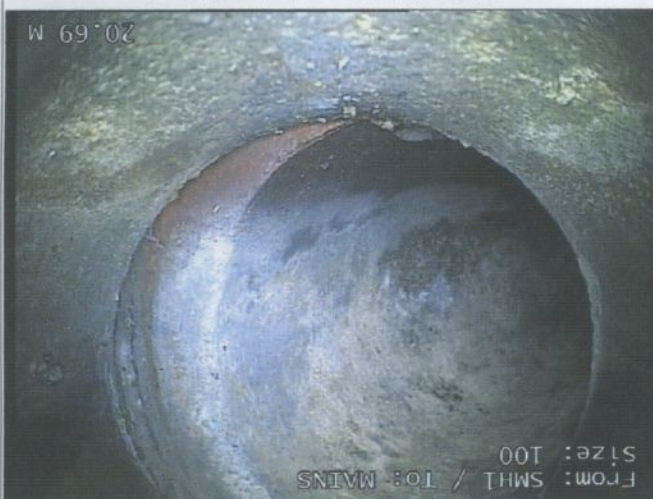
Line of drain/ sewer deviates left

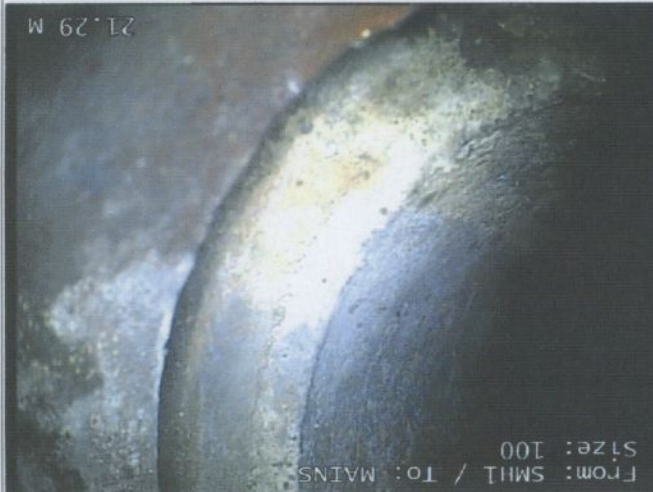
Material of drain/ sewer changes to concrete at this point
