ARBORICULTURAL ASSESSMENT & IMPACT REPORT

Transitional Care Facility,
Unit 21 First Avenue,
Cookstown Industrial Estate,
Dublin 24

Project No.	Project name	Date	Revision
T00002	Cookstown	13/09/22	-

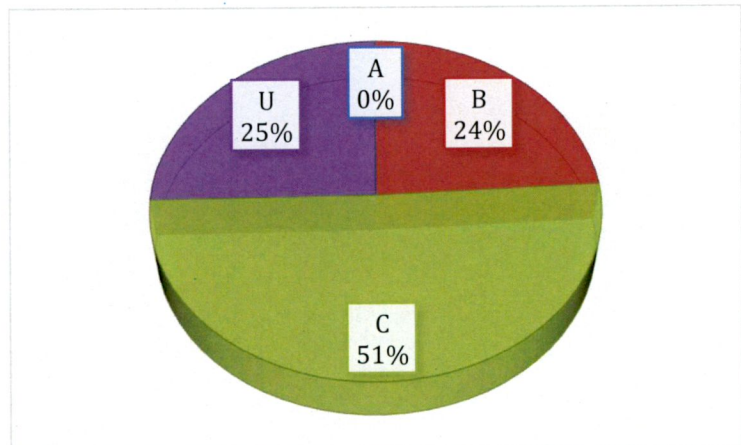
Chart 1. Percentage breakdown of categories of trees

The site is a former industrial unit located within Cookstown, Dublin 24 with trees located on the boundaries. The primary species is Italian poplar (*Populus nigra italica*) with very occasional birch (*Betula pendula*). The poplar which were presumably planted as part of the original landscape treatment for the site and are now reaching the end of their potential as boundary trees. They are most likely even aged clones therefore given the relatively short-lived nature of the species and their current condition it suggests that the removal of the poorer specimens within categories C & U would inevitably lead to the necessary removal of the remaining trees as gaps occur in the structure of the planting. Chart 1 illustrates the lower categories C & U making up 76% of the trees present. Image 2 also illustrates the nature of the canopy form of some of the trees as it opens up from a more compact shape. This often leads to branch failure as limbs become end-weighted and more exposed to the elements.

It is advised that the owner of these trees addresses their management as a matter of urgency as a number have been identified for removal based on their condition with the remaining trees of poor quality overall.
