An Arboricultural Assessment for the Site Area at 'Edmondstown Mill', Edmondstown Road, Rathfarnham, Dublin 16.

Prepared for: Ronan MacDiarmada & Associates Ltd.

Prepared by: Felim Sheridan F. Arbor. A, RFS Dip, Nat. Dip & NCH in
Arboriculture

Date: 25th July 2022

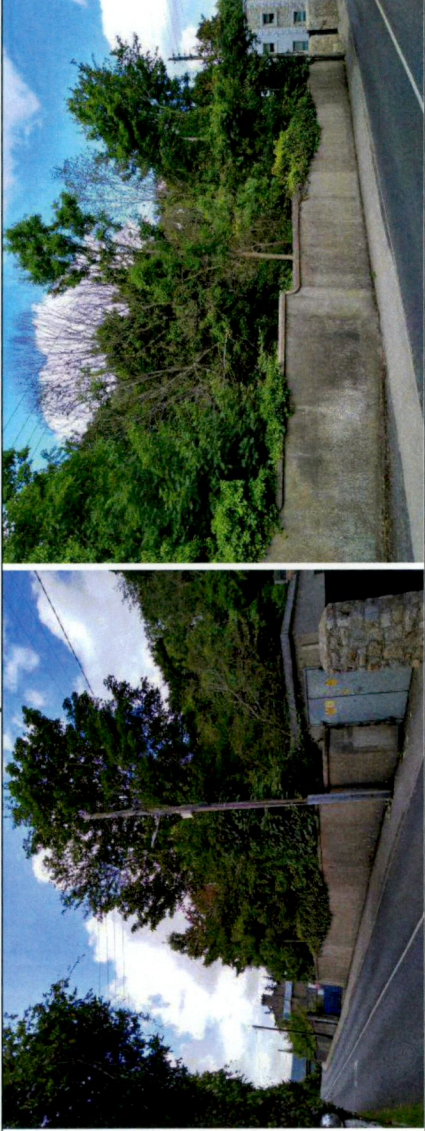
1426	Sycamore <i>Acer pseudoplatanus</i>	14	370/ 160/ 160	4N 4S 4E 5W	4	Early Mature	Fair	Poor A group of three self-sown trees growing out of the base of the adjacent walls. Two of the trees have been cut back on the roadside to provide clearance with the overhead utility lines. The main tree has a somewhat unbalanced crown weighed out to the north and west. There is some deadwood in the lower crown with ivy growth extending up into its crown, increasing the wind sail. These trees are likely to cause structural damage to the adjacent walls as they develop and they have no long- term potential in this location as a	I would recommend their removal as part of management and to prevent structural damage occurring to the surrounding structures.	<10	U

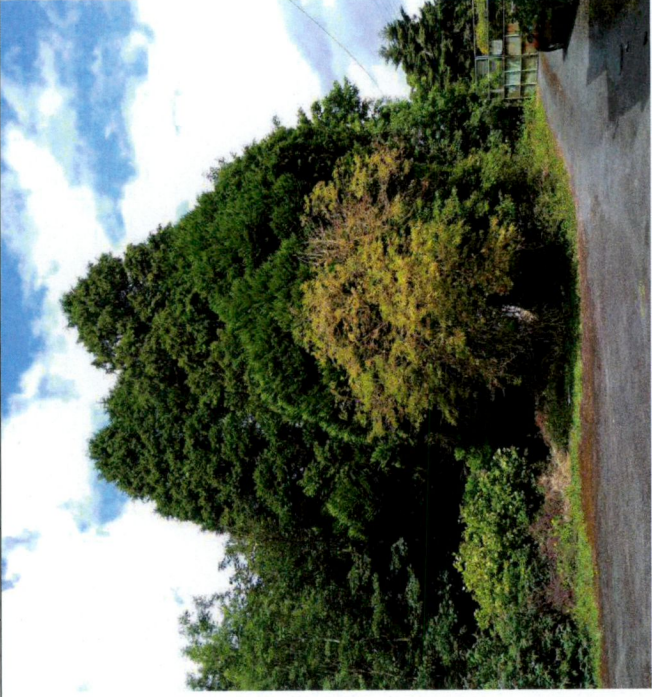
Tree No.	Tree Species	Ht. (m)	Stem Dia. (mm)	Branch Spread (m)	C-Ht. (m)	Age Class	Phys. Con.	Structural Condition Other Comments	Preliminary Recommendation	EUL	Cat. Grade
								N-north S-south E-east W-west Phys.-physiological.	A- average		
Tree Nos. 1447 and 1448 shown above.											
1447	Lawson Cypress cv. <i>Chamaecyparis lawsoniana</i> cv.	17	580 420	5N 2S 3E 5W	2	Mature	Fair	Poor Growing as one of a pair with Tree No. 1448. It is growing with a slight lean to the north indicating root movement / heave and issues over its stability. It divides low down with an acute union between the stems. The crown contains deadwood and is somewhat suppressed on the eastern side due to the presence of Tree No. 1448. There are stored materials and debris around the base of the tree. Heavy Ivy cover on the main trunk is extending high up into the crown, increasing the wind sail.	This tree has no potential and I would recommend its removal as part of management. If retained for the present time, cut Ivy at ground level to improve the wind sail of its crown and the risk of wind damage/ failure.	<10	U

1448	Lawson Cypress cv. <i>Chamaecyparis lawsoniana</i> cv.	17	720	5N 2S 3E 3W	2	Mature	Fair	Poor. It is growing as one of a pair with Tree No. 1447. It is a single-stem tree growing on a slightly raised bank at the entrance to the site. There is an Elder tree growing out of its base with heavy Ivy cover extending up into the crown increasing wind loading. The crown contains deadwood and is somewhat suppressed on the west side due to Tree No. 1447.	This tree has no potential and I would recommend its removal as part of management. If retained for the present time, cut Ivy at ground level to improve the wind sail of its crown and the risk of wind damage/ failure.	<10	U
1449	Cherry <i>Prunus</i> sp.	-	-	-	-	-	-	- This tree has recently fallen due to restricted rooting space.	Cut up fallen tree.	<10	U

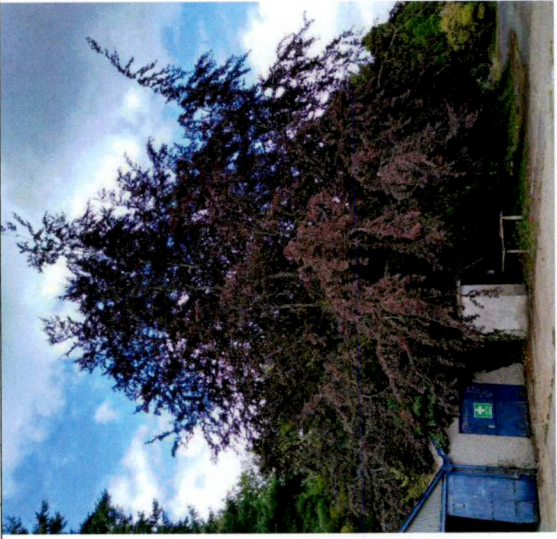
Cut Ivy to ground level. Monitor its condition and review again in twelve months.		
1455	Sycamore <i>Acer pseudoplatanus</i>	8	160 130	3N 3S 1E 3W	3	Early Mature	Fair	Fair / Poor Self-seeded into this area and is twin- stemmed from base. It has been drawn up for light due to competition affecting its structure. Ivy cover is extending up into the crown and it contains deadwood in the lower crown.	Retain for now as part of the bulking of the area. Cut Ivy at ground level at present.	10-20	C1
1456	Sycamore <i>Acer pseudoplatanus</i>	18	560 820	6N 3S 6E 0W	5	Mature	Fair	Fair / Poor Originally this tree divided from ground level into three-stems. The stem on the west side has broken out near the base or has been removed. The remaining stems have been drawn up for light due to competition from the surrounding trees. There is basal decay present on the west side of the tree where major limb loss has occurred in the past.	Retain for now as part of the bulking of the area. Cut Ivy to ground level. Review when this area is cleaned up.	10+	C1

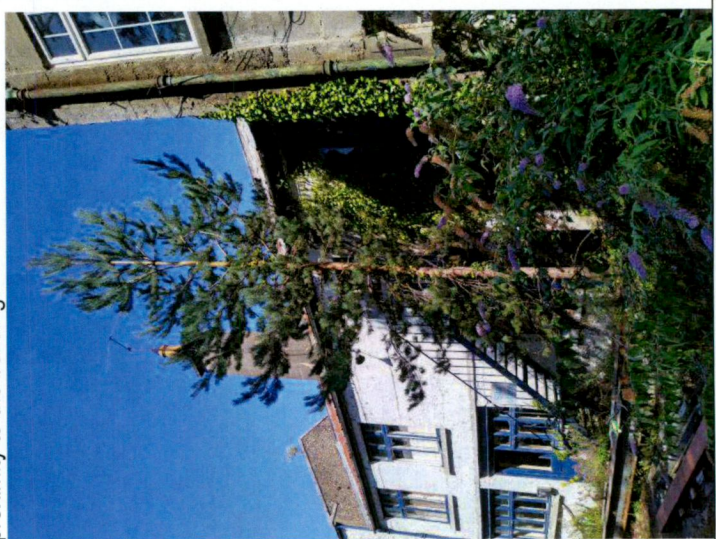
Tree No.	Tree Species	Ht. (m)	Stem Dia. (mm)	Branch Spread (m)	C-Ht. (m)	Age Class	Phys. Con.	Structural Condition Other Comments	Preliminary Recommendation	EUL	Cat. Grade
								N-north S-south E-east W-west Phys.-physiological. light due to competition. It contains branch stubs and deadwood along the main stems. It is unsuitable for this location and has no long-term potential.	A- average to the Mill structure.		
Tag Nos. 1480 – 1496 are not in use.											
1497	Scots Pine <i>Pinus sylvestris</i>	8	130	1N 1.5S 1E 1.5W	1	Semi Mature	Good	Fair / Good A single-stemmed tree, growing in a plant bed beside the main building. It is establishing well, but may eventually outgrow this location due to its proximity to the building.	Requires no work at the present time.	20+	C1
