SOIL CHARACTERISATION AND SITE SUITABILITY ASSESSMENT REPORT TE REF: 22/206 TE

NICOLA LYNCH & BRIAN DUNNE & CIARA
LYNCH & RICHARD O'FARRELL
LYNBROOK
WHITECHURCH RD
RATHFARNHAM
DUBLIN 16
D16T2P7

SITE CHARACTERISATION FORM FOR AN ON-SITE WASTEWATER TREATMENT SYSTEM

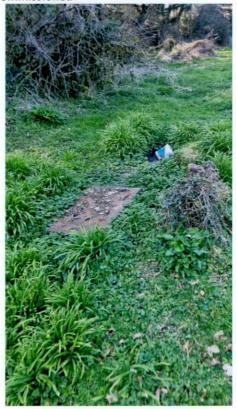
SITE LAYOUT DRAWING SHOWING TEST HOLE LOCATIONS

Existing Septic Tank to be Decommissioned

Approximate Location of Trial Hole & Percolation Test Holes Examined on 24.03.22
