Arboricultural Survey & Report

Client: Richie O'Farrell

Site: Lynnbrook, Whitechurch Rd, Rathfarnham, Dublin 16

Gary Doherty, Dermot Casey Tree Care Ltd.

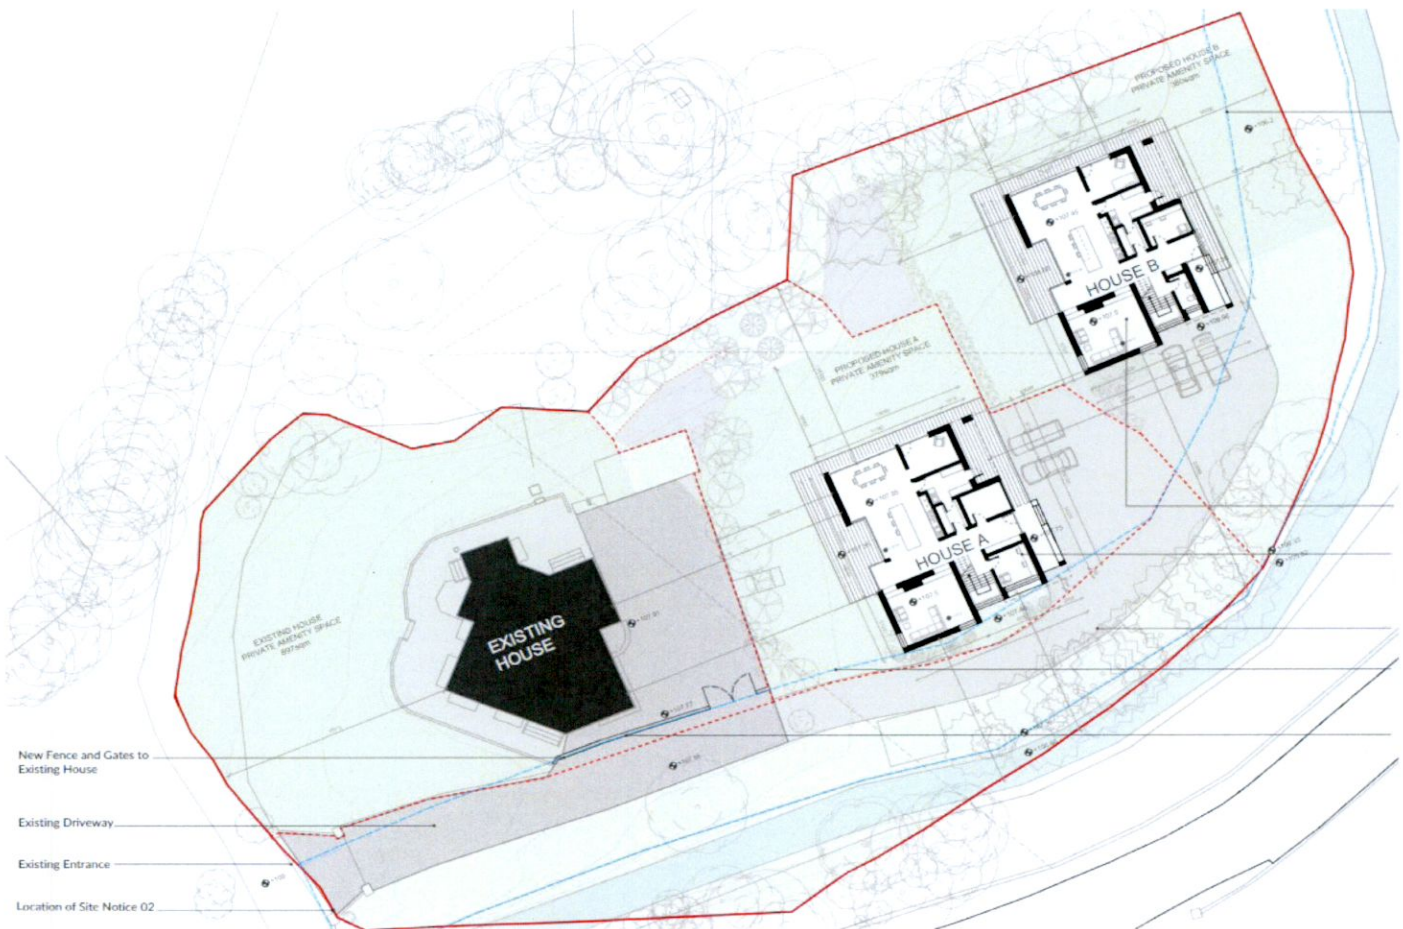
FIG 2 – Design layout

The image in Fig 2 highlights the proposed design layout and the location of the trees within the footprint of the site. The trees of concern are those that may be in direct conflict with the proposed development and are located along the eastern, T030 – T038, and western, T045 – T053, boundaries.

The proposed design, outlined in Fig's 2 below, and their subsequent construction works are within the RPA of trees recommended for retention. Any works within the RPA's of trees will have negative effects on those trees with the potential to limit their survival into the future, refer to section 3.1 on the impacts of working within the RPA of trees.
