ARBORICULTURAL METHOD STATEMENT

TREE PROTECTION PLAN

Church of Scientology & Community Centre of Dublin, Firhouse Road, Tallaght, Dublin 24

20th January 2023

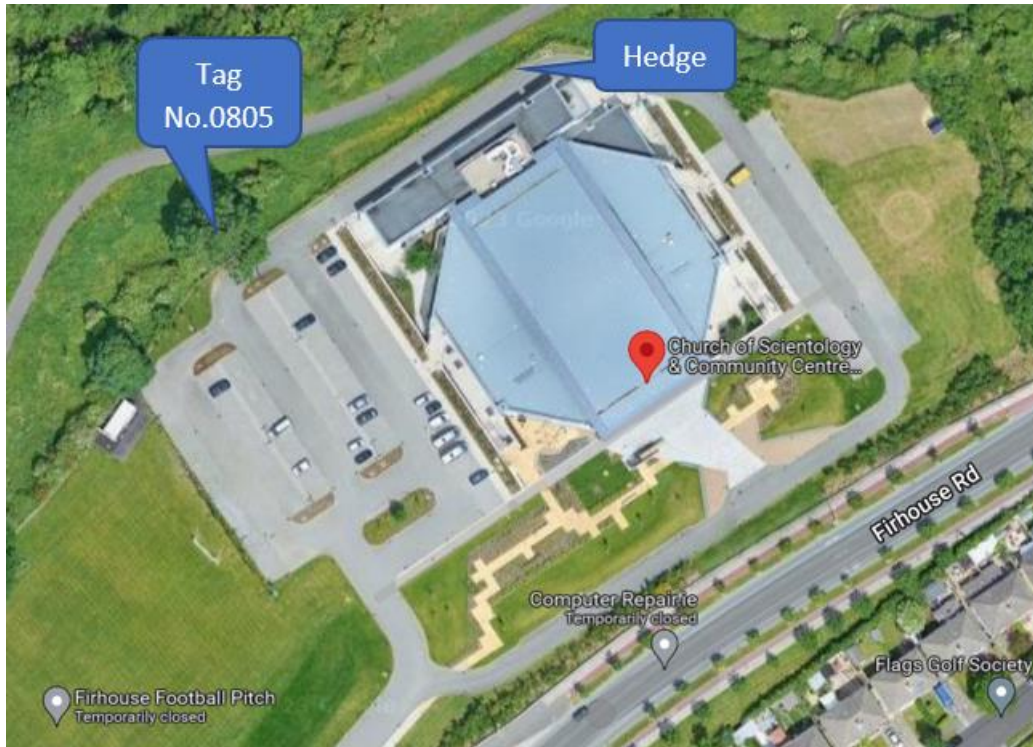
2.4 Tag No.0805 has a large bark wound at base on its western side that equates to c.40% of the trunk circumference and to a height of c.3m. The wound is infected by brittle cinder fungus (*Kretzschmaria deusta*), with extensive decay developing into the underlying timbers and large size dead wood in the crown, some of which has already fallen into the adjoining car park.

Extensive basal decay in Tag No.0805

I would recommend that this tree be reduced to a 2.5m tall stump and retained for its ecological value whilst addressing the apparent risk towards the car park and proposed new entrance.
