# **ARCHITECTURAL HERITAGE IMPACT ASSESSMENT**

**Muldowney's Pub,  
Main Street,  
Rathcoole,  
Co. Dublin**

**Additional Information Stage: Reg. Ref. SD22A/0096**

**March 2023**

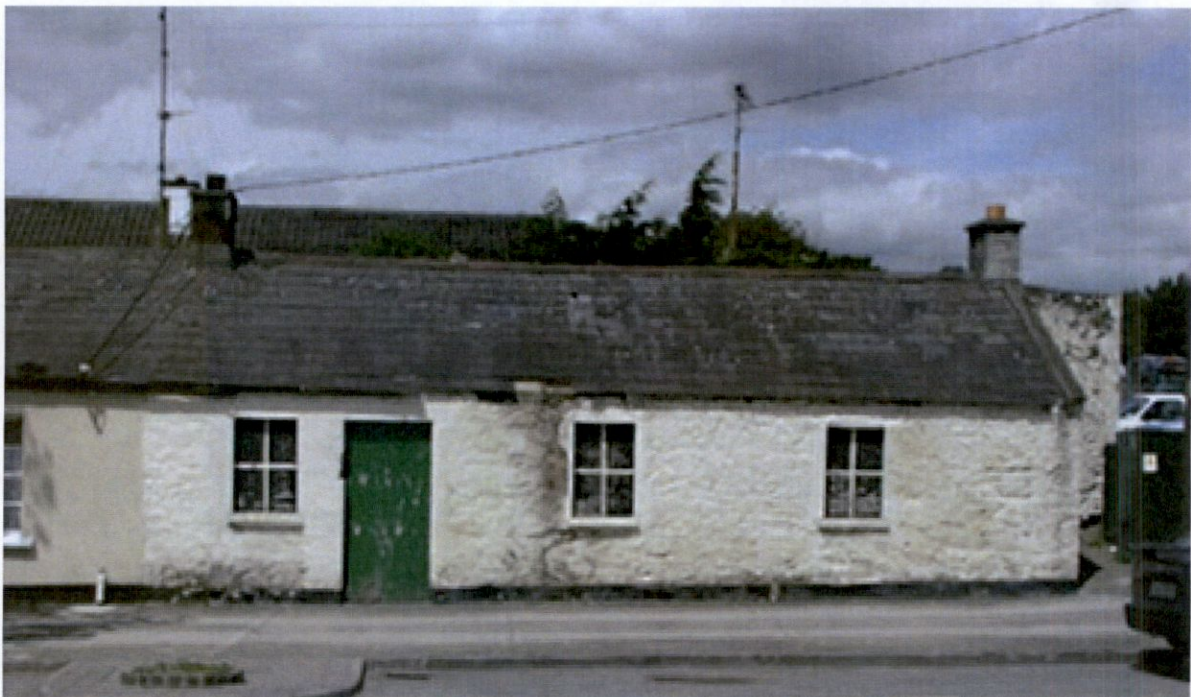
**Figure 4: Front Façade to Rathcoole Main Street**

The NIAG appraisal identifies that, *“Though in poor condition, the retention of its original proportions and many materials makes this house an important reminder of how the streetscape of Rathcoole has changed with time.”*

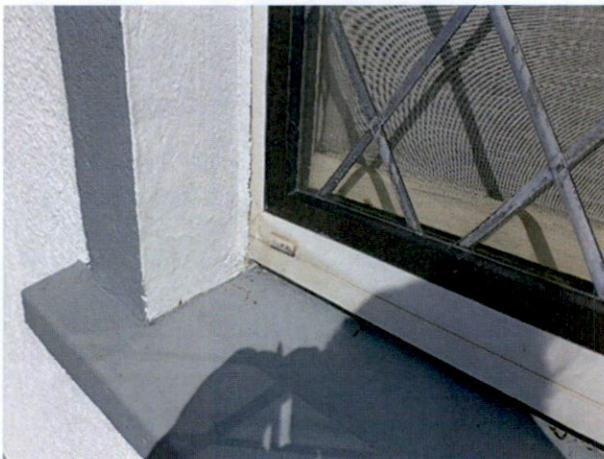
The original windows have been replaced with white uPVC framed windows with leaded glass affect. The original door has been replaced with a white uPVC door which has been set back from the main façade. The pitched roof has a slate finish. The roof is pitched with a natural slate finish and there are two chimneystacks rising from the ridge at each gable. There is a small, enclosed yard at the rear of the house.

**Figure 11: Window Detail**
