Clonburris T3

Road Safety Audit Response Report

CLB-T3-ZZZ-SW-DTM-RP-DBFL-CE-0005

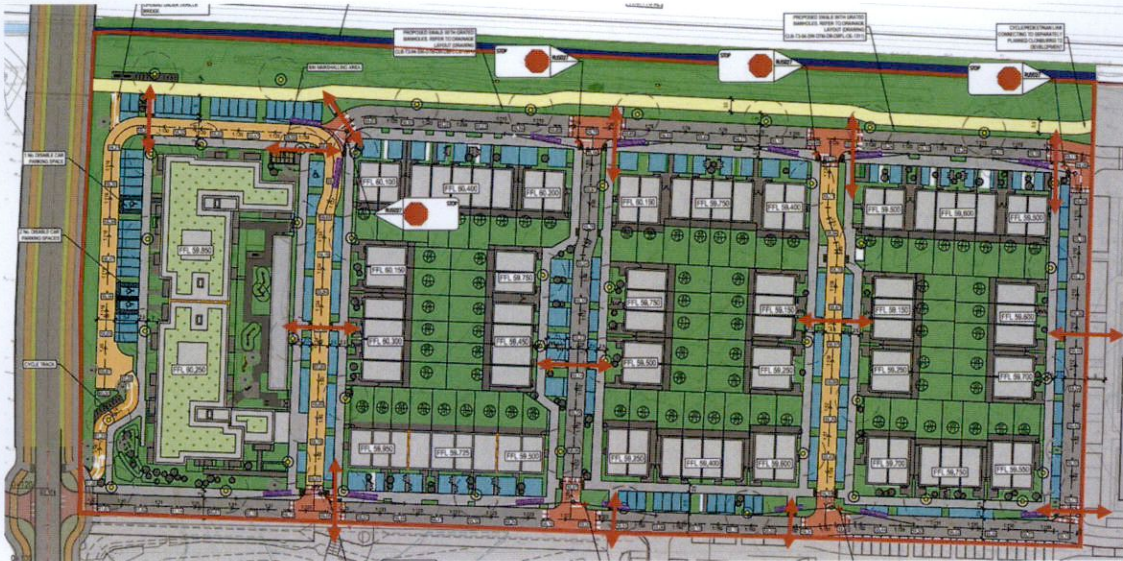
Location (G6) – Surface Drainage

From the scheme information provided for this audit, it has not been possible to ascertain the specific details of the surface drainage strategy. Surface water can prove a trip hazard in both warm and cold weather conditions in addition to adversely impacting the skid resistance of bicycles and motorized vehicles.

During the detail design stage, the design team should provide adequate measures are taken to ensure that all surface areas benefit from having sufficient drainage and that localised ponding does not arise during wet weather conditions. All access routes leading to/from the subject site should have adequate surface water drainage.

Appropriate pedestrian crossing points have been added at all desire lines indicated in the Road Safety Audit. Refer to drawing CLB-T3-95-SW-DTM-DR-DBFL-CE-1201.
