PROPOSED DEVELOPMENT SITE, OLD NANGOR ROAD, DUBLIN 22

EXISTING CULVERT HYDRAULIC ASSESSMENT REPORT

Document No:	IE1978-4525
Issue No:	01-ISSUE
Project No:	IE1978
Date:	27 th March 2020
Revision:	2.0
Prepared By:	N O'Malley BE CEng MIEI

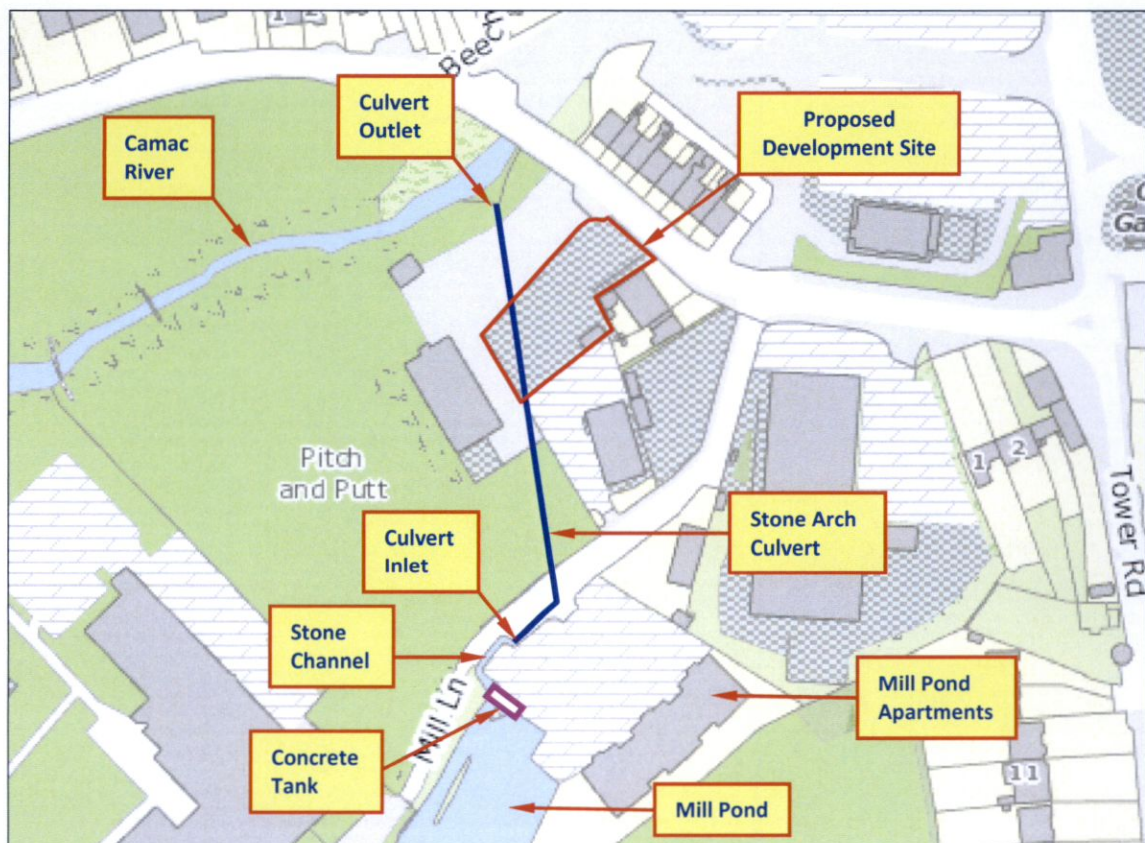
Figure 1 - Culvert Layout Plan

The culvert is a stone arch culvert, which was constructed as part of a paper mill that is no longer in operation. It is approximately 2.47m wide and 1.56m high. Waters spill from the Camac River into the Mill Pond located upstream of the culvert. These waters discharge to a concrete tank, which in turn discharges to a stone channel located on Mill Lane and into the culvert inlet via a large sump. The location of the culvert is shown on *Figure 1* below.

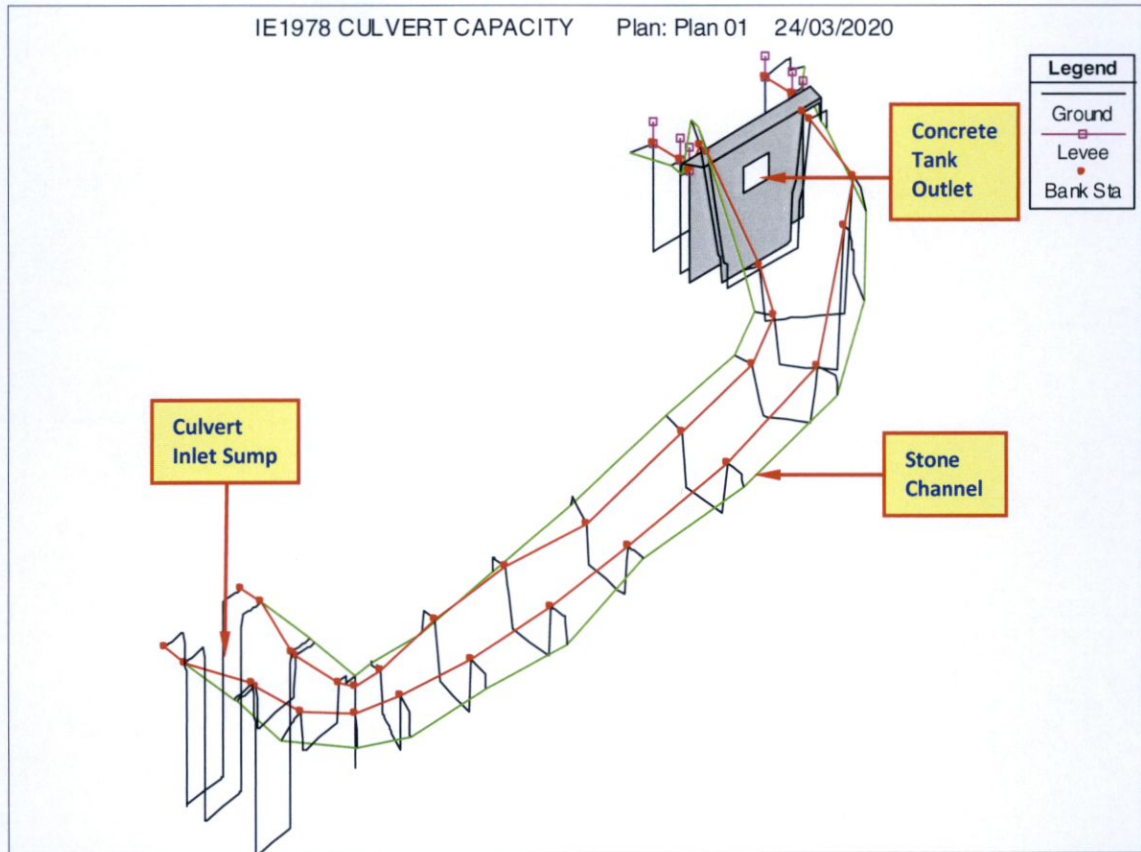
Figure 3 – Hydraulic Model

In order to determine the peak flow discharging from the Mill Pond a hydraulic model was developed using HEC RAS software of the outlet from the concrete tank, the stone channel and the inlet into the sump at the culvert inlet. The existing stone arch culvert has not been included in the hydraulic assessment. It is currently significantly blocked with stone, however if it was free from blockage the capacity of the culvert would be significantly greater than the rate of discharge from the Mill Pond. The extent of the model is shown in *Figure 3* below:

The flow limiting factor into the culvert is likely to be the Concrete tank outlet, which was assessed by increasing the flow into the hydraulic model until such time that the water levels surcharge above the top of the concrete tank roof level.

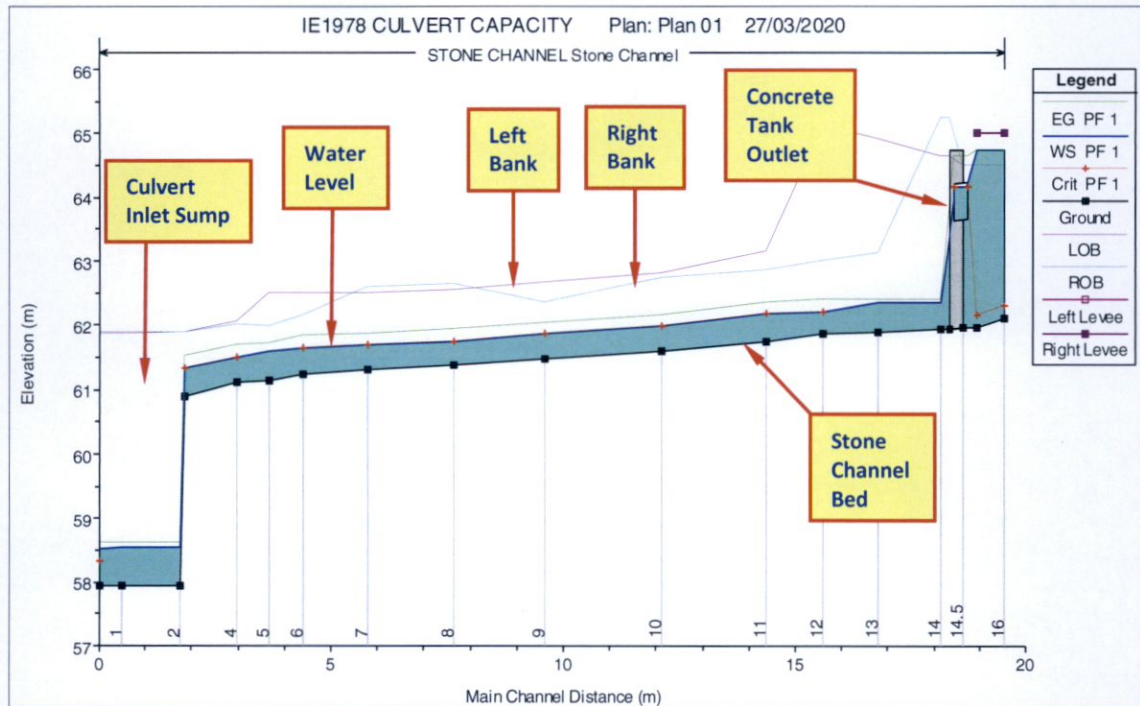
Figure 4 – Model Longitudinal Profile

A peak flow of $0.695\text{m}^3/\text{s}$ was determined to be the peak flow that may discharge from the outlet of the concrete tank.

The model simulation is represented by a longitudinal profile through the modelled reach as shown in *Figure 4* below.

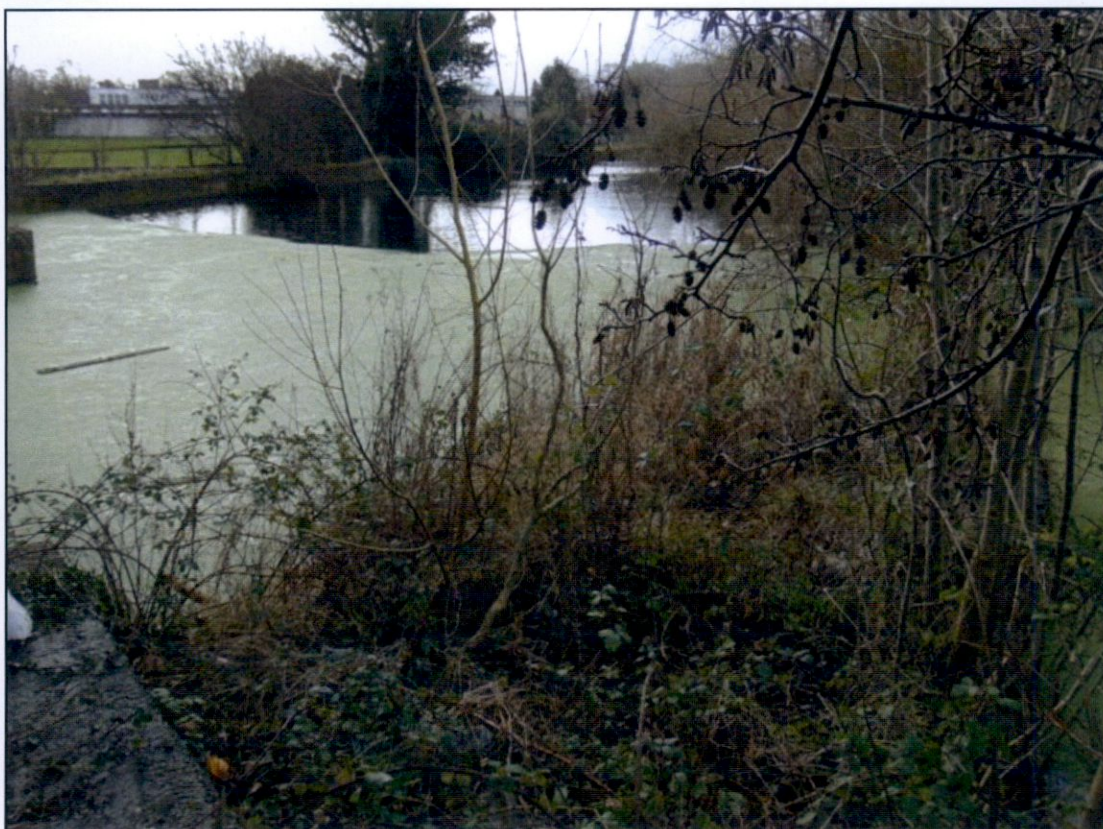
Photo 2: Pond Outlet into Concrete Tank

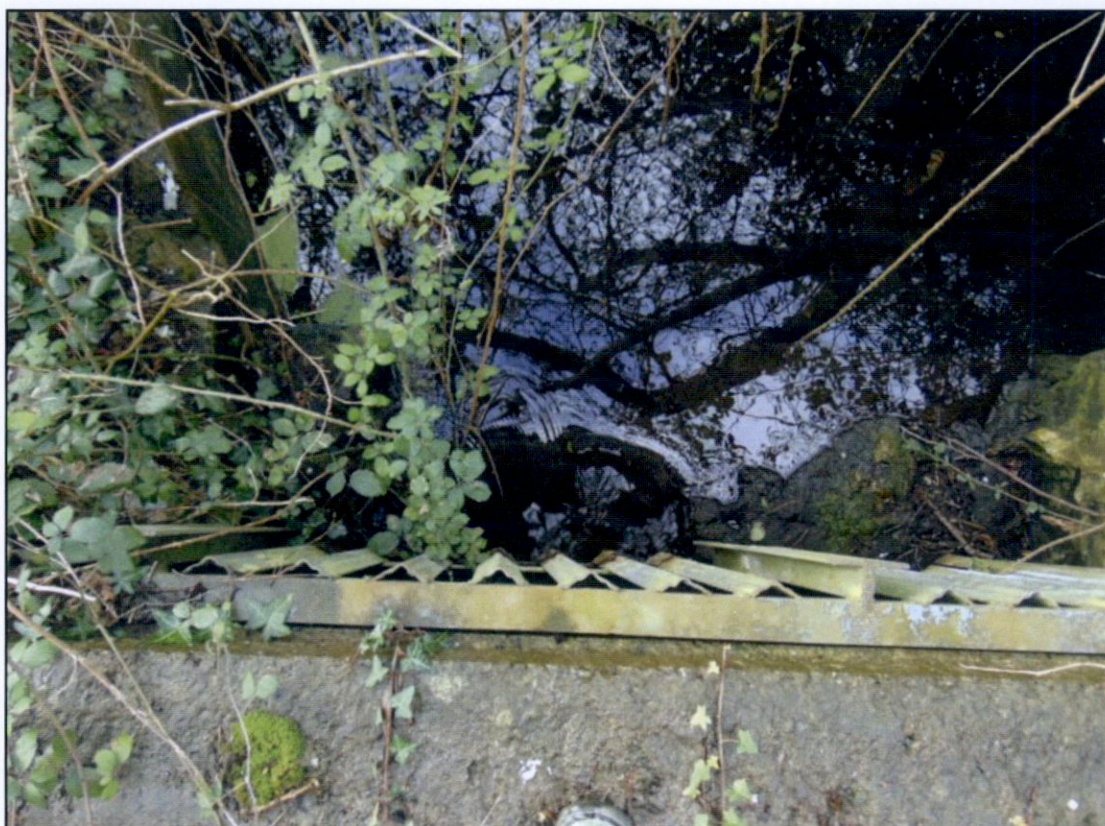
Photo 3: Concrete Tank Outlet

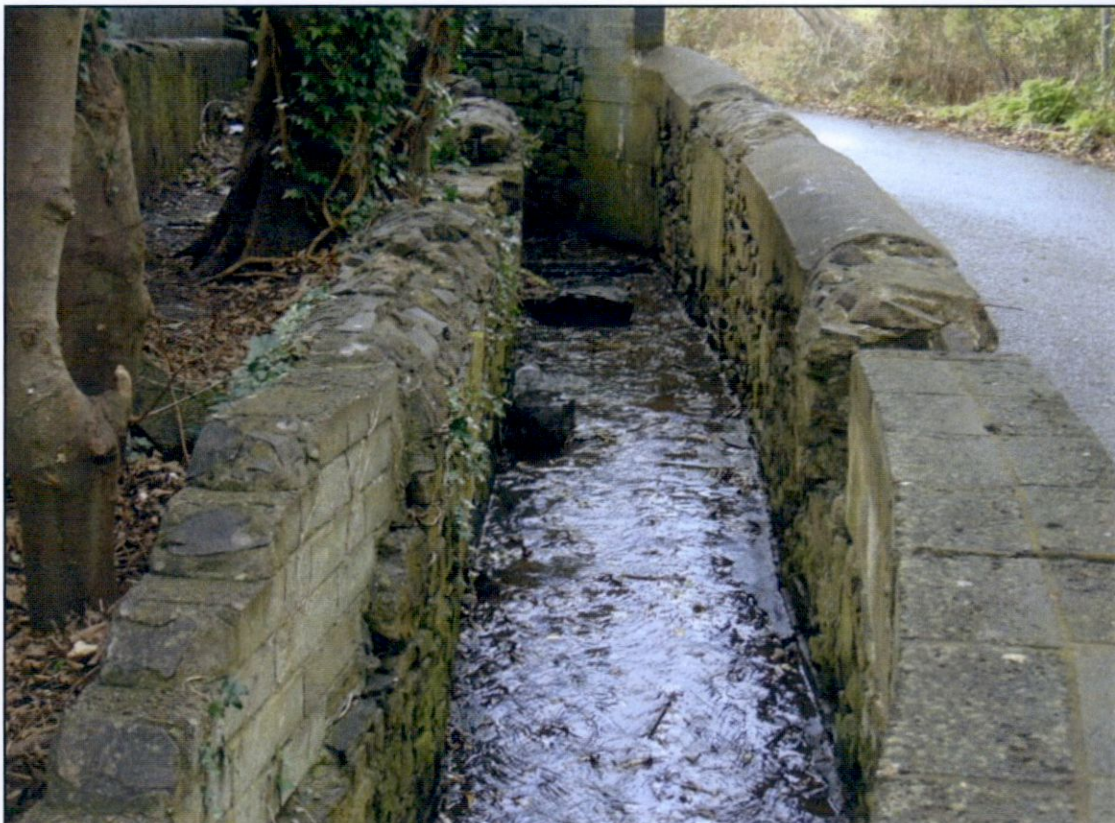
Photo 5: Stone Channel Downstream End

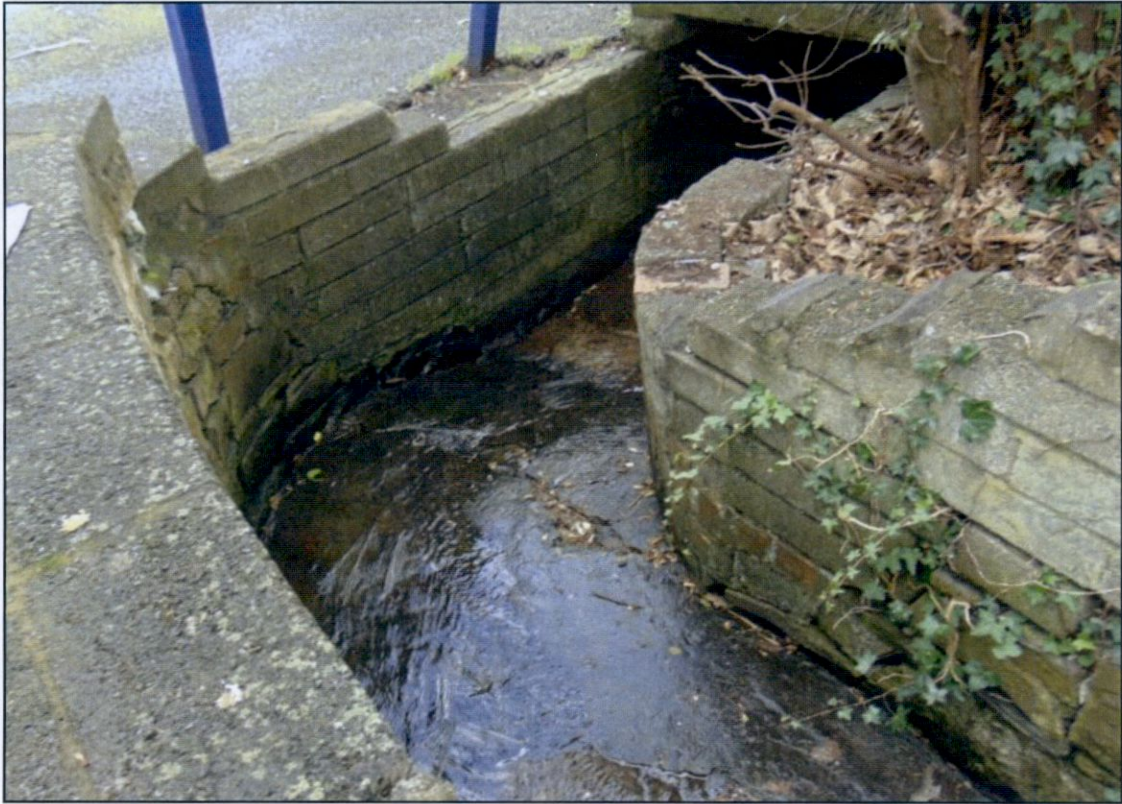
Photo 6: Sump Inlet & Grill

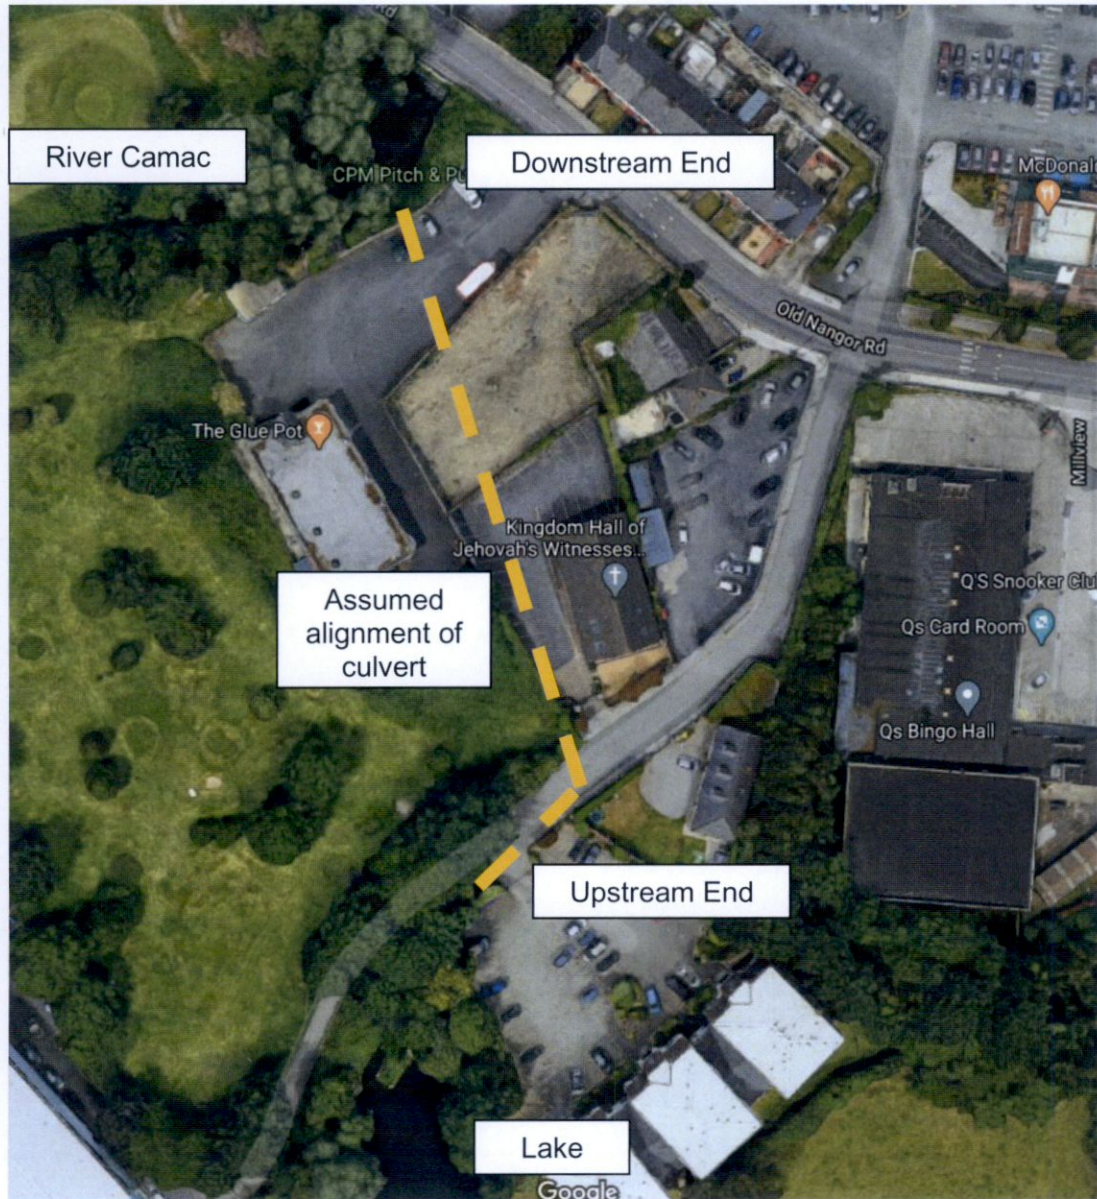
Figure 2: Location Plan

The inspection commenced at the upstream end via a steel grate. Confined space operatives attempted to walk down the culvert but were unable to proceed beyond a blockage in the culvert at the upstream end.
