JG:20:11309WMP01

AWN Consulting Limited

**Preliminary Tree Survey and Report
Trees at Proposed Site at
Newcastle Road
Grange Castle
Co Dublin**

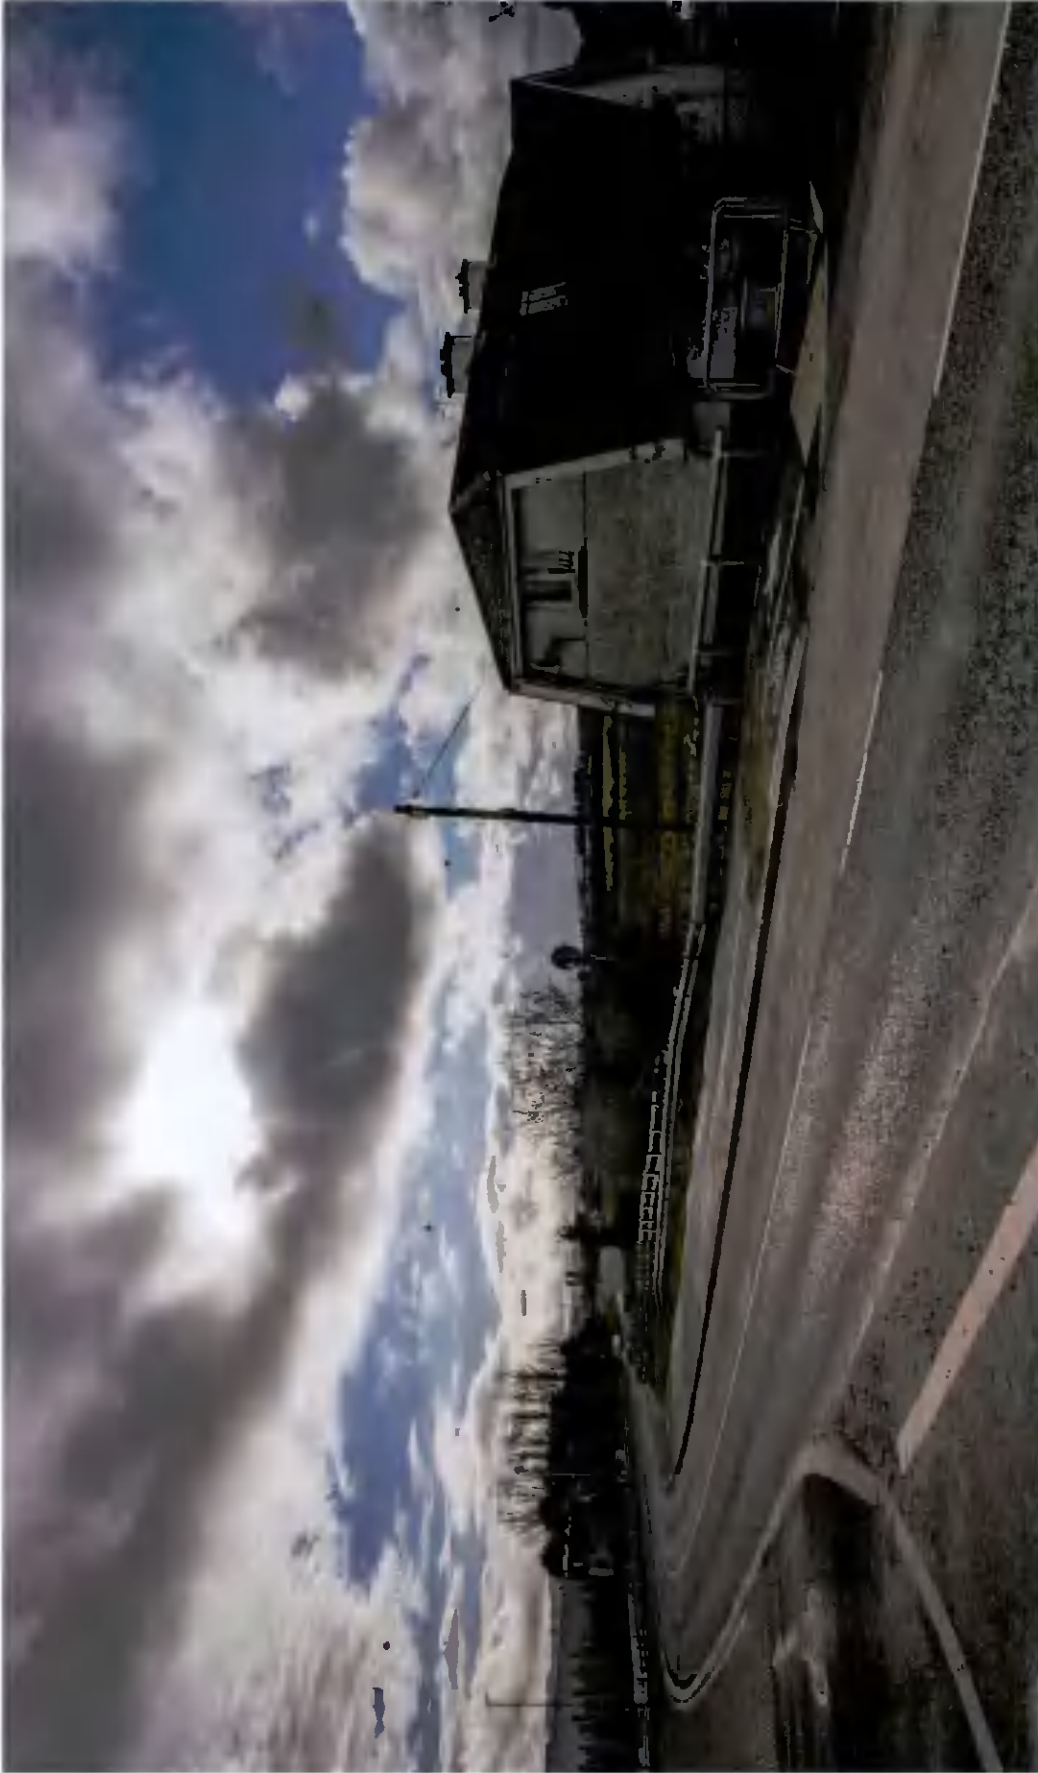
Location	Date	Field of view	35mm equivalent	Distance to site	Camera model
View 1 Existing	04-02-2021	73°	24mm	174m	Canon EOS 5DS

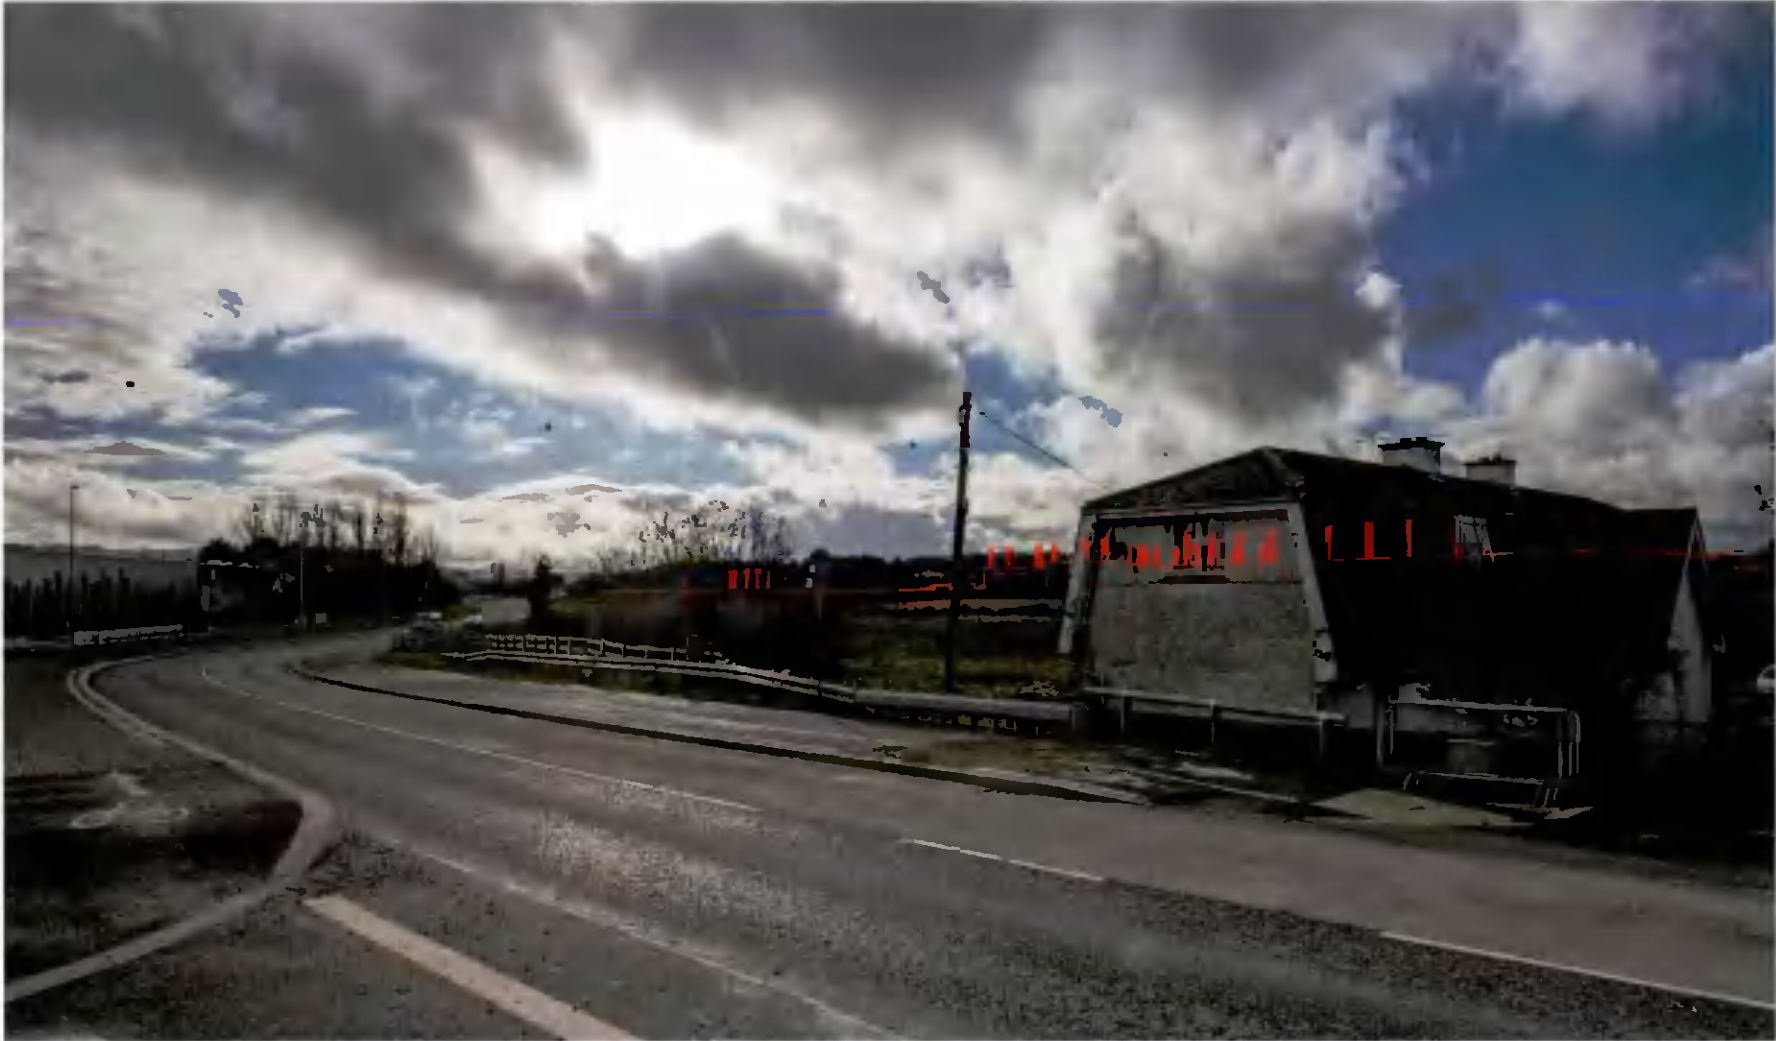
Location	Date	Field of view	35mm equivalent	Distance to site	Camera model
View 1 Proposed	04-02-2021	73°	24mm	174m	Canon EOS SDS

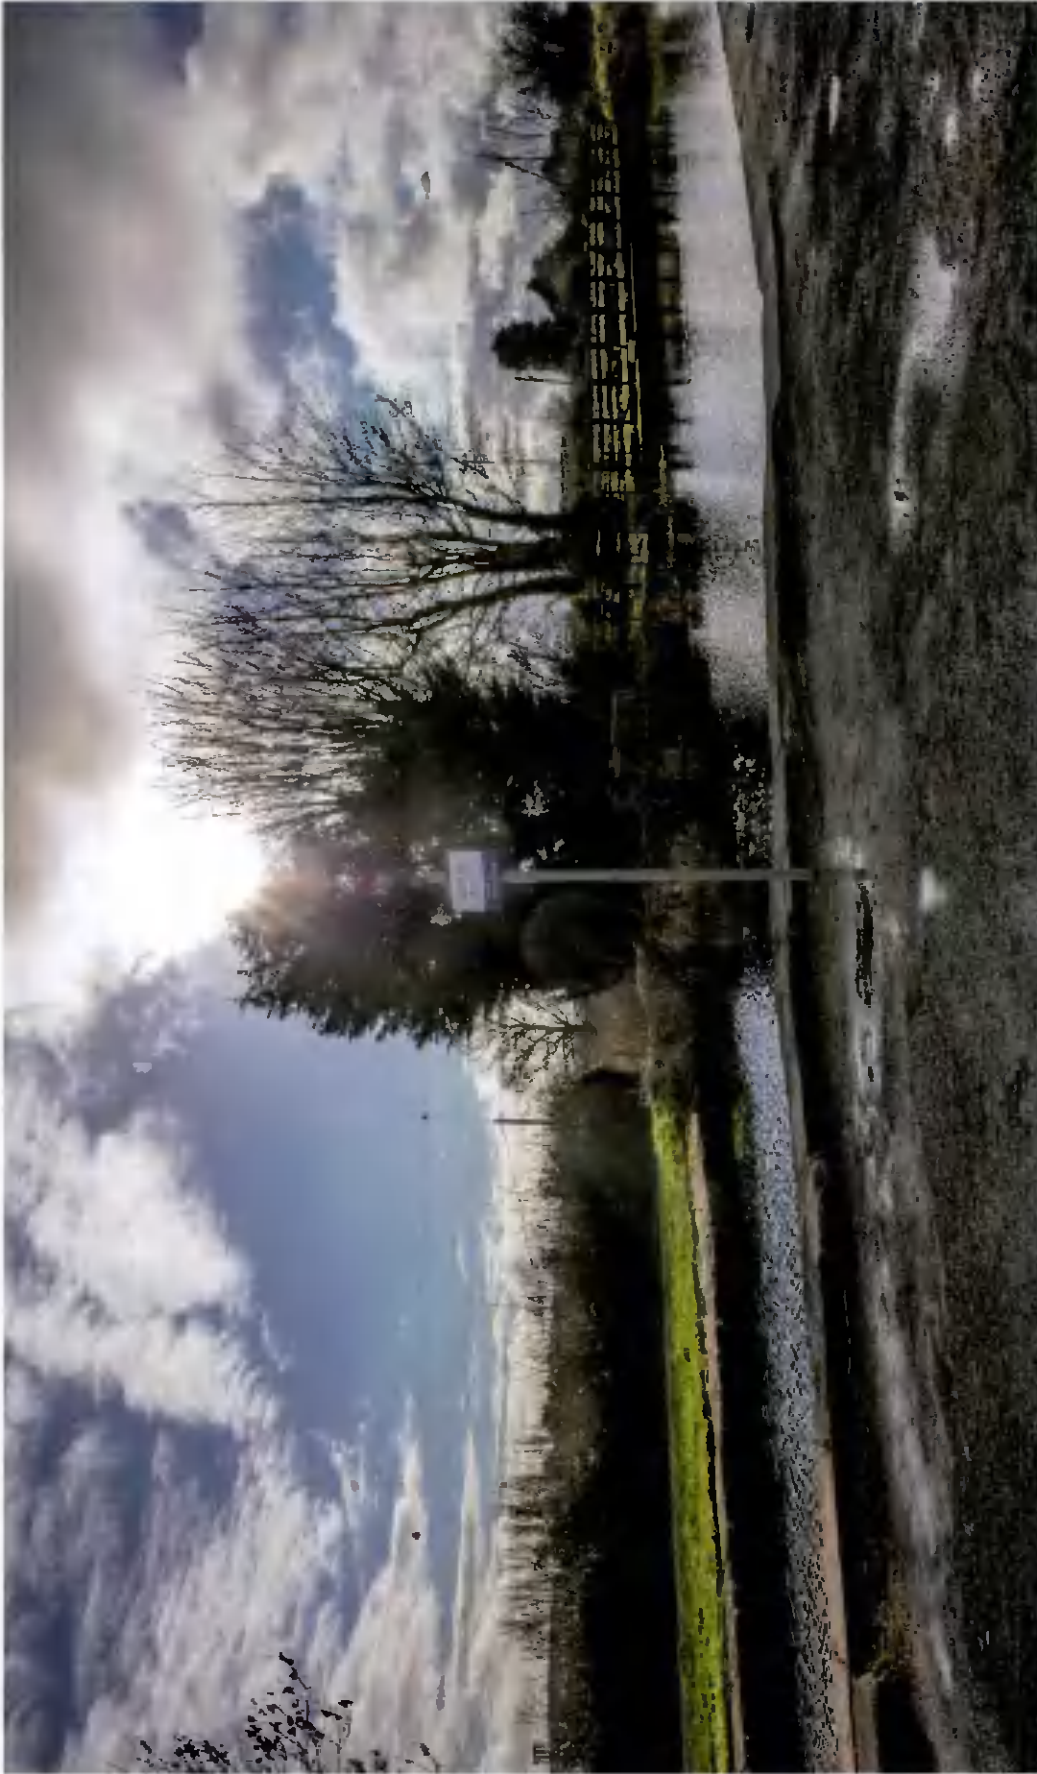
Location	Date	Field of view	35mm equivalent	Distance to site	Camera model
View 2 Existing	04-02-2021	73°	24mm	174m	Canon EOS SDS

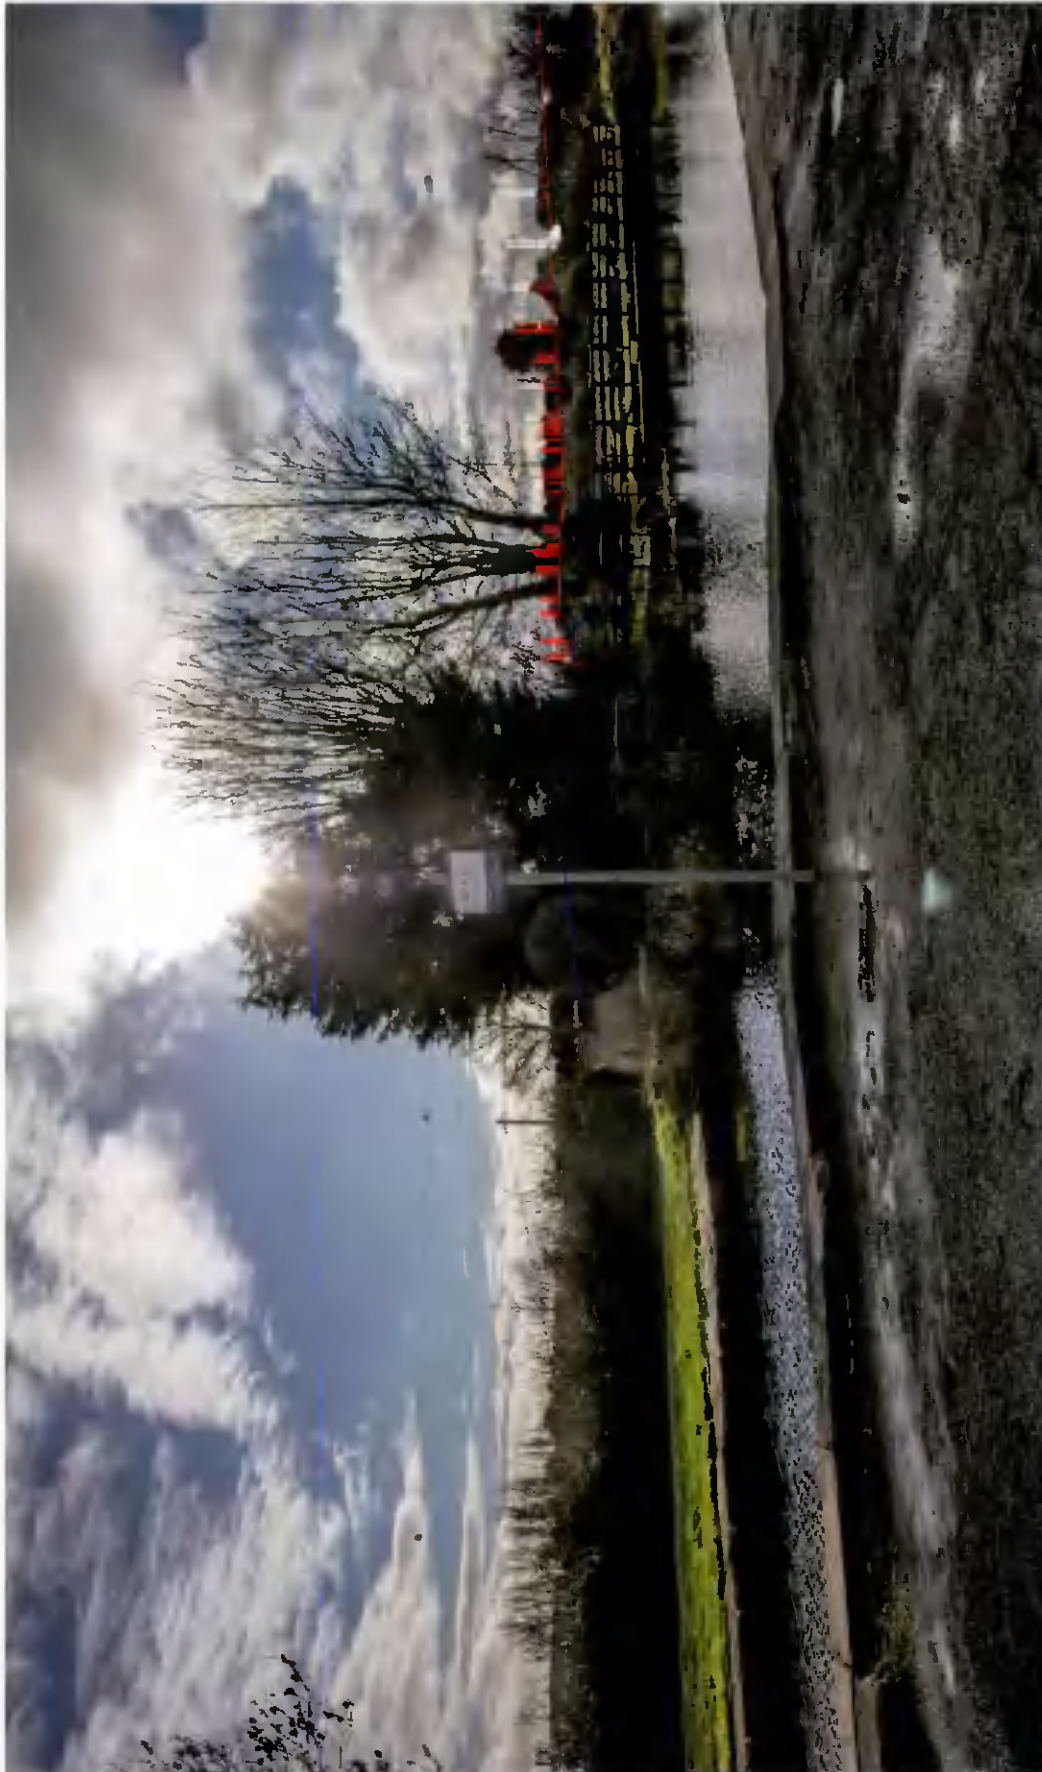
Location	Date	Field of view	35mm equivalent	Distance to site	Camera model
View 2 Proposed	04-02-2021	73°	24mm	174m	Canon EOS 5DS

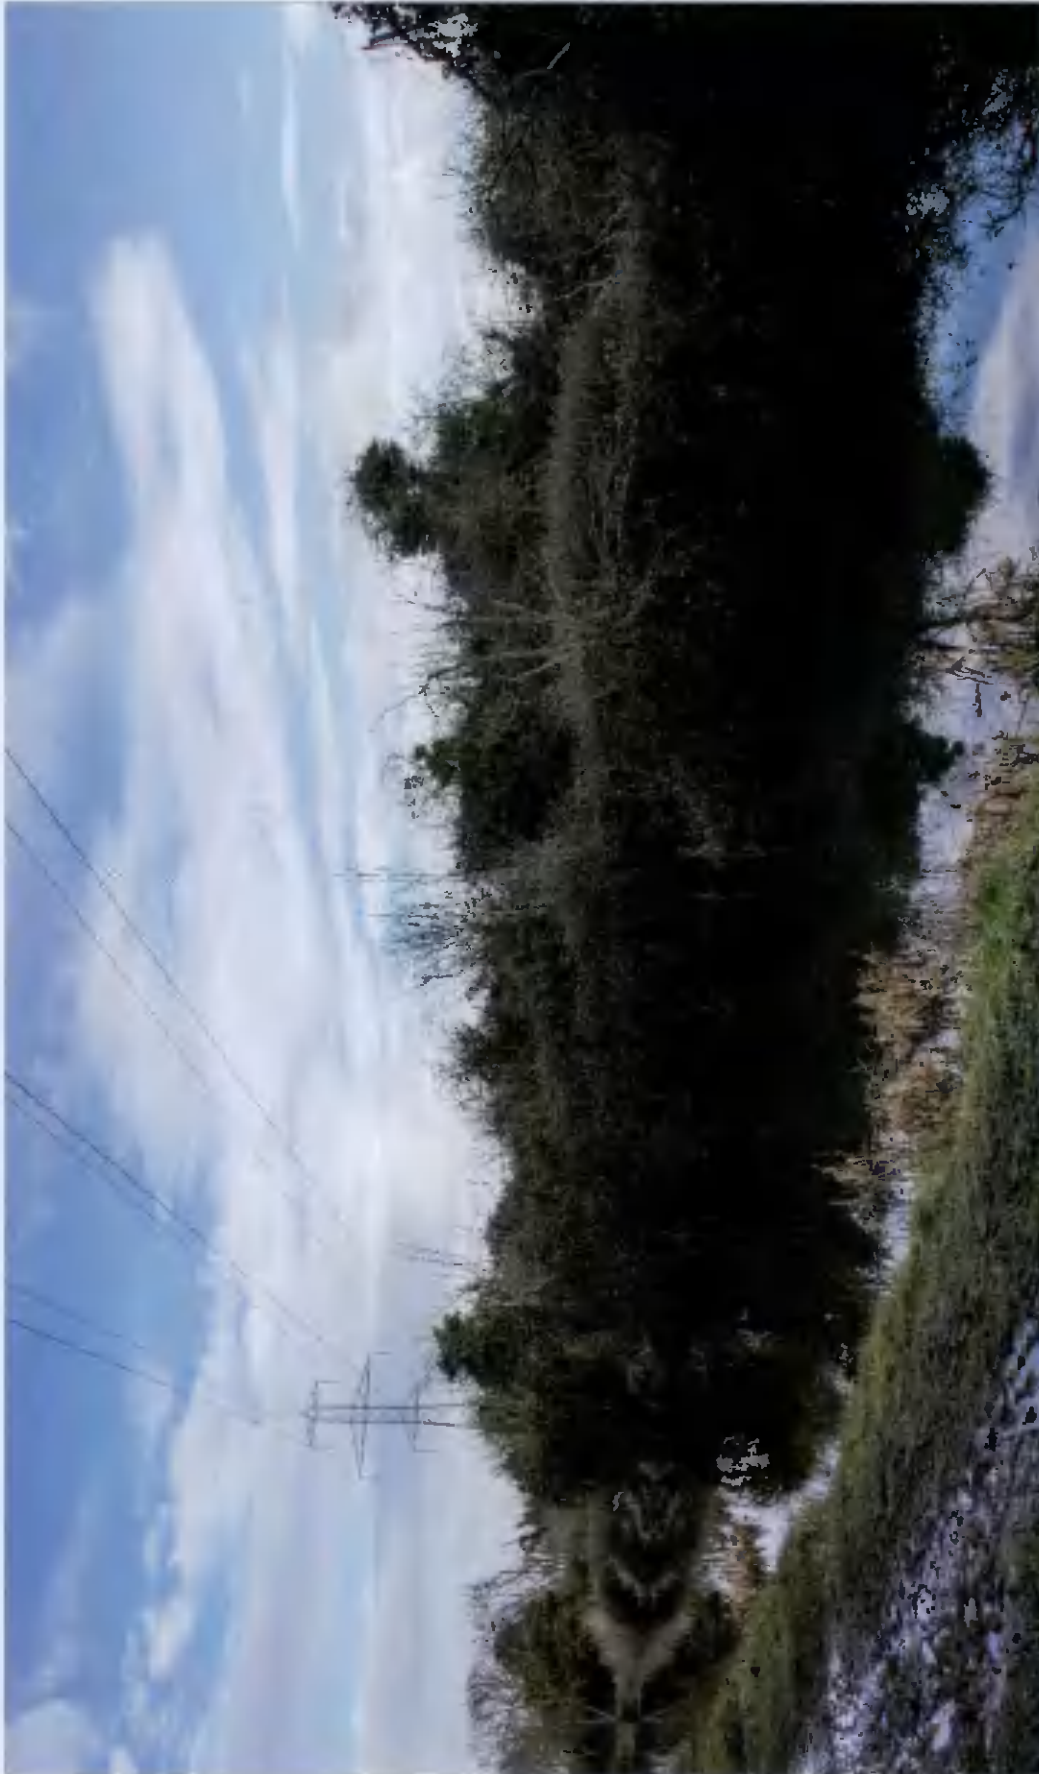
Location	Date	Field of view	35mm equivalent	Distance to site	Camera model
View 3 Existing	04-02-2021	73°	24mm	174m	Canon EOS 5DS

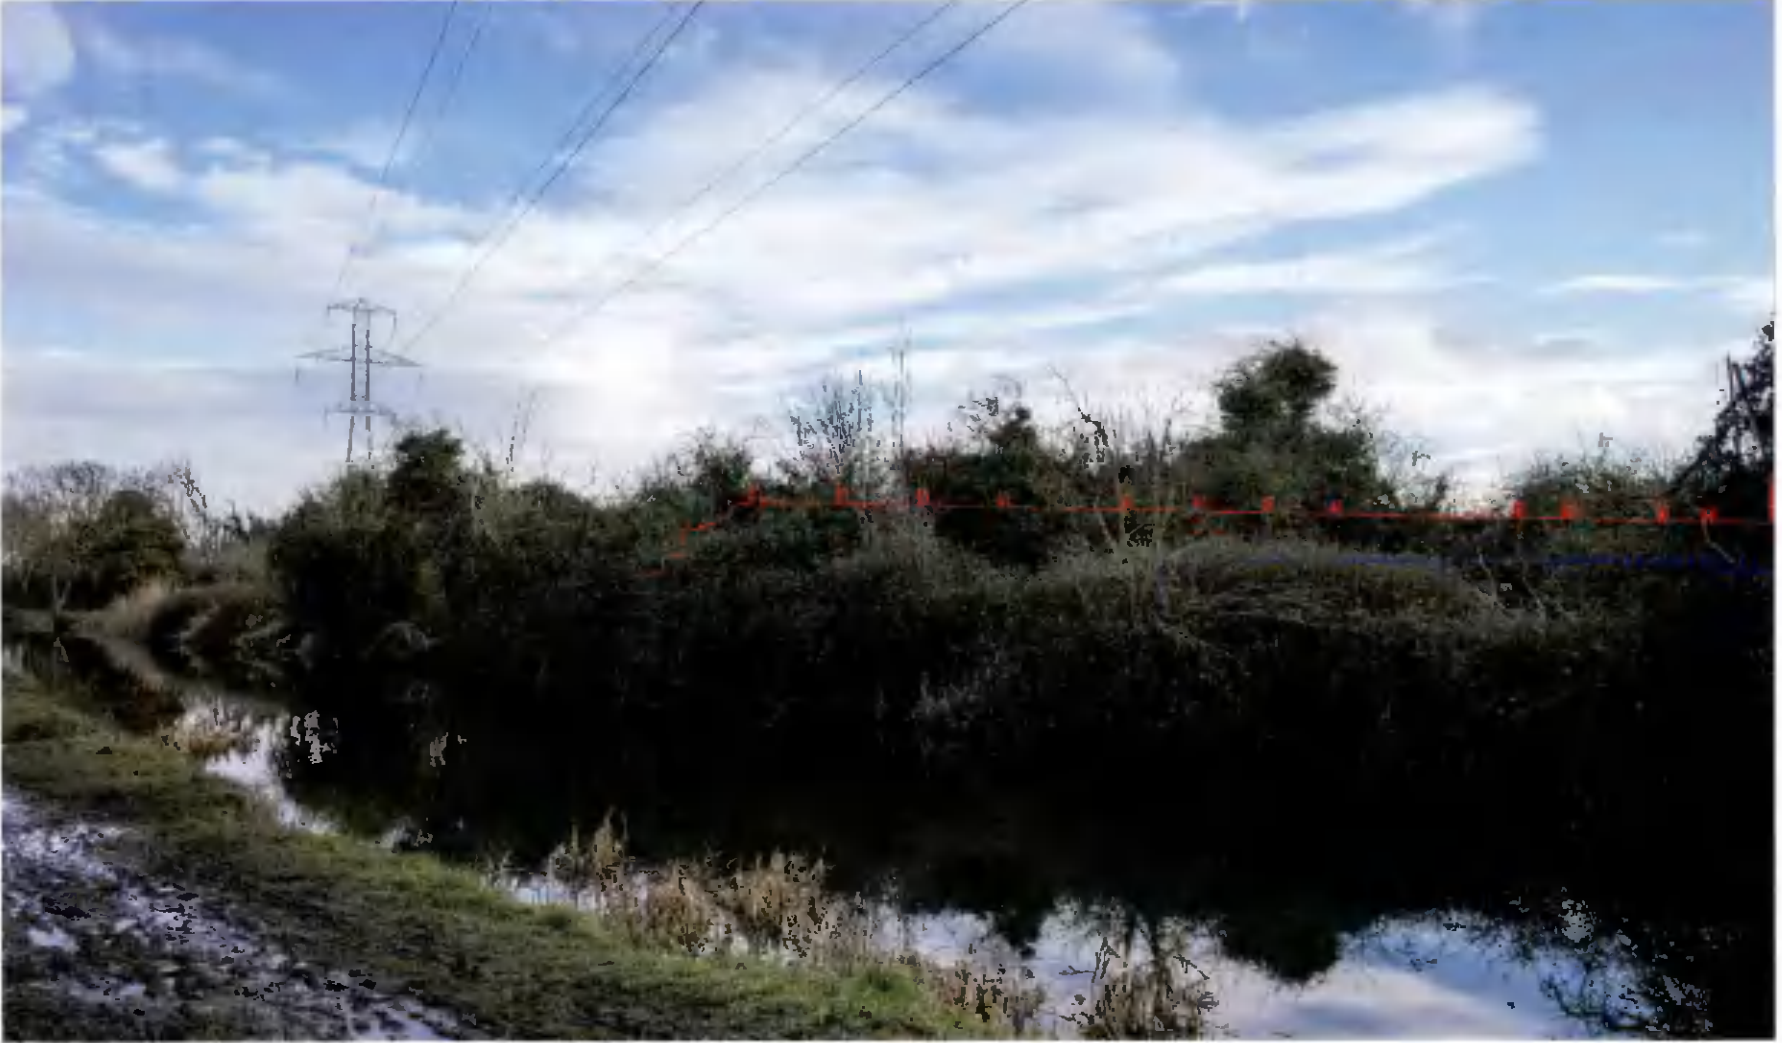
Location	Date	Field of view	35mm equivalent	Distance to site	Camera model
View 3 Proposed	04-02-2021	73°	24mm	174m	Canon EOS SDS

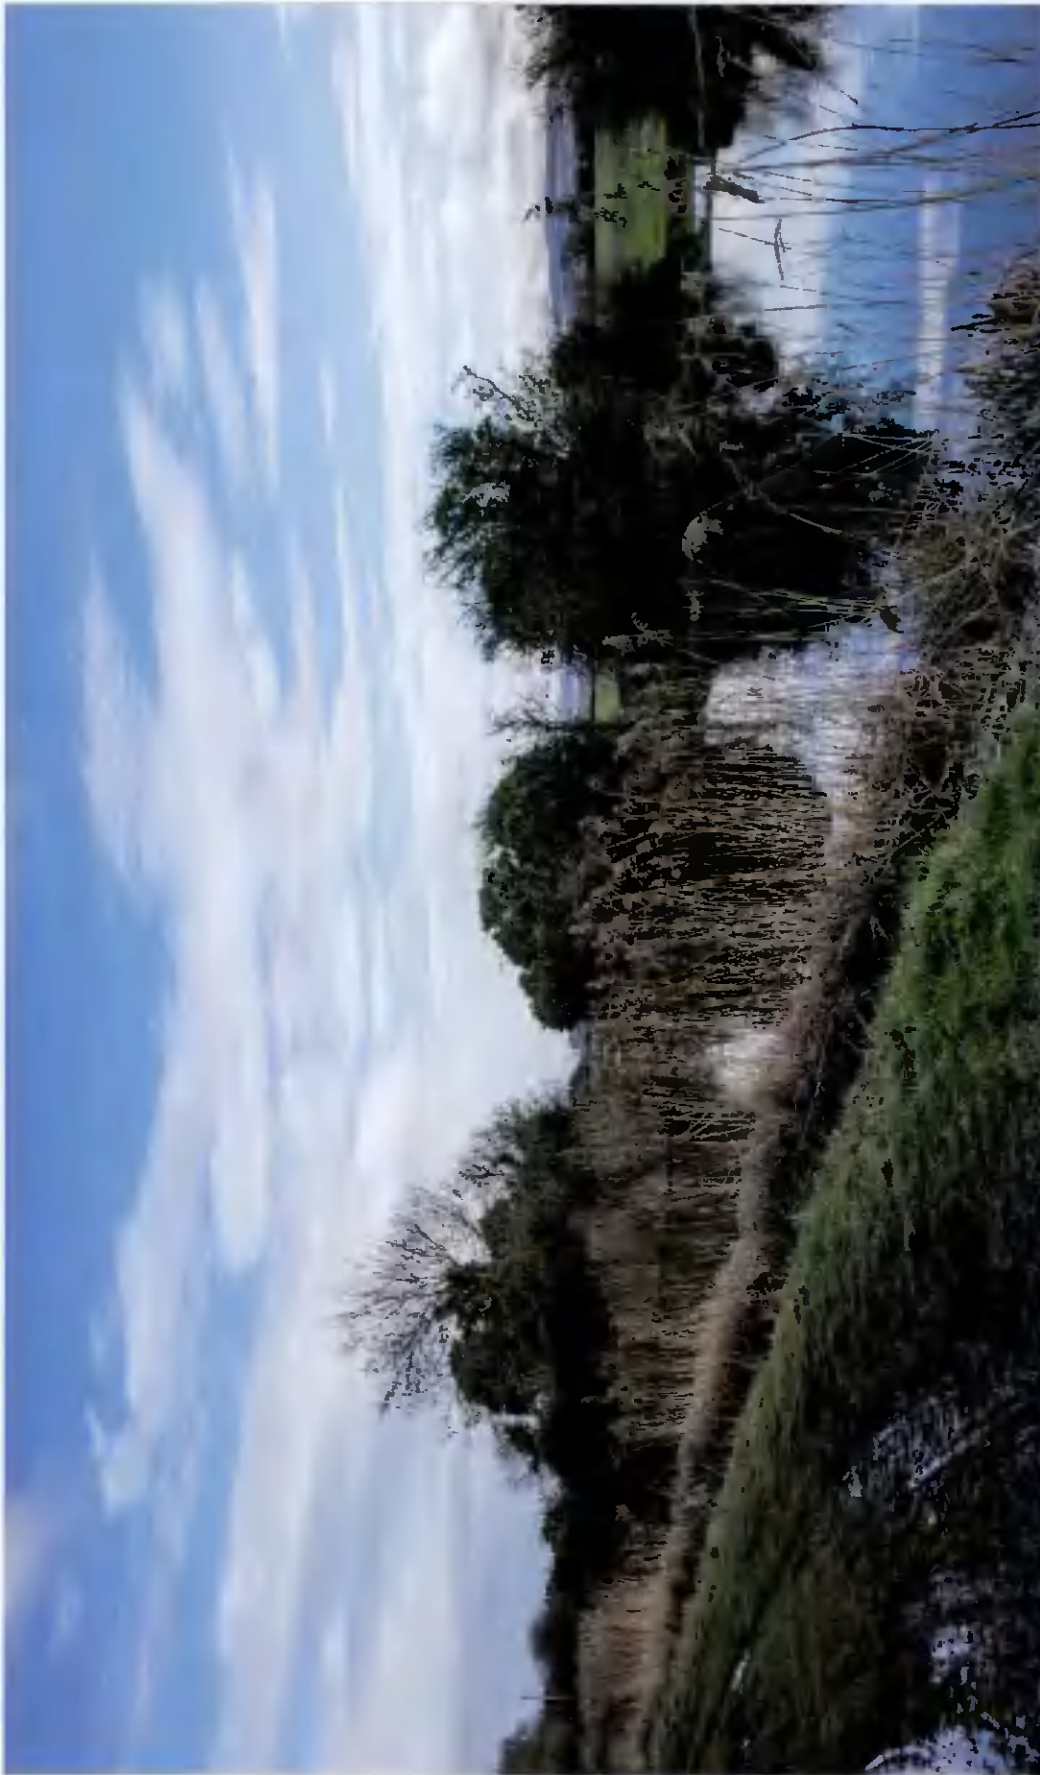
Location	Date	Field of view	35mm equivalent	Distance to site	Camera model
View 4 Existing	04-02-2021	73°	24mm	174m	Canon EOS 5DS

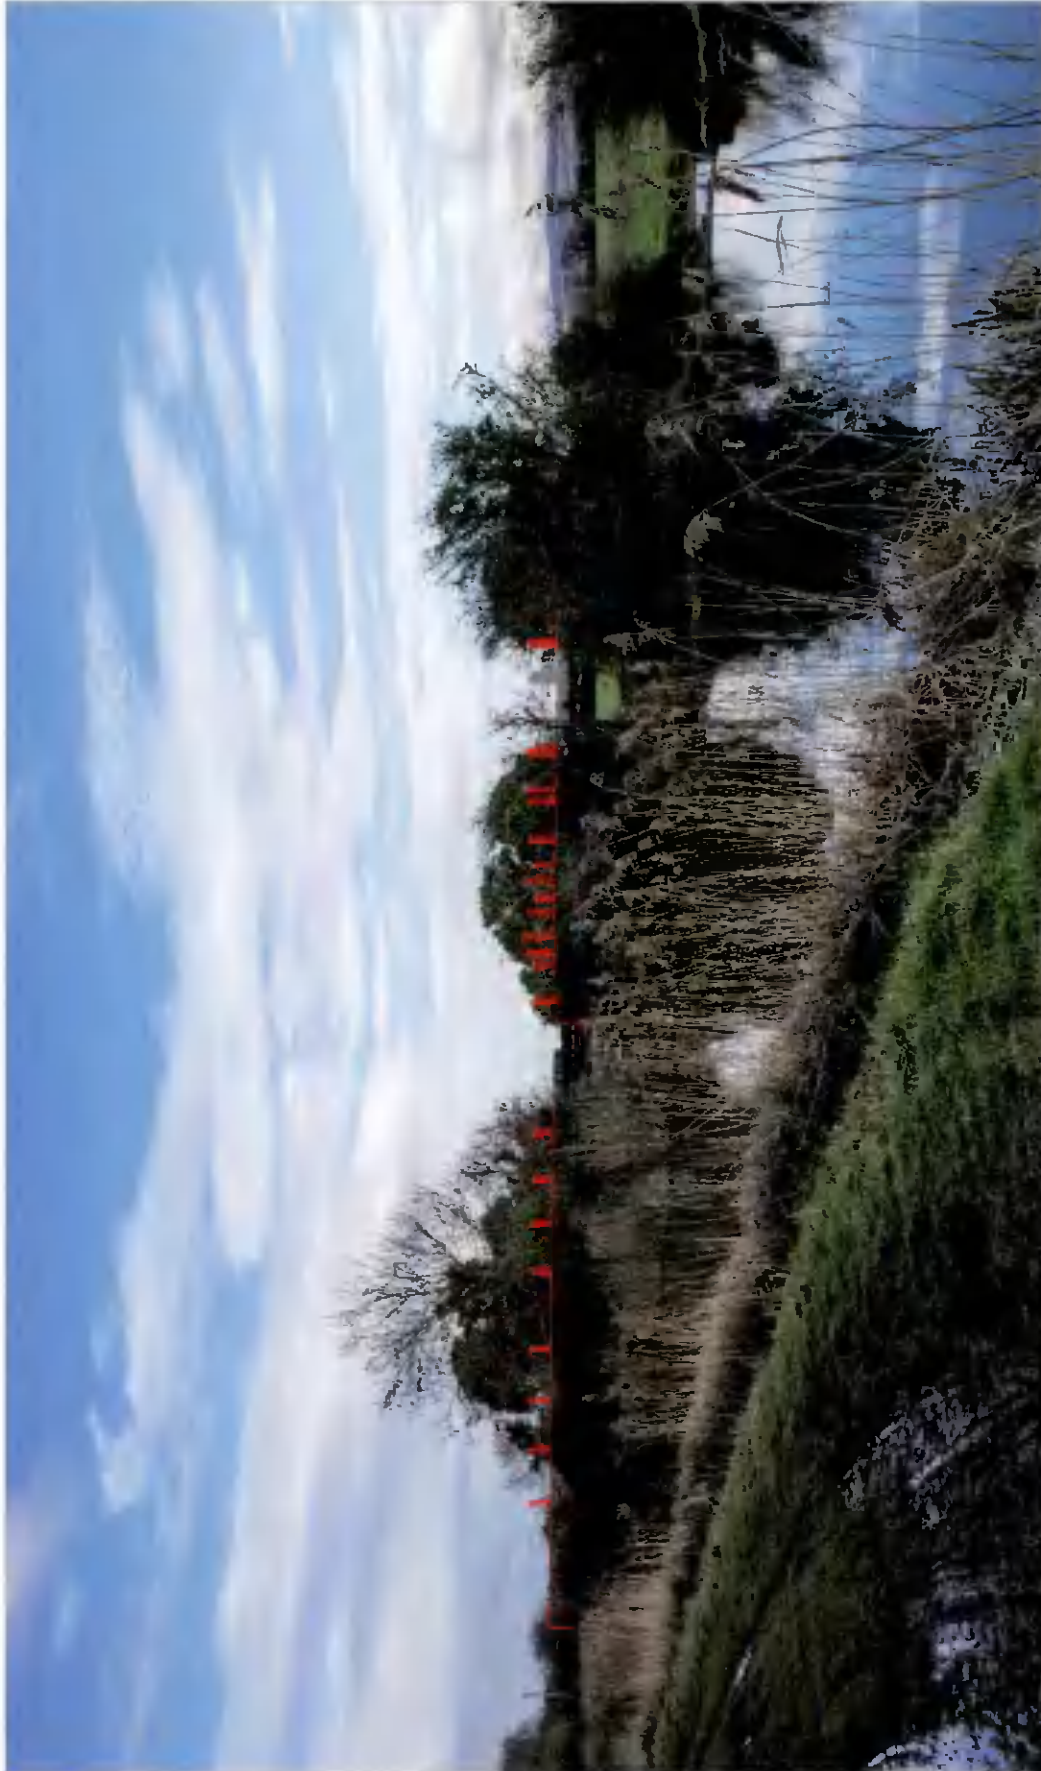
Location	Date	Field of view	35mm equivalent	Distance to site	Camera model
View 4 Proposed	04-02-2021	73°	24mm	174m	Canon EOS 5DS

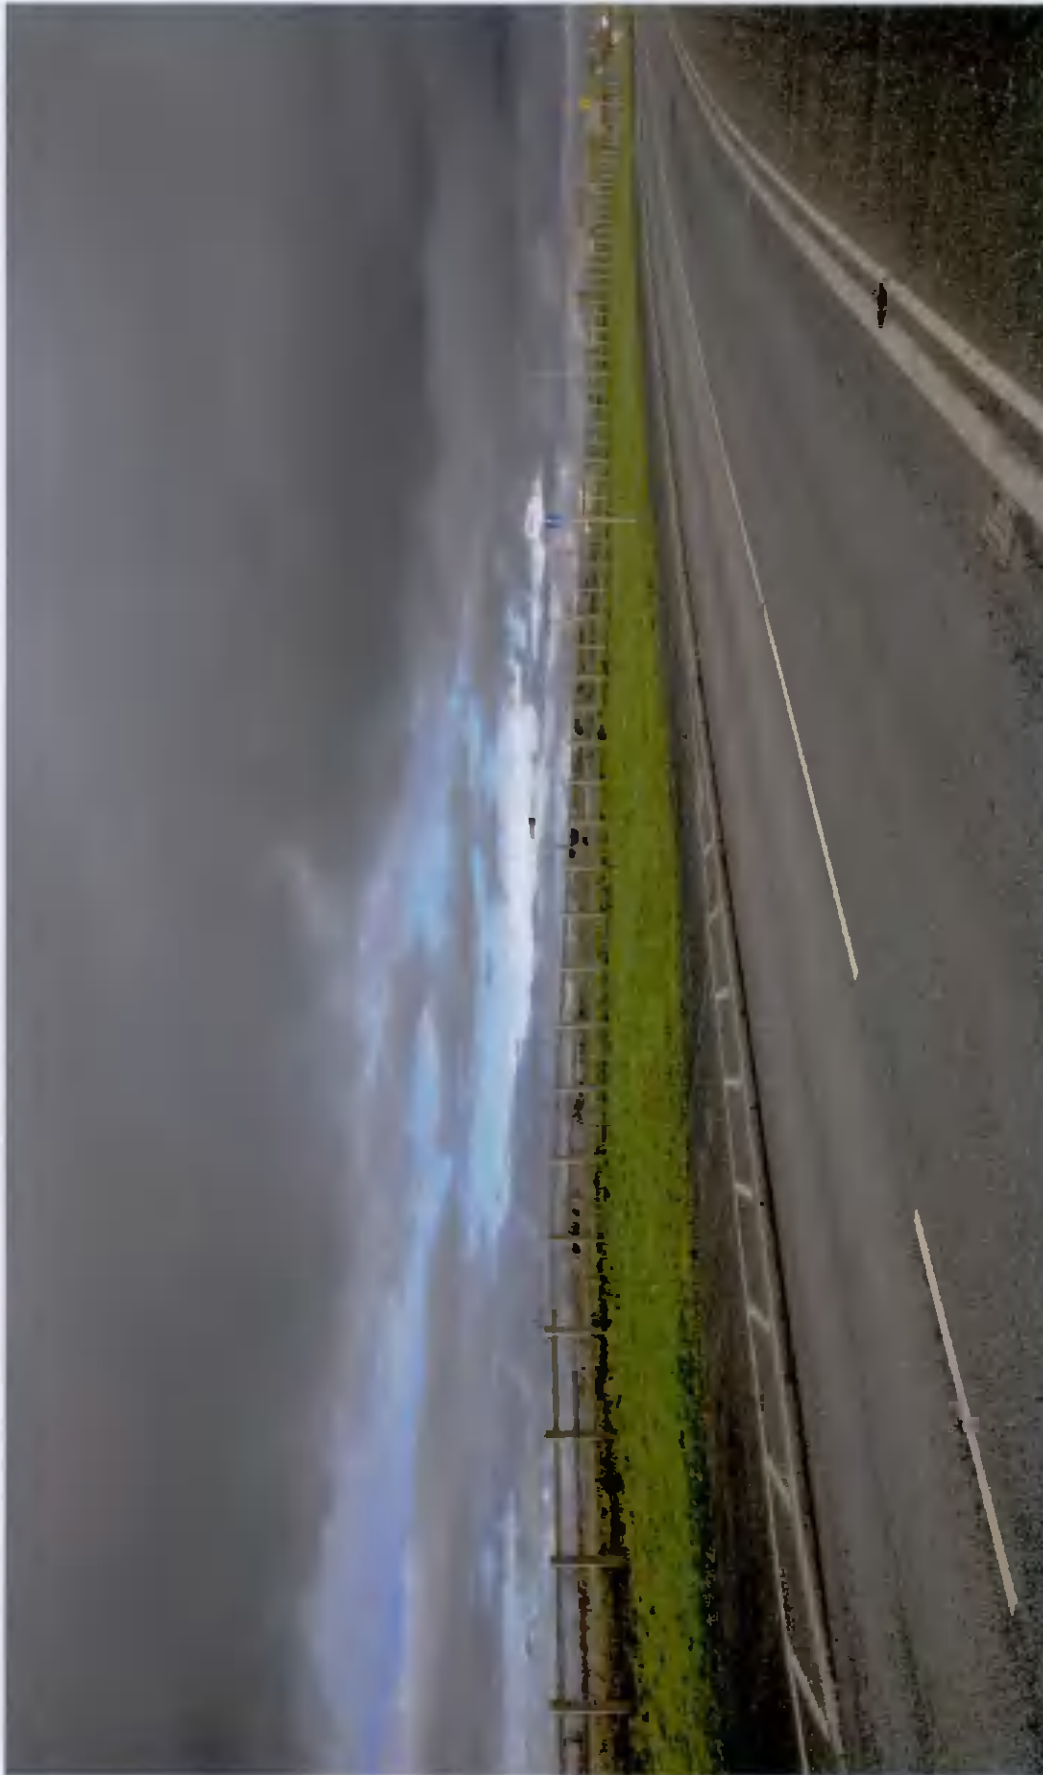
Location	Date	Field of view	35mm equivalent	Distance to site	Camera model
View 5 Existing	04-02-2021	73°	24mm	174m	Canon EOS 5DS

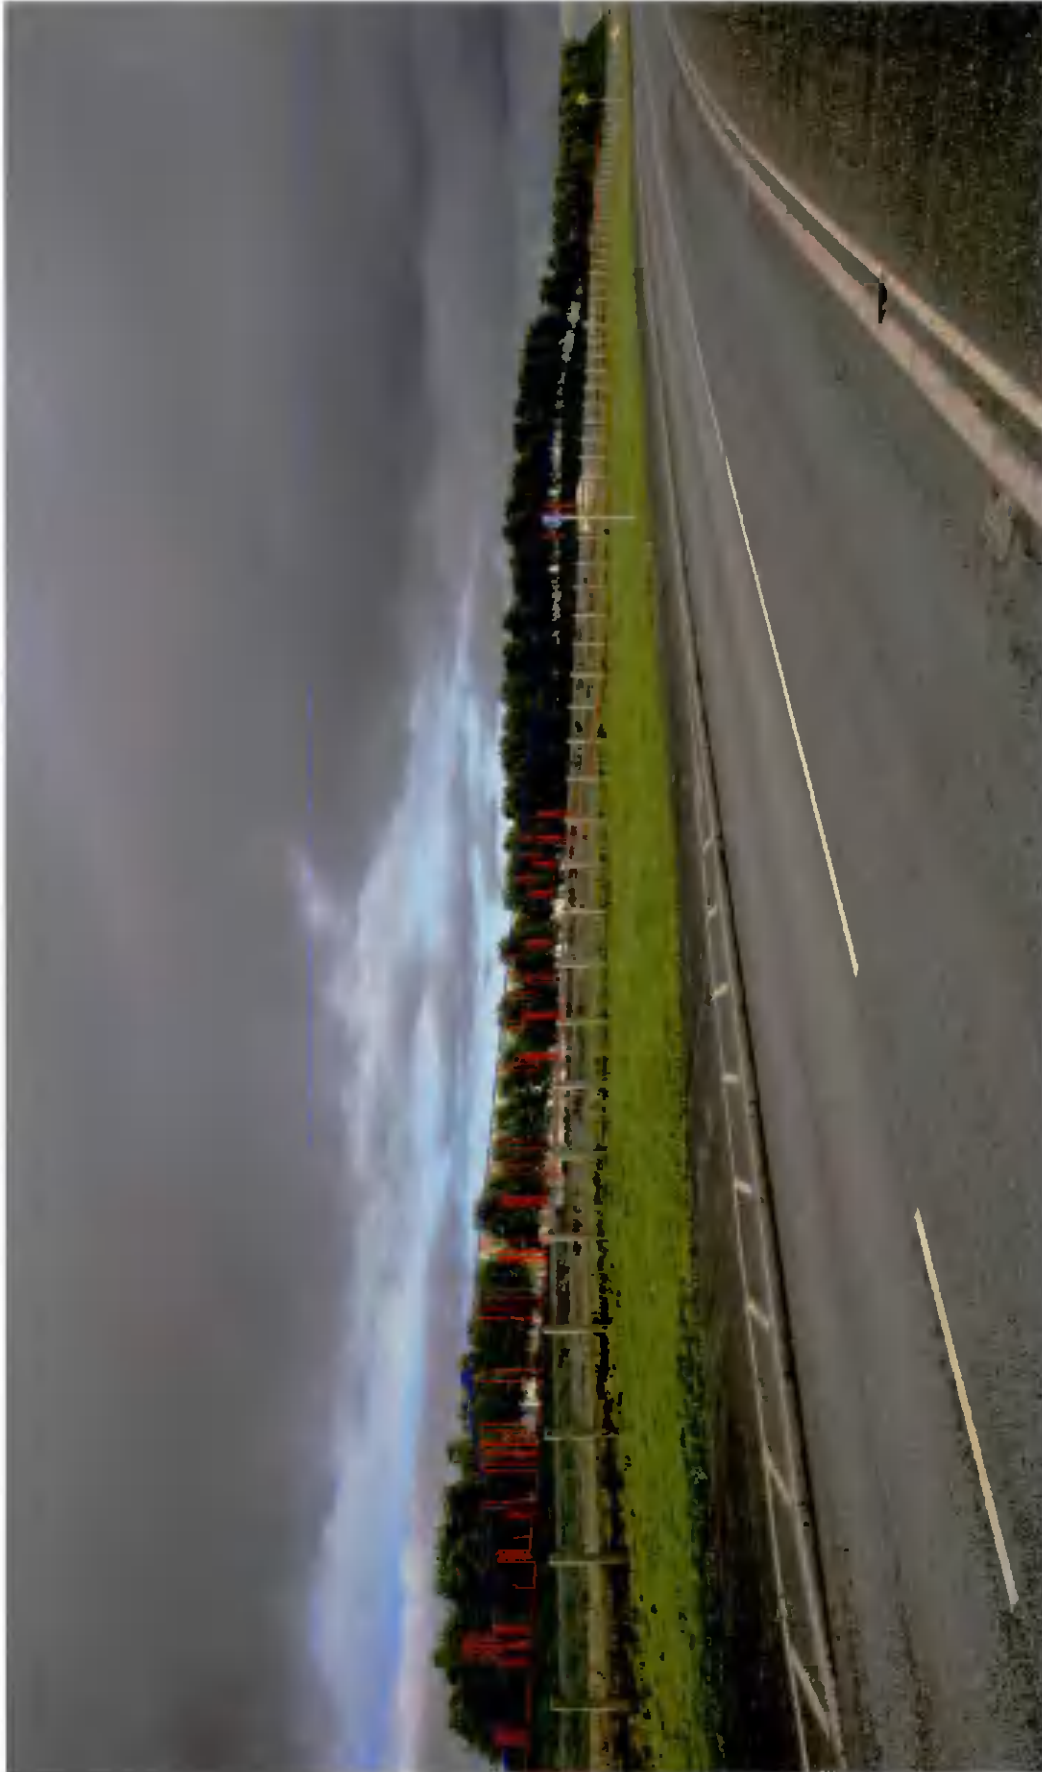
Location	Date	Field of view	35mm equivalent	Distance to site	Camera model
View 5 Proposed	04-02-2021	73°	24mm	174m	Canon EOS 5DS

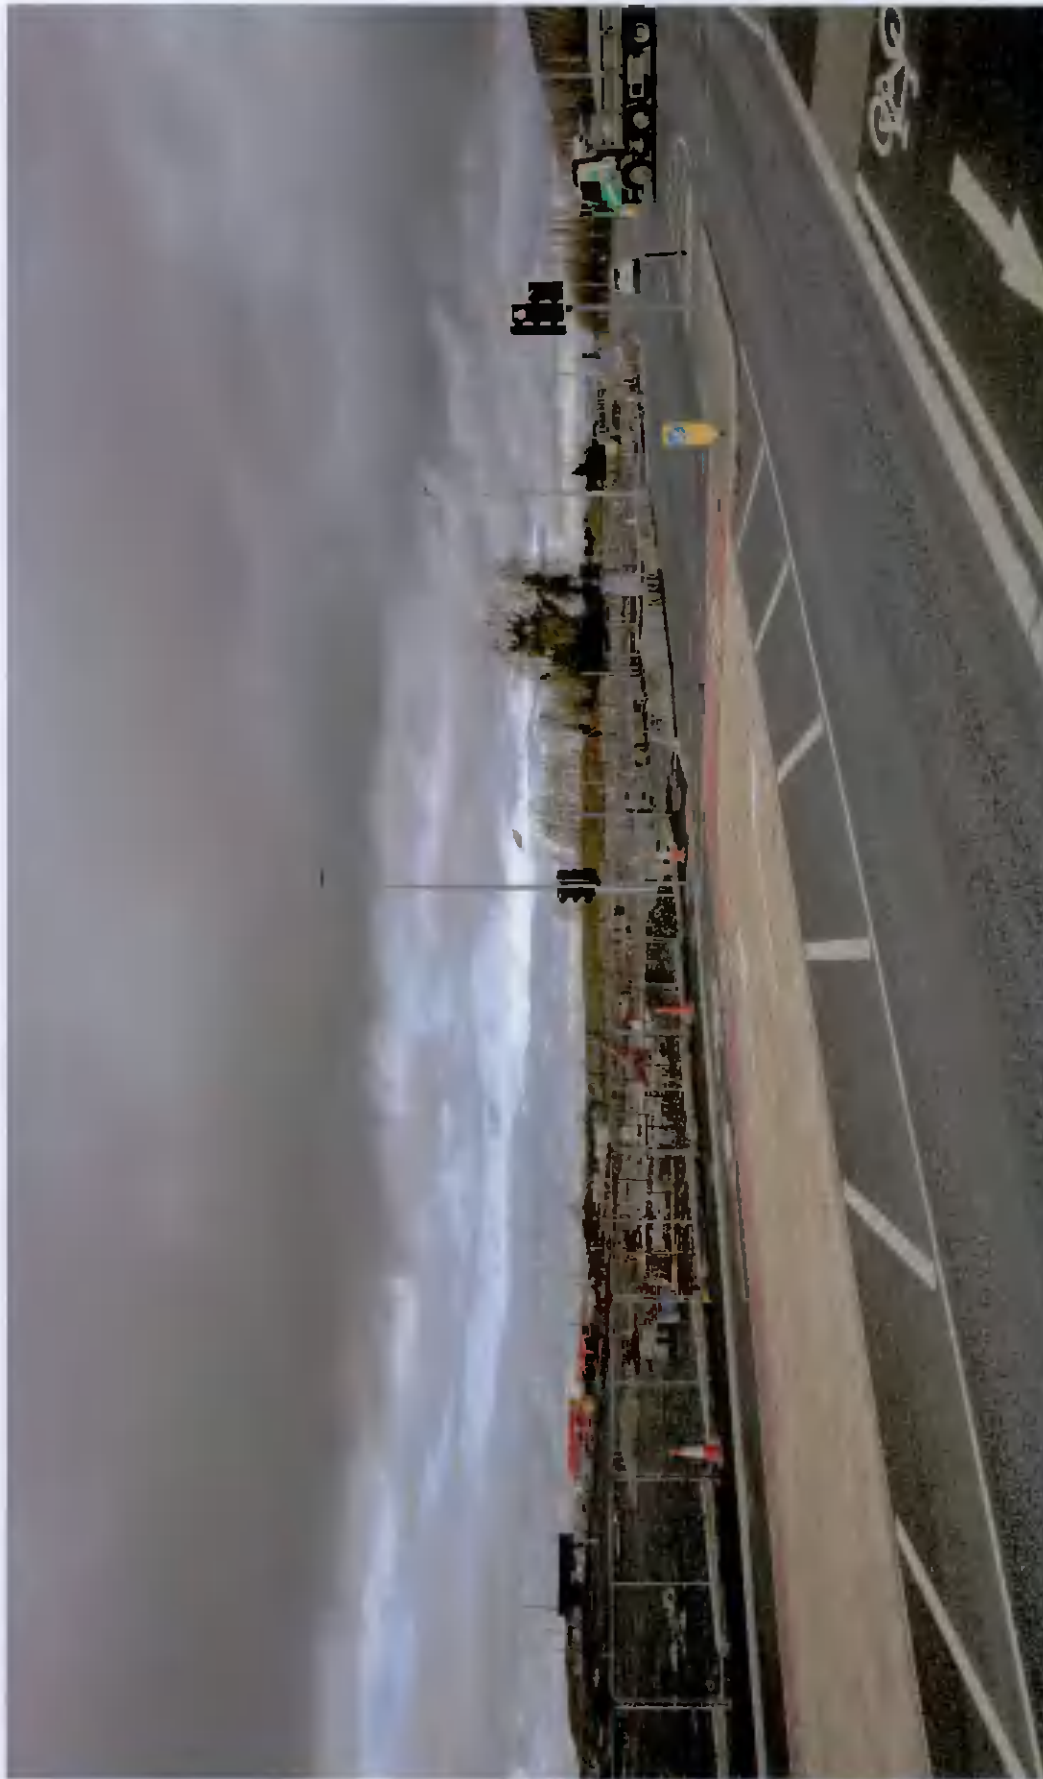
Location	Date	Field of view	35mm equivalent	Distance to site	Camera model
View 6 Existing	04-02-2021	73°	24mm	174m	Canon EOS 5DS

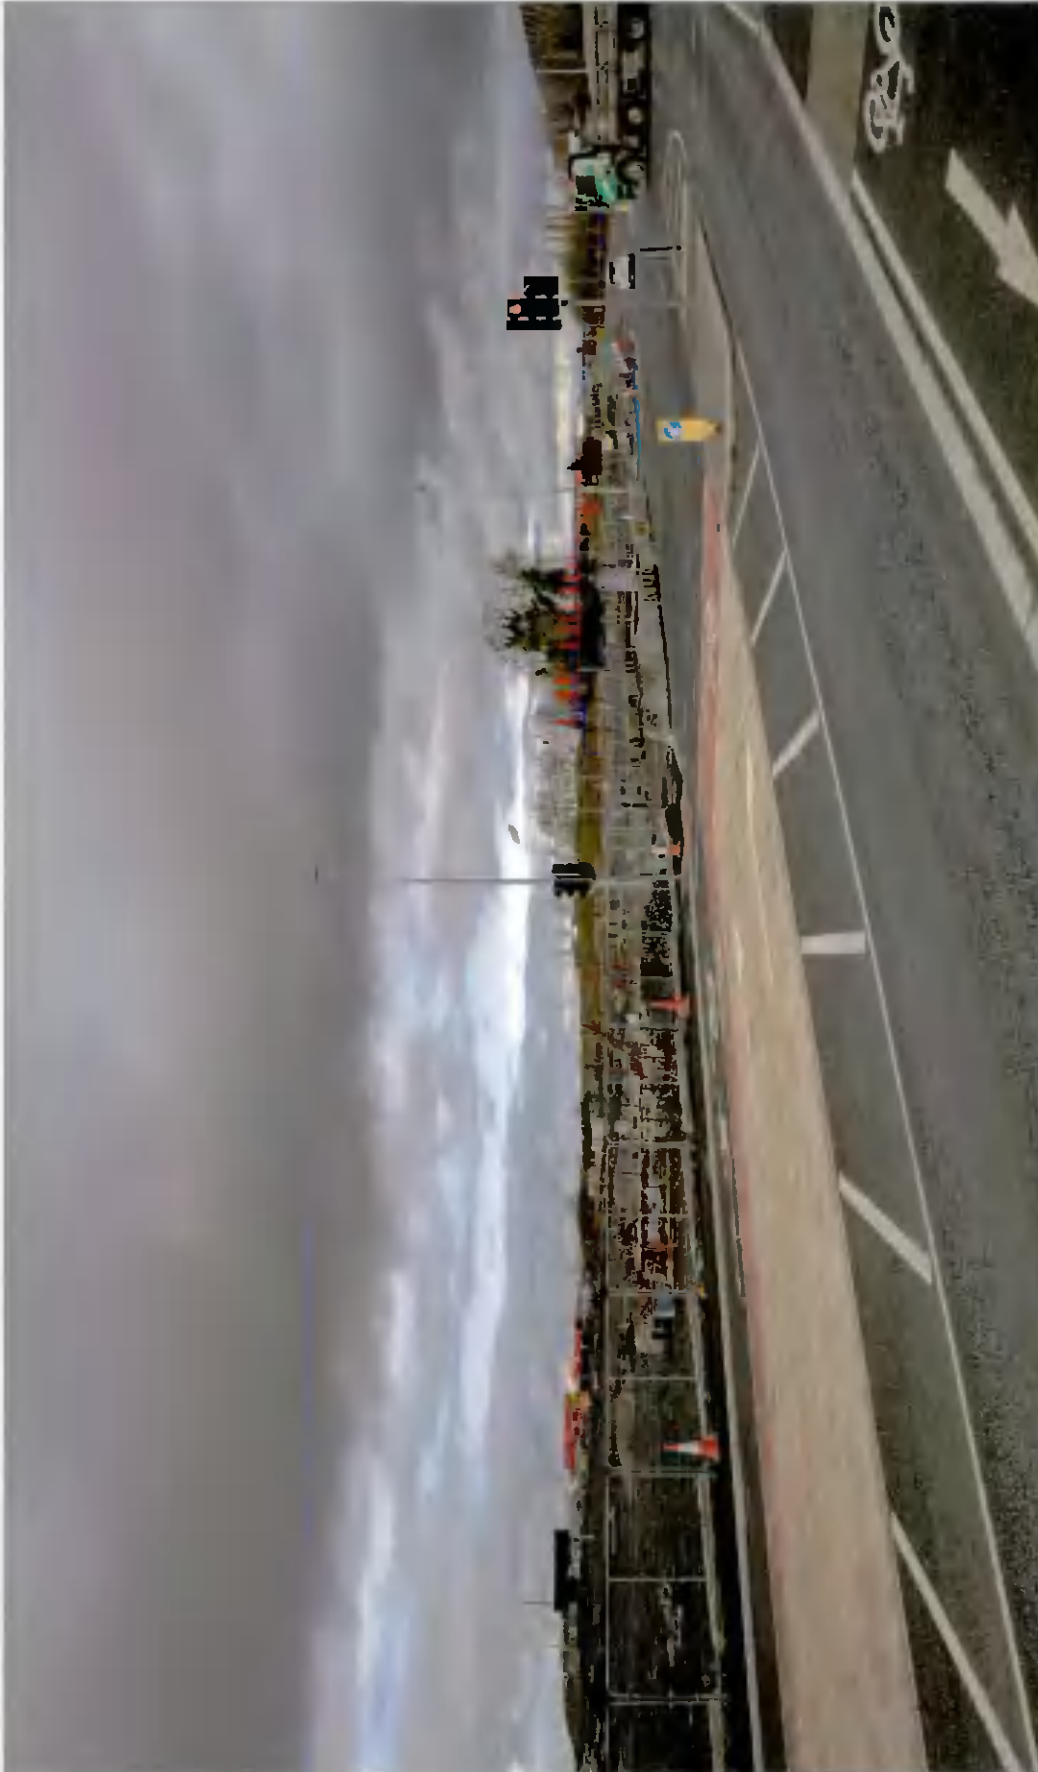
Location	Date	Field of view	35mm equivalent	Distance to site	Camera model
View 6 Proposed	04-02-2021	73°	24mm	174m	Canon EOS 5DS
