JG:20:11309WMP01

AWN Consulting Limited

**Preliminary Tree Survey and Report
Trees at Proposed Site at
Newcastle Road
Grange Castle
Co Dublin**

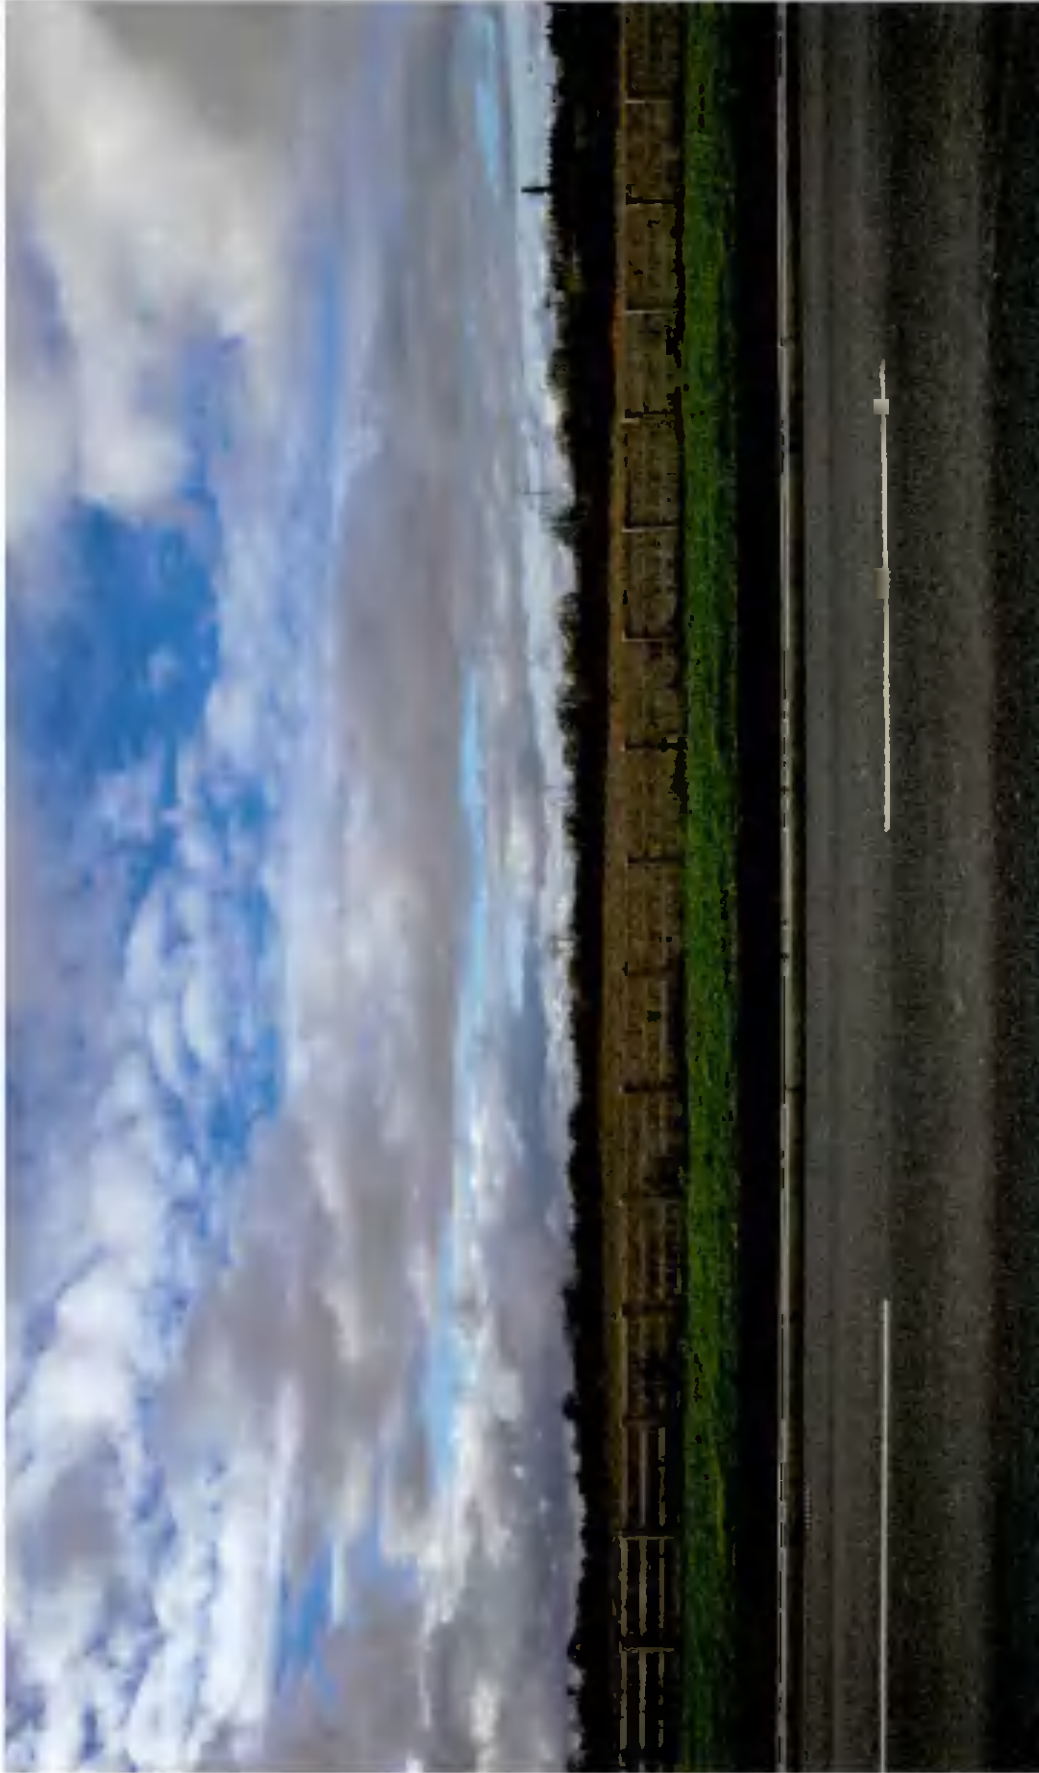
Location	Date	Field of view	35mm equivalent	Distance to site	Camera model
View 7 Existing	04-02-2021	73°	24mm	174m	Canon EOS 5DS

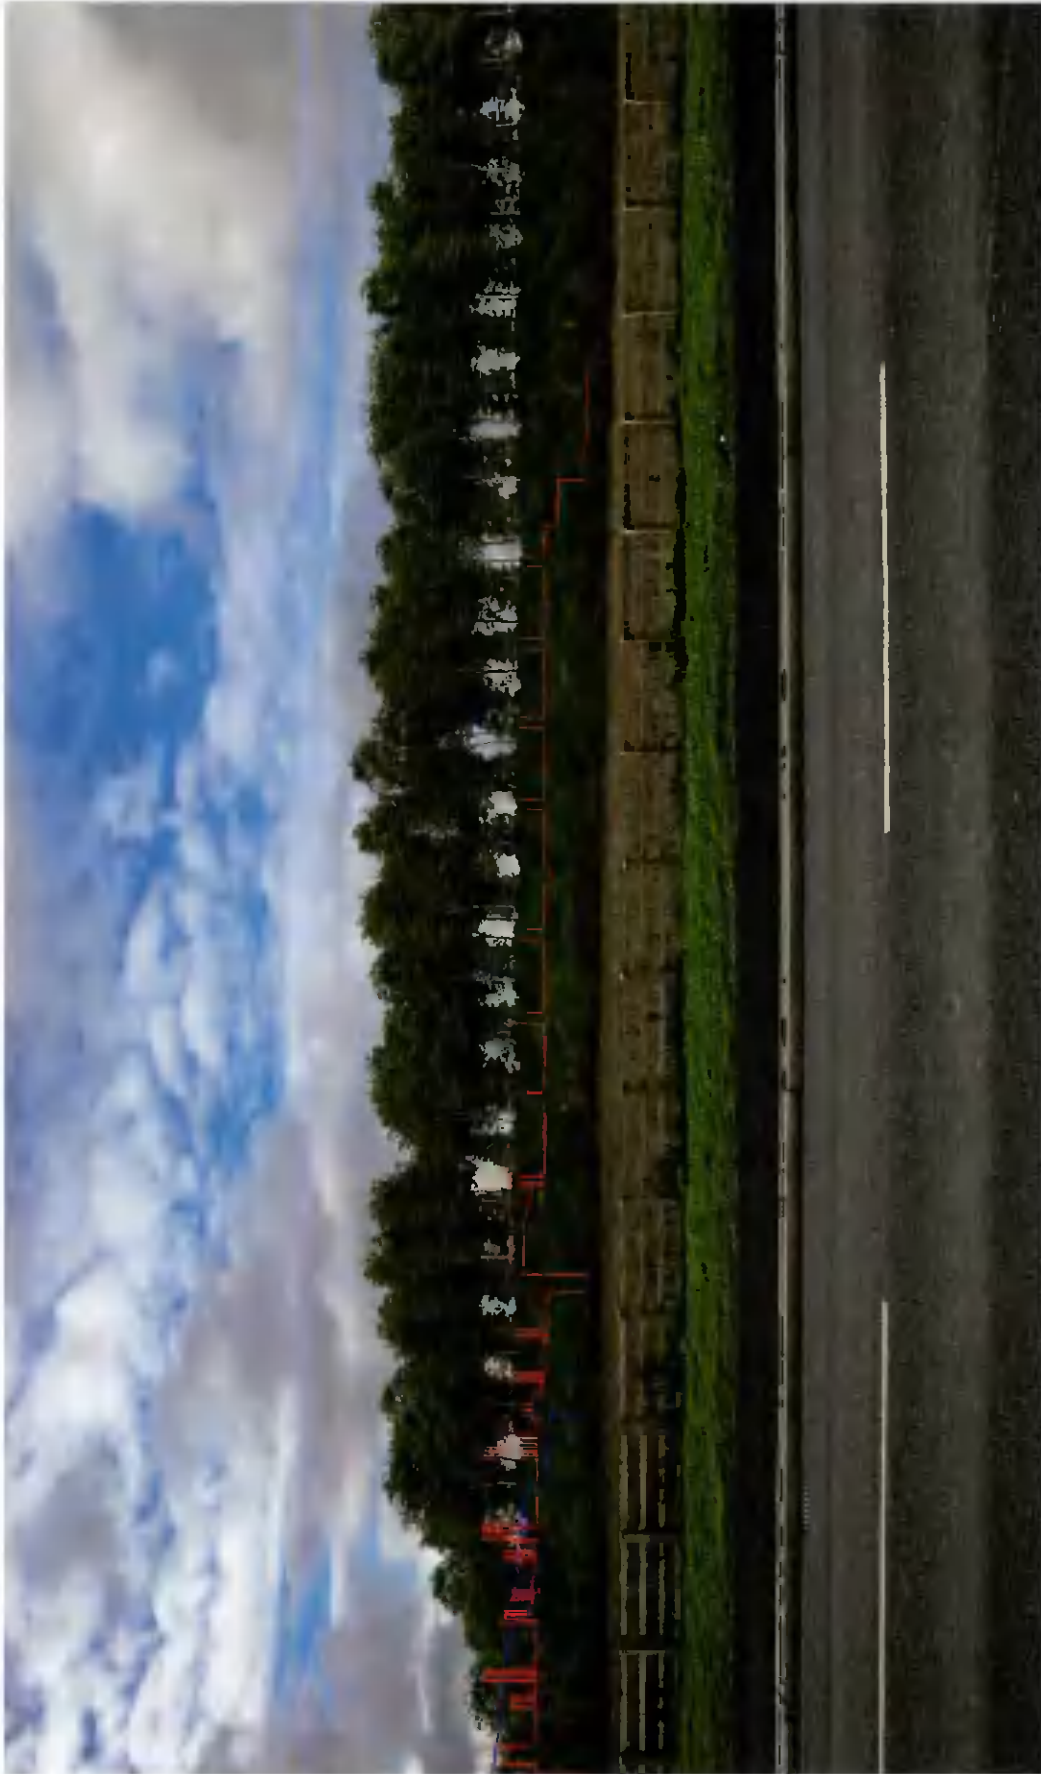
Location	Date	Field of view	35mm equivalent	Distance to site	Camera model
View 7 Proposed	04-02-2021	73°	24mm	174m	Canon EOS 5DS

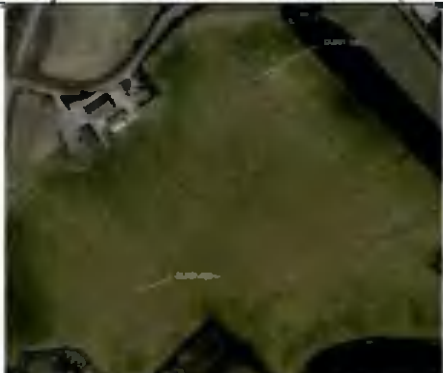
Images

RMP No.	DU021-108
Townland	BALLYBANE
Site Type	Concentric enclosure
NGR	703060, 730985
Description	Not indicated on any OS map a large concentric enclosure is visible as a crop-mark on an aerial photo. A second enclosure (DU021-109----) is visible to the SW. The area of AH1 contains a recorded concentric enclosure (DU021-108). This site contains subsurface remains of a large double ditched enclosure and the morphology of this monument and its associated ditches suggest it is of possible early medieval date. However, 12 th to 13 th century pottery finds associated with the upper fills of both the internal and external ditch appear to suggest multiple periods of activity. Internal features and deposits within the enclosure are suggestive of settlement evidence. This monument has a diameter of approximately 60m (Stirland 2016, 10).
Sources	RMP Google Maps. Stirland, J. (ACS) 2016 Archaeological testing at Grange Castle South Business Park Ballybane, Clondalkin, Dublin 22 (16E0531).
