### 2.3 Proposed Landscaping

## 4. Bat Survey

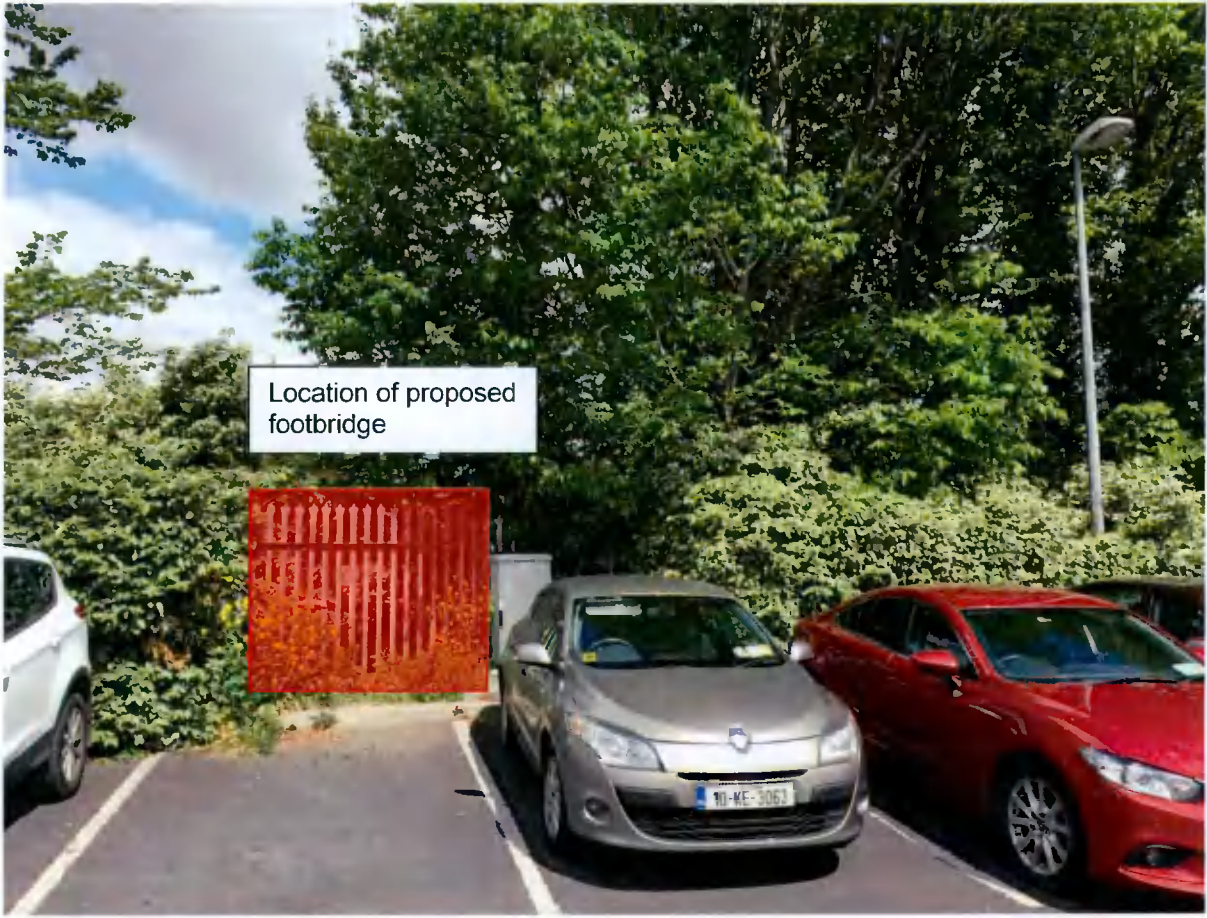
Location of proposed  
footbridge

Minimal clearance of the existing hedge growth will be required as the footbridge is positioned immediately adjacent to a telecom switchbox which is already clear of dense vegetation:

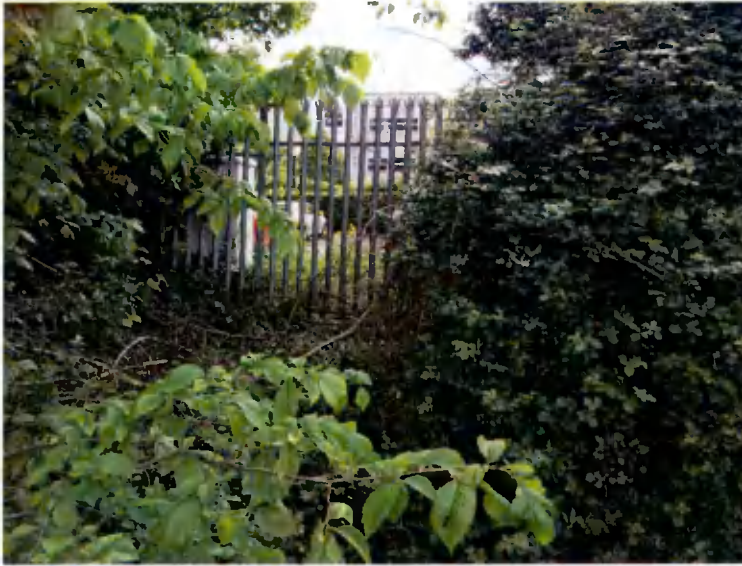
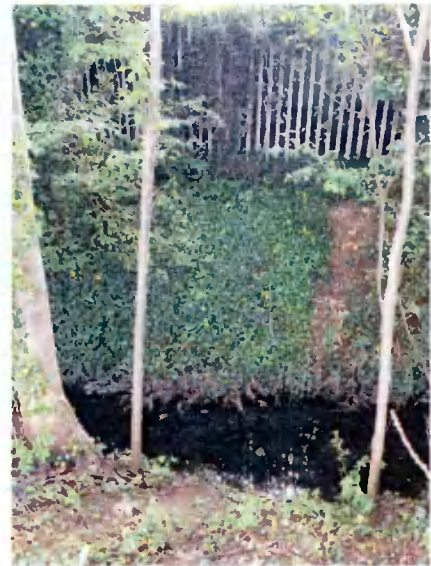
This is a repeat on the Airton Close side of the drainage channel:

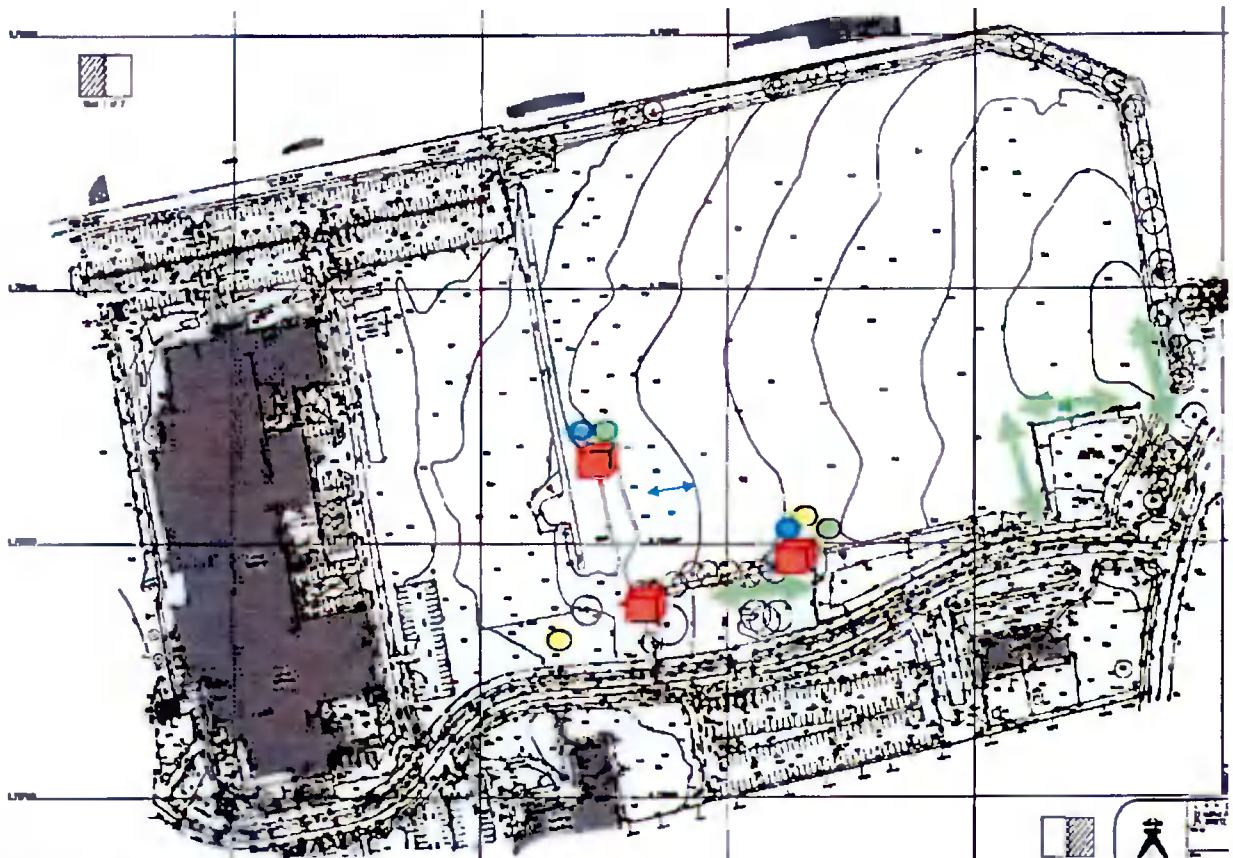
**Bat activity at ITT noted on 3<sup>rd</sup> to 4<sup>th</sup> May 2016**

Red box - Location of SM2 monitor

Green arrow - Feeding activity of common pipistrelle

Green dot - Common pipistrelle recorded on SM2

Yellow dot - Leisler's bat recorded on SM2

Blue arrow - single soprano pipistrelle feeding

Blue dot - soprano pipistrelle recorded on SM2

The 2No. trees proposed for removal are young and undeveloped and unsuitable as roost sites. In May 2016 the survey found that no bats were noted to roost within the hedgerow but were potentially entering the buildings within the campus. There are no proposals under this application to carry out building works to any campus building. The majority of bat activity within the campus grounds was common pipistrelle. This species fed around the mature horse chestnut trees in addition to feeding around a pond to the east of the campus grounds which is almost 400m from the proposed footbridge.

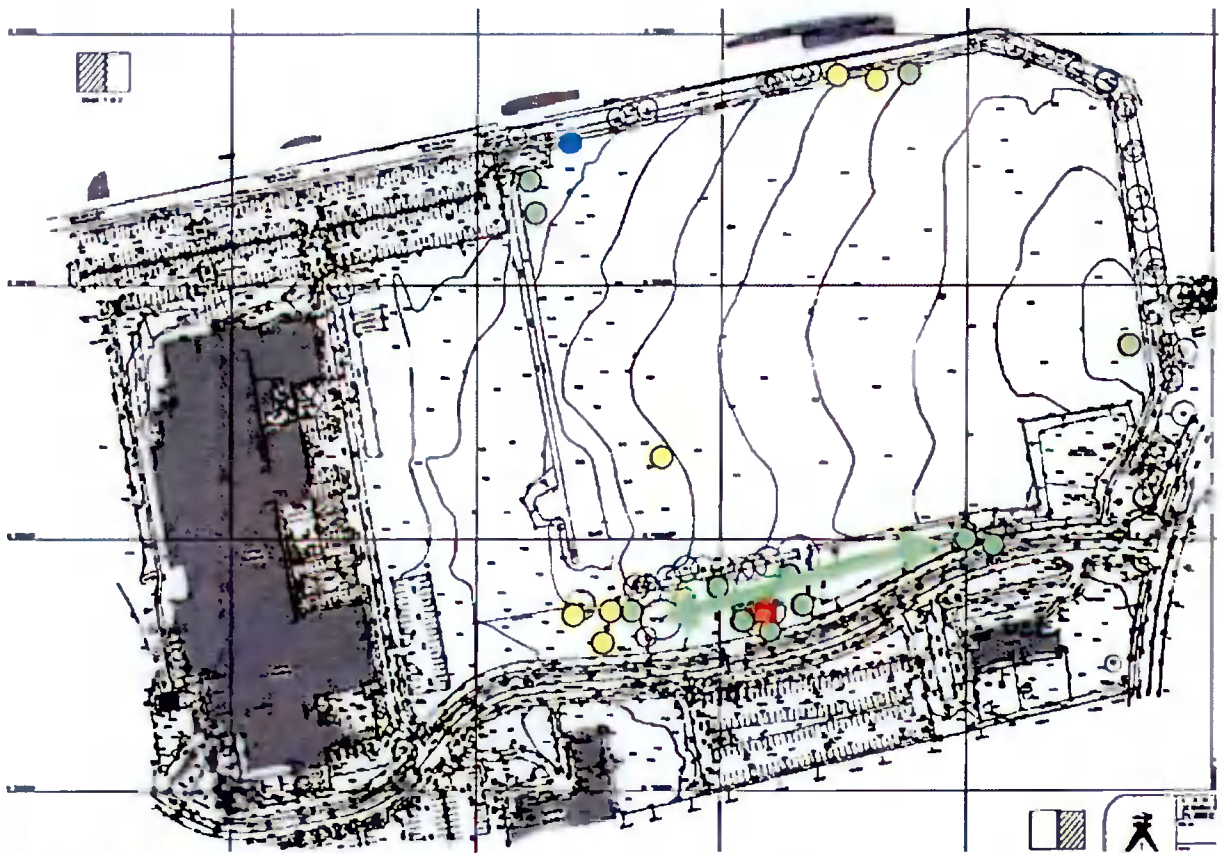
**Bat activity at ITT September 20<sup>th</sup> and 27th 2018**

Red box - Location of SM2 monitor at tree cavity

Green arrow - Feeding activity of common pipistrelle

Yellow dots - Leisler's bat recorded on EM3

Green dots - Common pipistrelle recorded on SM2

Blue dot - soprano pipistrelle recorded on EM3

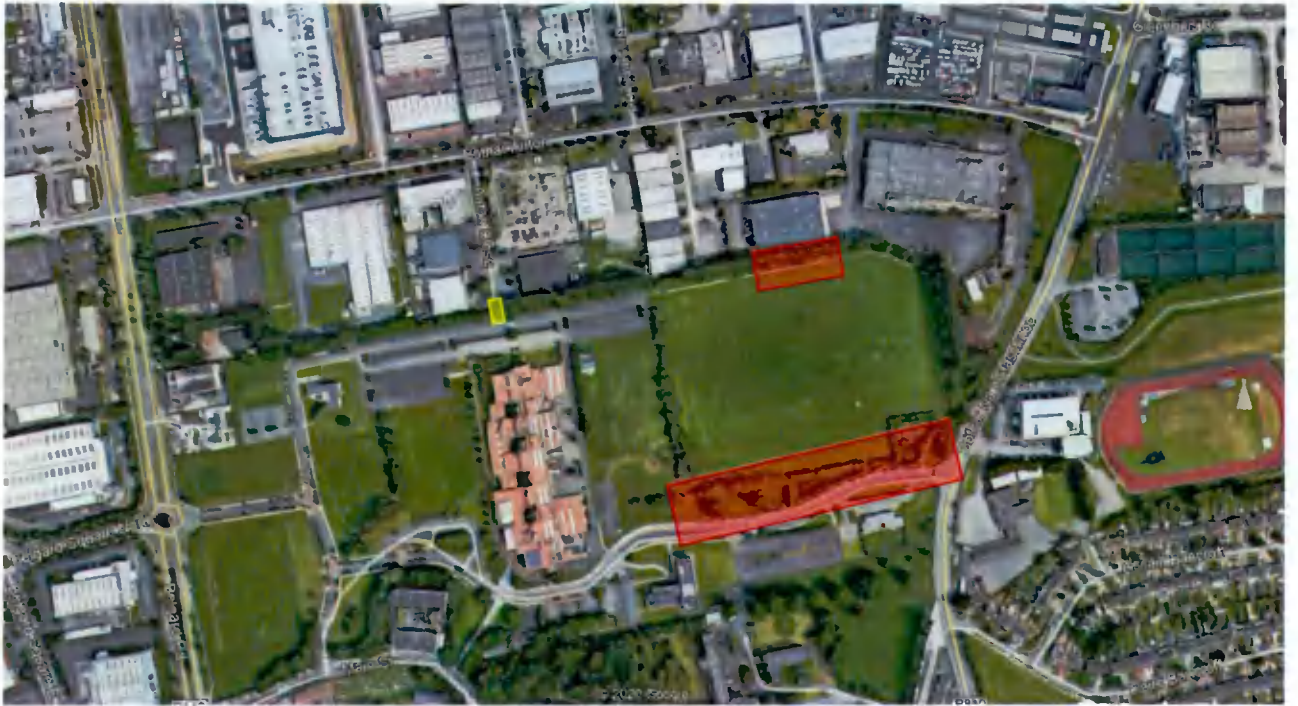
Boxes shaded red indicate areas of highest bat activity. Proposed footbridge highlighted with yellow box.

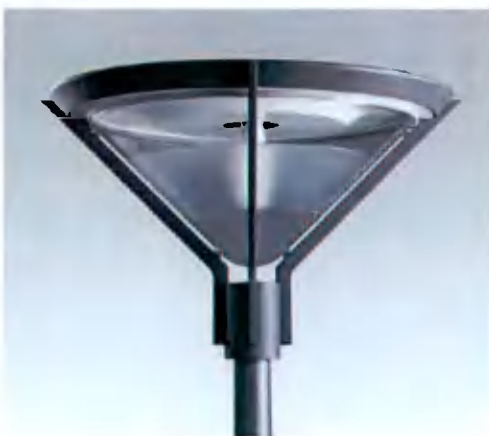
Artificial light can affect light-intolerant bat species in particular. However, as noted within the bat survey, *there are no known roosts on site therefore illumination would only affect commuting rather than roosting.*<sup>3</sup> It was recommended that hoods or cowls be fitted on the lights to reduce light spillage. The light fitting proposed is a Thorn Avenue F2 32W as per electrical consultant's specification:

Artificial lighting calculations have been carried out and are included within Appendix 3. The lighting has been designed in accordance with BS 5489 Part 1: 2013.

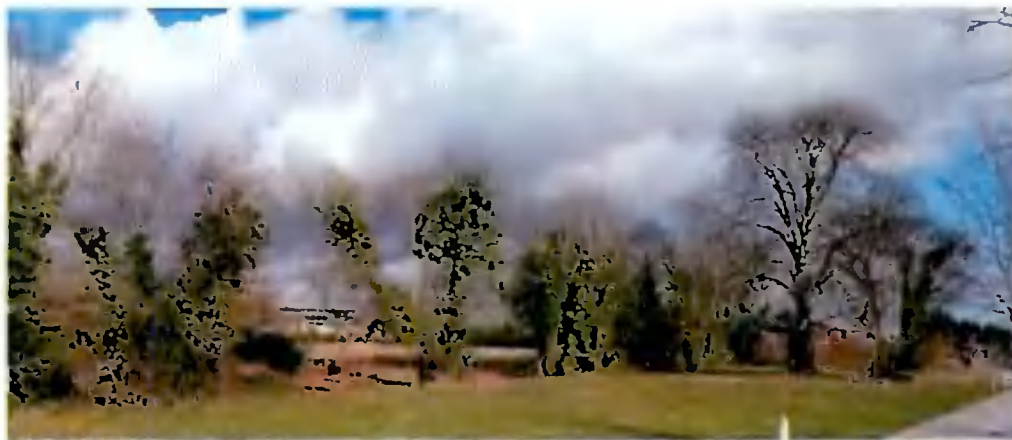
Photo 1 Old hedgerow (H1) and remnants of old woodland at the southern edge of the site (tagged 3053-3080)

Trees 3053-3074 include the trees that make up the old hedgerow (H1) running east-west along the southern part of the site; the trees are mostly Ash and Sycamore, with some Elm Hawthorn and Elder. The trees making up the hedge are mostly in a poor condition, having been impacted by previous groundworks and suffering a general lack of management.

Trees 3075-80 are the remnant trees of an area of woodland that has been mostly cleared in the last decade; the trees are in variable condition with two Horse Chestnuts suffering from bleeding canker and all of the trees having been impacted by groundworks and soil compaction.

The hedges have been neglected in terms of regular hedgerow management in recent years and have also been impacted by adjacent groundworks and are showing signs of dieback in places. The hedge-line H1 including trees 3053-3074 has become patchy and has continued to deteriorate since the previous survey; this decline will continue over the coming years unless some restoration works are undertaken.

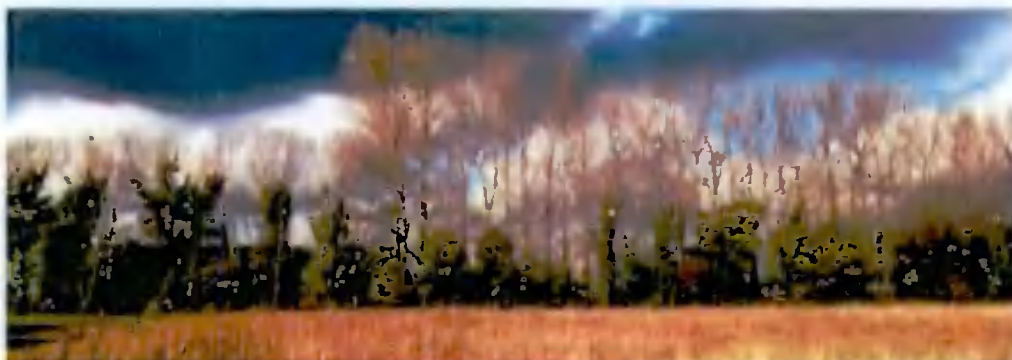
*Photo 2 Elm, Ash and Hawthorn tree-line along the northern edge of the site (tagged 3124-3139) with tall Poplar tree-line in neighbouring property behind.*

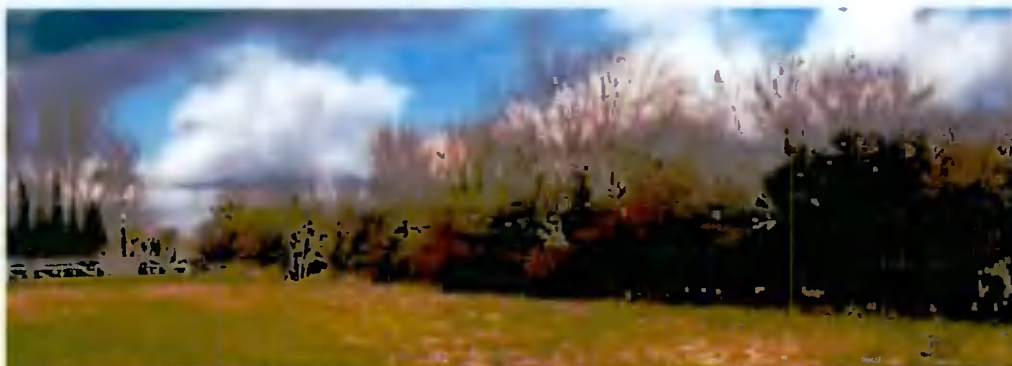
Trees 3140-3147 are individual Ash stems within the old agricultural field boundary hedge (H2) running north south between the two fields. The hedge itself is in poor condition having been left unmanaged for many years, and growth has expanded out into the grassland distorting the line of the hedge. A lack of trimming or hedge-laying has allowed the emergence of several Ash trees within the Hawthorn, Blackthorn and Elder mix to dominate the hedge profile. There seems to have been some ground-works adjacent to the hedge in more recent times and there is evidence of a substantial rabbit population living within the hedge.

*Photo 3 Hedge (H2) running between the two fields including the sample Ash trees tagged 3140-3147)*

The hedgerow running between the two fields has suffered less in terms of root damage, but has become very overgrown since regular management ceased. The hedges could be restored if brought back into proper management over a period of time; such restoration should include an initial phase of side pruning and clearance of the suckering and scrub encroachment into the adjacent fields, followed by reinforcement planting of new hedging plants where significant gaps occur and regular/annual trimming.

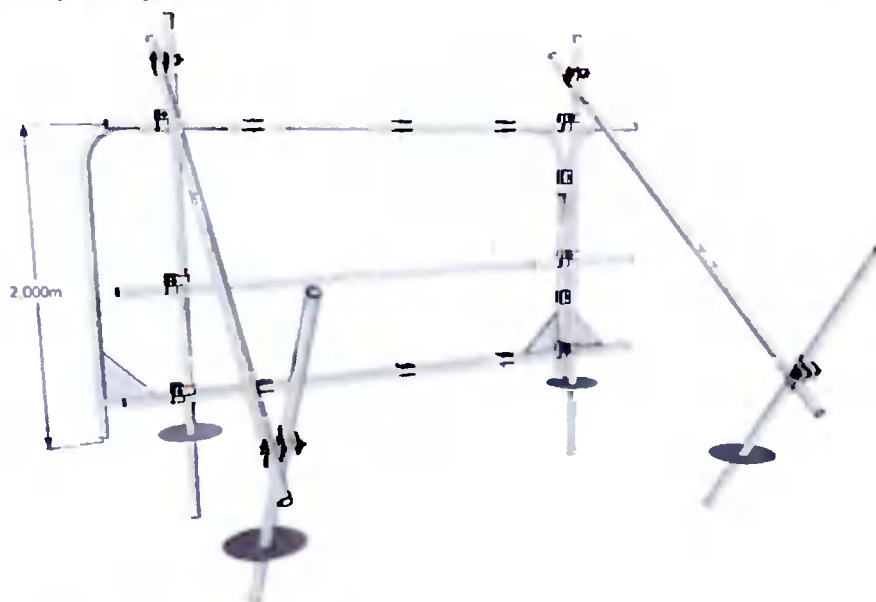
Figure 1. Protective fence specification

Trees being retained should be protected from unnecessary damage during the construction process by effective construction-proof barriers that will define the limits for machinery drivers and other construction staff. Ground protected by the fencing will be known as the Construction Exclusion Zone (CEZ). Sturdy protective fencing will be erected along the points identified in the Tree Protection Plan prior to any soil disturbance and excavation work starting; this is essential to prevent any root or branch damage to the retained trees. The British Standard BS5837: *Trees in relation to design, demolition and construction (2012)* specifies appropriate fencing; see figure 1 below

When tree and hedge removal works are completed, sturdy tree protection fencing (see figure 1 below) will be erected along the lines shown on the Tree Protection Plan Drawing 18027\_TPP to prevent construction work encroaching into the root protection areas of the trees to be retained.

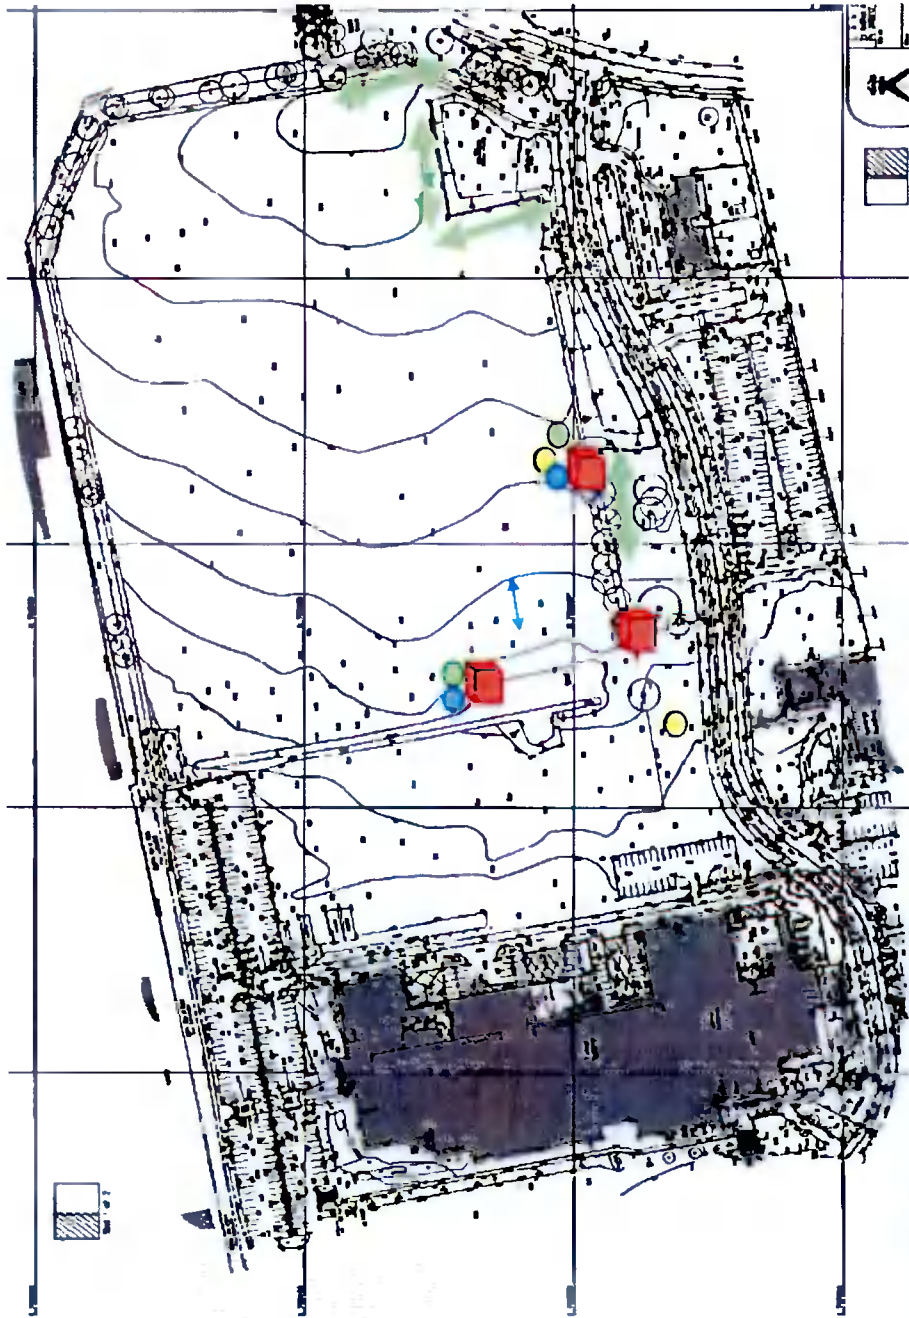
**Bat activity at ITT noted on 3<sup>rd</sup> to 4<sup>th</sup> May 2016**

Red box - Location of SM2 monitor

Blue arrow - single soprano pipistrelle feeding

Blue dot - soprano pipistrelle recorded on SM2

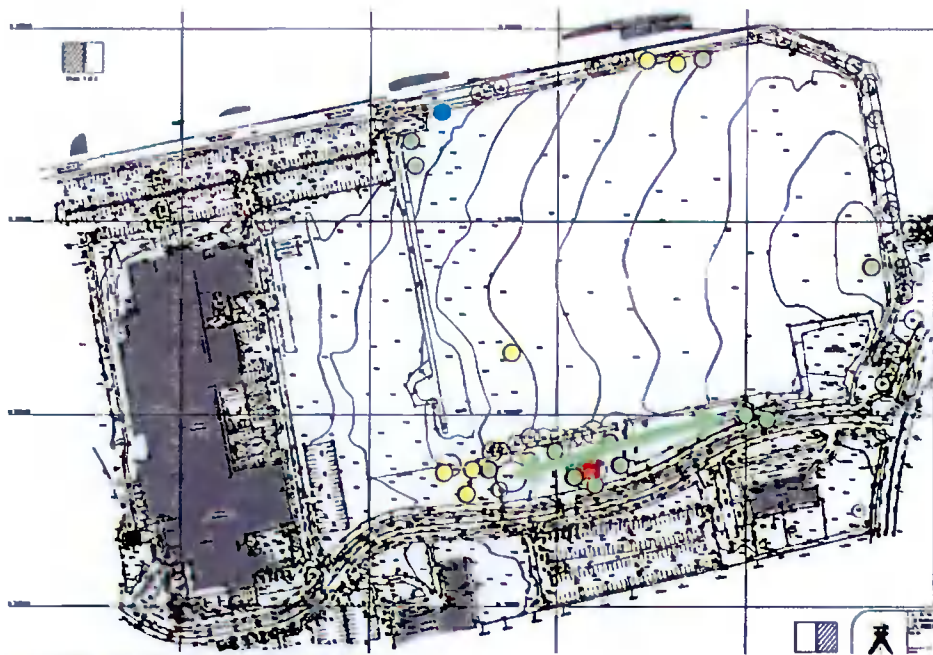
**Bat activity at ITT September 20<sup>th</sup> and 27<sup>th</sup> 2018**

Red box - Location of SM2 monitor at tree cavity  
 Green arrow -- Feeding activity of common pipistrelle  
 Yellow dots - Leisler's bat recorded on EM3

Green dots - Common pipistrelle recorded on SM2  
 Blue dot - soprano pipistrelle recorded on EM3

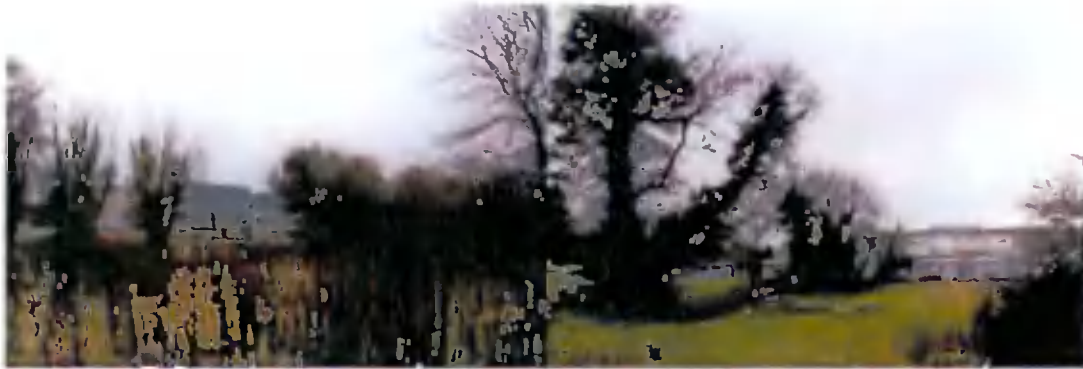
**Hedgerow that will be removed as part of the proposal**

This provides cover for feeding and commuting bats. The left photo shows a site for feeding and commuting soprano and common pipistrelles and Leisler's bats and very low roost potential.

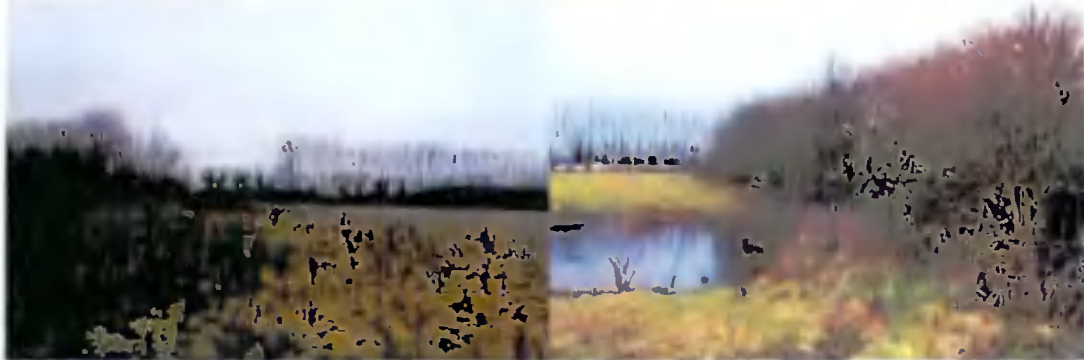
**The eastern side of the hedgerow (left) and pool along this hedger (right)**

This side of the hedge is the better location for commuting bats. This is a seasonal water body and was absent in May 2016 and September 2018.

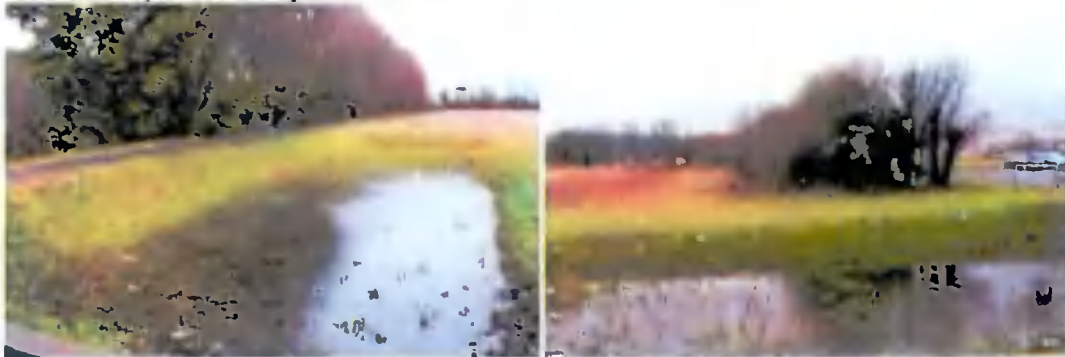
**Pool of water to the east of the north-south hedge a(facing east, left) (facing south, right)**

This was absent in the summer and autumn assessments

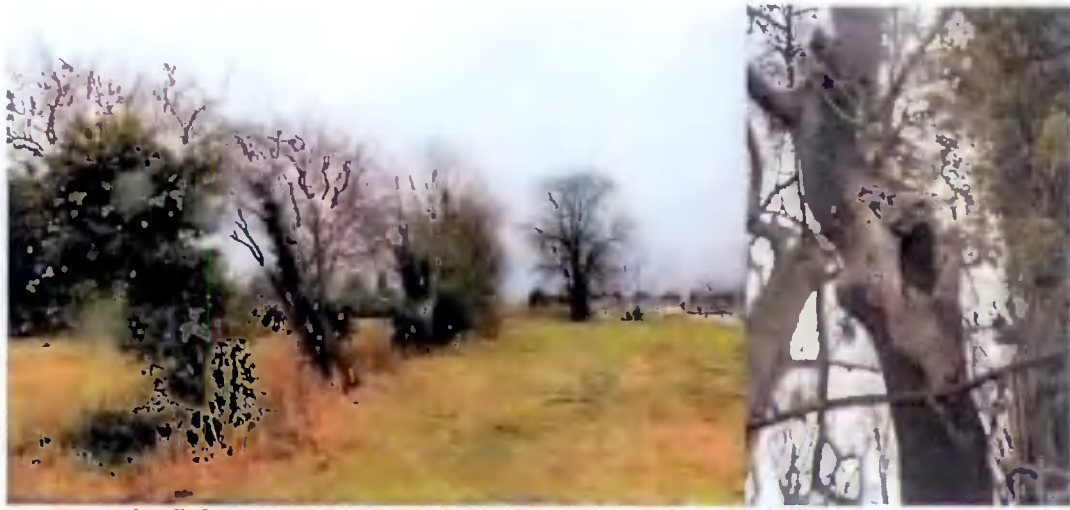
**Southern edge (left photo) facing towards mature trees to the south of site**  
The trees to the right (right photo) with high roost potential will be retained. These trees are not within the clearance area and will be retained.

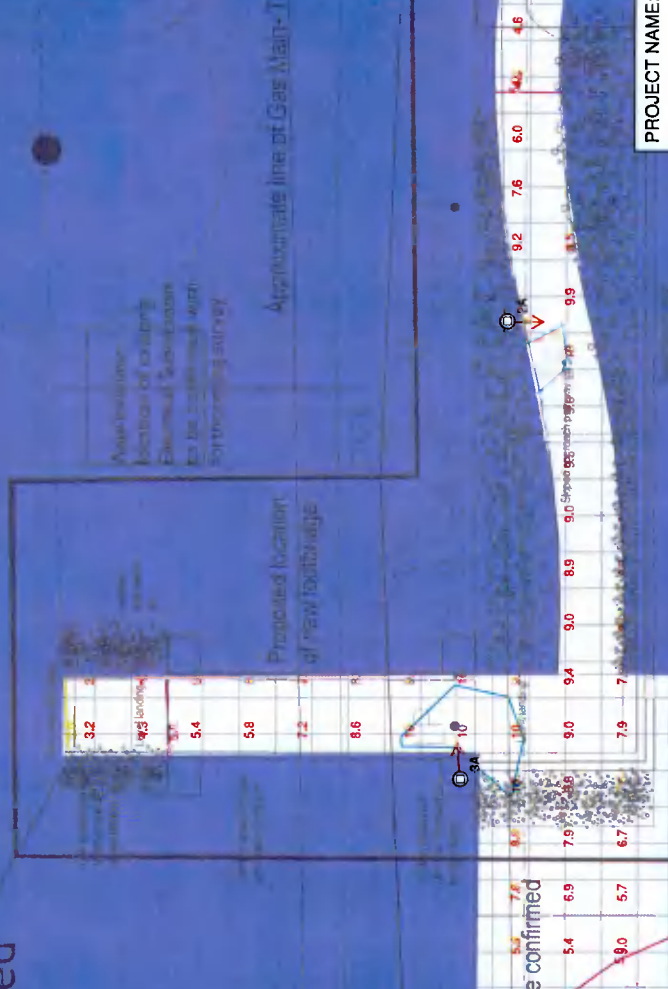
PROJECT NAME: ITT 1 Airton Close-Footbridge	
PROJECT No: 18179	DATE: 27 May 2020
SCALE: 1:200	DESIGNER: Vinsent Paul
Designed in accordance with BS 5489-1:2013, Lighting Class P4	
Results Grid 1	
Eav	7.43
Emin	3.21
Emax	10.42
Emin/Eav	0.31
Emin/Eav	0.43

Luminaire A	Thorn UK
Avenue F2 - Clear Illuminer - Clear ring - 18 x LED 4000K 700	LED 4000K
Lamp(s)	4.01
Lamp Flux (lm)	0.78
Maintenance Factor	2
No. in Project

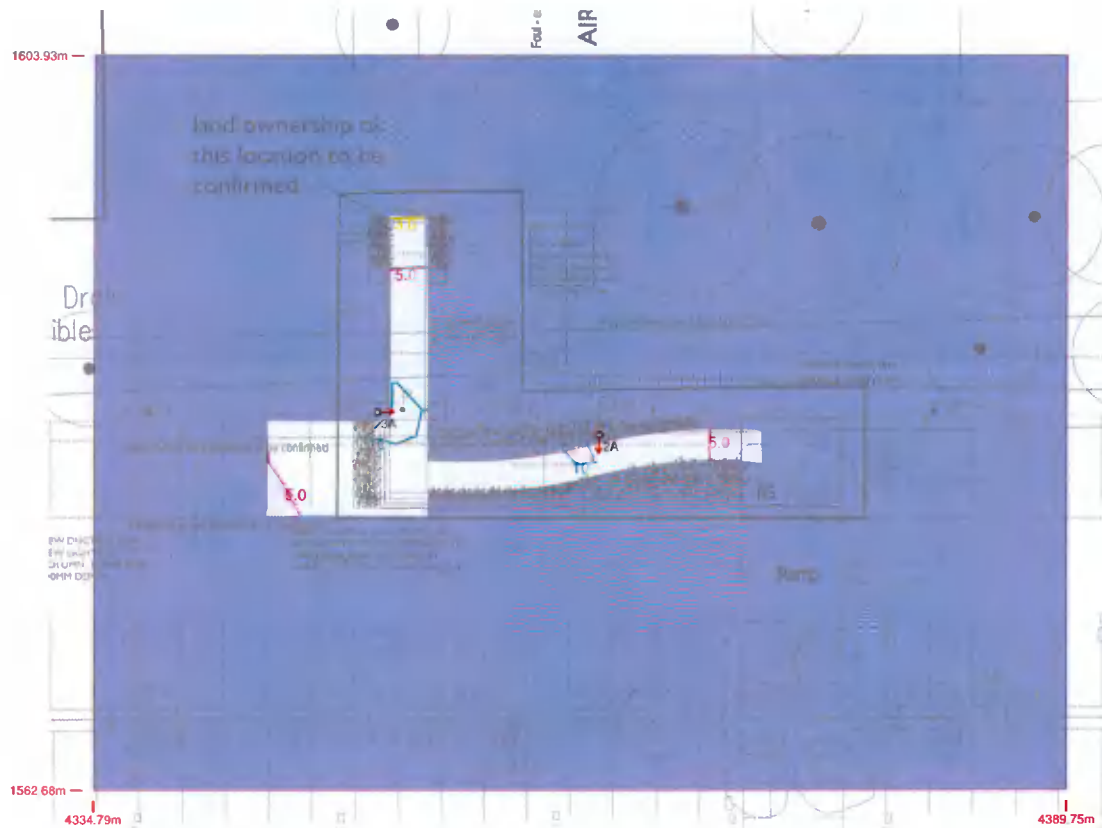
Grid 1

### Results

Eav	7.43
Emin	3.21
E <sub>max</sub>	10.42
Emin/E <sub>max</sub>	0.31
Emin/Eav	0.43
