Phase 1 Desk Study Report
Taylor's Lane
Rathfarnham
Dublin

Client: MCCL

July 2021
Issue 2

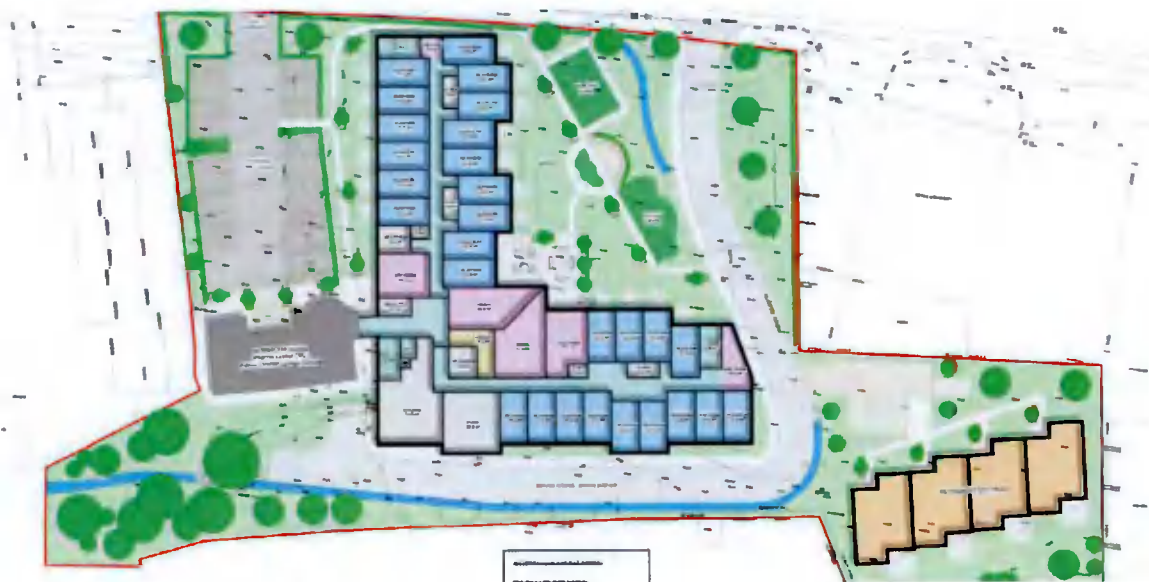
The new build Nursing Home is a multi-storey build, including 90 bedrooms over the 3 storeys and 4 retirement cottages which will incorporate Newbrook House. Newbrook House will be carefully retained, protected and incorporated into the Nursing Home facility. Newbrook House is the listed build on site, located to the south-west of the site, which will be converting for Admin/ Visiting Lounge/ Dining.

Below is an extract of the ground floor from the proposed site plan, a detailed proposed site plan is included in Appendix A.

Appendix A: Proposed Site Plan

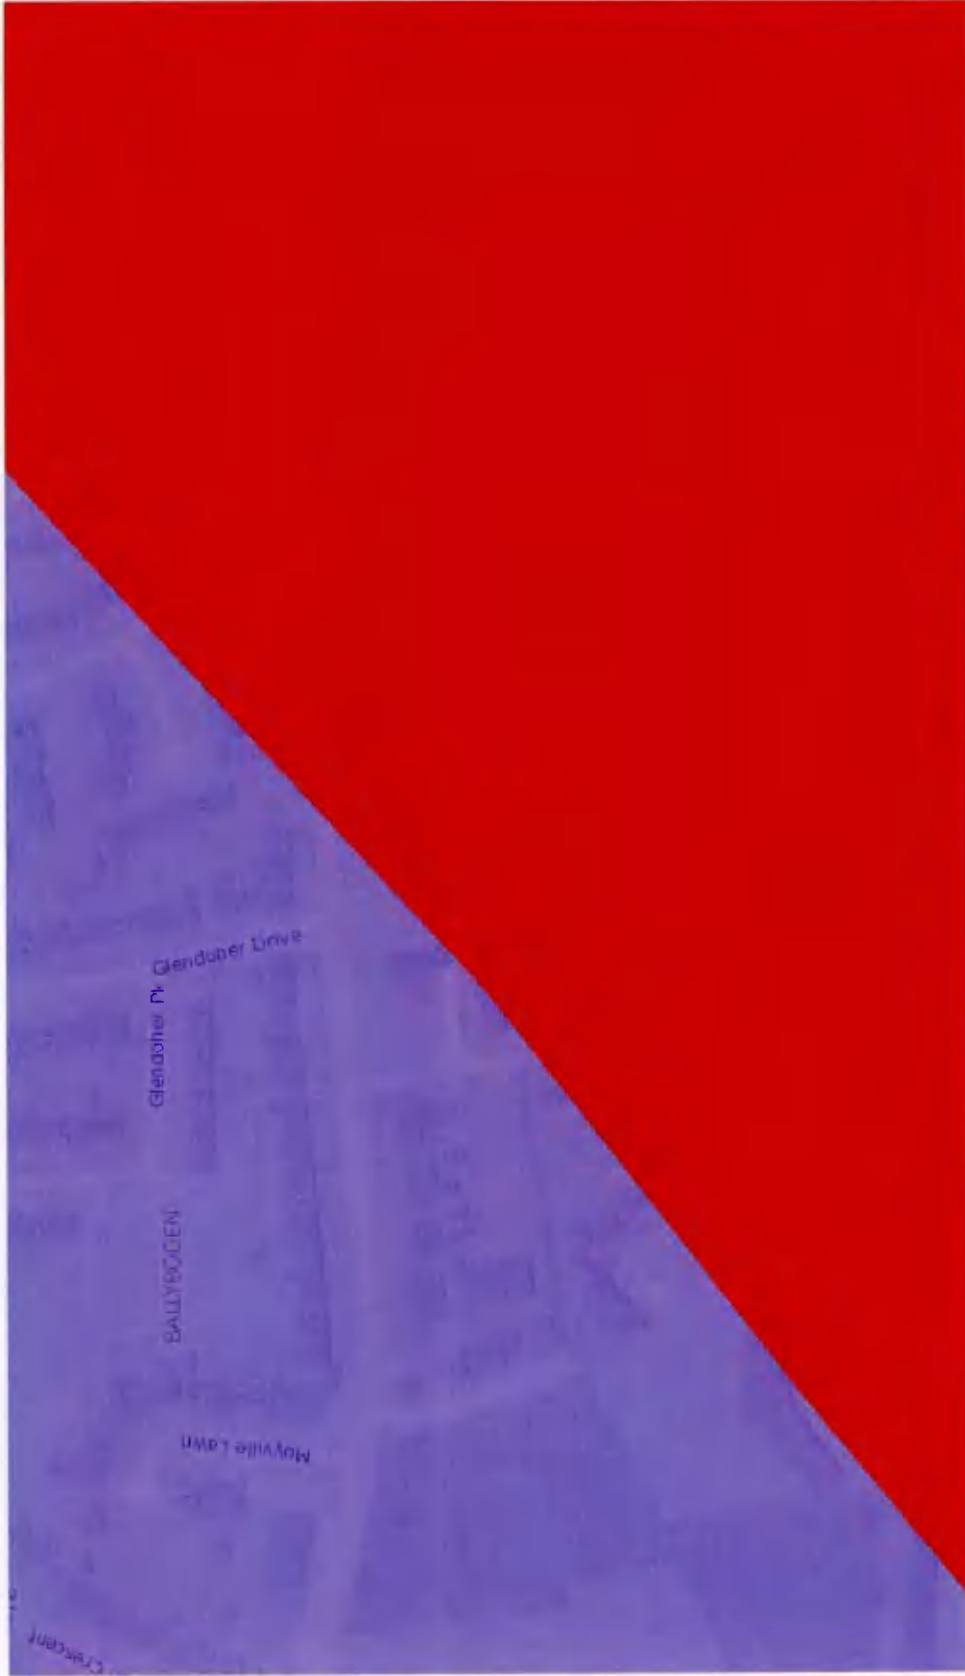
Appendix C – Extractions from Geological Maps
Bedrock Geological Deposits formed 100,000 years ago

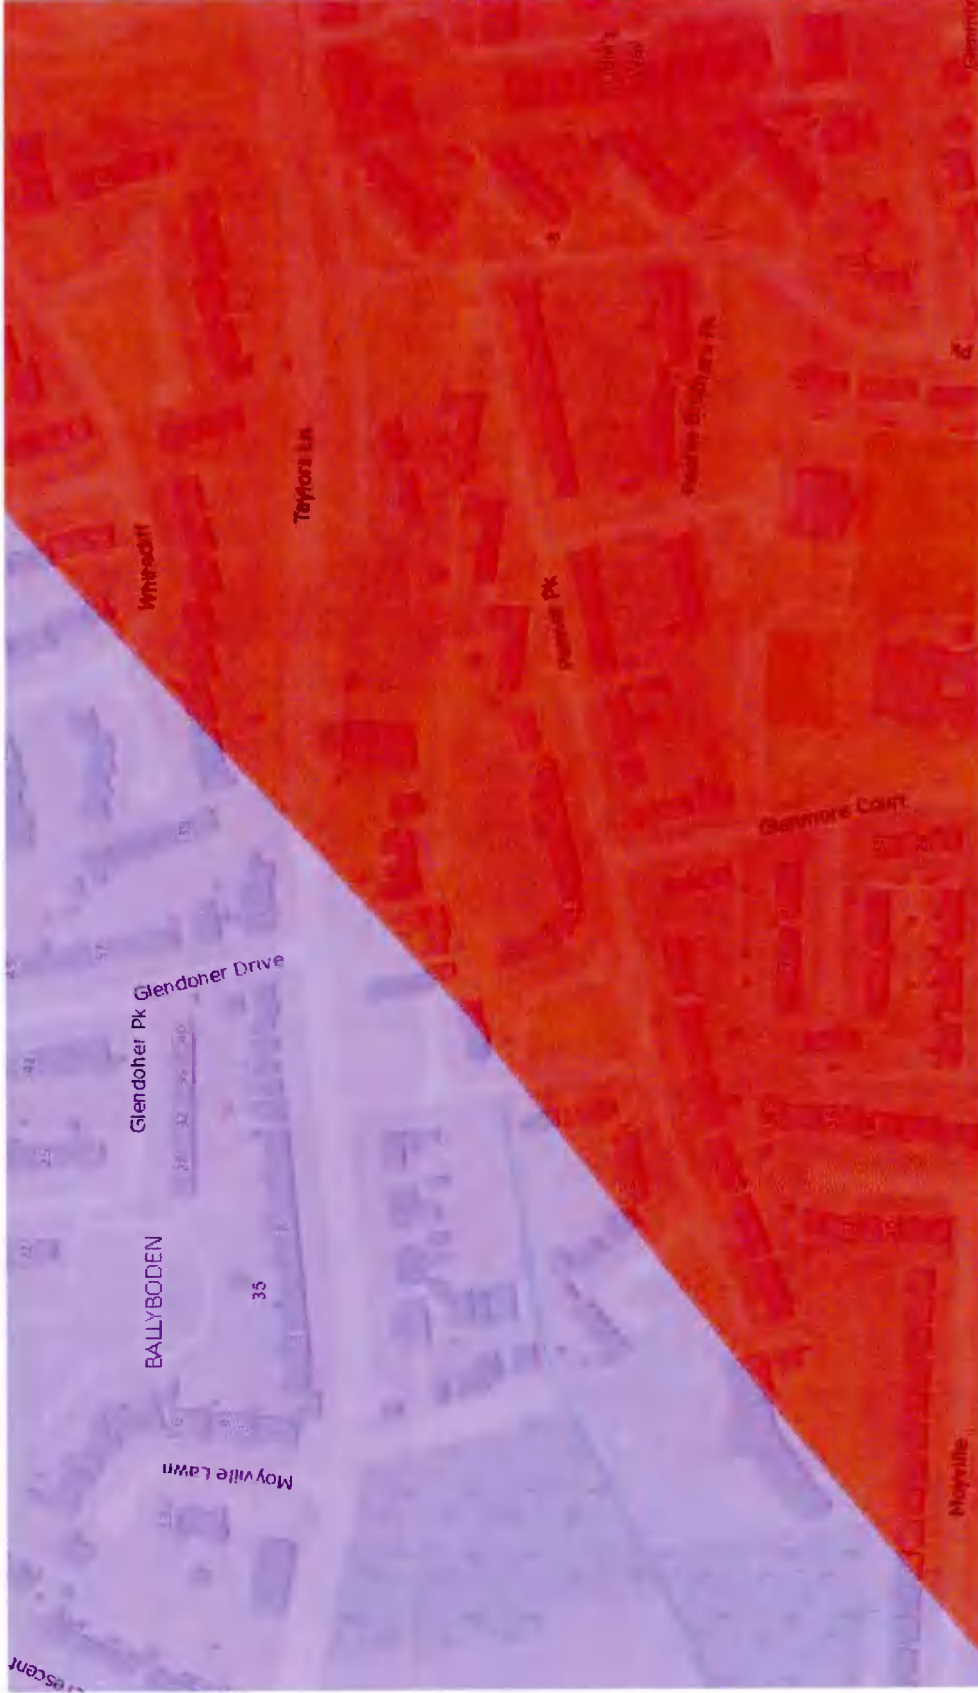
Appendix C – Extractions from Geological Maps
Bedrock Geological Deposits formed 500,000 years ago

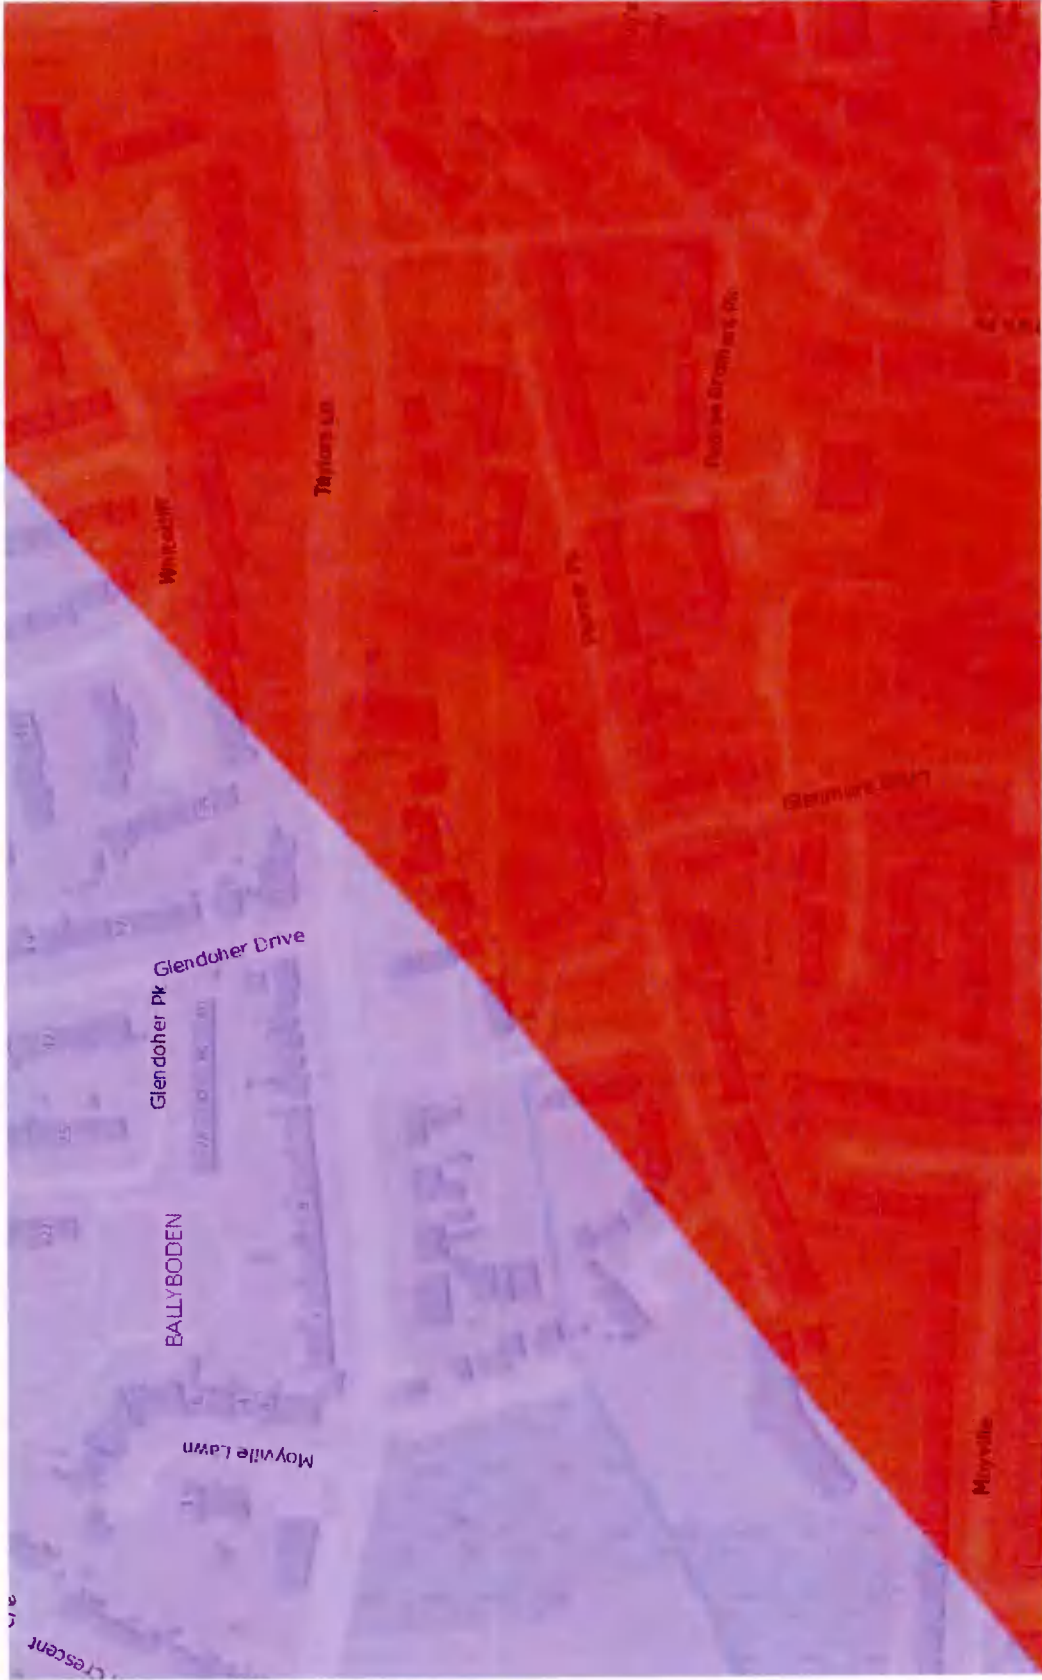
**Appendix C – Extractions from Geological Maps
Bedrock Geological Deposits formed 1,000,000 years ago**

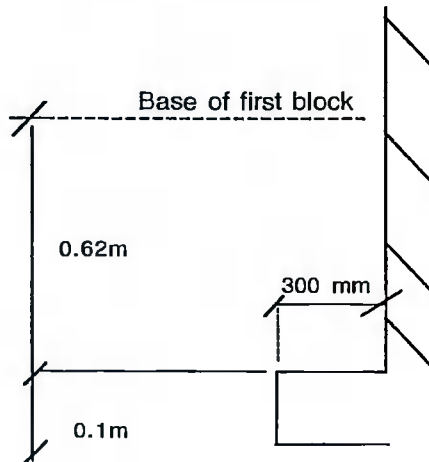
Foundation Details:

Description	Red. Level	Leg end	Depth	samples			Remarks
				Ref. No.	Type	Depth	
TOPSOIL			0.20				
MADE GROUND containing black clay, sand, gravel, red brick, granite cobbles, concrete blocks, roots and metal							
Very stiff brown sandy gravelly CLAY with cobbles			0.75				
End of trial pit at 0.9m			0.90

Located in walled garden 4.4m from corner of building

Detailed records are presented in Appendix III. In several locations stiff gravelly clay was noted below surface fill and excavations were terminated in this stratum. In other positions excavations were terminated on made ground deposits.

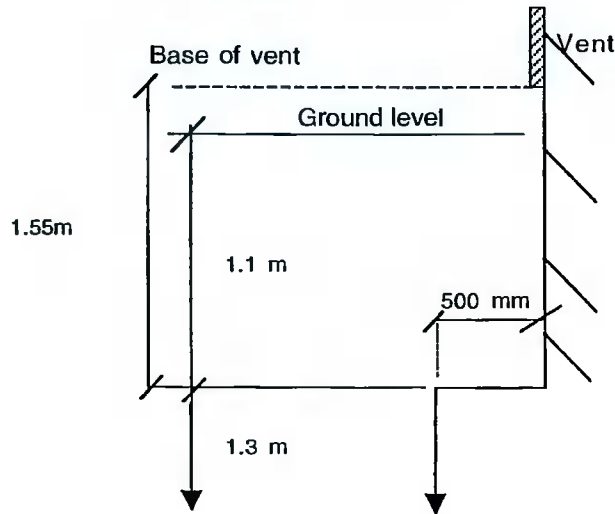
Foundation Details:

Description	Red. Level	Leg end	Depth	samples			Remarks
				Ref. No.	Type	Depth	
MADE GROUND containing black clay, sand, gravel, red brick, granite cobbles and boulders (750mm diameter), concrete blocks, roots and metal		█	0.20				
End of trial pit at 1.3m		█	1.30

Located against in walled garden at corner of old and new building
 Base of foundation not located

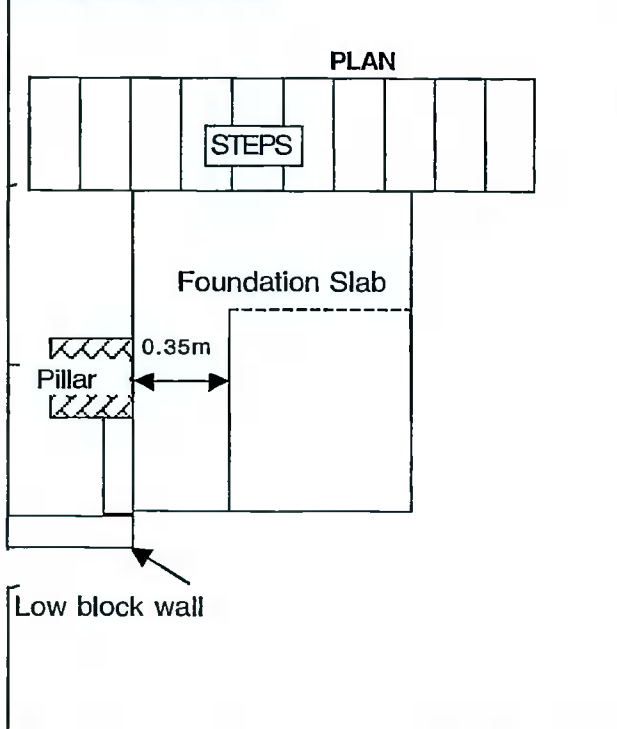
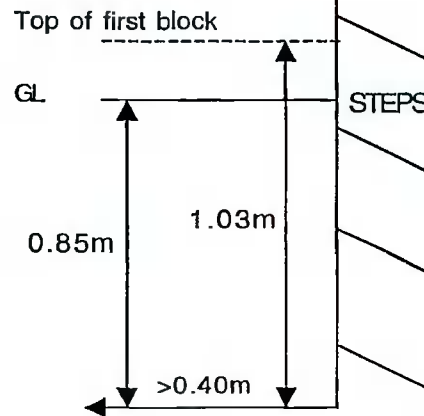
Foundation Details:

Description	Red. Level	Leg end	Depth	samples			Remarks
				Ref. No.	Type	Depth	
MADE GROUND consisting of hardcore			0.20				
MADE GROUND containing black clay, sand, gravel, red brick, granite cobbles and boulders, concrete blocks, polystyrene, wire and plastic							
End of trial pit at 0.85m			0.85

Located in courtyard by concrete steps
 Base of foundation not located

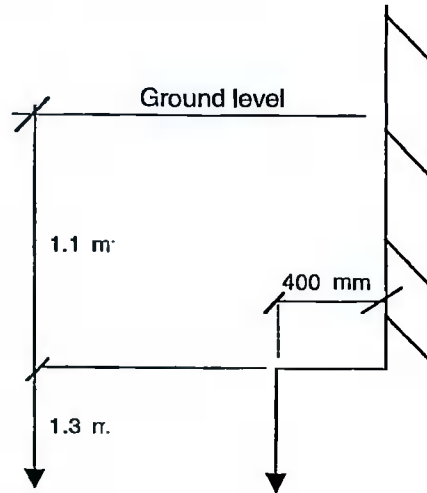
Foundation Details:

Description	Red. Level	Leg end	Depth	samples			Remarks
				Ref. No.	Type	Depth	
TOPSOIL			0.20				
MADE GROUND containing black clay, sand, gravel, red brick, granite cobbles, concrete blocks, roots and metal							
End of trial pit at 1.3m			1.30

Remarks	Groundwater Conditions
Located against South wall of building Obstruction at 1.3m (possible boulders) Base of foundation not located	No groundwater encountered
	Logged by: Jennifer Felton

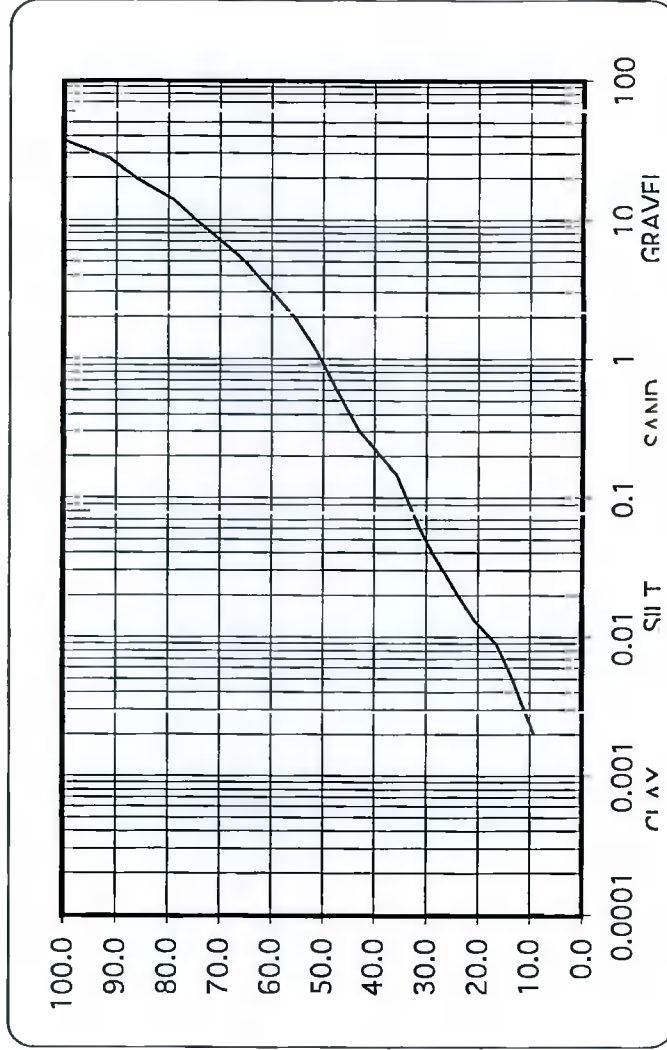
PARTICLE SIZE ANALYSIS

CONTRACT: ST ENDA'S
 LOCATION No. WS 2
 SAMPLE No. WS2
 DEPTH: 1.50
 TEST METHOD: Wet Sieve and Hydrometer
 DESCRIPTION: Brown silty sandy gravelly CLAY

particle size	% passing	
75	100.0	COBBLES
63	100.0	GRAVEL
50	100.0	
37.5	100.0	
28	91.4	
20	86.3	SAND
14	78.9	
10	74.5	
6.3	68.1	
5	65.0	
3.35	60.8	SILT/CLAY
2	55.5	
1.18	51.4	
0.6	47.3	
0.425	45.0	
0.3	42.7	
0.15	35.8	
0.063	31.3	
0.04	28.8	
0.03	26.7	
0.02	23.9	
0.013	20.5	
0.009	16.4	
0.005	13.2	
0.002	9.1
