Phase 2 Ground Investigation  
Taylor's Lane  
Rathfarnham  
Dublin

Client: MCCL

July 2021  
Issue 2

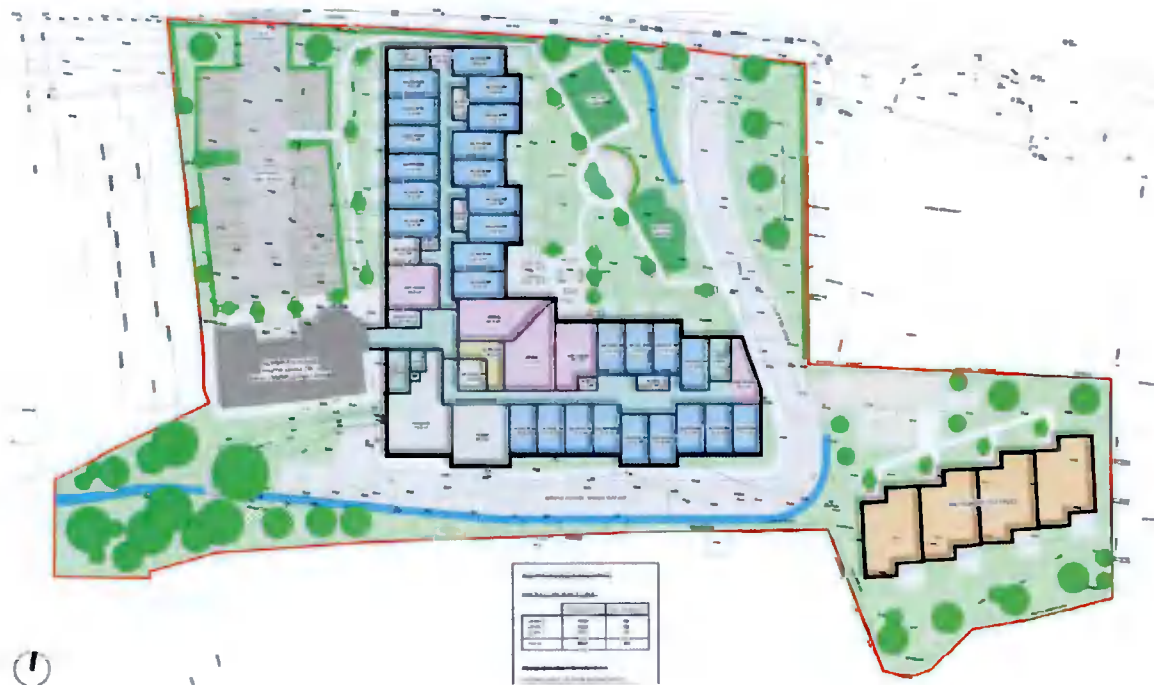
Below is an extract of the ground floor from the proposed site plan, a detailed proposed site plan is included in Appendix A.
