**Advanced
Sewage
Treatment
Solutions**

Sewage System Survey

Survey Details

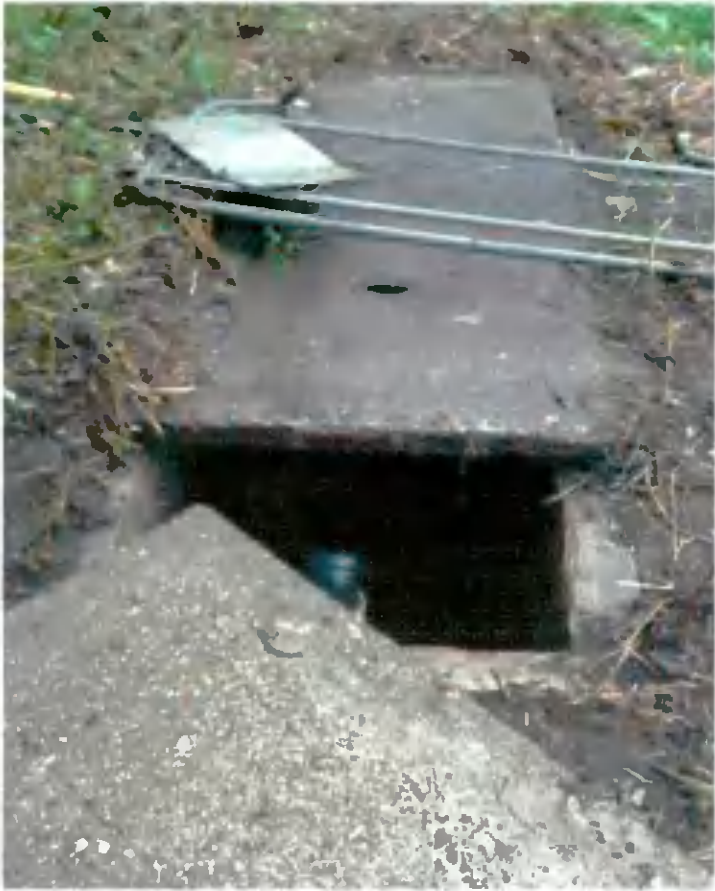
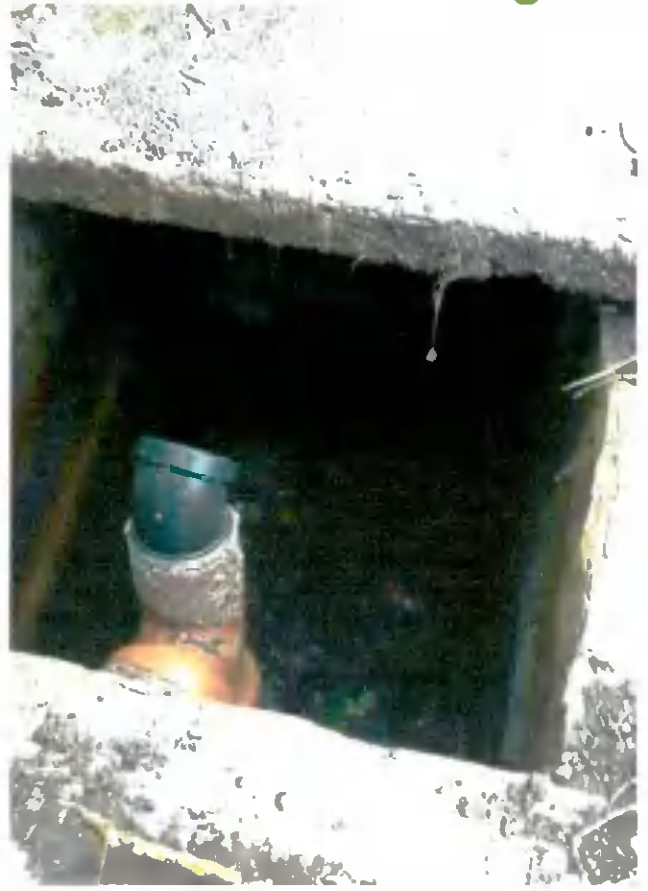
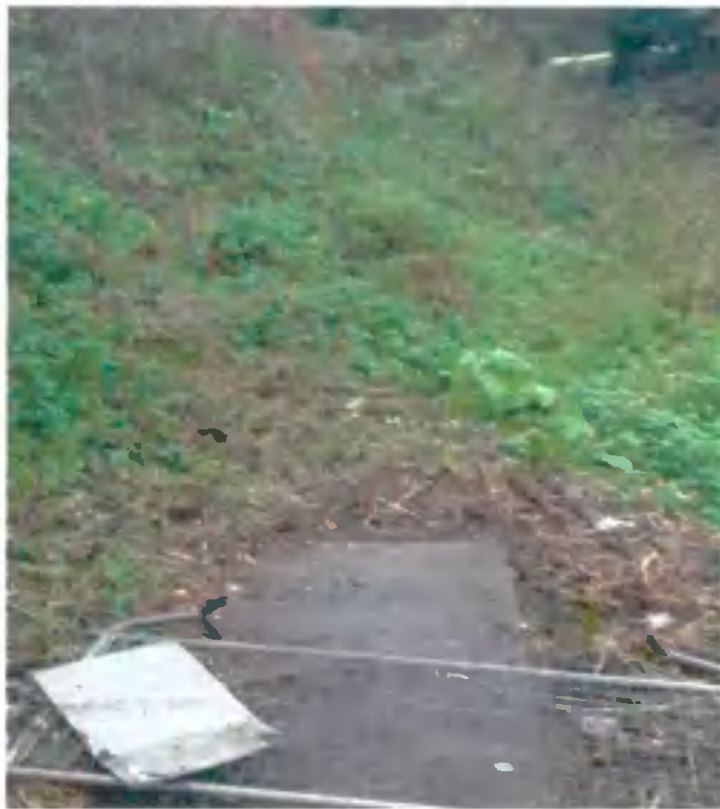
Waste Water Treatment System / Septic Tank:

Sewage System type	Septic Tank
Manufacturer & Model	N/A
Population Equivalent	5PE
Construction Material (if known)	Concrete
Year Unit Installed (approx.)	1980
Distance of tank from dwelling?*	14m
Distance of tank from nearest	2m
