Project Title: Drive Thru Coffee Unit, Lucan Retail Park,
Lucan Road, Co. Dublin

Report Title: Stage 1/2 Flood Risk Assessment Report

Report Ref: 21192-LDE-ZZ-ZZ-RP-SC-0001_FRA

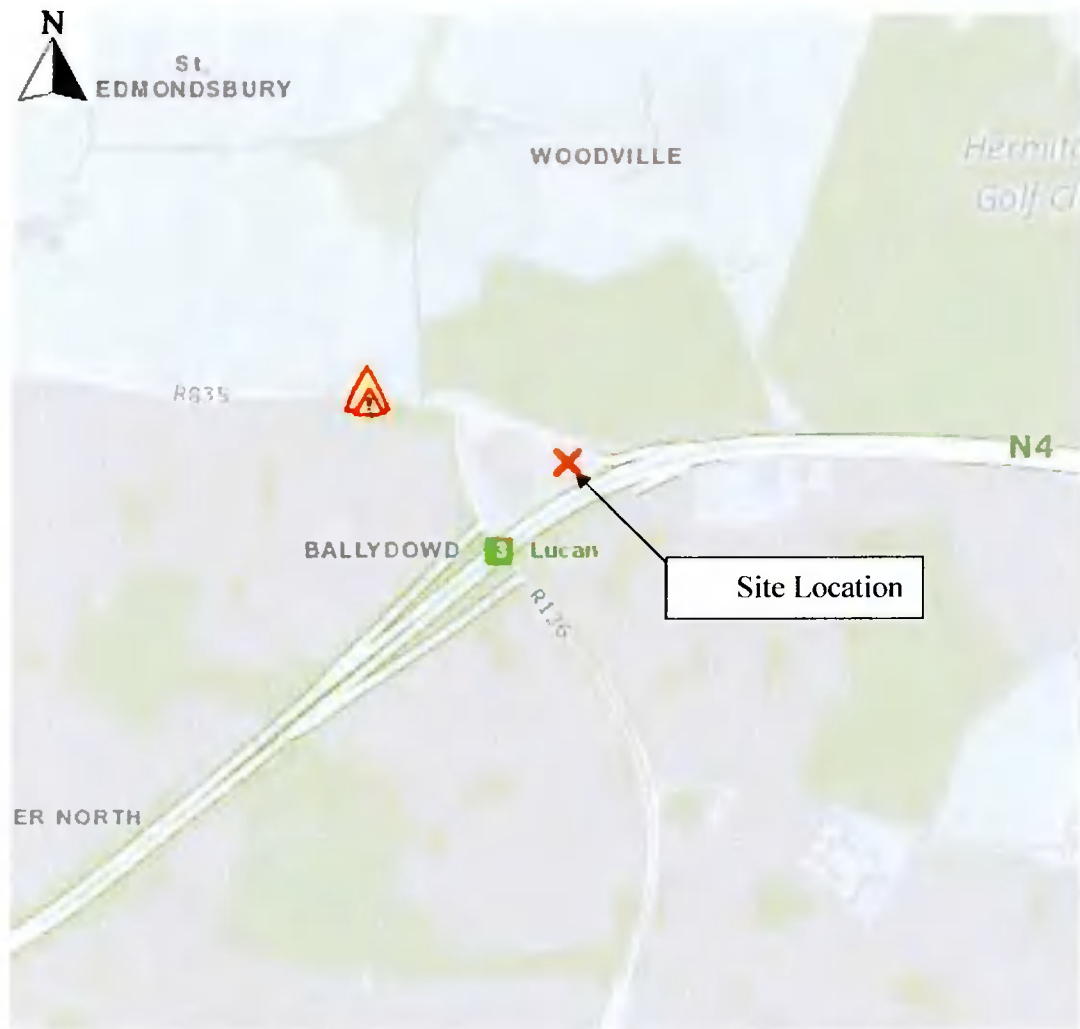
Figure 3: Map Extract from OPW Flood Maps Website (floodinfo.ie, 2021)

Inspection of OPW records indicates that there has been a previous flood event further up the Lucan Road towards St. Edmonsbury. There has not been much data recorded for this flood but that part of Lucan Road flooded. The flood event was approximately 350m from the subject site. The subject site is at an approximate elevation of 50m, whereas the flood event location is at an approximate elevation of 48m. Considering both the distance from the subject site as well as the change in elevation between the site and flood location it can be assumed that the subject site would not be affected by a similar flood event.

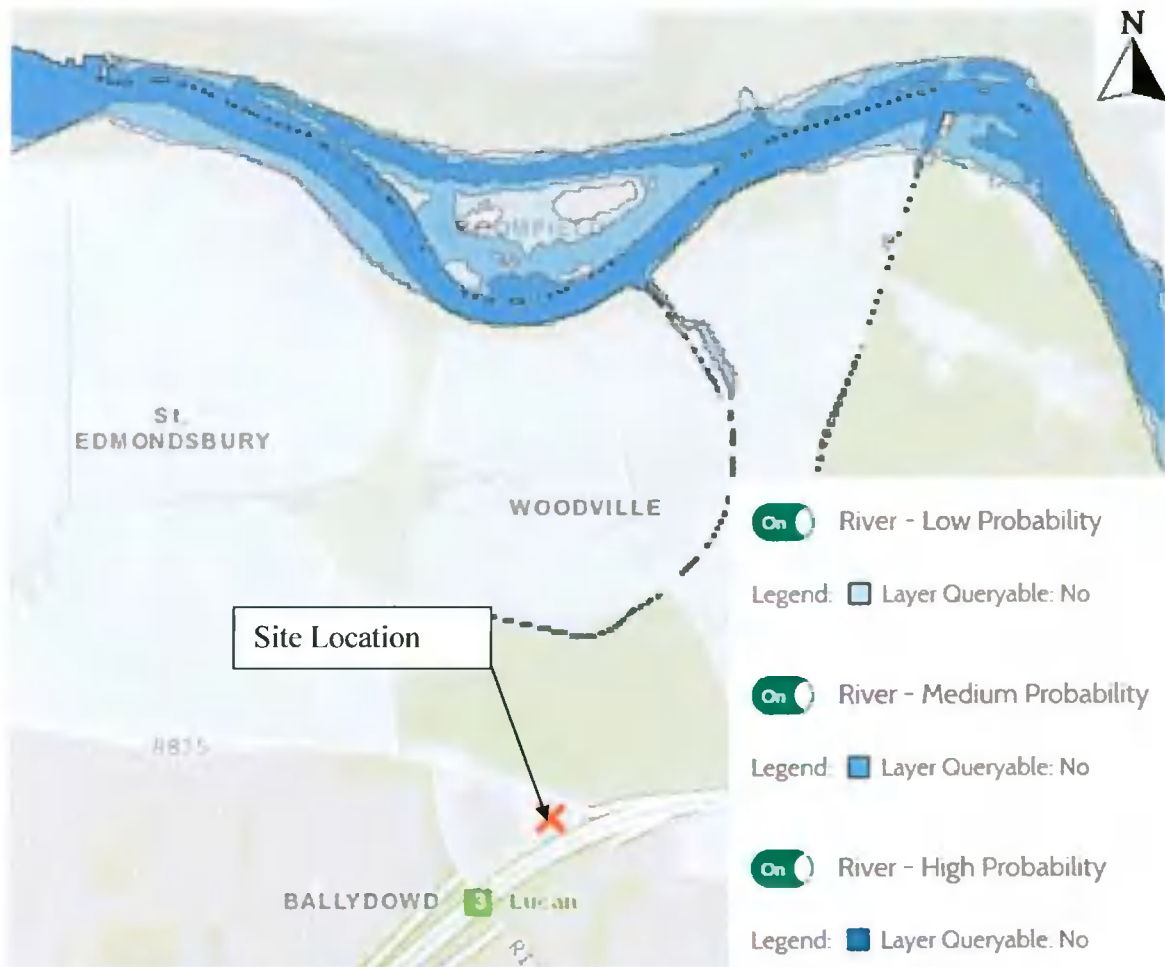
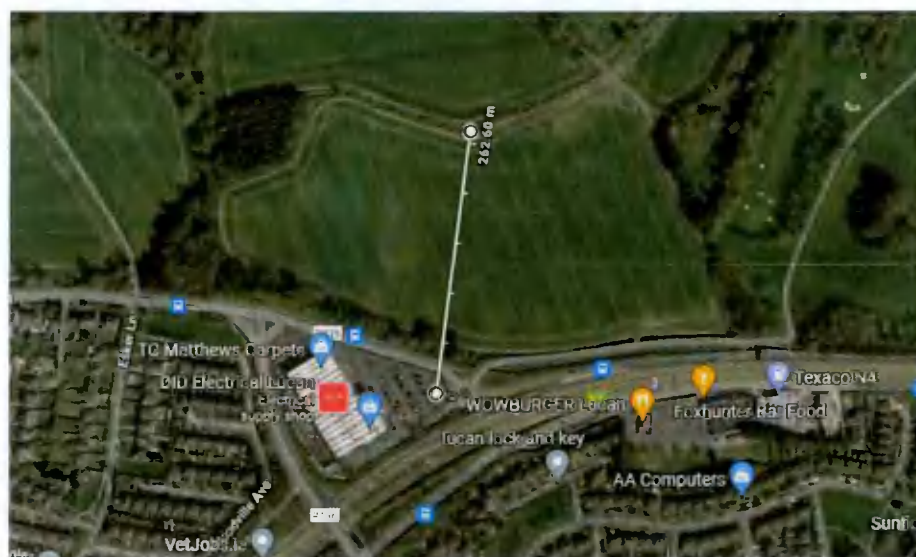
Figure 5: Map of Fluvial Flood Extents (Extract from floodinfo.ie)

The maps obtained from the floodinfo.ie indicate that areas in the vicinity of the site are not predicted to flood during in 0.1% Annual Exceedance Probability (AEP). The site is located 265m away from the nearest water course (See Figure 4).
