REV.	DATE	DESCRIPTION	A/W	CHK	BY
PLANNING					
Drawing number 21-36/204					
Project Proposed Outdoor Dining Extension at Edmondstown Golf Club					
Client Edmondstown Golf Club CLG					
Drawing PROPOSED SITE PLAN					
Scale 1:200					
Date 15/12/2021					
Drawn by aW					
Carew Kelly Architects 21/22 Grafton Street, Dublin 2 Tel. 01 - 6333 000 Fax. 01 - 6333 001 E-mail : design@carewelly.ie

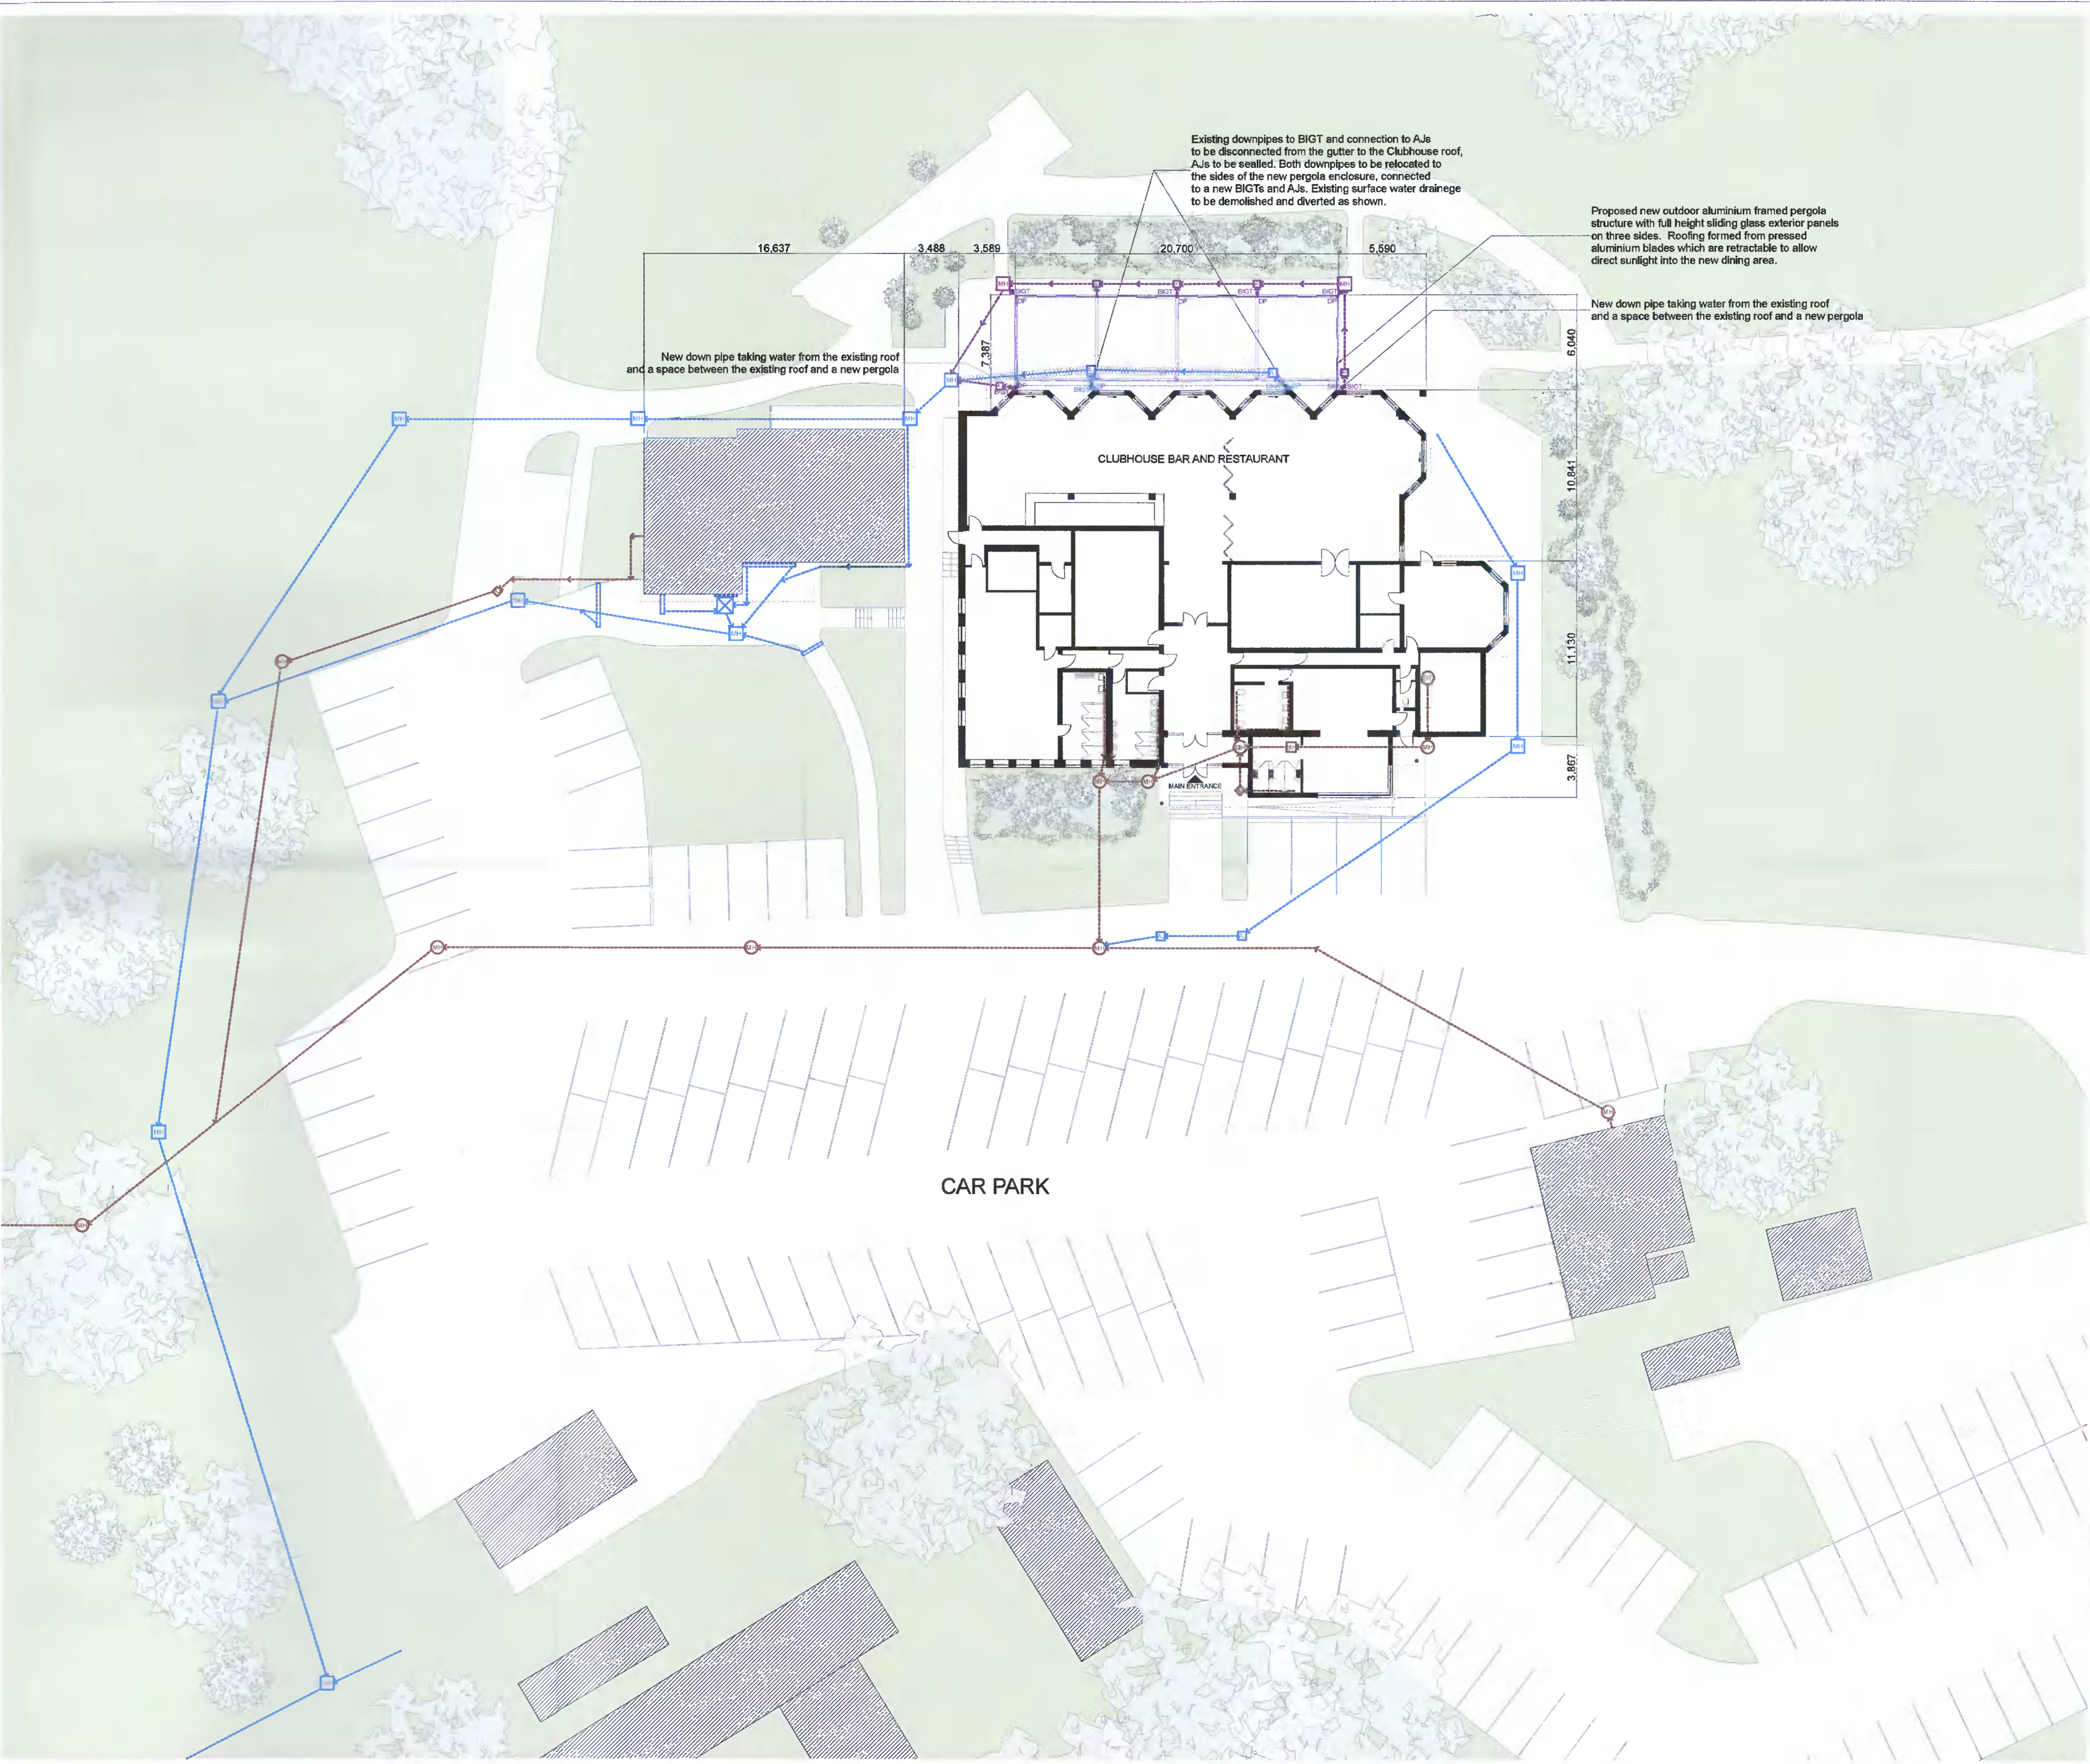
Existing downpipes to BIGT and connection to AJs to be disconnected from the gutter to the Clubhouse roof, AJs to be sealed. Both downpipes to be relocated to the sides of the new pergola enclosure, connected to a new BIGTs and AJs. Existing surface water drainage to be demolished and diverted as shown.

Proposed new outdoor aluminium framed pergola structure with full height sliding glass exterior panels on three sides. Roofing formed from pressed aluminium blades which are retractable to allow direct sunlight into the new dining area.

New down pipe taking water from the existing roof and a space between the existing roof and a new pergola
