CONSERVATION / METHOD STATEMENT

Further Information for Application Planning Register Reference: SD21B/0530,

RE: The development consisting of: (i) Partial demolition and reconstruction of a two storey corner extension to the rear, provision of a new flat roof with roof-light to this extension, (ii) Demolition of the two storey extension at the centre of the back (east) of the house and the construction of a new flat roofed two storey extension with roof-light(s), (iii) Repairs to windows with replacements where necessary or appropriate. Construction of single storey bay extension with pitched roof to the south elevation at lower ground floor/basement level, (iv) Minor internal alterations, general refurbishment, provision of maintenance access to centre valley, addition of photovoltaic panels, repairs to plasterwork, increase in height of rear garden boundary wall to the north, (v) Outbuilding to the Rear: internal alterations, roof repairs, new doors and window and general refurbishment, (vi) Minor hard and soft landscaping works including parking area to the North-East and all ancillary site works above and below ground. At **Oak Lodge**, New Road, Clondalkin, Dublin 22, D22 F

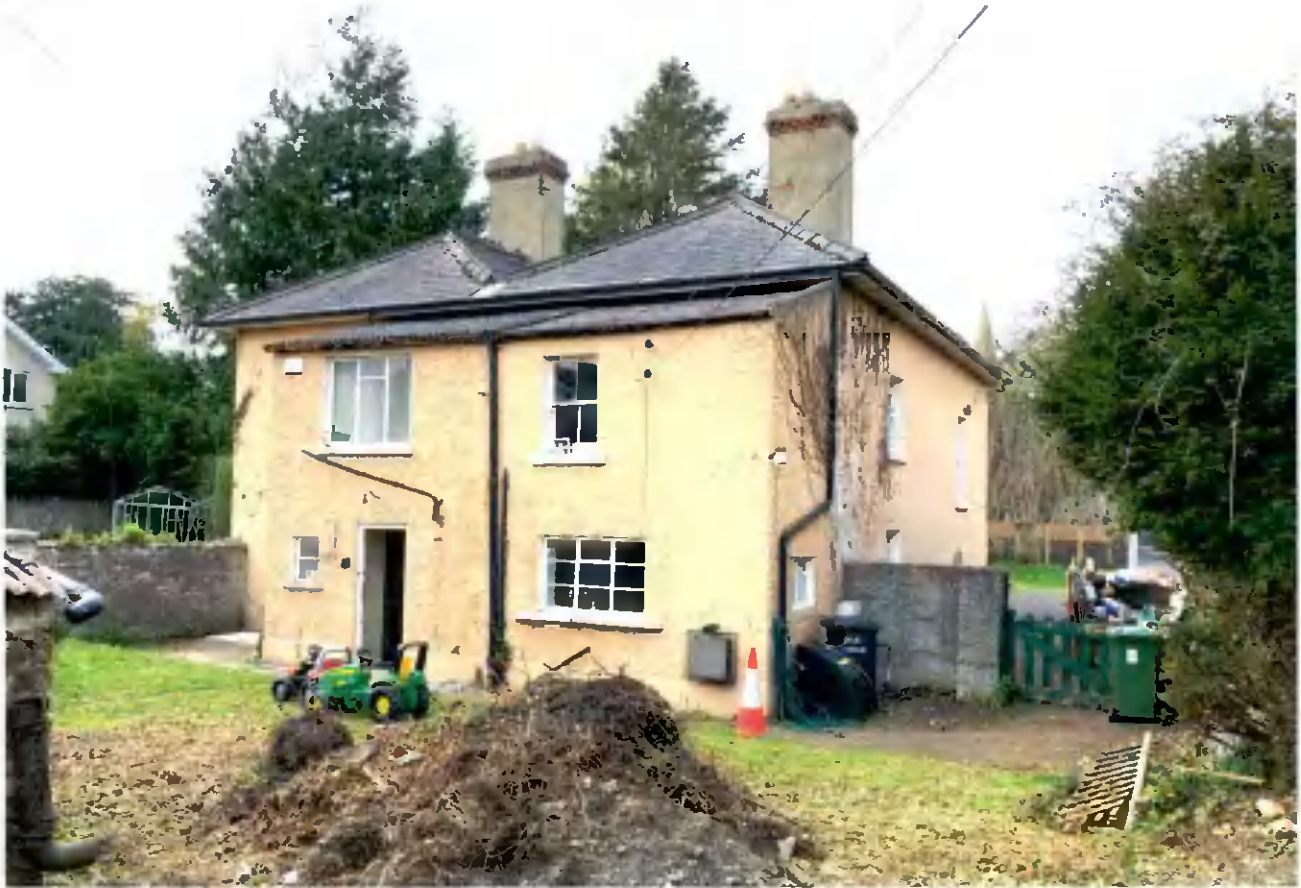
Above: Asbestos roofed extension proposed for demolition & slated corner extension to be retained.

There are two existing extensions to the back of the house. The first forms the **north-east corner** of the building as it currently stands, has a pitched lean-to roof with a two over two sliding sash window at first floor level, over a (circa 1930s) steel window at ground floor with a simple timber framed window to the side. This, (circa 10sq.m. footprint), first extension, to the building is not properly tied into the main building and has a very low-pitched slated lean-to roof. Overall, the corner extension is in poor condition and houses one small room at each level. The room on the upper floor is approached by a steep, easy to miss steps at the doorway to the main part of the house.

It is **proposed to** retain the external walls, roof and sliding sash window of this extension and to carefully insert a new floor at first floor level to match the floor level in the adjoining room in the interest of safety. This proposed work will involve the careful removal of the existing flooring (linoleum), non-original floorboards and joists which, as can be seen from the photograph below, run parallel to the main house facilitating their removal without damage to original building fabric. It is proposed to insert new joists parallel to the back of the original part of the house to avoid any interference with its building fabric. The existing doorway connecting the extension to the main house does not require adjustment.

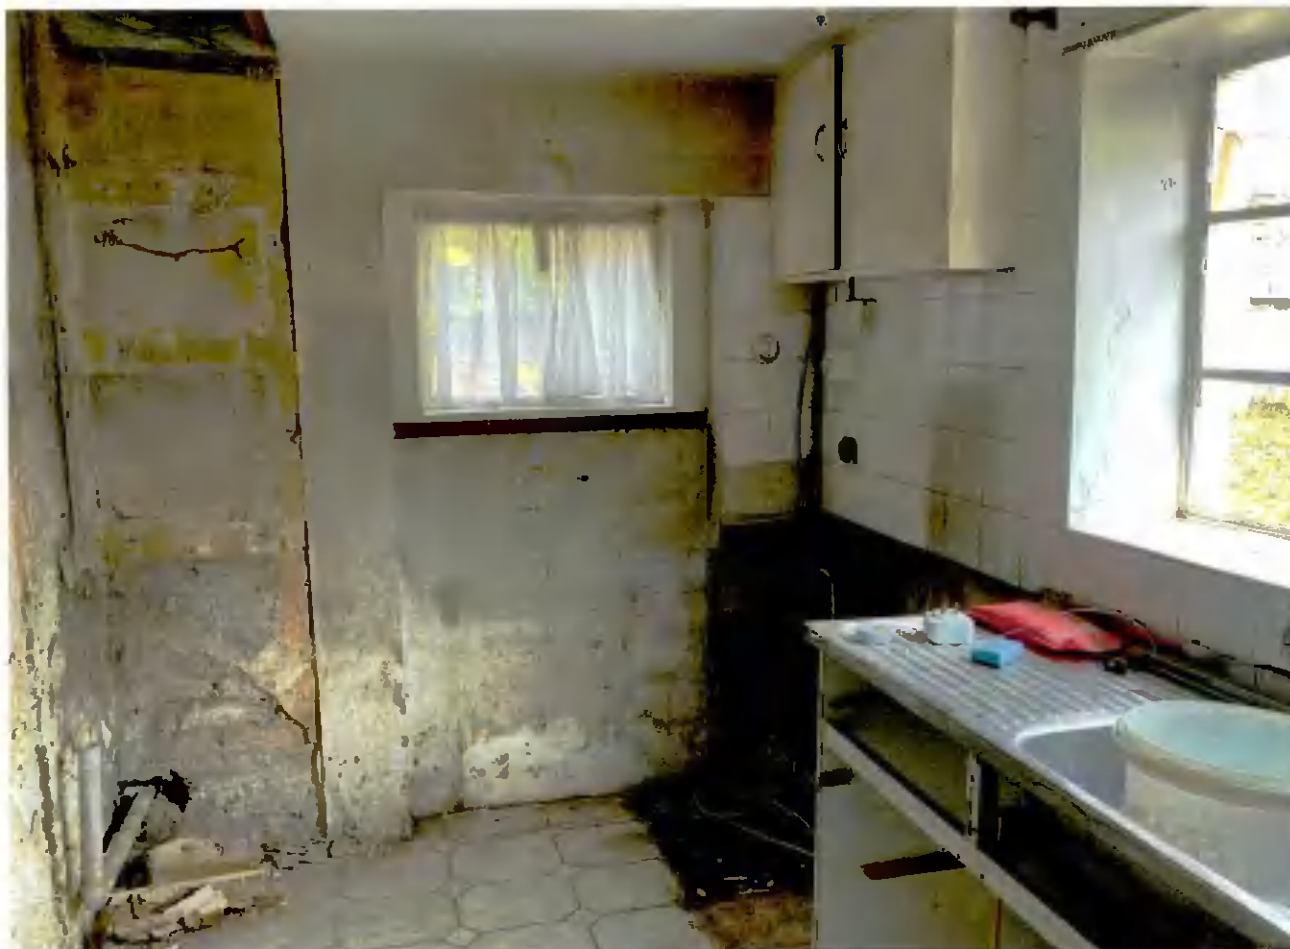
Above: The direction of the ceiling joists over the corner extension basement room is visible in the top left corner.

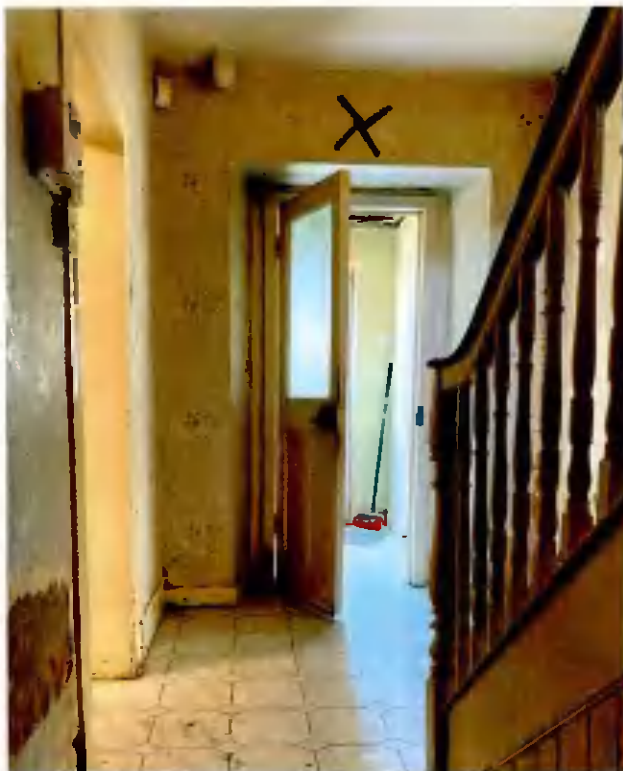
Above: Basement Hall: (back door)

- (i) There is an existing doorway at basement level into the original part of the house which will become the back door to the house once the extension in front of it is removed. These works will include the reinstatement of a threshold which is work that will be done from the outside without disturbing original building fabric.
- (ii) At first floor level the arched doorway, (visible in the background of the below right photograph), will need to be closed in to protect the building from the elements. It is proposed to do this by glazing the opening as a temporary measure until such time as the Applicants can afford to extend the

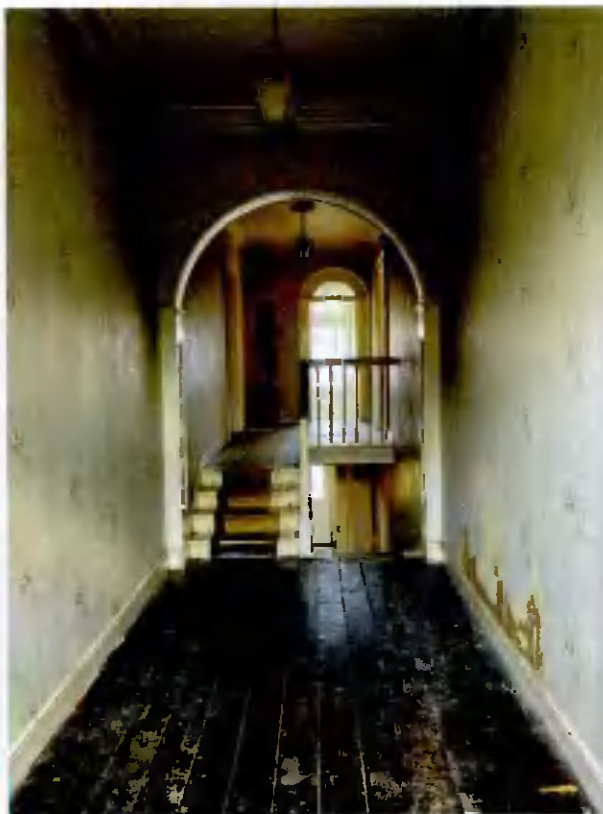
First Floor Hall: arched opening in the background

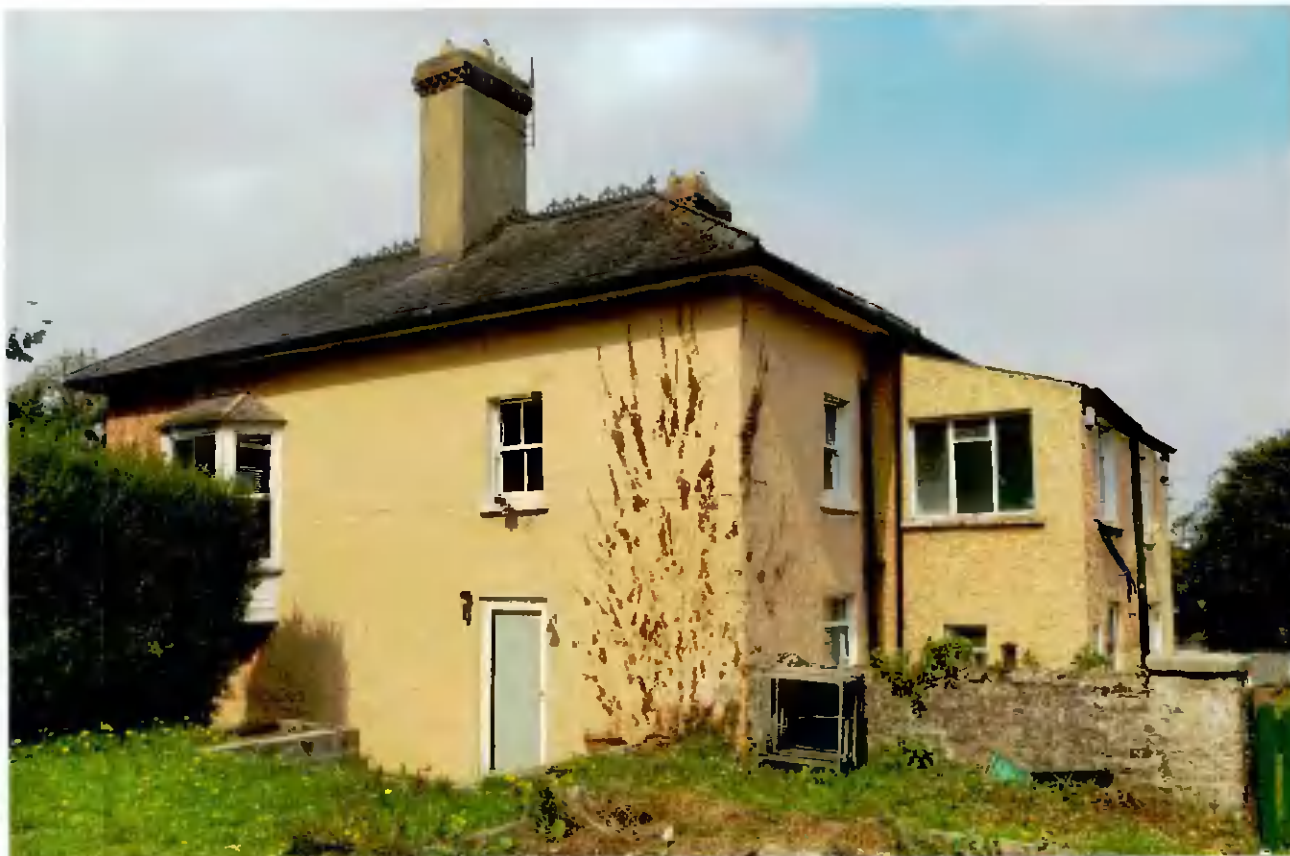
Above: Existing house as seen from the south-east

The proposed extension to the **basement room in the south-eastern corner** of the house will involve the following works:

Increasing the width and height of the existing external doorway which will include careful needling through the wall and careful propping of the wall, careful removal of a section of wall and insertion of a beam to the project engineer's instruction and specification. Careful insertion of new structure (beam) to the engineer's instruction and specification. Careful repair and make good works to the lining of the opening reveal between the new and old parts of house. The construction of new walls, floor and roof as shown on the enclosed drawings. Connection between original and new walls to use lime mortar in the interest of maintaining breathability of original building fabric. The existing basement room does not include any original decorative details, wall or ceiling linings and has a modern concrete subfloor that includes provision for matching the original finished floor level.

The photograph shows that the external walls have been previously "repaired", the existing render repairs are thought to be cementitious, the Applicants hope to be able to replace this with lime plaster in time when funds become available.

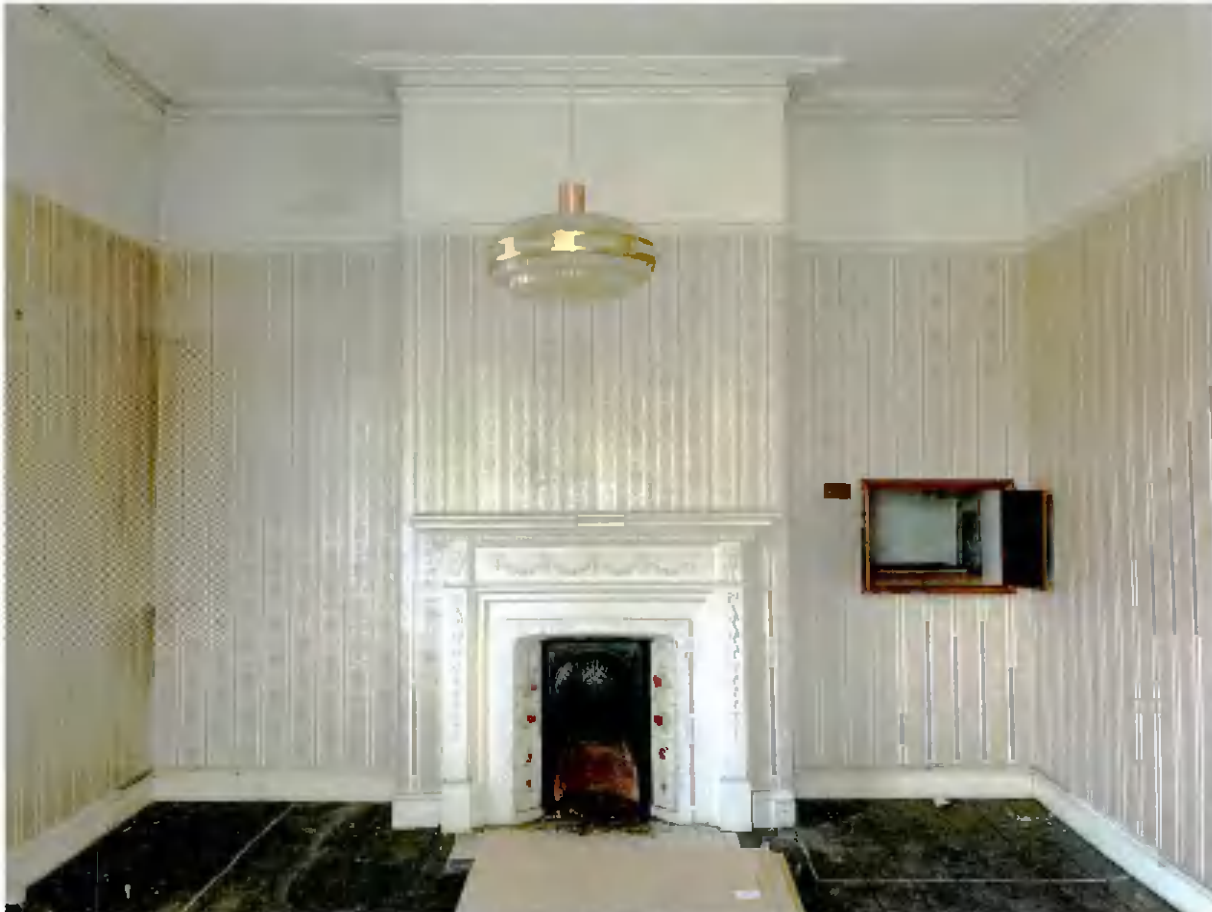
Above: Front room: north-west corner of the original building.

There is an existing dumb waiter (circa 1984) between the basement and ground floor on the north side of the house. The dumbwaiter shaft is the full depth of the wall. In the first-floor room to the north east, (proposed dining room) the opening is approximately one meter high by 600mm wide. It is proposed to increase the size of this opening to form a doorway connecting the front (see photograph below) and back rooms on this side of the house.

The proposed opening will involve careful needling through the wall so that it can be propped before removing a small part of wall and inserting a lintel all to the engineer's instruction. Once the structural work is done the reveals will be repaired and made good with lime plaster. It is proposed to keep the top of the opening below the level of the picture rail (circa 2570mm above the floor in the front (west) room. There is no picture rail on the proposed dining room side of the wall. It is proposed that the work be done slowly and with great care from the dining room side in order to protect and retain the picture rail, which in the event of damage (not anticipated) will require repair by a conservation plasterer using materials that match the original, (lime plaster). The proposed opening is a reversible change. As part of this work

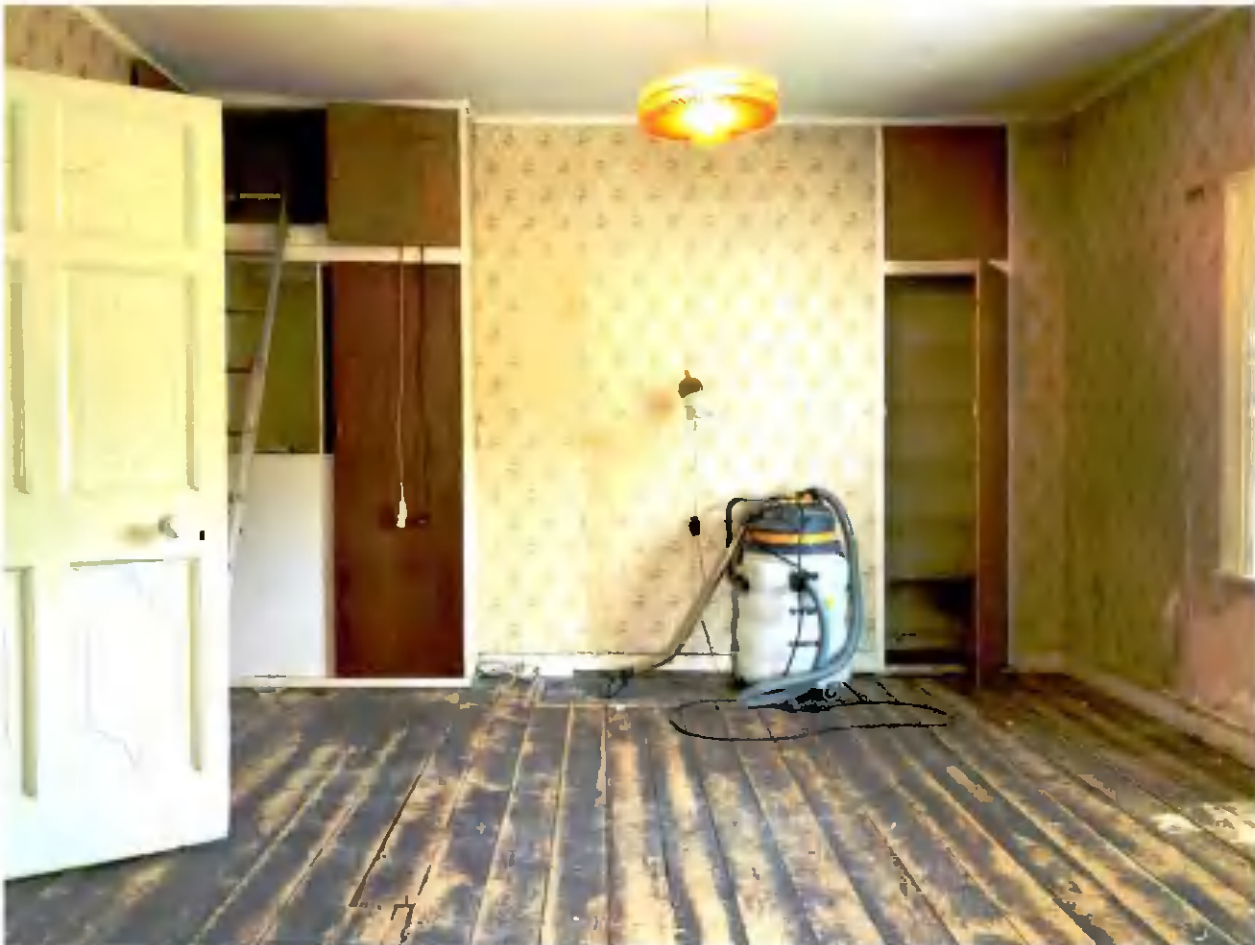
Above: proposed dining room, north-east corner of the house, note the absence of corning, picture rail and fireplace, non-original cupboards (now removed), inset into the chimney alcoves.
