SOAKAWAY LAYOUT RED AREA

CLONDALKIN RUGBY CLUB
CLONDALKIN,
CO. DUBLIN

SOAKAWAY SECTION

SITE OVERVIEW

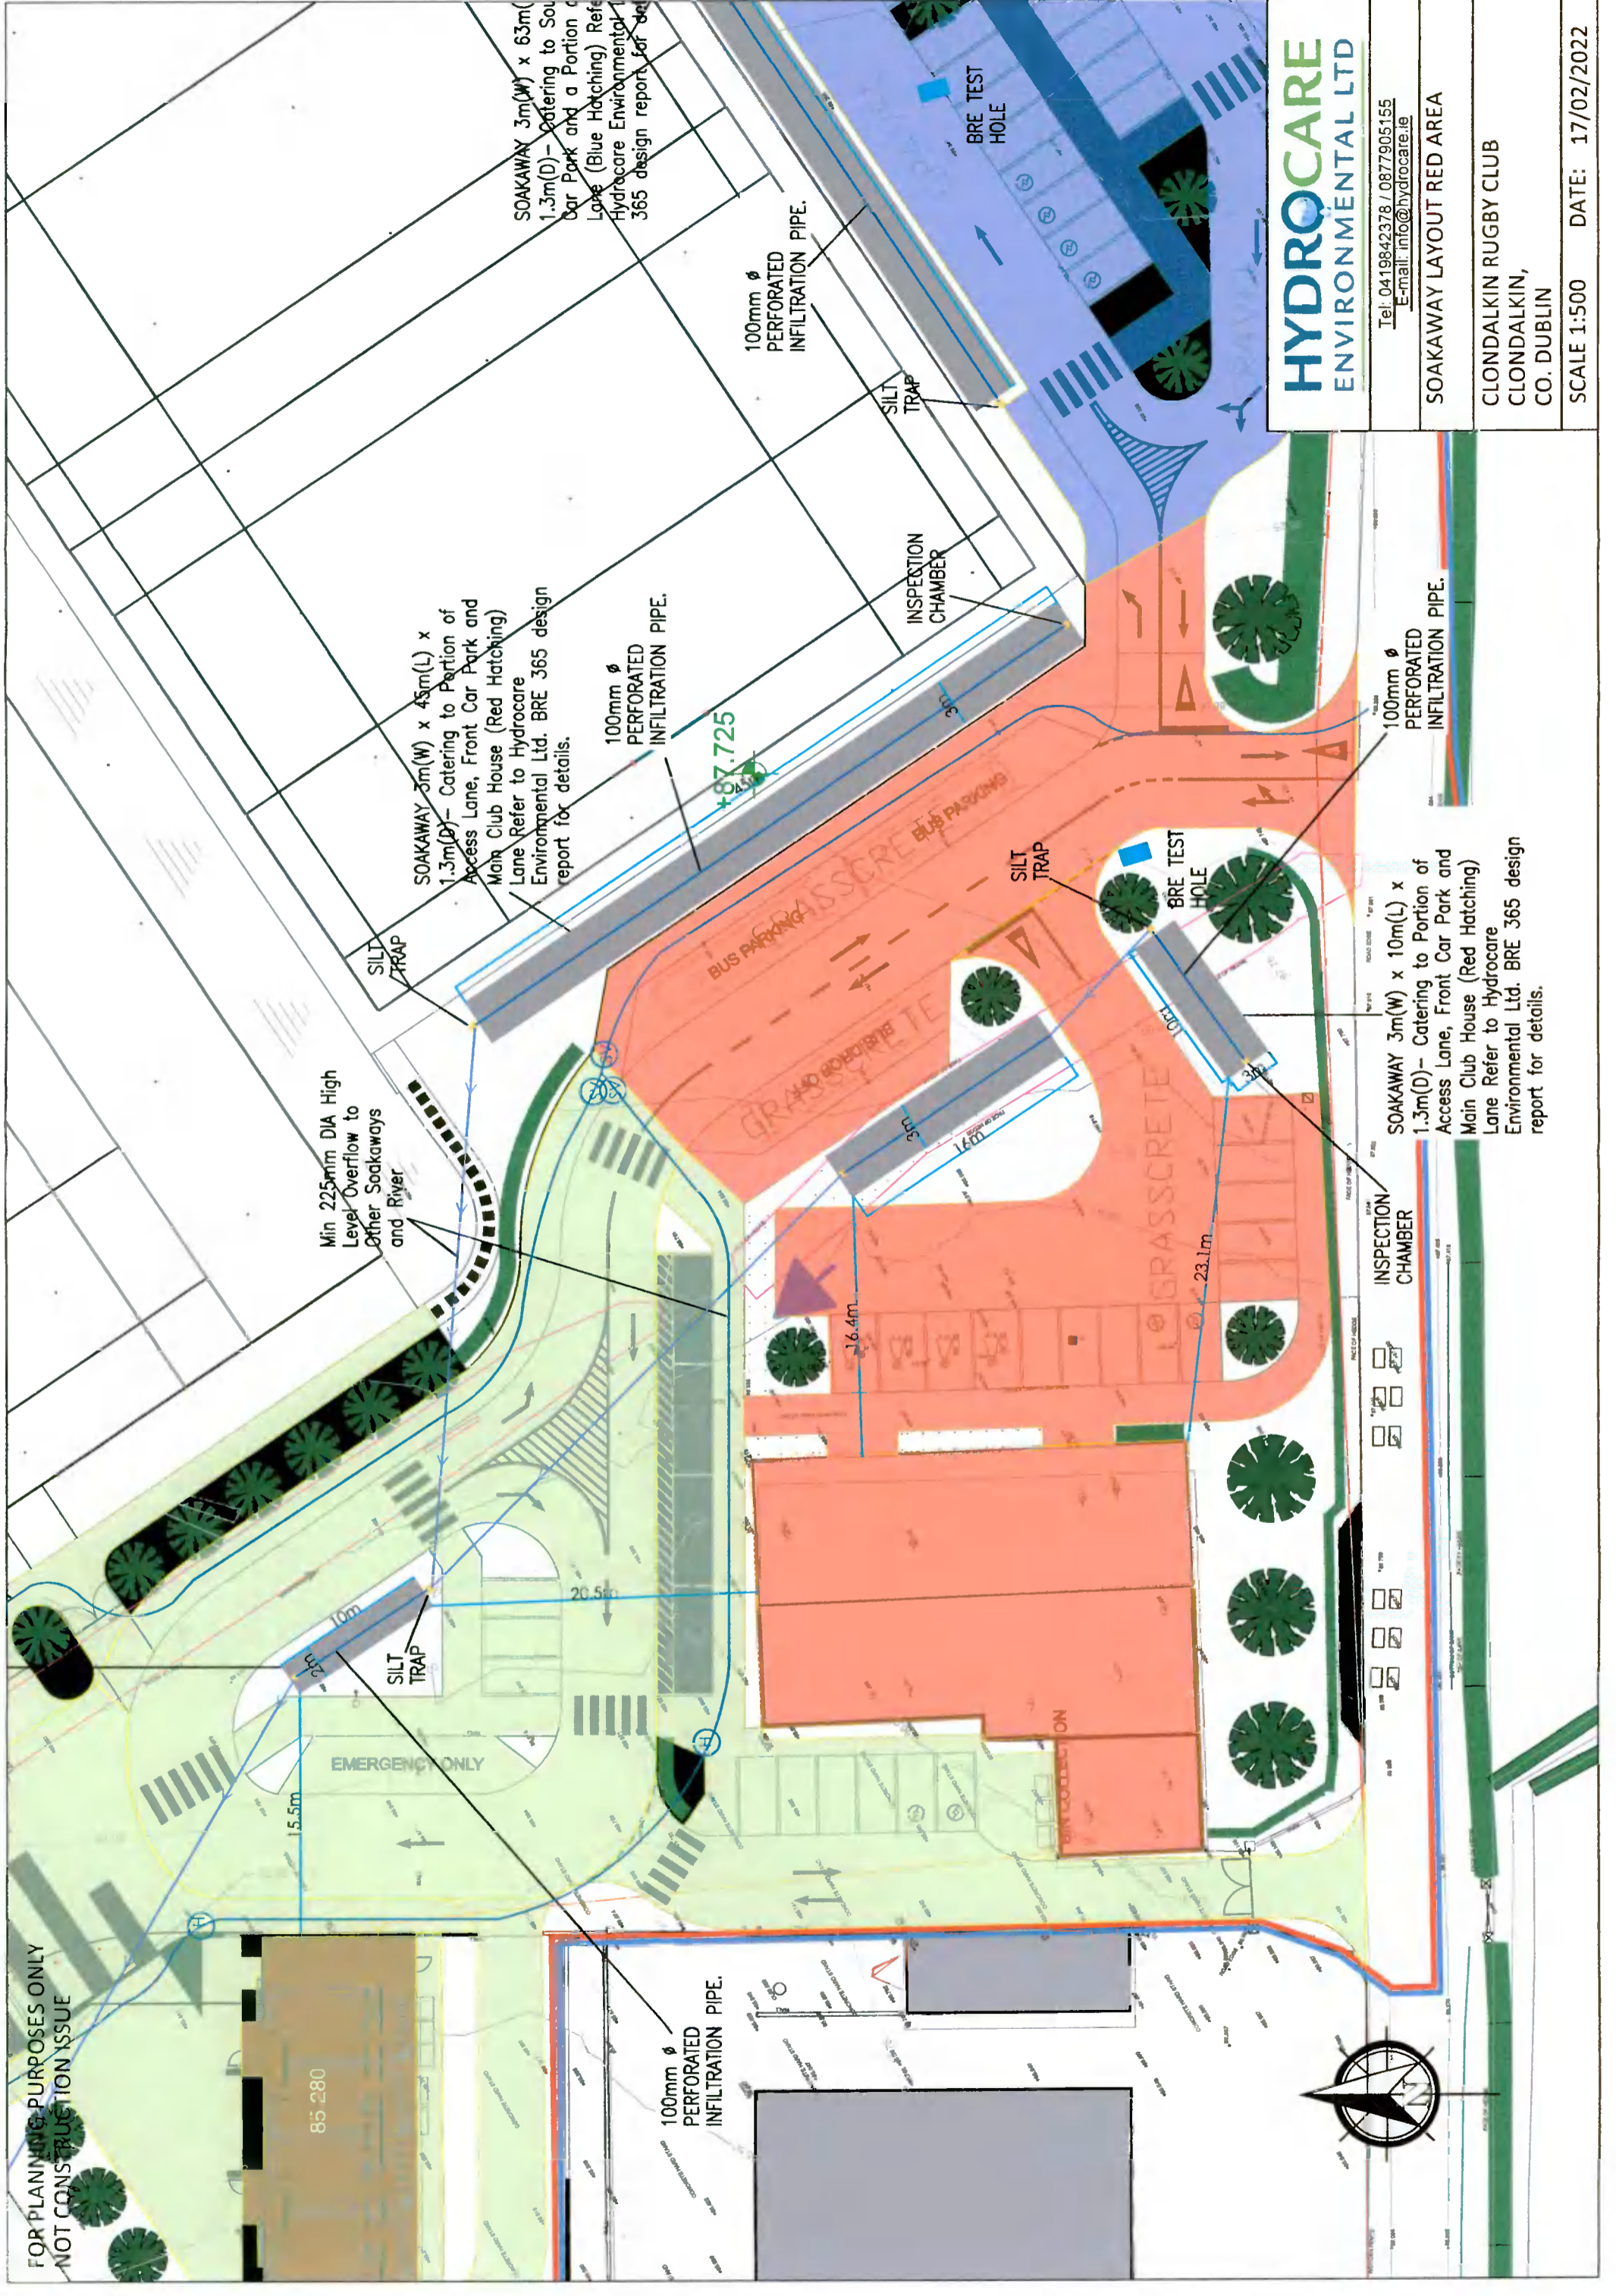
SOAKAWAY 3m(W) x 1.3m(D) x 45m(L) x 45m(L) - Catering to Portion of Access Lane, Front Car Park and Main Club House (Red Hatching) Lane Refer to Hydrocare Environmental Ltd. BRE 365 design report for details.

SOAKAWAY 3m(W) x 1.3m(D) - Catering to Soakaway Car Park and a Portion of Lane (Blue Hatching) Refer to Hydrocare Environmental Ltd. BRE 365 design report for details.

100mm ϕ PERFORATED INFILTRATION PIPE.

INSPECTION CHAMBER

SOAKAWAY 3m(W) x 1.3m(D) - Catering to Portion of Access Lane, Front Car Park and Main Club House (Red Hatching) Lane Refer to Hydrocare Environmental Ltd. BRE 365 design report for details.

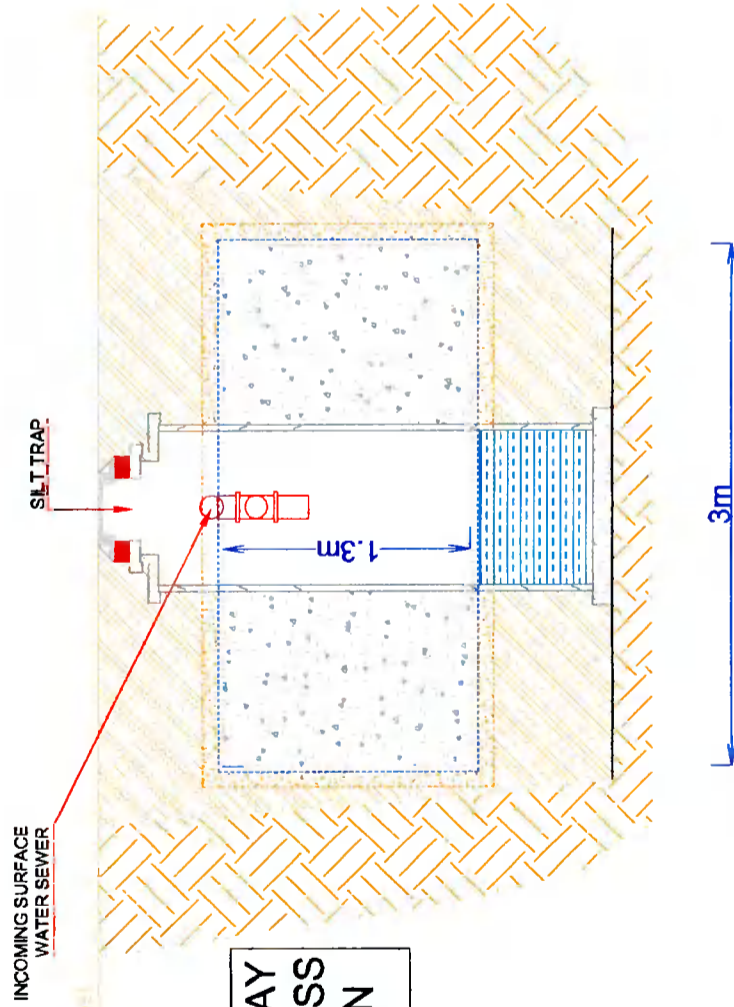
**SOAKAWAY
No.1 CROSS
SECTION**

Varies See Site Layout Drawing

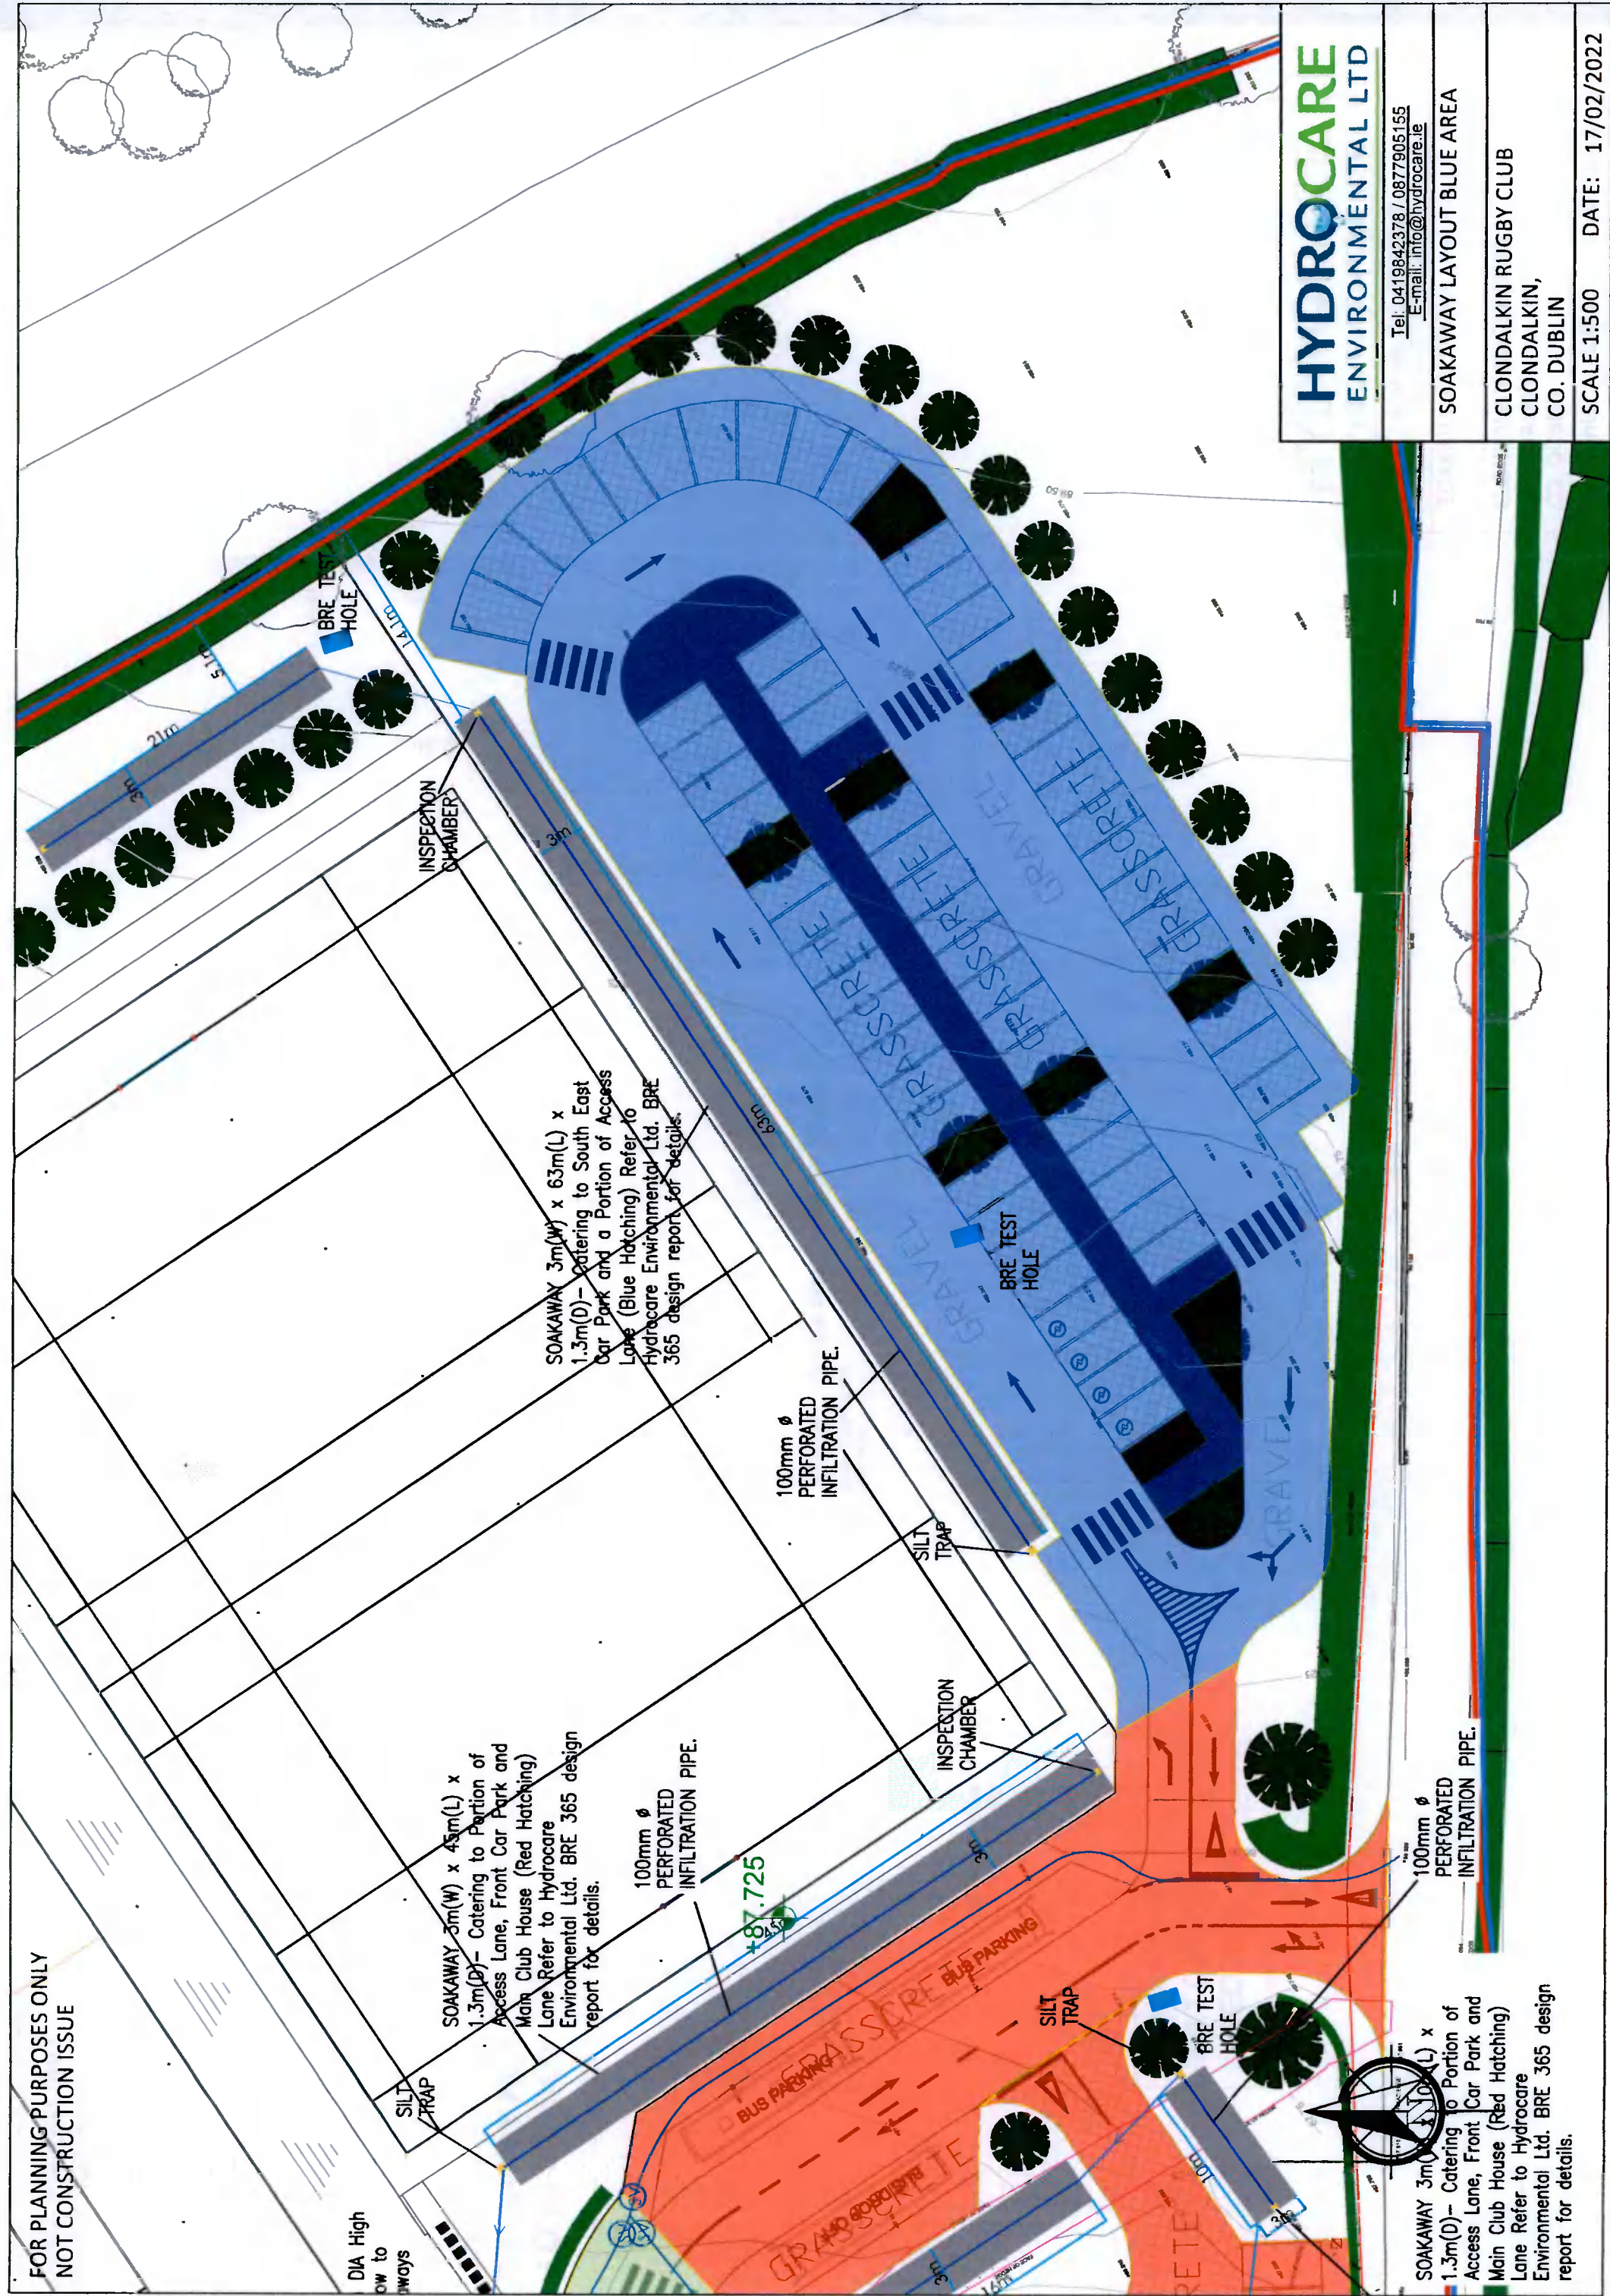
SOAKAWAY LAYOUT BLUE AREA

SOAKAWAY 3m(W) x 45m(L) x
1.3m(D) - Catering to Portion of
Access Lane, Front Car Park and
Main Club House (Red Hatching)
Lane. Refer to Hydrocare
Environmental Ltd. BRE 365 design
report for details.

100mm ϕ
PERFORATED
INFILTRATION PIPE.

SOAKAWAY 3m(W) x 63m(L) x
1.3m(D) - Catering to South East
Car Park and a Portion of Access
Lane (Blue Hatching) Refer to
Hydrocare Environmental Ltd. BRE
365 design report for details.

SOAKAWAY 3m(W) x 100m(L) x
1.3m(D) - Catering to Portion of
Access Lane, Front Car Park and
Main Club House (Red Hatching)
Lane Refer to Hydrocare
Environmental Ltd. BRE 365 design
report for details.

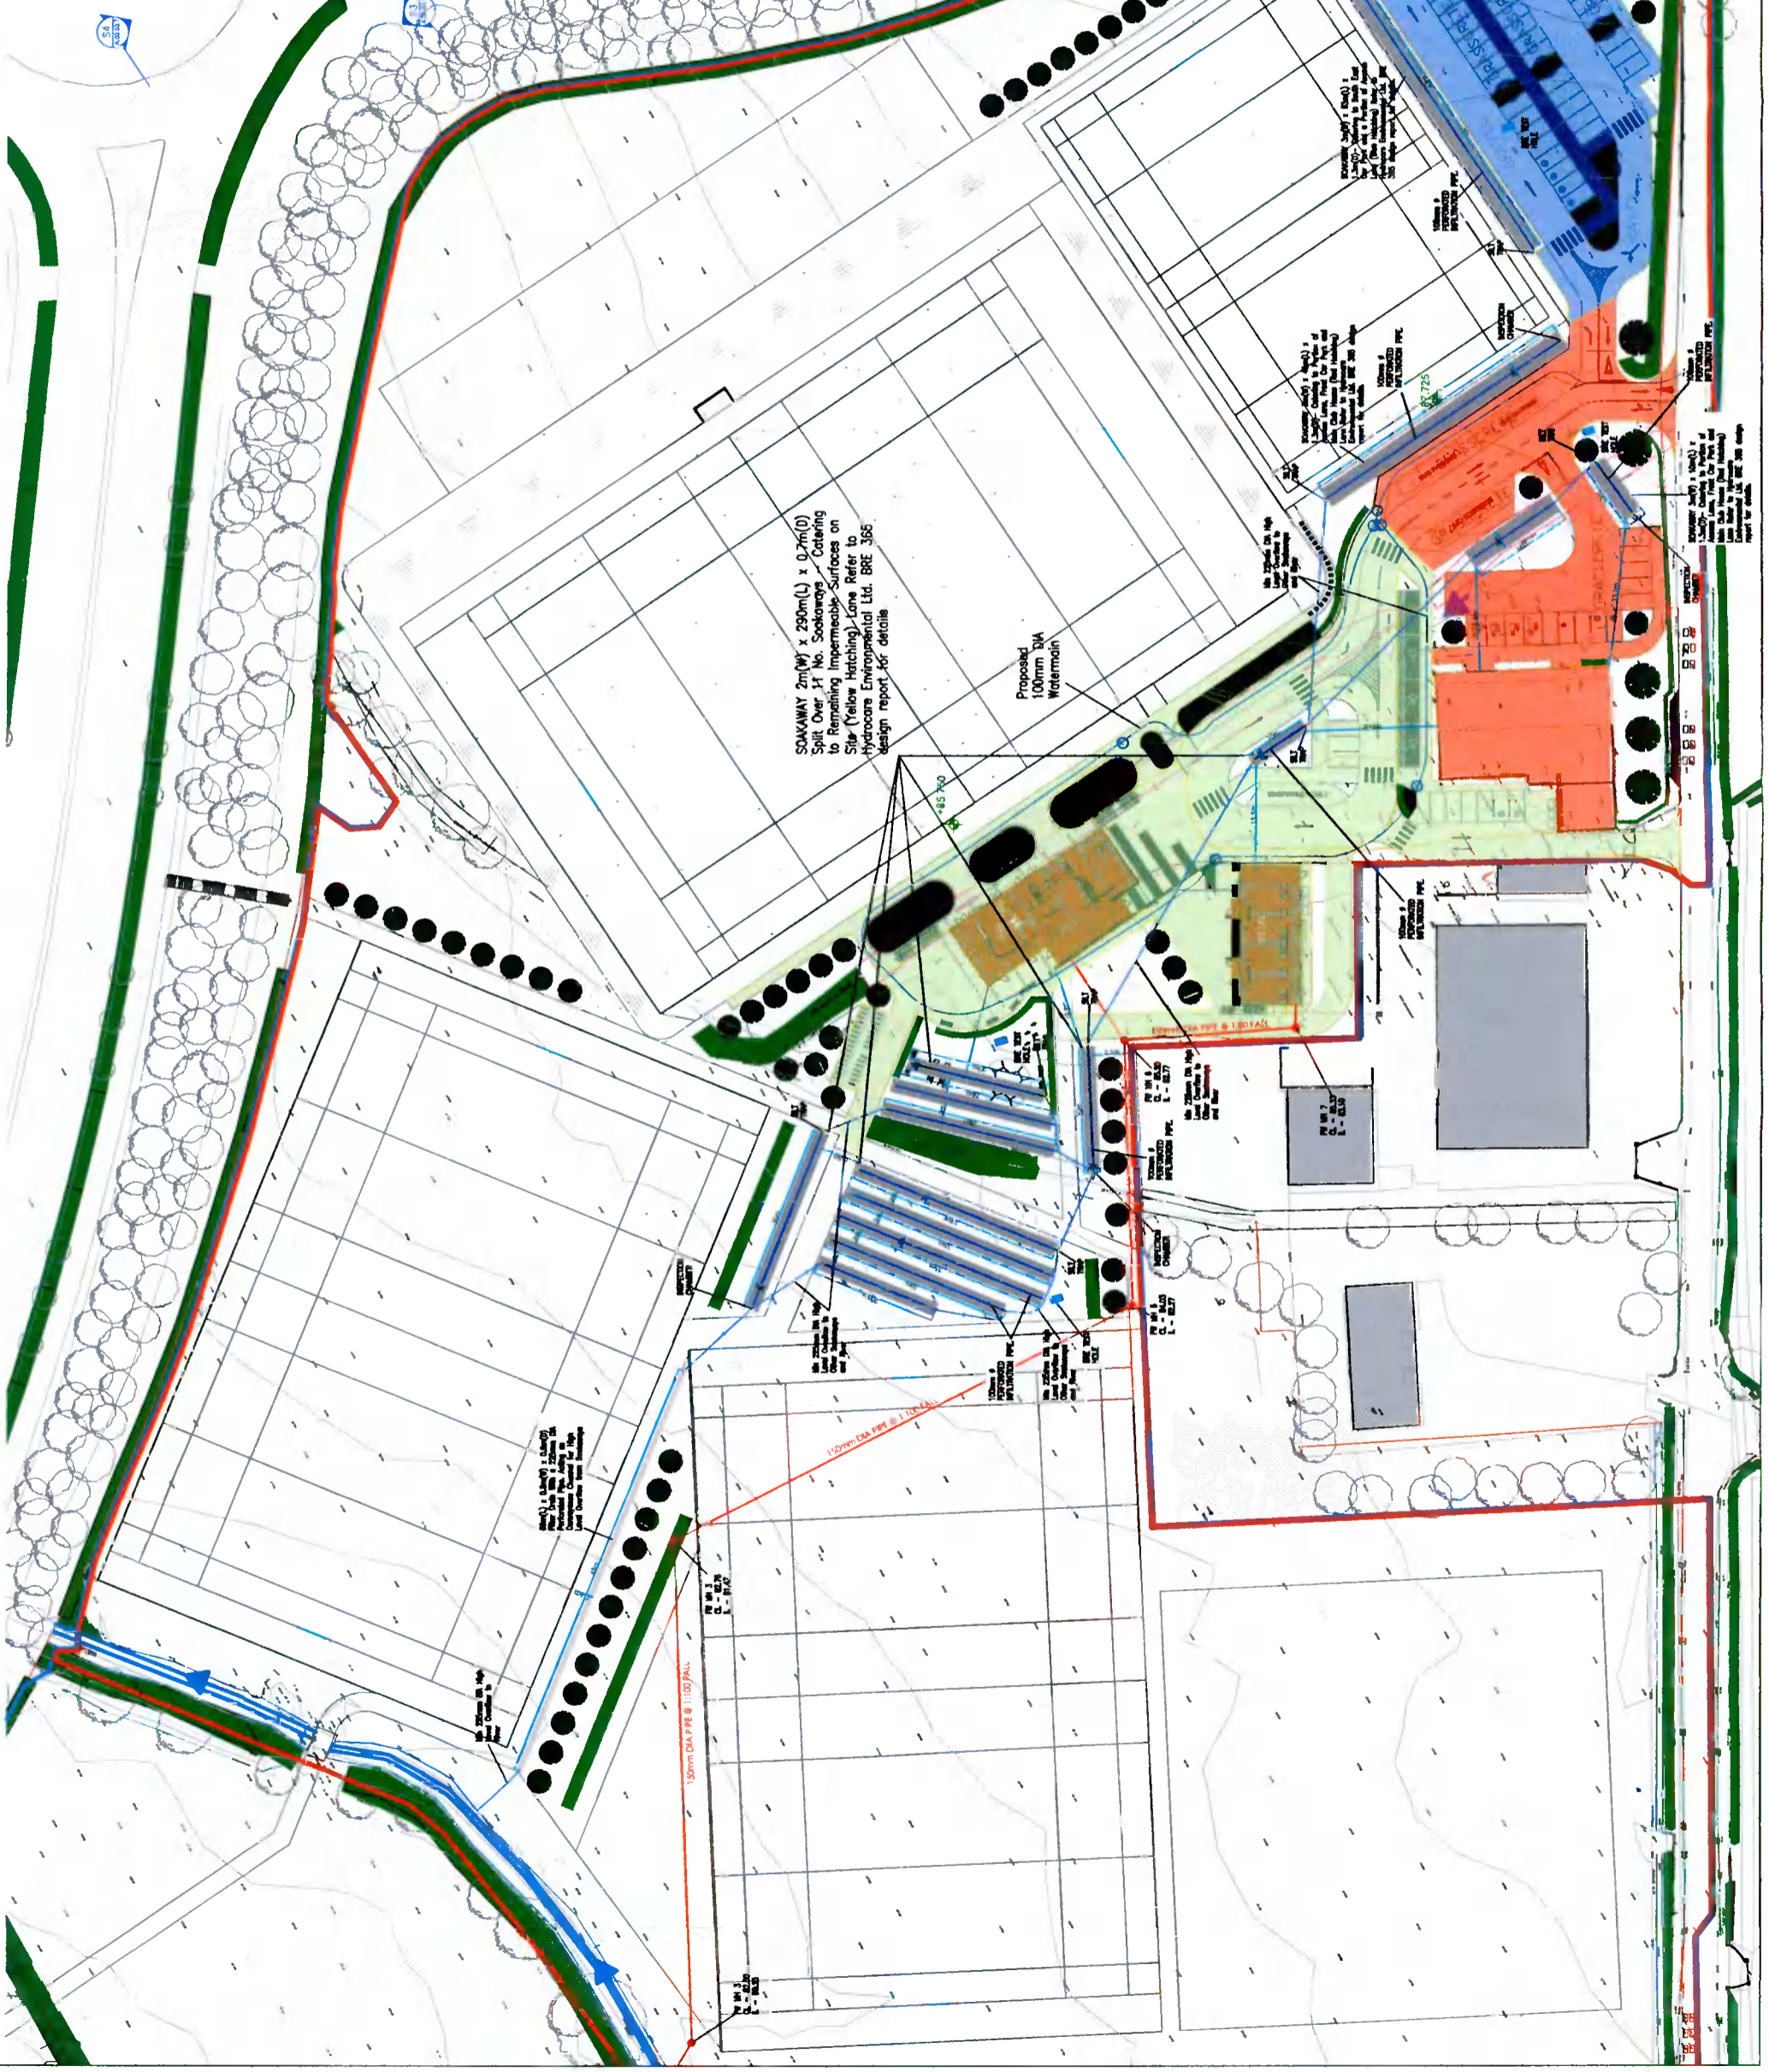
SOAKAWAY 2m(W) x 290m(L) x 0.7m(D)
 Split Over 17 No. Soakaways Catering
 to Remaining Impermeable Surfaces on
 Site (Yellow Hatching) - Lone Refer to
 Hydrocare Environmental Ltd. BRE 365
 design report for details

Proposed
 100mm BIA
 Watermain

150mm DIA PPE @ 1100 PAL

120mm DIA PPE @ 1100 PAL
