DESIGN REPORT
27th May 2022

IN SUPPORT OF
PLANNING APPLICATION

GAELOCHOLÁISTE AN PHIARSAIGH
REDEVELOPMENT
LORETO ABBEY
RATHFARNHAM
DUBLIN 14

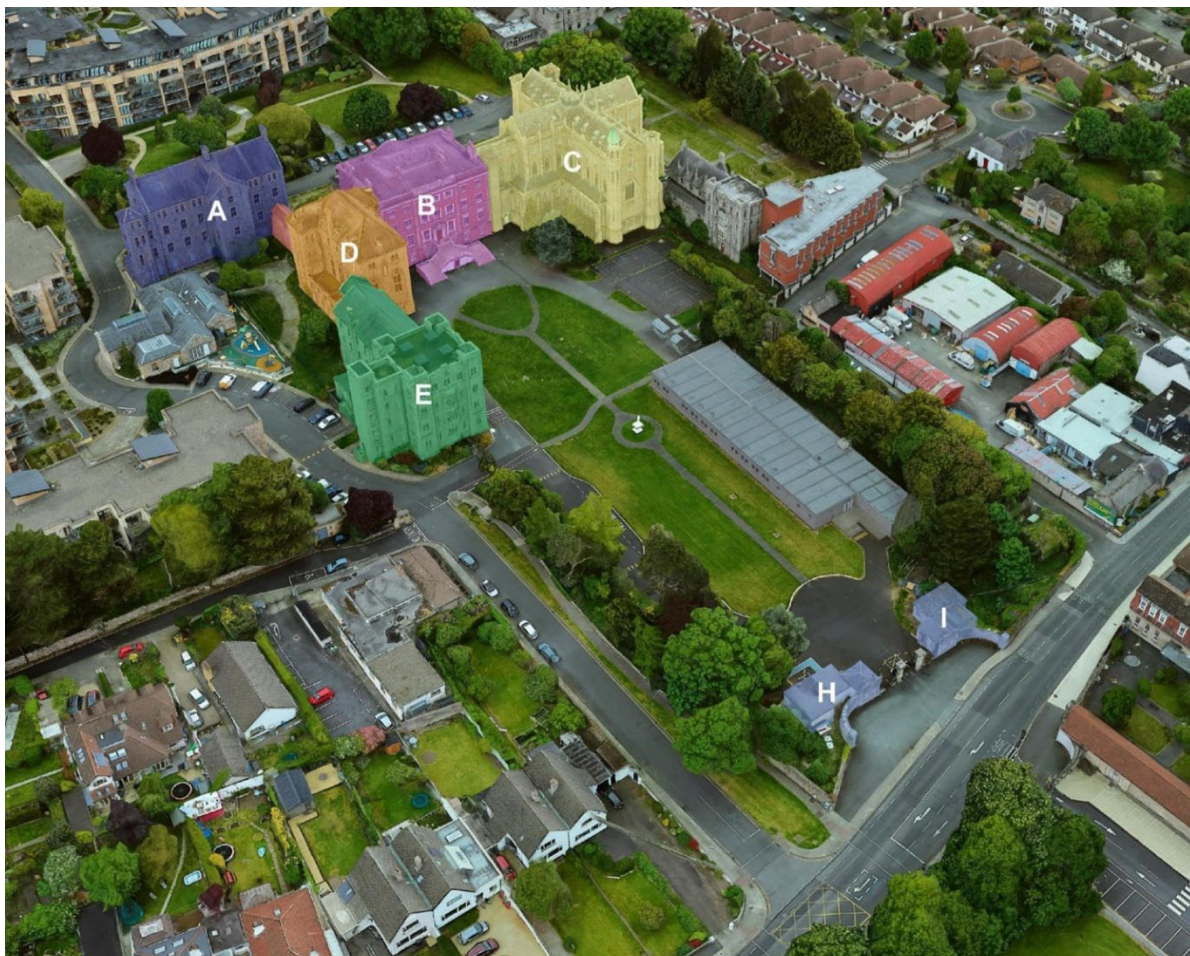
Aerial view of existing complex with building blocks labelled

The existing buildings have been assigned letters, and these are as follows: Block A – St. Anne’s Dormitory, Block B – Georgian House, Block C – Loreto Abbey (Pugin Chapel), Block D – Concert Hall, Block E – Sports Hall and the H,I - Gatelodges.

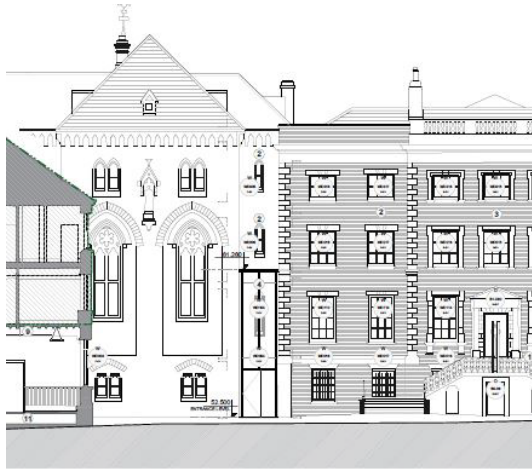
Extract from planning application drawing 2350-SJK-S2B-0-250 showing the addition of a fully glazed 2-storey screen which is designed to align with the Georgian House string course, while being set back and secondary to its corner

A contemporary intervention is proposed at the junction of Blocks B and D facing west (the front elevation) in order to provide a clearly visible and identifiable accessible pedestrian entrance into the new circulation link behind. This intervention involves the strategic demolition at lower ground floor of part of the wall to make an accessible entrance, and the addition of a fully glazed 2-storey screen which is designed to align with the Georgian House string course, while being set back and secondary to its corner. Below snip from the planning application drawing and similar approach reference image from the Hugh Lane Gallery to illustrate the design intent:

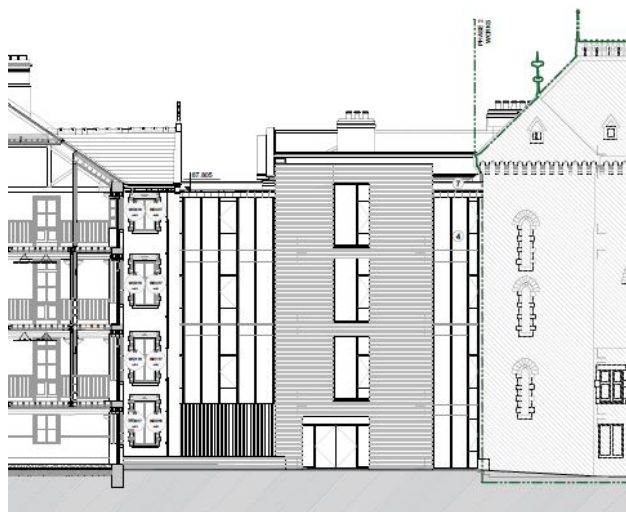
Extract from planning application drawing 2350-SJK-S2B-0-252 showing the north elevation of the proposed addition of a fully glazed 4-storey link building

The design intention of the new link is primarily as a fully glazed 4-storey building which is designed set back and secondary to its adjoining historic structures. The set back is proposed both in plan and elevation.

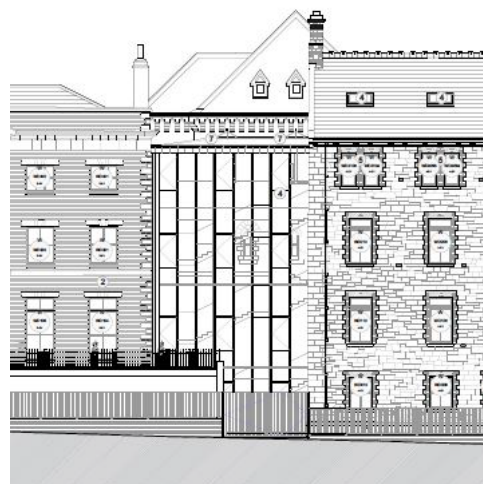
Extract from planning application drawing 2350-SJK-S2B-0-251 showing the east elevation of the proposed addition of a fully glazed 4-storey link building

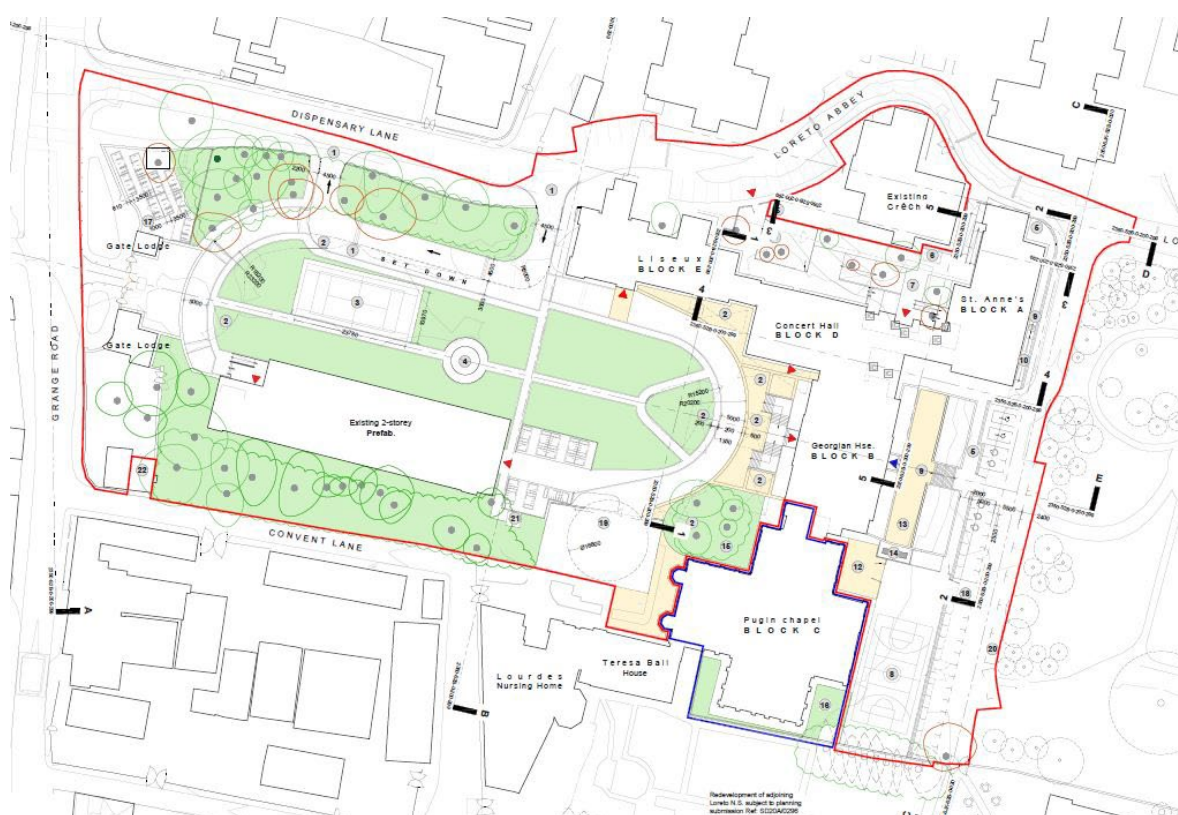
Extract from Phase 1 site layout drawing 2350-SJK-S2B-0-002 accompanying this Phase 1 application

The Planning Application proposes a continuance of the current vehicular entrance from Dispensary Lane area with an enhanced one-way drop-off arrangement leading to a new proposed vehicular egress onto Dispensary Lane.

Vehicles are not proposed to access the landscaped forecourt area east of the current access gate leading to the school (except for emergency / disabled access) which is proposed to prioritize pedestrian and student amenity to the fore of the school. A quantum of covered bicycle parking associated with the temporary accommodation will remain in use at Phase 1. The existing tarmac ball court to the fore of the Pugin Chapel will remain during Phase 1 and this provides turning area for emergency vehicles, pending the installation of the full Phase 2 site layout.

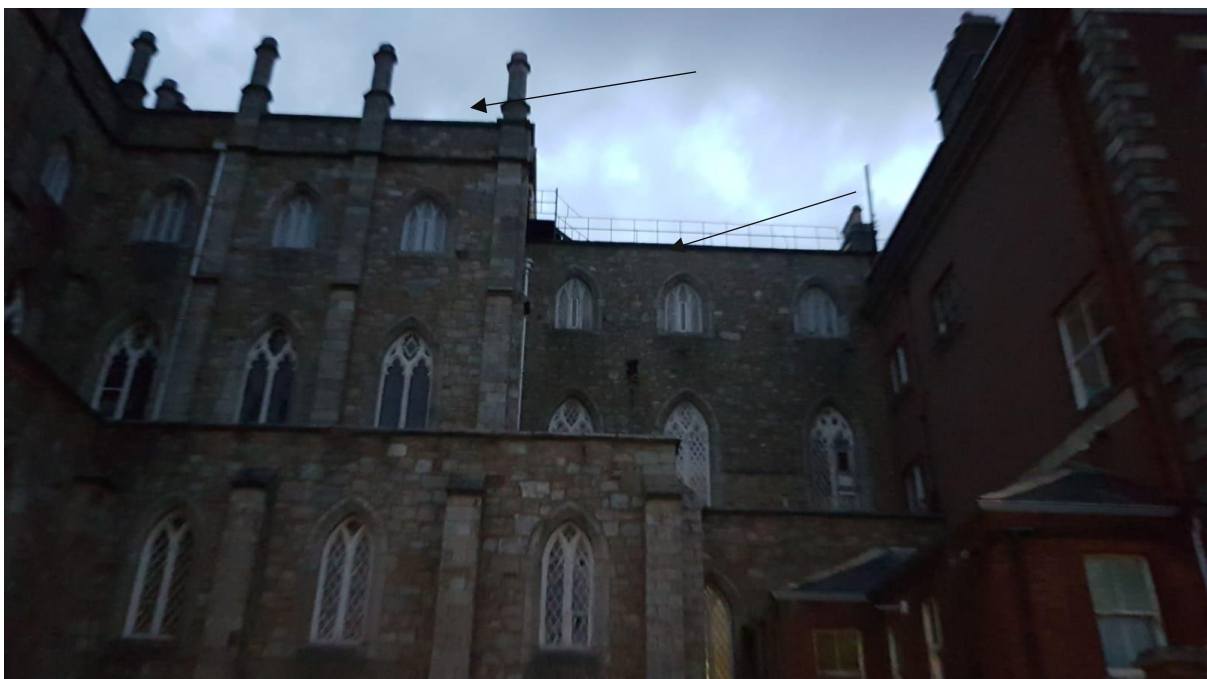
Bats swarming hereat the Pugin Chapel building. This area is a roost.

At 21.55, a Leisler's bat was seen at the rear of the school. A common pipistrelle was seen at the south western part of the site. then was seen at the roof. A common pipistrelle appeared to come from the Chapel roof. Both pipistrelles were swarming around the chimneys and roof area at the rear of the Pugin chapel. This area is a roost. There is an attic behind the chimneys, and the bats may be using this. Common pipistrelles continued swarming in this area until 22.09, when they moved around to the front of the building.

At 22.18 a common pipistrelle flew along the west wing of the building. At 22.19 there was intense swarming of common pipistrelles, and one entered the Pugin Chapel building at the eaves. Feeding and swarming continued at this area until 22.38

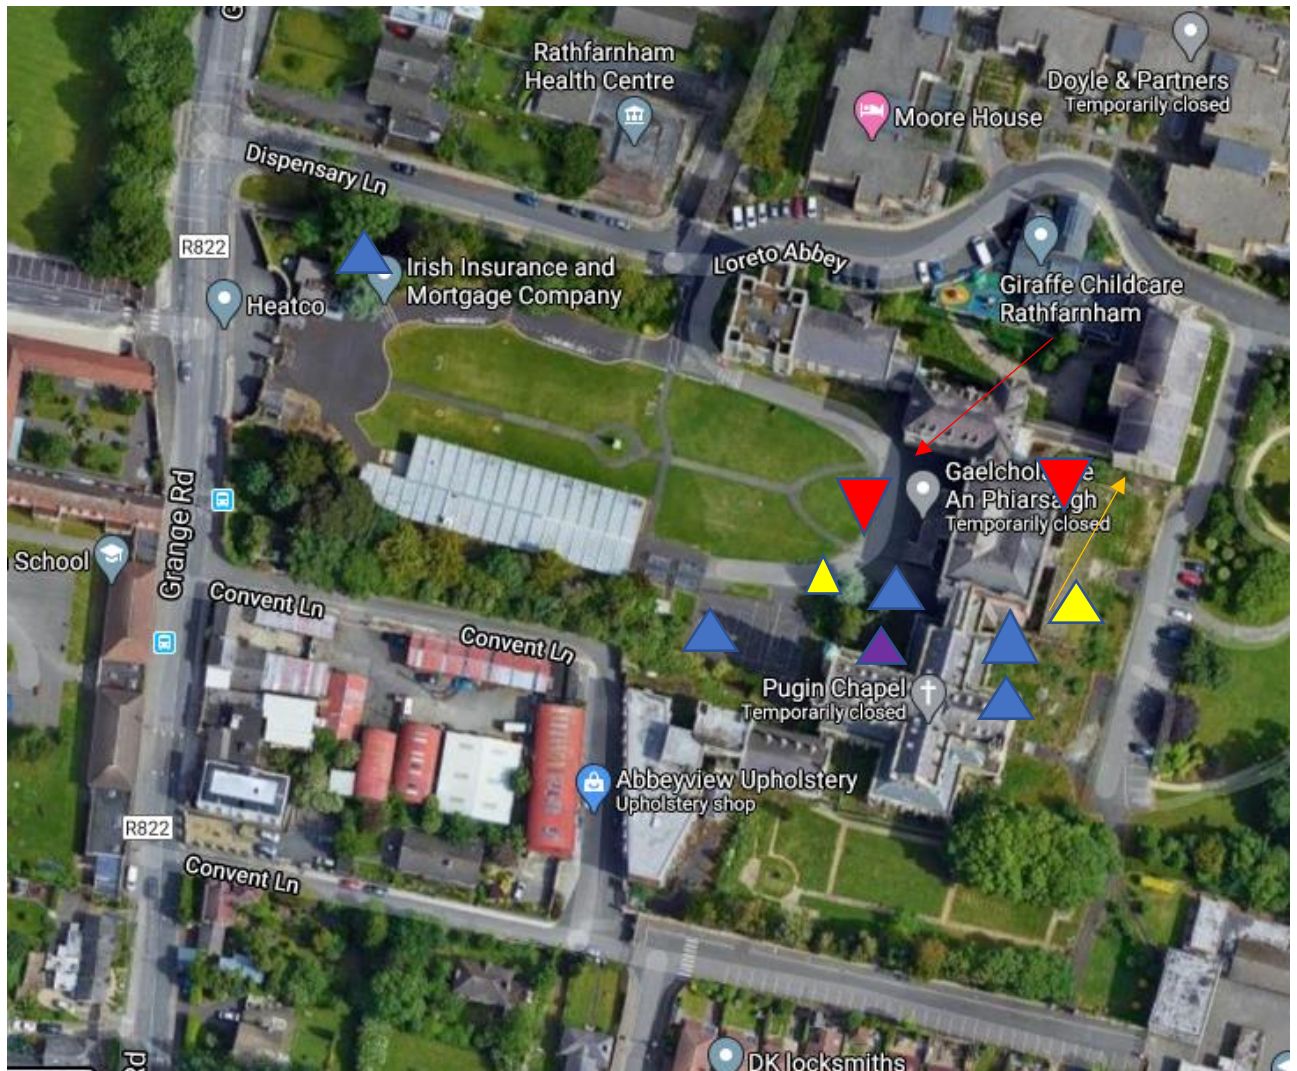
Main bat activity as recorded by Donna Mullen on handheld detector and song meter mini on July 20-21st

Blue triangle – Common pipistrelle

Orange arrow – Common pipistrelle feeding/commuting route

Purple triangle – Daubenton's bat

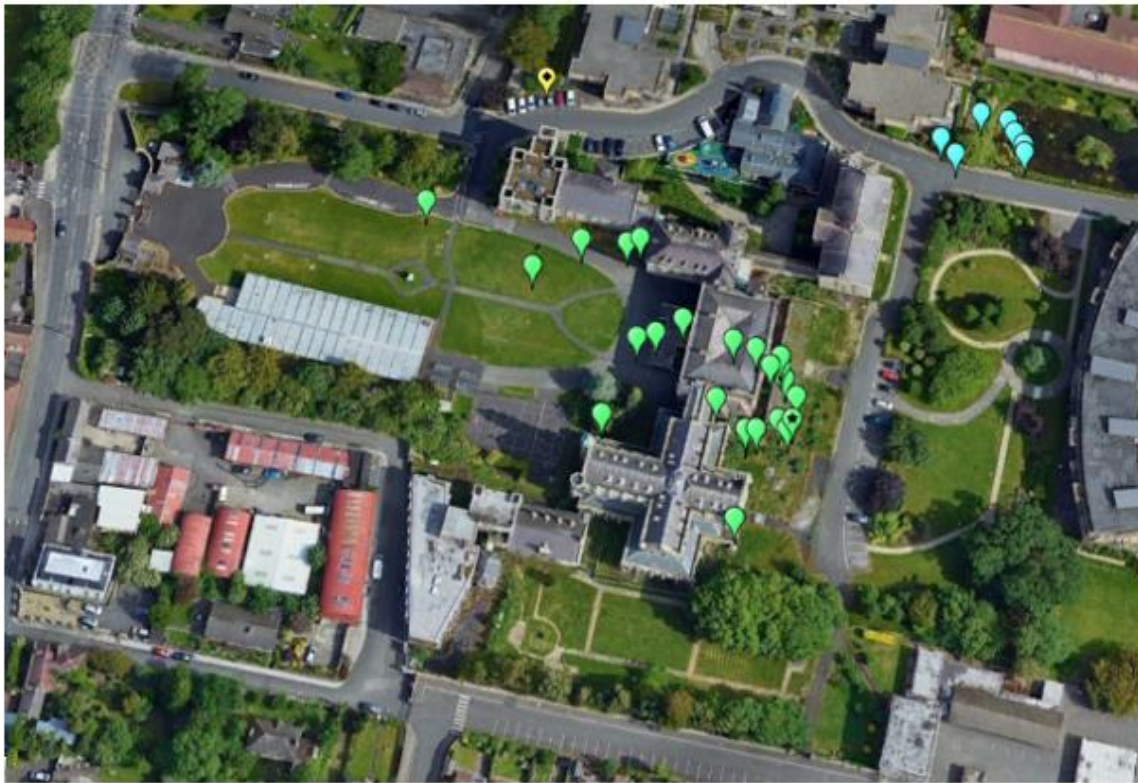
Main bat activity as recorded by Brian Keeley on 20 July with an EM3 Handheld recorder

Green- Common pipistrelle

Green with star- Common pipistrelle + Leisler's bat

Yellow- Leisler's bat

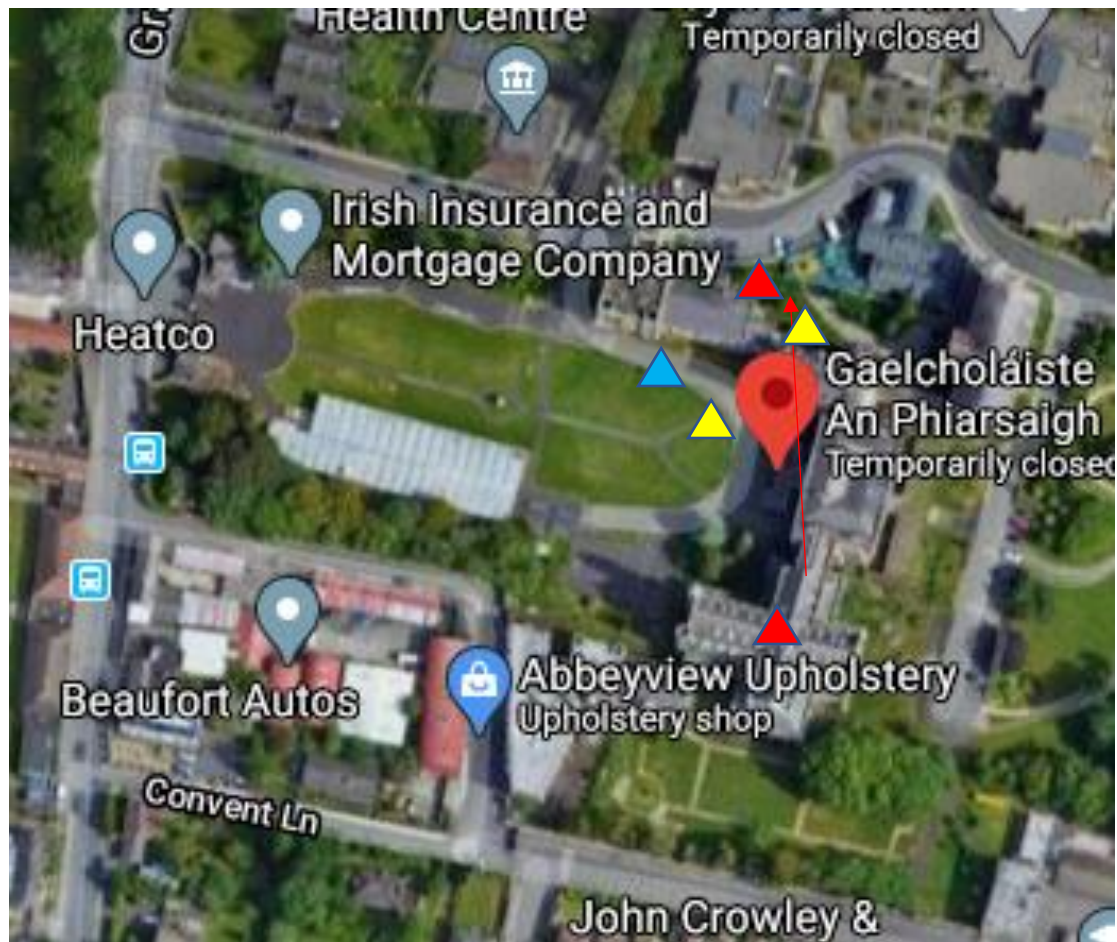
Main bat activity as recorded by handheld Song meters and Mini detector on August 17

Blue triangle – Common pipistrelle

Orange arrow – Common pipistrelle feeding/commuting route

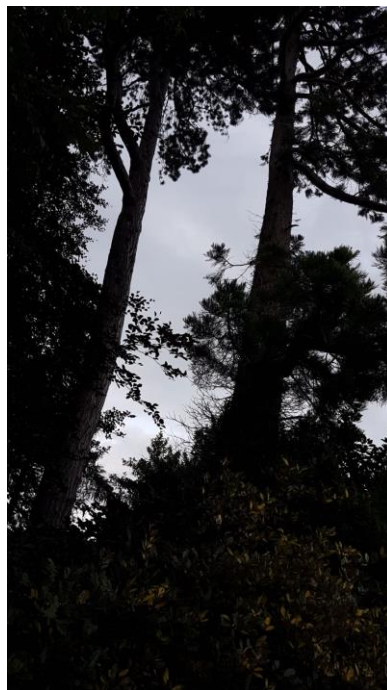
These Scots pine trees are ideal for the placement of bat boxes

(4) Three 2F and three 1FF Schwegler bat boxes with built-in timber panel bat boxes must be put in place. These should be placed on trees or posts, at least 3m high, with a clear drop below (as bats need to drop to start their flight). These can be purchased from www.nhbs.com They must be placed in a dark area – ideally on the Scot's pine trees near the entrance

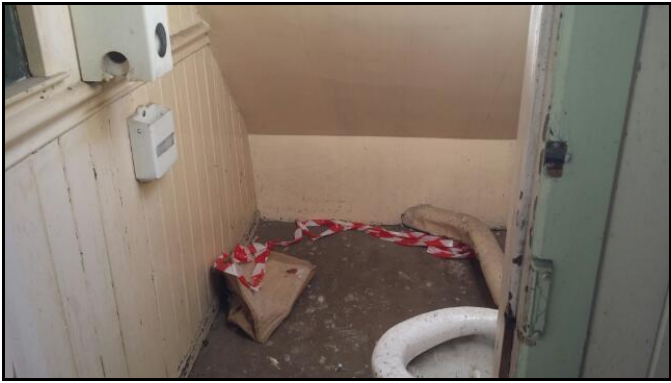
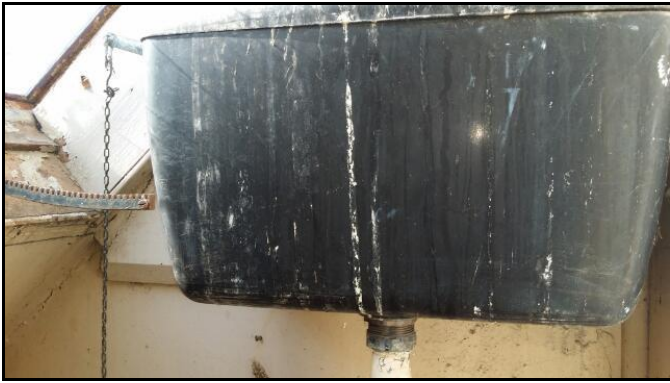
FLOOR:	3rd Floor			SURVEY DATES:	16/05/2018		
ROOM NAME / NO.:	3-038			SAMPLE REF NO.:	Same as S4

USE OF MATERIAL:	Cistern (PVC / Reinforced Plastics)			ACCESSIBILITY:	Medium		
LOCATION:	Toilet			EXTENT / QUANTITY:	1 no		
ASBESTOS TYPE	NON ASBESTOS	0		EXTENT OF DAMAGE / DETERIORATION	GOOD CONDITION	0	
	CHRYSOTILE	1			LOW DAMAGE	1	✓
	AMOSITE	2	✓		MEDIUM DAMAGE	2	
	CROCIDOLITE	3			HIGH DAMAGE	3	
	OTHER	2			LOOSE ASBESTOS	3	
SURFACE TREATMENT	COMPOSITE MATERIAL	0	✓	FIBRE RELEASE POTENTIAL	HIGH RISK	10-12	
	ENCLOSED SPRAY / LAGGING, PAINTED / ENCAPSULATED AIB, ASBESTOS CEMENT SHEETS	1			MEDIUM RISK	7-9	
	UNSEALED AIB OR ENCAPSULATED LAGGING AND SPRAYS	2			LOW RISK	5-6	
	UNSEALED LAGGING / SPRAY COATING	3			VERY LOW RISK	1-4	✓
PRODUCT TYPE	ASBESTOS REINFORCED COMPOSITES	1	✓	RECOMMENDED ACTION	REMOVE		✓
	ASBESTOS INSULATING BOARD, TEXTILES, GASKETS, ROPE, PAPER, FELT	2			REPAIR / SEAL ENCAPSULATE

Loreto Abbey, Rathfarnham, Dublin 14						
Sample	Floor	Location	Description	Asbestos	Extent / Amount	Recommended Action
XS4	3rd Floor	Toilet 3-038	Cistern (PVC / Reinforced Plastics)	Amosite	1 no	Remove
XS4	2nd Floor	Toilets 2-001	Cistern (PVC / Reinforced Plastics)	Amosite	3 no	Remove
XS4	1st Floor	Toilets 1-001	Cistern (PVC / Reinforced Plastics)	Amosite	2 no	Remove
XS4	Ground Floor	Toilets 0-001	Cistern (PVC / Reinforced Plastics)	Amosite	2 no	Remove
XS4	Ground Floor	Toilets 0-041	Cistern (PVC / Reinforced Plastics)	Amosite	no	Remove
SP	Basement	Chapel -1-001	Cement Board (debris)	Chrysotile/ Amosite/ Crocidolite	1 m ²	Remove
XS4	Basement	Toilets -1-023	Cistern (PVC / Reinforced Plastics)	Amosite	1 no	Remove
XS9	Basement	Hall -1-026	Pipework (Pipe Insulation & String)	Chrysotile in: String	1 lin m	Remove
XS3	Basement	Hall -1-026	Vinyl Floor Tiles (brown) & Bitumen	Chrysotile	2 m ²	Remove
XS4	Basement	Toilets -1-032	Cistern (PVC / Reinforced Plastics)	Amosite	1 no	Remove

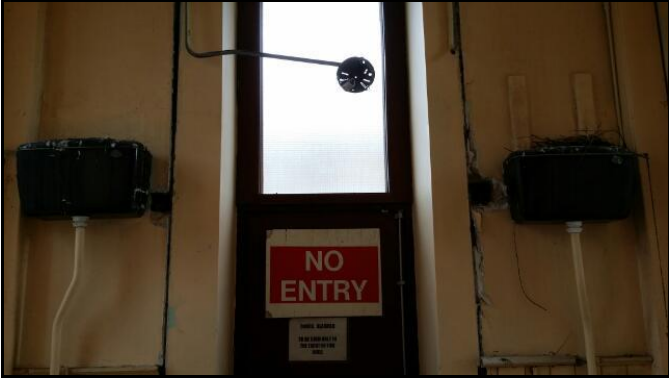
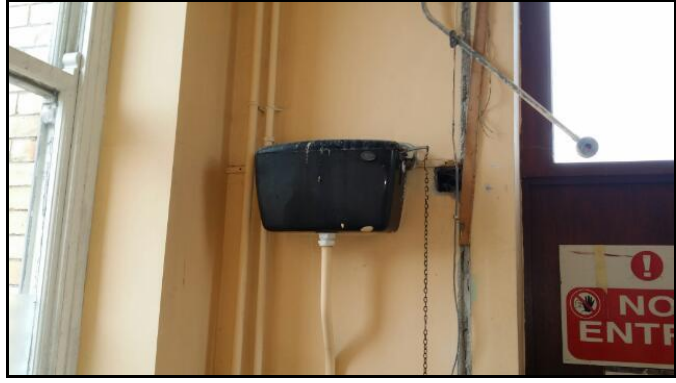
FLOOR:	1st Floor			SURVEY DATES:	09/05/2018		
ROOM NAME / NO.:	1-001			SAMPLE REF NO.:	Same as S4

USE OF MATERIAL:	Cistern (PVC / Reinforced Plastics)			ACCESSIBILITY:	Easy		
LOCATION:	Toilets			EXTENT / QUANTITY:	2 no		
ASBESTOS TYPE	NON ASBESTOS	0		EXTENT OF DAMAGE / DETERIORATION	GOOD CONDITION	0	
	CHRYCOTILE	1			LOW DAMAGE	1	✓
	AMOSITE	2	✓		MEDIUM DAMAGE	2	
	CROCIDOLITE	3			HIGH DAMAGE	3	
	OTHER	2			LOOSE ASBESTOS	3	
SURFACE TREATMENT	COMPOSITE MATERIAL	0	✓	FIBRE RELEASE POTENTIAL	HIGH RISK	10-12	
	ENCLOSED SPRAY / LAGGING, PAINTED / ENCAPSULATED AIB, ASBESTOS CEMENT SHEETS	1			MEDIUM RISK	7-9	
	UNSEALED AIB OR ENCAPSULATED LAGGING AND SPRAYS	2			LOW RISK	5-6	
	UNSEALED LAGGING / SPRAY COATING	3			VERY LOW RISK	1-4	✓
PRODUCT TYPE	ASBESTOS REINFORCED COMPOSITES	1	✓	RECOMMENDED ACTION	REMOVE		✓
	ASBESTOS INSULATING BOARD, TEXTILES, GASKETS, ROPE, PAPER, FELT	2			REPAIR / SEAL ENCAPSULATE

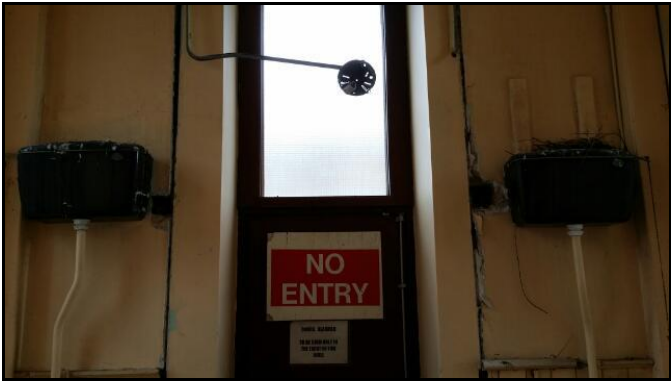
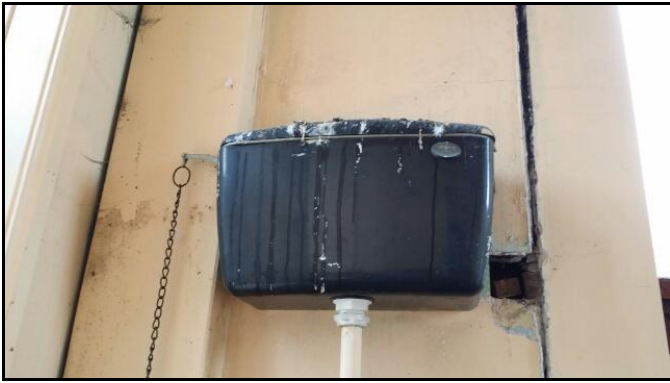
FLOOR:	Ground Floor			SURVEY DATES:	08/05/2018		
ROOM NAME / NO.:	0-001			SAMPLE REF NO.:	Same as S4

USE OF MATERIAL:	Cistern (PVC / Reinforced Plastics)			ACCESSIBILITY:	Easy		
LOCATION:	Toilets			EXTENT / QUANTITY:	2 no		
ASBESTOS TYPE	NON ASBESTOS	0		EXTENT OF DAMAGE / DETERIORATION	GOOD CONDITION	0	
	CHRYCOTILE	1			LOW DAMAGE	1	✓
	AMOSITE	2	✓		MEDIUM DAMAGE	2	
	CROCIDOLITE	3			HIGH DAMAGE	3	
	OTHER	2			LOOSE ASBESTOS	3	
SURFACE TREATMENT	COMPOSITE MATERIAL	0	✓	FIBRE RELEASE POTENTIAL	HIGH RISK	10-12	
	ENCLOSED SPRAY / LAGGING, PAINTED / ENCAPSULATED AIB, ASBESTOS CEMENT SHEETS	1			MEDIUM RISK	7-9	
	UNSEALED AIB OR ENCAPSULATED LAGGING AND SPRAYS	2			LOW RISK	5-6	
	UNSEALED LAGGING / SPRAY COATING	3			VERY LOW RISK	1-4	✓
PRODUCT TYPE	ASBESTOS REINFORCED COMPOSITES	1	✓	RECOMMENDED ACTION	REMOVE		✓
	ASBESTOS INSULATING BOARD, TEXTILES, GASKETS, ROPE, PAPER, FELT	2			REPAIR / SEAL ENCAPSULATE

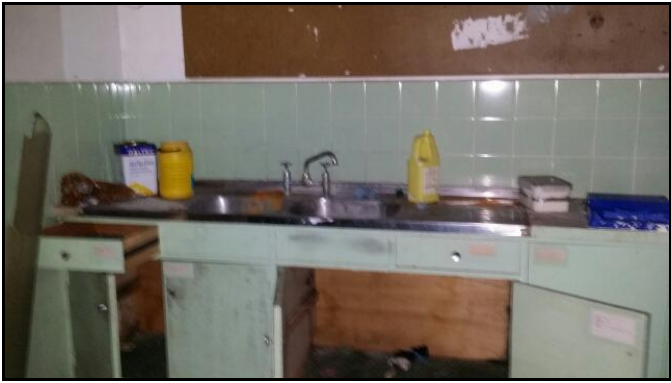
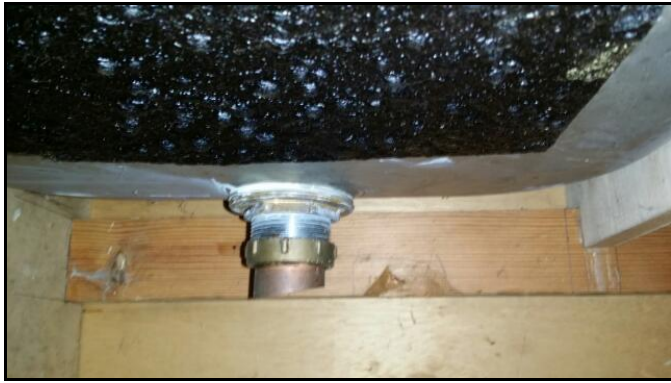
FLOOR:	Basement	SURVEY DATES:	04/05/2018				
ROOM NAME / NO.:	-1-014	SAMPLE REF NO.:	S6

USE OF MATERIAL:	Bitumen Sink Pad	ACCESSIBILITY:	Easy				
LOCATION:	Dining area	EXTENT / QUANTITY:	2 no				
ASBESTOS TYPE	NON ASBESTOS	0		EXTENT OF DAMAGE / DETERIORATION	GOOD CONDITION	0	
	CHRYCOTILE	1	✓		LOW DAMAGE	1	✓
	AMOSITE	2			MEDIUM DAMAGE	2	
	CROCIDOLITE	3			HIGH DAMAGE	3	
	OTHER	2			LOOSE ASBESTOS	3	
SURFACE TREATMENT	COMPOSITE MATERIAL	0	✓	FIBRE RELEASE POTENTIAL	HIGH RISK	10-12	
	ENCLOSED SPRAY / LAGGING, PAINTED / ENCAPSULATED AIB, ASBESTOS CEMENT SHEETS	1			MEDIUM RISK	7-9	
	UNSEALED AIB OR ENCAPSULATED LAGGING AND SPRAYS	2			LOW RISK	5-6	
	UNSEALED LAGGING / SPRAY COATING	3			VERY LOW RISK	1-4	✓
PRODUCT TYPE	ASBESTOS REINFORCED COMPOSITES	1	✓	RECOMMENDED ACTION	REMOVE		✓
	ASBESTOS INSULATING BOARD, TEXTILES, GASKETS, ROPE, PAPER, FELT	2			REPAIR / SEAL ENCAPSULATE		
	THERMAL INSULATION, SPRAYED ASBESTOS, LOOSE ASBESTOS	3			LABEL AND MANAGE

Loreto Abbey, Rathfarnham, Dublin 14						
Sample	Floor	Location	Description	Asbestos	Extent / Amount	Recommended Action
S16	2nd Floor	Toilets 2-001	Vinyl Floor Tiles (green) & Bitumen	Chrysotile in: VFT & Bitumen	11 m ²	Remove
S17	2nd Floor	Science room 2-008	Cement Board	Chrysotile	48 lin m	Remove
S14	1st Floor	Toilets 1-001	Vinyl Floor Tiles (red) & Bitumen	Chrysotile in: VFT & Bitumen	4 m ²	Remove
S15	1st Floor	Toilets 1-001	Vinyl Floor Tiles (purple) & Bitumen	Chrysotile in: VFT & Bitumen	8 m ²	Remove
S13	Ground Floor	Toilet 0-018	Vinyl Floor Tiles (cream) & Bitumen	Chrysotile in: VFT	6 m ²	Remove
S3	Basement	Hall -1-004	Vinyl Floor Tiles (brown) & Bitumen	Chrysotile in: VFT & Bitumen	1 m ²	Remove
S4	Basement	Toilets -1-010	Cistern (PVC / Reinforced Plastics)	Amosite	1 no	Remove
S5	Basement	Dining area -1-014	Vinyl Floor Tiles (orange) & Bitumen	Chrysotile in: VFT & Bitumen	78 m ²	Remove
S6	Basement	Dining area -1-014	Bitumen Sink Pad	Chrysotile	2 no	Remove

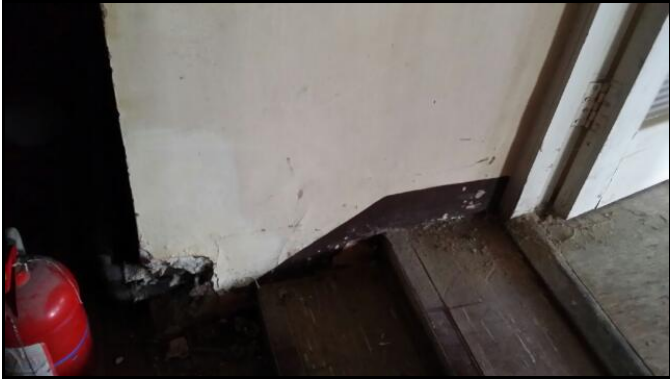
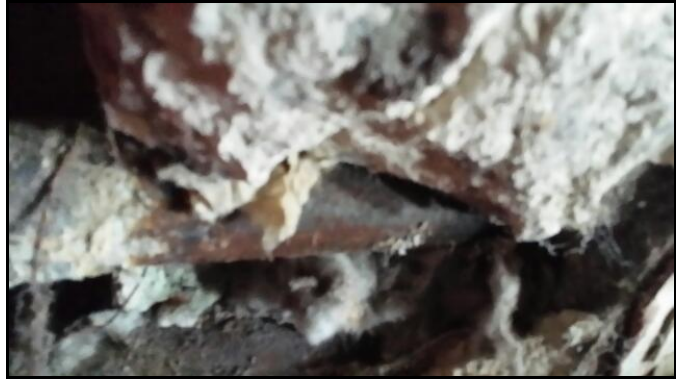
FLOOR:	Basement	SURVEY DATES:	08/05/2018		
ROOM NAME / NO.:	-1-026	SAMPLE REF NO.:	Same as S9

USE OF MATERIAL:	Pipework (Pipe Insulation & String & Cloth)		ACCESSIBILITY:	Difficult	
LOCATION:	Hall		EXTENT / QUANTITY:	1 lin m	
ASBESTOS TYPE	NON ASBESTOS	0	EXTENT OF DAMAGE / DETERIORATION	GOOD CONDITION	0
	CHRYSOTILE	1		LOW DAMAGE	1
	AMOSITE	2		MEDIUM DAMAGE	2
	CROCIDOLITE	3		HIGH DAMAGE	3
	OTHER	2		LOOSE ASBESTOS	3
SURFACE TREATMENT	COMPOSITE MATERIAL	0	FIBRE RELEASE POTENTIAL	HIGH RISK	10-12
	ENCLOSED SPRAY / LAGGING, PAINTED / ENCAPSULATED AIB, ASBESTOS CEMENT SHEETS	1		MEDIUM RISK	7-9
	UNSEALED AIB OR ENCAPSULATED LAGGING AND SPRAYS	2		LOW RISK	5-6
	UNSEALED LAGGING / SPRAY COATING	3		VERY LOW RISK	1-4
PRODUCT TYPE	ASBESTOS REINFORCED COMPOSITES	1	RECOMMENDED ACTION	REMOVE	
	ASBESTOS INSULATING BOARD, TEXTILES, GASKETS, ROPE, PAPER, FELT	2		REPAIR / SEAL ENCAPSULATE	
	THERMAL INSULATION, SPRAYED ASBESTOS, LOOSE ASBESTOS	3		LABEL AND MANAGE

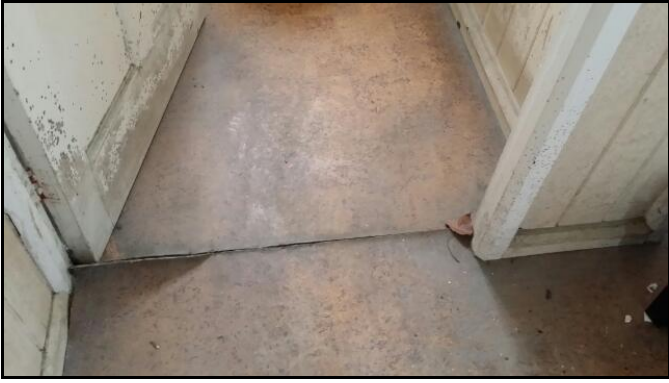
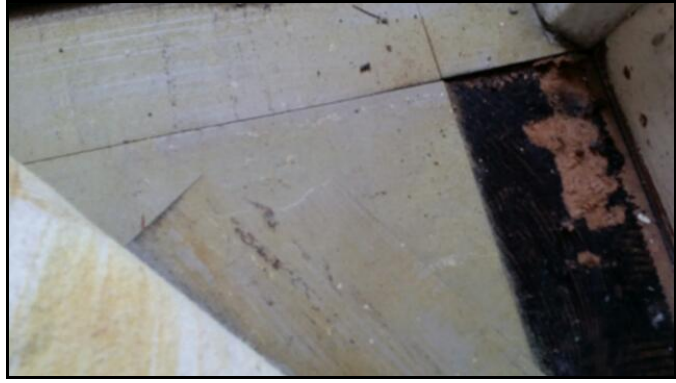
FLOOR:	Ground Floor			SURVEY DATES:	08/05/2018		
ROOM NAME / NO.:	0-018			SAMPLE REF NO.:	S13

USE OF MATERIAL:	Vinyl Floor Tiles (cream) and Bitumen			ACCESSIBILITY:	Medium		
LOCATION:	Toilet			EXTENT / QUANTITY:	6 m ²		
ASBESTOS TYPE	NON ASBESTOS	0		EXTENT OF DAMAGE / DETERIORATION	GOOD CONDITION	0	
	CHRYSTOLE	1	✓		LOW DAMAGE	1	✓
	AMOSITE	2			MEDIUM DAMAGE	2	
	CROCIDOLITE	3			HIGH DAMAGE	3	
	OTHER	2			LOOSE ASBESTOS	3	
SURFACE TREATMENT	COMPOSITE MATERIAL	0	✓	FIBRE RELEASE POTENTIAL	HIGH RISK	10-12	
	ENCLOSED SPRAY / LAGGING, PAINTED / ENCAPSULATED AIB, ASBESTOS CEMENT SHEETS	1			MEDIUM RISK	7-9	
	UNSEALED AIB OR ENCAPSULATED LAGGING AND SPRAYS	2			LOW RISK	5-6	
	UNSEALED LAGGING / SPRAY COATING	3			VERY LOW RISK	1-4	✓
PRODUCT TYPE	ASBESTOS REINFORCED COMPOSITES	1	✓	RECOMMENDED ACTION	REMOVE		✓
	ASBESTOS INSULATING BOARD, TEXTILES, GASKETS, ROPE, PAPER, FELT	2			REPAIR / SEAL ENCAPSULATE

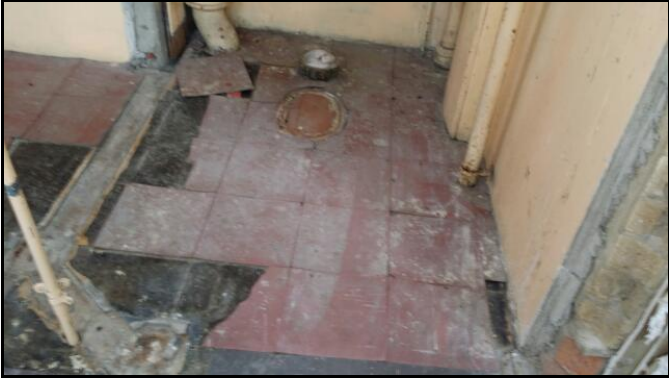
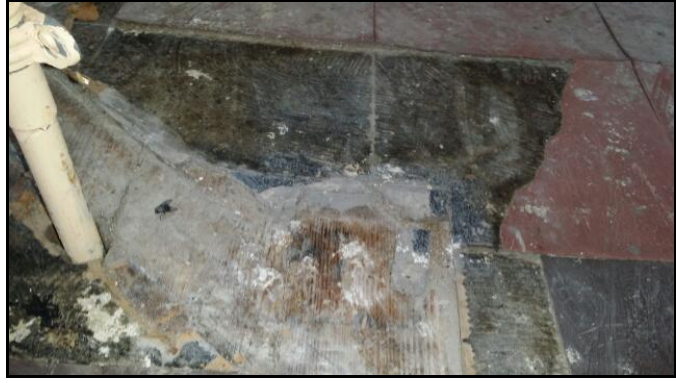
FLOOR:	1st Floor			SURVEY DATES:	09/05/2018		
ROOM NAME / NO.:	1-001			SAMPLE REF NO.:	S14

USE OF MATERIAL:	Vinyl Floor Tiles (red) and Bitumen			ACCESSIBILITY:	Easy		
LOCATION:	Toilets			EXTENT / QUANTITY:	4 m ²		
ASBESTOS TYPE	NON ASBESTOS	0		EXTENT OF DAMAGE / DETERIORATION	GOOD CONDITION	0	
	CHRYCOTILE	1	✓		LOW DAMAGE	1	
	AMOSITE	2			MEDIUM DAMAGE	2	
	CROCIDOLITE	3			HIGH DAMAGE	3	✓
	OTHER	2			LOOSE ASBESTOS	3	
SURFACE TREATMENT	COMPOSITE MATERIAL	0	✓	FIBRE RELEASE POTENTIAL	HIGH RISK	10-12	
	ENCLOSED SPRAY / LAGGING, PAINTED / ENCAPSULATED AIB, ASBESTOS CEMENT SHEETS	1			MEDIUM RISK	7-9	
	UNSEALED AIB OR ENCAPSULATED LAGGING AND SPRAYS	2			LOW RISK	5-6	✓
	UNSEALED LAGGING / SPRAY COATING	3			VERY LOW RISK	1-4	
PRODUCT TYPE	ASBESTOS REINFORCED COMPOSITES	1	✓	RECOMMENDED ACTION	REMOVE		✓
	ASBESTOS INSULATING BOARD, TEXTILES, GASKETS, ROPE, PAPER, FELT	2			REPAIR / SEAL ENCAPSULATE

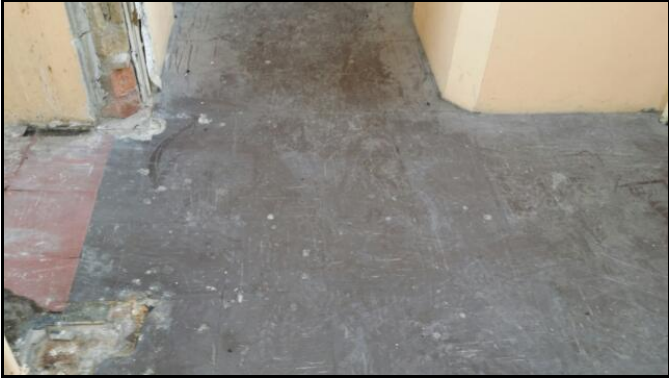
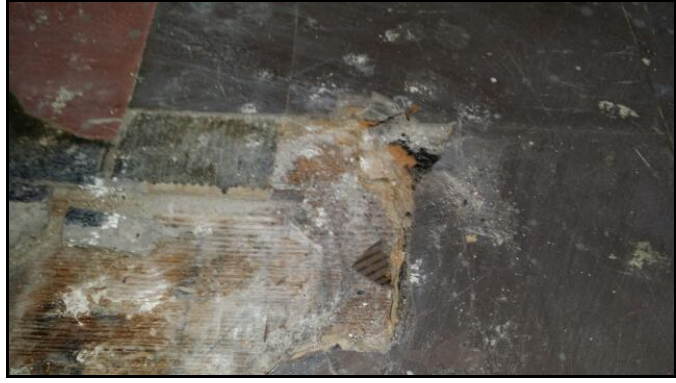
FLOOR:	1st Floor			SURVEY DATES:	09/05/2018		
ROOM NAME / NO.:	1-001			SAMPLE REF NO.:	S15

USE OF MATERIAL:	Vinyl Floor Tiles (purple) and Bitumen			ACCESSIBILITY:	Easy		
LOCATION:	Toilets			EXTENT / QUANTITY:	8 m ²		
ASBESTOS TYPE	NON ASBESTOS	0		EXTENT OF DAMAGE / DETERIORATION	GOOD CONDITION	0	
	CHRYCOTILE	1	✓		LOW DAMAGE	1	
	AMOSITE	2			MEDIUM DAMAGE	2	
	CROCIDOLITE	3			HIGH DAMAGE	3	✓
	OTHER	2			LOOSE ASBESTOS	3	
SURFACE TREATMENT	COMPOSITE MATERIAL	0	✓	FIBRE RELEASE POTENTIAL	HIGH RISK	10-12	
	ENCLOSED SPRAY / LAGGING, PAINTED / ENCAPSULATED AIB, ASBESTOS CEMENT SHEETS	1			MEDIUM RISK	7-9	
	UNSEALED AIB OR ENCAPSULATED LAGGING AND SPRAYS	2			LOW RISK	5-6	✓
	UNSEALED LAGGING / SPRAY COATING	3			VERY LOW RISK	1-4	
PRODUCT TYPE	ASBESTOS REINFORCED COMPOSITES	1	✓	RECOMMENDED ACTION	REMOVE		✓
	ASBESTOS INSULATING BOARD, TEXTILES, GASKETS, ROPE, PAPER, FELT	2			REPAIR / SEAL ENCAPSULATE

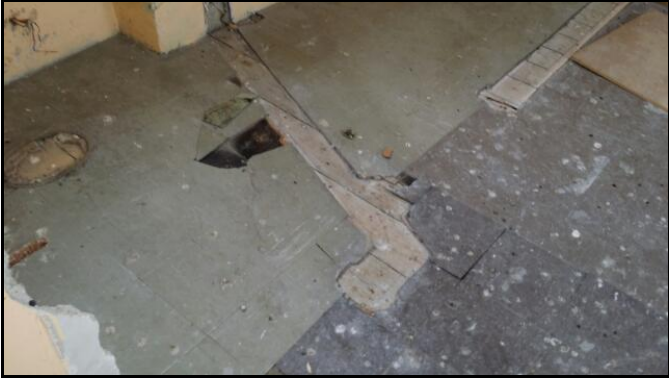
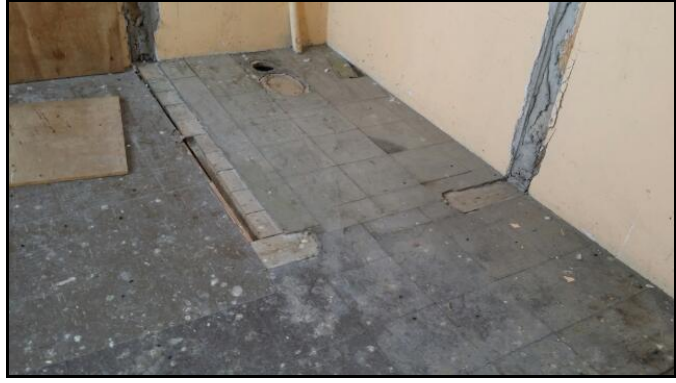
FLOOR:	2nd Floor			SURVEY DATES:	09/05/2018		
ROOM NAME / NO.:	2-001			SAMPLE REF NO.:	S16

USE OF MATERIAL:	Vinyl Floor Tiles (green) and Bitumen			ACCESSIBILITY:	Easy		
LOCATION:	Toilets			EXTENT / QUANTITY:	11 m ²		
ASBESTOS TYPE	NON ASBESTOS	0		EXTENT OF DAMAGE / DETERIORATION	GOOD CONDITION	0	
	CHRYCOTILE	1	✓		LOW DAMAGE	1	
	AMOSITE	2			MEDIUM DAMAGE	2	
	CROCIDOLITE	3			HIGH DAMAGE	3	✓
	OTHER	2			LOOSE ASBESTOS	3	
SURFACE TREATMENT	COMPOSITE MATERIAL	0	✓	FIBRE RELEASE POTENTIAL	HIGH RISK	10-12	
	ENCLOSED SPRAY / LAGGING, PAINTED / ENCAPSULATED AIB, ASBESTOS CEMENT SHEETS	1			MEDIUM RISK	7-9	
	UNSEALED AIB OR ENCAPSULATED LAGGING AND SPRAYS	2			LOW RISK	5-6	✓
	UNSEALED LAGGING / SPRAY COATING	3			VERY LOW RISK	1-4	
PRODUCT TYPE	ASBESTOS REINFORCED COMPOSITES	1	✓	RECOMMENDED ACTION	REMOVE		✓
	ASBESTOS INSULATING BOARD, TEXTILES, GASKETS, ROPE, PAPER, FELT	2			REPAIR / SEAL ENCAPSULATE

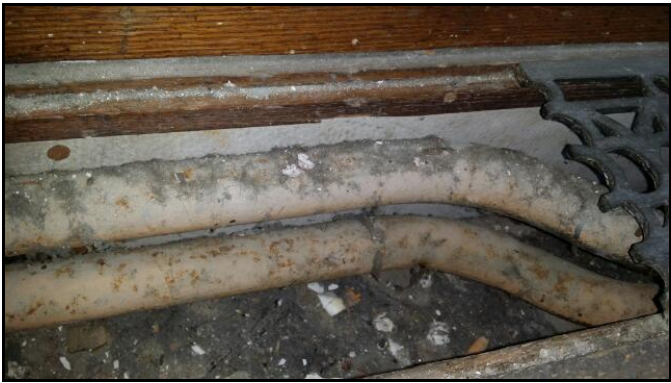
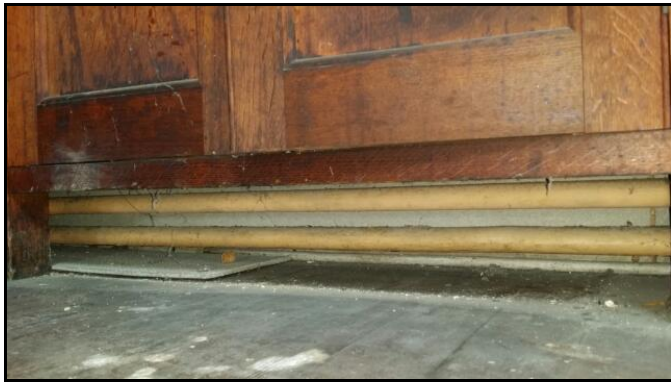
FLOOR:	2nd Floor	SURVEY DATES:	09/05/2018				
ROOM NAME / NO.:	2-008	SAMPLE REF NO.:	S17

USE OF MATERIAL:	Cement Board	ACCESSIBILITY:	Difficult				
LOCATION:	Science room	EXTENT / QUANTITY:	48 lin m				
ASBESTOS TYPE	NON ASBESTOS	0		EXTENT OF DAMAGE / DETERIORATION	GOOD CONDITION	0	
	CHRYCOTILE	1	✓		LOW DAMAGE	1	
	AMOSITE	2			MEDIUM DAMAGE	2	✓
	CROCIDOLITE	3			HIGH DAMAGE	3	
	OTHER	2			LOOSE ASBESTOS	3	
SURFACE TREATMENT	COMPOSITE MATERIAL	0		FIBRE RELEASE POTENTIAL	HIGH RISK	10-12	
	ENCLOSED SPRAY / LAGGING, PAINTED / ENCAPSULATED AIB, ASBESTOS CEMENT SHEETS	1	✓		MEDIUM RISK	7-9	
	UNSEALED AIB OR ENCAPSULATED LAGGING AND SPRAYS	2			LOW RISK	5-6	✓
	UNSEALED LAGGING / SPRAY COATING	3			VERY LOW RISK	1-4	
PRODUCT TYPE	ASBESTOS REINFORCED COMPOSITES	1	✓	RECOMMENDED ACTION	REMOVE		✓
	ASBESTOS INSULATING BOARD, TEXTILES, GASKETS, ROPE, PAPER, FELT	2			REPAIR / SEAL ENCAPSULATE		
	THERMAL INSULATION, SPRAYED ASBESTOS, LOOSE ASBESTOS	3			LABEL AND MANAGE

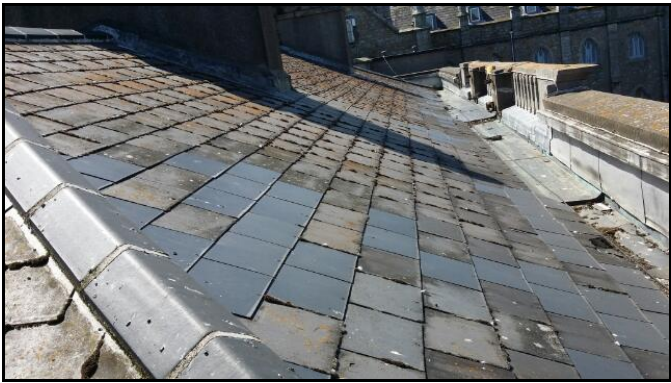
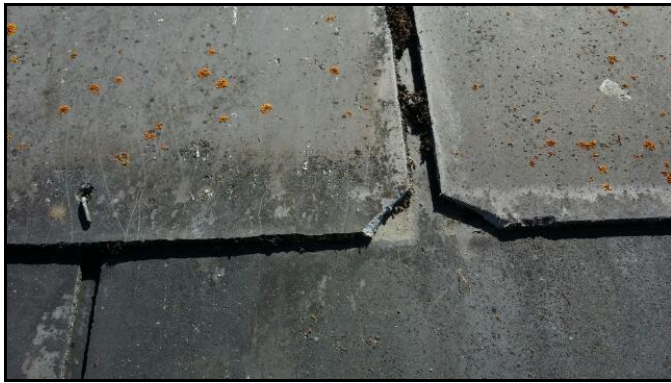
FLOOR:	External	SURVEY DATES:	16/05/2018				
ROOM NAME / NO.:	99-002	SAMPLE REF NO.:	S21

USE OF MATERIAL:	Cement Slates	ACCESSIBILITY:	Difficult				
LOCATION:	Roof area	EXTENT / QUANTITY:	350 approx m ²				
ASBESTOS TYPE	NON ASBESTOS	0		EXTENT OF DAMAGE / DETERIORATION	GOOD CONDITION	0	
	CHRYCOTILE	1	✓		LOW DAMAGE	1	
	AMOSITE	2			MEDIUM DAMAGE	2	✓
	CROCIDOLITE	3			HIGH DAMAGE	3	
	OTHER	2			LOOSE ASBESTOS	3	
SURFACE TREATMENT	COMPOSITE MATERIAL	0		FIBRE RELEASE POTENTIAL	HIGH RISK	10-12	
	ENCLOSED SPRAY / LAGGING, PAINTED / ENCAPSULATED AIB, ASBESTOS CEMENT SHEETS	1	✓		MEDIUM RISK	7-9	
	UNSEALED AIB OR ENCAPSULATED LAGGING AND SPRAYS	2			LOW RISK	5-6	✓
	UNSEALED LAGGING / SPRAY COATING	3			VERY LOW RISK	1-4	
PRODUCT TYPE	ASBESTOS REINFORCED COMPOSITES	1	✓	RECOMMENDED ACTION	REMOVE		
	ASBESTOS INSULATING BOARD, TEXTILES, GASKETS, ROPE, PAPER, FELT	2			REPAIR / SEAL ENCAPSULATE		✓
	THERMAL INSULATION, SPRAYED ASBESTOS, LOOSE ASBESTOS	3			LABEL AND MANAGE		✓

cement slates roof to outer slopes of box shaped roof. Repair label and manage, remove if refurbishment involves roof. Small amount of damage.

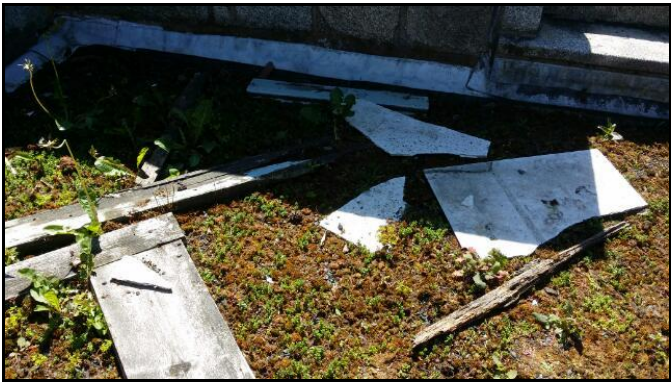
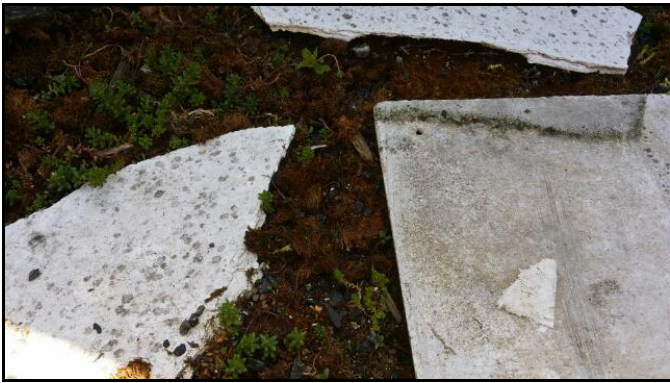
FLOOR:	External			SURVEY DATES:	16/05/2018		
ROOM NAME / NO.:	99-005			SAMPLE REF NO.:	S22

USE OF MATERIAL:	Insulating Board debris			ACCESSIBILITY:	Difficult		
LOCATION:	Roof area			EXTENT / QUANTITY:	1 m ²		
ASBESTOS TYPE	NON ASBESTOS	0		EXTENT OF DAMAGE / DETERIORATION	GOOD CONDITION	0	
	CHRYCOTILE	1			LOW DAMAGE	1	
	AMOSITE	2	✓		MEDIUM DAMAGE	2	
	CROCIDOLITE	3			HIGH DAMAGE	3	✓
	OTHER	2			LOOSE ASBESTOS	3	
SURFACE TREATMENT	COMPOSITE MATERIAL	0		FIBRE RELEASE POTENTIAL	HIGH RISK	10-12	
	ENCLOSED SPRAY / LAGGING, PAINTED / ENCAPSULATED AIB, ASBESTOS CEMENT SHEETS	1			MEDIUM RISK	7-9	✓
	UNSEALED AIB OR ENCAPSULATED LAGGING AND SPRAYS	2	✓		LOW RISK	5-6	
	UNSEALED LAGGING / SPRAY COATING	3			VERY LOW RISK	1-4	
PRODUCT TYPE	ASBESTOS REINFORCED COMPOSITES	1		RECOMMENDED ACTION	REMOVE		✓
	ASBESTOS INSULATING BOARD, TEXTILES, GASKETS, ROPE, PAPER, FELT	2	✓		REPAIR / SEAL ENCAPSULATE		
	THERMAL INSULATION, SPRAYED ASBESTOS, LOOSE ASBESTOS	3			LABEL AND MANAGE

insulating board (in very poor condition) debris on flat roof at access door to roof. Maybe lining to old timber door left on roof beside debris.

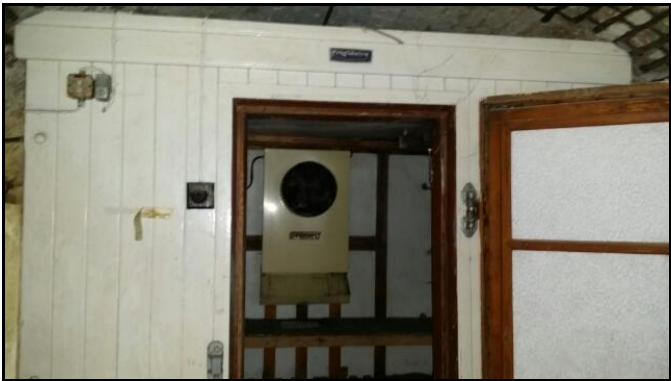
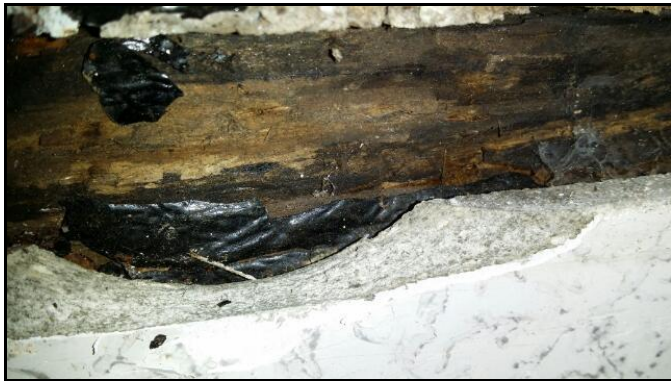
FLOOR:	Basement	SURVEY DATES:	16/05/2018				
ROOM NAME / NO.:	-1-037	SAMPLE REF NO.:	S23

USE OF MATERIAL:	Cement Board	ACCESSIBILITY:	Medium				
LOCATION:	Store	EXTENT / QUANTITY:	15 m ²				
ASBESTOS TYPE	NON ASBESTOS	0		EXTENT OF DAMAGE / DETERIORATION	GOOD CONDITION	0	
	CHRYSTOLE	1	✓		LOW DAMAGE	1	✓
	AMOSITE	2			MEDIUM DAMAGE	2	
	CROCIDOLITE	3			HIGH DAMAGE	3	
	OTHER	2			LOOSE ASBESTOS	3	
SURFACE TREATMENT	COMPOSITE MATERIAL	0		FIBRE RELEASE POTENTIAL	HIGH RISK	10-12	
	ENCLOSED SPRAY / LAGGING, PAINTED / ENCAPSULATED AIB, ASBESTOS CEMENT SHEETS	1	✓		MEDIUM RISK	7-9	
	UNSEALED AIB OR ENCAPSULATED LAGGING AND SPRAYS	2			LOW RISK	5-6	
	UNSEALED LAGGING / SPRAY COATING	3			VERY LOW RISK	1-4	✓
PRODUCT TYPE	ASBESTOS REINFORCED COMPOSITES	1	✓	RECOMMENDED ACTION	REMOVE		✓
	ASBESTOS INSULATING BOARD, TEXTILES, GASKETS, ROPE, PAPER, FELT	2			REPAIR / SEAL ENCAPSULATE		
	THERMAL INSULATION, SPRAYED ASBESTOS, LOOSE ASBESTOS	3			LABEL AND MANAGE

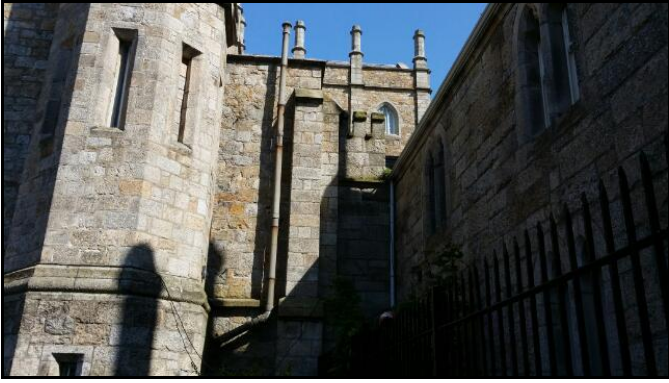
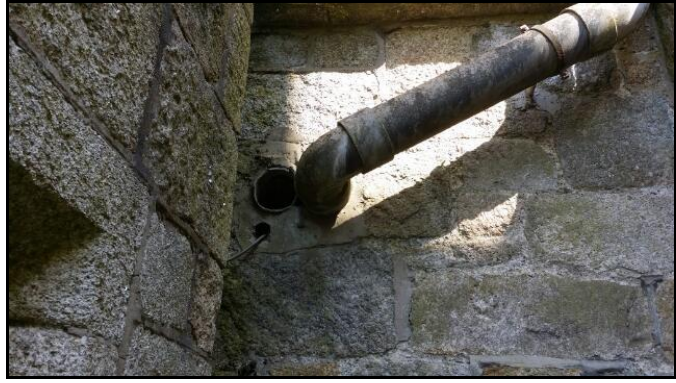
FLOOR:	External			SURVEY DATES:	16/05/2018		
ROOM NAME / NO.:	99-008			SAMPLE REF NO.:	S24

USE OF MATERIAL:	Cement Flue Pipe			ACCESSIBILITY:	Difficult		
LOCATION:	Externals			EXTENT / QUANTITY:	8 lin m		
ASBESTOS TYPE	NON ASBESTOS	0		EXTENT OF DAMAGE / DETERIORATION	GOOD CONDITION	0	
	CHRYSTOLITE	1	✓		LOW DAMAGE	1	
	AMOSITE	2			MEDIUM DAMAGE	2	✓
	CROCIDOLITE	3	✓		HIGH DAMAGE	3	
	OTHER	2			LOOSE ASBESTOS	3	
SURFACE TREATMENT	COMPOSITE MATERIAL	0		FIBRE RELEASE POTENTIAL	HIGH RISK	10-12	
	ENCLOSED SPRAY / LAGGING, PAINTED / ENCAPSULATED AIB, ASBESTOS CEMENT SHEETS	1	✓		MEDIUM RISK	7-9	✓
	UNSEALED AIB OR ENCAPSULATED LAGGING AND SPRAYS	2			LOW RISK	5-6	
	UNSEALED LAGGING / SPRAY COATING	3			VERY LOW RISK	1-4	
PRODUCT TYPE	ASBESTOS REINFORCED COMPOSITES	1	✓	RECOMMENDED ACTION	REMOVE		✓
	ASBESTOS INSULATING BOARD, TEXTILES, GASKETS, ROPE, PAPER, FELT	2			REPAIR / SEAL ENCAPSULATE		
	THERMAL INSULATION, SPRAYED ASBESTOS, LOOSE ASBESTOS	3			LABEL AND MANAGE

cement flue pipes (2 in total) built into wall. One is broken at wall juncture (no visible debris on ground). The other one has a full length of 8m approx.

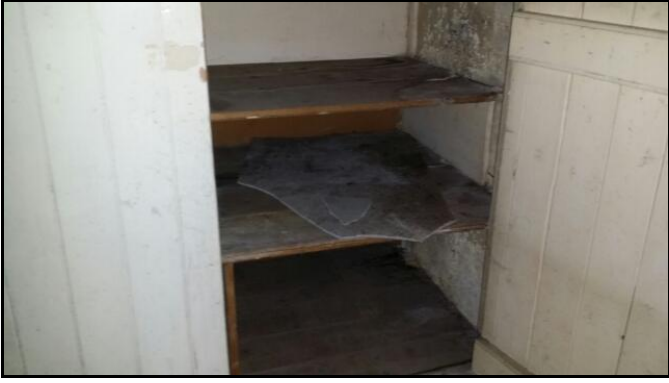
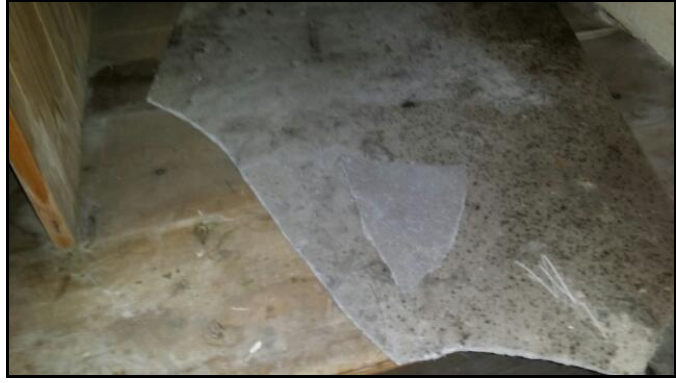
FLOOR:	Basement			SURVEY DATES:	04/05/2018		
ROOM NAME / NO.:	-1-001			SAMPLE REF NO.:	Strongly Presumed

USE OF MATERIAL:	Cement Board debris			ACCESSIBILITY:	Medium		
LOCATION:	Chapel			EXTENT / QUANTITY:	1 m ²		
ASBESTOS TYPE	NON ASBESTOS	0		EXTENT OF DAMAGE / DETERIORATION	GOOD CONDITION	0	
	CHRYCOTILE	1	✓		LOW DAMAGE	1	
	AMOSITE	2	✓		MEDIUM DAMAGE	2	✓
	CROCIDOLITE	3	✓		HIGH DAMAGE	3	
	OTHER	2			LOOSE ASBESTOS	3	
SURFACE TREATMENT	COMPOSITE MATERIAL	0		FIBRE RELEASE POTENTIAL	HIGH RISK	10-12	
	ENCLOSED SPRAY / LAGGING, PAINTED / ENCAPSULATED AIB, ASBESTOS CEMENT SHEETS	1	✓		MEDIUM RISK	7-9	✓
	UNSEALED AIB OR ENCAPSULATED LAGGING AND SPRAYS	2			LOW RISK	5-6	
	UNSEALED LAGGING / SPRAY COATING	3			VERY LOW RISK	1-4	
PRODUCT TYPE	ASBESTOS REINFORCED COMPOSITES	1	✓	RECOMMENDED ACTION	REMOVE		✓
	ASBESTOS INSULATING BOARD, TEXTILES, GASKETS, ROPE, PAPER, FELT	2			REPAIR / SEAL ENCAPSULATE

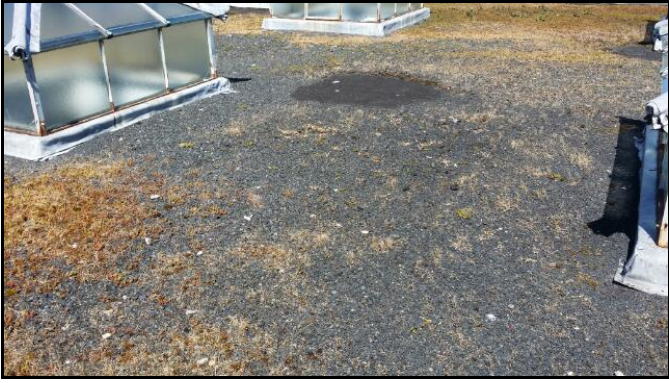
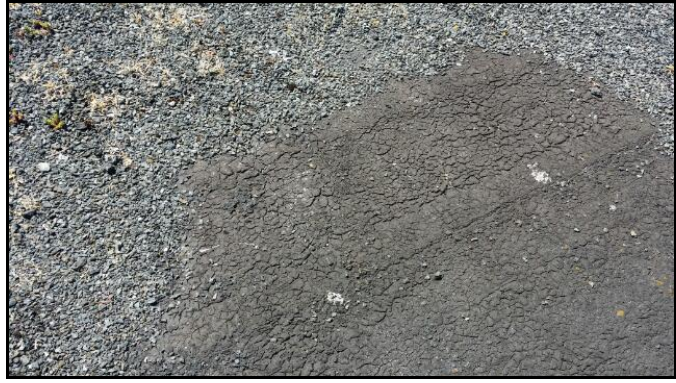
FLOOR:	External			SURVEY DATES:	16/05/2018		
ROOM NAME / NO.:	99-005			SAMPLE REF NO.:	Strongly Presumed

USE OF MATERIAL:	Bituminous Product (felt)			ACCESSIBILITY:	Difficult		
LOCATION:	Roof area			EXTENT / QUANTITY:	250 approx m ²		
ASBESTOS TYPE	NON ASBESTOS	0		EXTENT OF DAMAGE / DETERIORATION	GOOD CONDITION	0	
	CHRYSTOLE	1	✓		LOW DAMAGE	1	✓
	AMOSITE	2			MEDIUM DAMAGE	2	
	CROCIDOLITE	3			HIGH DAMAGE	3	
	OTHER	2			LOOSE ASBESTOS	3	
SURFACE TREATMENT	COMPOSITE MATERIAL	0	✓	FIBRE RELEASE POTENTIAL	HIGH RISK	10-12	
	ENCLOSED SPRAY / LAGGING, PAINTED / ENCAPSULATED AIB, ASBESTOS CEMENT SHEETS	1			MEDIUM RISK	7-9	
	UNSEALED AIB OR ENCAPSULATED LAGGING AND SPRAYS	2			LOW RISK	5-6	
	UNSEALED LAGGING / SPRAY COATING	3			VERY LOW RISK	1-4	✓
PRODUCT TYPE	ASBESTOS REINFORCED COMPOSITES	1	✓	RECOMMENDED ACTION	REMOVE		
	ASBESTOS INSULATING BOARD, TEXTILES, GASKETS, ROPE, PAPER, FELT	2			REPAIR / SEAL ENCAPSULATE

THERMAL INSULATION, SPRAYED ASBESTOS, LOOSE ASBESTOS	3			LABEL AND MANAGE		✓
OTHER RELEVANT INFORMATION:							
It was not possible to take a sample (building in use). Felt has been presumed to contain asbestos. If refurbishment involves roof, a sample can be taken, otherwise label and manage.

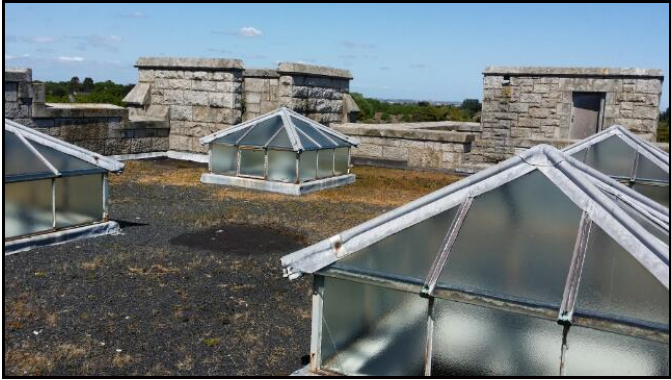
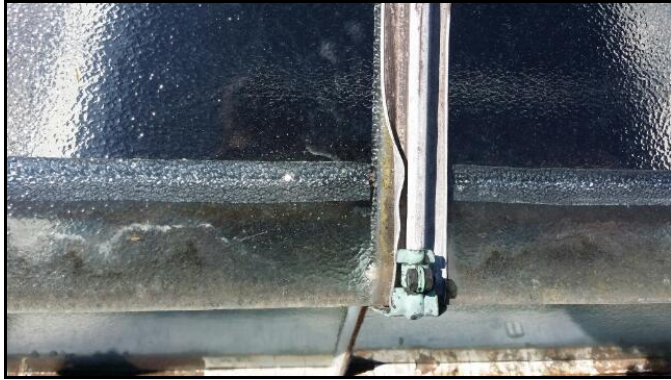
FLOOR:	External			SURVEY DATES:	16/05/2018		
ROOM NAME / NO.:	99-005			SAMPLE REF NO.:	Strongly Presumed

USE OF MATERIAL:	Rope seal to glazed windows			ACCESSIBILITY:	Difficult		
LOCATION:	Roof area			EXTENT / QUANTITY:	4 block with 48 no of cords in total		
ASBESTOS TYPE	NON ASBESTOS	0		EXTENT OF DAMAGE / DETERIORATION	GOOD CONDITION	0	
	CHRYCOTILE	1	✓		LOW DAMAGE	1	✓
	AMOSITE	2			MEDIUM DAMAGE	2	
	CROCIDOLITE	3			HIGH DAMAGE	3	
	OTHER	2			LOOSE ASBESTOS	3	
SURFACE TREATMENT	COMPOSITE MATERIAL	0		FIBRE RELEASE POTENTIAL	HIGH RISK	10-12	
	ENCLOSED SPRAY / LAGGING, PAINTED / ENCAPSULATED AIB, ASBESTOS CEMENT SHEETS	1	✓		MEDIUM RISK	7-9	
	UNSEALED AIB OR ENCAPSULATED LAGGING AND SPRAYS	2			LOW RISK	5-6	✓
	UNSEALED LAGGING / SPRAY COATING	3			VERY LOW RISK	1-4	
PRODUCT TYPE	ASBESTOS REINFORCED COMPOSITES	1		RECOMMENDED ACTION	REMOVE		
	ASBESTOS INSULATING BOARD, TEXTILES, GASKETS, ROPE, PAPER, FELT	2	✓		REPAIR / SEAL ENCAPSULATE

THERMAL INSULATION, SPRAYED ASBESTOS, LOOSE ASBESTOS	3			LABEL AND MANAGE		✓
OTHER RELEVANT INFORMATION:							
Cord visible in glazing bars (no access without opening up glazing and, possibly, damaging it; occupied building).
