DESIGN REPORT
27th May 2022

IN SUPPORT OF
PLANNING APPLICATION

GAELOCHOLÁISTE AN PHIARSAIGH
REDEVELOPMENT
LORETO ABBEY
RATHFARNHAM
DUBLIN 14

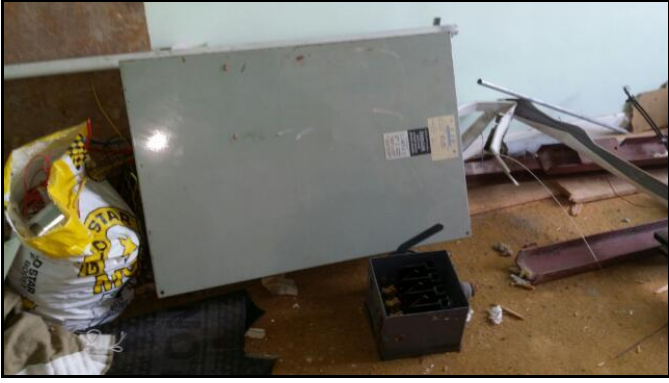
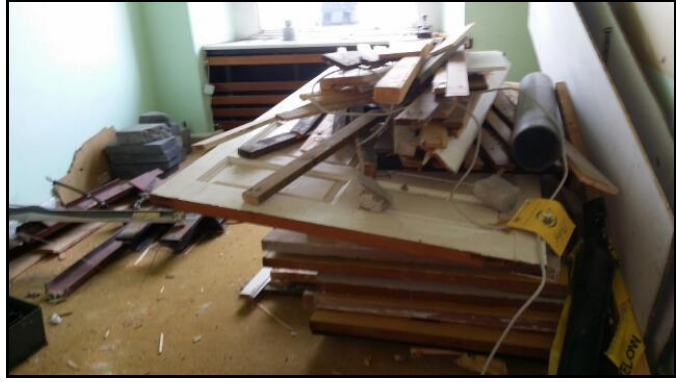
FLOOR:	2nd Floor			SURVEY DATES:	15/05/2018		
ROOM NAME / NO.:	2-029			SAMPLE REF NO.:	Presumed

USE OF MATERIAL:	Fuse box (Flash Guards) stored on the floor			ACCESSIBILITY:	Difficult		
LOCATION:	Room			EXTENT / QUANTITY:	2 no		
ASBESTOS TYPE	NON ASBESTOS	0		EXTENT OF DAMAGE / DETERIORATION	GOOD CONDITION	0	
	CHRYCOTILE	1	✓		LOW DAMAGE	1	✓
	AMOSITE	2			MEDIUM DAMAGE	2	
	CROCIDOLITE	3			HIGH DAMAGE	3	
	OTHER	2			LOOSE ASBESTOS	3	
SURFACE TREATMENT	COMPOSITE MATERIAL	0		FIBRE RELEASE POTENTIAL	HIGH RISK	10-12	
	ENCLOSED SPRAY / LAGGING, PAINTED / ENCAPSULATED AIB, ASBESTOS CEMENT SHEETS	1	✓		MEDIUM RISK	7-9	
	UNSEALED AIB OR ENCAPSULATED LAGGING AND SPRAYS	2			LOW RISK	5-6	✓
	UNSEALED LAGGING / SPRAY COATING	3			VERY LOW RISK	1-4	
PRODUCT TYPE	ASBESTOS REINFORCED COMPOSITES	1		RECOMMENDED ACTION	REMOVE		✓
	ASBESTOS INSULATING BOARD, TEXTILES, GASKETS, ROPE, PAPER, FELT	2	✓		REPAIR / SEAL ENCAPSULATE

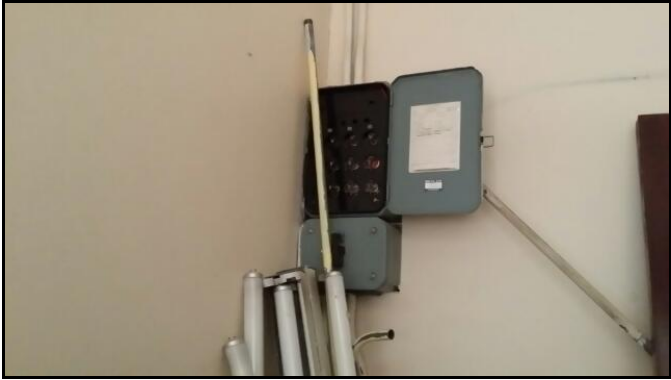
FLOOR:	Ground Floor			SURVEY DATES:	08/05/2018		
ROOM NAME / NO.:	0-002			SAMPLE REF NO.:	Presumed

No Photo Available			
USE OF MATERIAL:	Fuse box (Flash Guards)			ACCESSIBILITY:	Difficult		
LOCATION:	Corridor			EXTENT / QUANTITY:	2 no		
ASBESTOS TYPE	NON ASBESTOS	0		EXTENT OF DAMAGE / DETERIORATION	GOOD CONDITION	0	
	CHRYSTOLE	1	✓		LOW DAMAGE	1	✓
	AMOSITE	2			MEDIUM DAMAGE	2	
	CROCIDOLITE	3			HIGH DAMAGE	3	
	OTHER	2			LOOSE ASBESTOS	3	
SURFACE TREATMENT	COMPOSITE MATERIAL	0		FIBRE RELEASE POTENTIAL	HIGH RISK	10-12	
	ENCLOSED SPRAY / LAGGING, PAINTED / ENCAPSULATED AIB, ASBESTOS CEMENT SHEETS	1	✓		MEDIUM RISK	7-9	
	UNSEALED AIB OR ENCAPSULATED LAGGING AND SPRAYS	2			LOW RISK	5-6	✓
	UNSEALED LAGGING / SPRAY COATING	3			VERY LOW RISK	1-4	
PRODUCT TYPE	ASBESTOS REINFORCED COMPOSITES	1		RECOMMENDED ACTION	REMOVE		✓
	ASBESTOS INSULATING BOARD, TEXTILES, GASKETS, ROPE, PAPER, FELT	2	✓		REPAIR / SEAL ENCAPSULATE

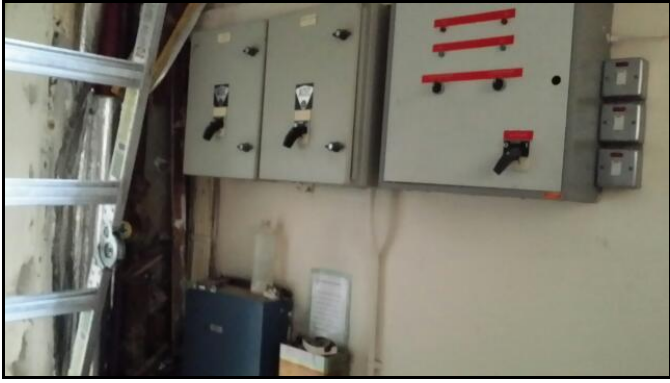
FLOOR:	Ground Floor			SURVEY DATES:	08/05/2018		
ROOM NAME / NO.:	0-013			SAMPLE REF NO.:	Presumed

No Photo Available			
USE OF MATERIAL:	Fuse box (Flash Guards)			ACCESSIBILITY:	Difficult		
LOCATION:	Room			EXTENT / QUANTITY:	4 no		
ASBESTOS TYPE	NON ASBESTOS	0		EXTENT OF DAMAGE / DETERIORATION	GOOD CONDITION	0	
	CHRYCOTILE	1	✓		LOW DAMAGE	1	✓
	AMOSITE	2			MEDIUM DAMAGE	2	
	CROCIDOLITE	3			HIGH DAMAGE	3	
	OTHER	2			LOOSE ASBESTOS	3	
SURFACE TREATMENT	COMPOSITE MATERIAL	0		FIBRE RELEASE POTENTIAL	HIGH RISK	10-12	
	ENCLOSED SPRAY / LAGGING, PAINTED / ENCAPSULATED AIB, ASBESTOS CEMENT SHEETS	1	✓		MEDIUM RISK	7-9	
	UNSEALED AIB OR ENCAPSULATED LAGGING AND SPRAYS	2			LOW RISK	5-6	✓
	UNSEALED LAGGING / SPRAY COATING	3			VERY LOW RISK	1-4	
PRODUCT TYPE	ASBESTOS REINFORCED COMPOSITES	1		RECOMMENDED ACTION	REMOVE		✓
	ASBESTOS INSULATING BOARD, TEXTILES, GASKETS, ROPE, PAPER, FELT	2	✓		REPAIR / SEAL ENCAPSULATE

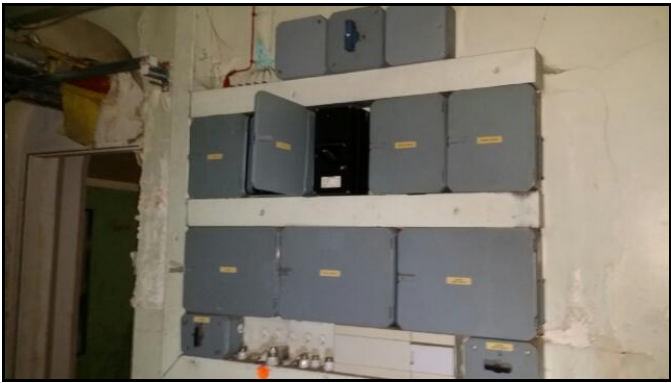
FLOOR:	Basement			SURVEY DATES:	04/05/2018		
ROOM NAME / NO.:	-1-001			SAMPLE REF NO.:	Presumed

No Photo Available			
USE OF MATERIAL:	Fuse box (Flash Guards)			ACCESSIBILITY:	Difficult		
LOCATION:	Chapel			EXTENT / QUANTITY:	12 no		
ASBESTOS TYPE	NON ASBESTOS	0		EXTENT OF DAMAGE / DETERIORATION	GOOD CONDITION	0	
	CHRYSTOLE	1	✓		LOW DAMAGE	1	✓
	AMOSITE	2			MEDIUM DAMAGE	2	
	CROCIDOLITE	3			HIGH DAMAGE	3	
	OTHER	2			LOOSE ASBESTOS	3	
SURFACE TREATMENT	COMPOSITE MATERIAL	0		FIBRE RELEASE POTENTIAL	HIGH RISK	10-12	
	ENCLOSED SPRAY / LAGGING, PAINTED / ENCAPSULATED AIB, ASBESTOS CEMENT SHEETS	1	✓		MEDIUM RISK	7-9	
	UNSEALED AIB OR ENCAPSULATED LAGGING AND SPRAYS	2			LOW RISK	5-6	✓
	UNSEALED LAGGING / SPRAY COATING	3			VERY LOW RISK	1-4	
PRODUCT TYPE	ASBESTOS REINFORCED COMPOSITES	1		RECOMMENDED ACTION	REMOVE		✓
	ASBESTOS INSULATING BOARD, TEXTILES, GASKETS, ROPE, PAPER, FELT	2	✓		REPAIR / SEAL ENCAPSULATE

Basement	Strongly Presumed	Chapel -1-001 - Cement Board (debris)	Chrysotile/ Amosite/ Crocidolite	Medium Damage	Medium	1 m ²	7	Remove
Basement	Presumed	Chapel -1-001 - Water Heater (Rope Gaskets)	Chrysotile	Low Damage	Difficult	1 no	5	Remove
Basement	Presumed	Chapel -1-001 - Fuse box (Flash Guards)	Chrysotile	Low Damage	Difficult	12 no	5	Remove
Basement	S3	Hall -1-004 - Vinyl Floor Tiles (brown) & Bitumen	Chrysotile in: VFT & Bitumen	Medium Damage	Medium	1 m ²	4	Remove
Basement	S4	Toilets -1-010 - Cistern (PVC / Reinforced Plastics)	Amosite	Low Damage	Medium	1 no	4	Remove
Basement	Presumed	Chapel -1-012 - Fuse box (Flash Guards)	Chrysotile	Low Damage	Difficult	7 no	5	Remove

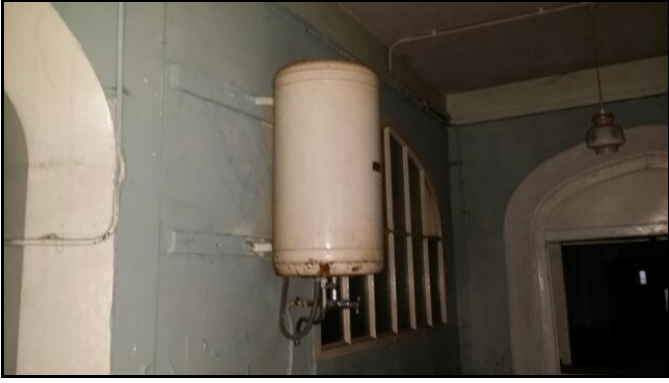
FLOOR:	Basement			SURVEY DATES:	04/05/2018		
ROOM NAME / NO.:	-1-001			SAMPLE REF NO.:	Presumed

No Photo Available			
USE OF MATERIAL:	Water heater (Rope Gaskets)			ACCESSIBILITY:	Difficult		
LOCATION:	Chapel			EXTENT / QUANTITY:	1 no		
ASBESTOS TYPE	NON ASBESTOS	0		EXTENT OF DAMAGE / DETERIORATION	GOOD CONDITION	0	
	CHRYCOTILE	1	✓		LOW DAMAGE	1	✓
	AMOSITE	2			MEDIUM DAMAGE	2	
	CROCIDOLITE	3			HIGH DAMAGE	3	
	OTHER	2			LOOSE ASBESTOS	3	
SURFACE TREATMENT	COMPOSITE MATERIAL	0		FIBRE RELEASE POTENTIAL	HIGH RISK	10-12	
	ENCLOSED SPRAY / LAGGING, PAINTED / ENCAPSULATED AIB, ASBESTOS CEMENT SHEETS	1	✓		MEDIUM RISK	7-9	
	UNSEALED AIB OR ENCAPSULATED LAGGING AND SPRAYS	2			LOW RISK	5-6	✓
	UNSEALED LAGGING / SPRAY COATING	3			VERY LOW RISK	1-4	
PRODUCT TYPE	ASBESTOS REINFORCED COMPOSITES	1		RECOMMENDED ACTION	REMOVE		✓
	ASBESTOS INSULATING BOARD, TEXTILES, GASKETS, ROPE, PAPER, FELT	2	✓		REPAIR / SEAL ENCAPSULATE

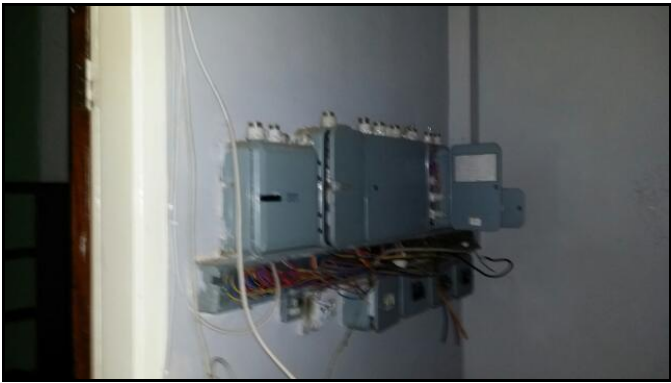
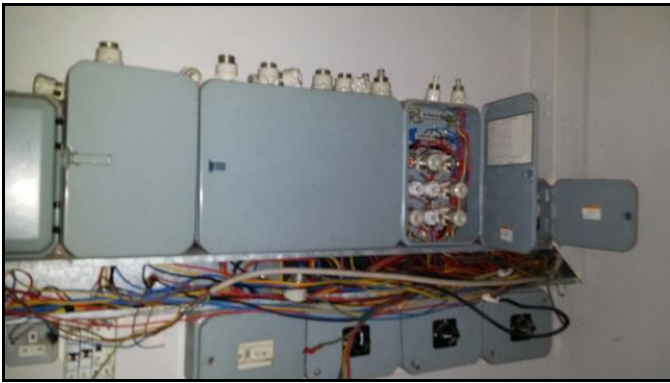
FLOOR:	Basement	SURVEY DATES:	04/05/2018				
ROOM NAME / NO.:	-1-012	SAMPLE REF NO.:	Presumed

USE OF MATERIAL:	Fuse box (Flash Guards)	ACCESSIBILITY:	Difficult				
LOCATION:	Chapel	EXTENT / QUANTITY:	7 no				
ASBESTOS TYPE	NON ASBESTOS	0		EXTENT OF DAMAGE / DETERIORATION	GOOD CONDITION	0	
	CHRYCOTILE	1	✓		LOW DAMAGE	1	✓
	AMOSITE	2			MEDIUM DAMAGE	2	
	CROCIDOLITE	3			HIGH DAMAGE	3	
	OTHER	2			LOOSE ASBESTOS	3	
SURFACE TREATMENT	COMPOSITE MATERIAL	0		FIBRE RELEASE POTENTIAL	HIGH RISK	10-12	
	ENCLOSED SPRAY / LAGGING, PAINTED / ENCAPSULATED AIB, ASBESTOS CEMENT SHEETS	1	✓		MEDIUM RISK	7-9	
	UNSEALED AIB OR ENCAPSULATED LAGGING AND SPRAYS	2			LOW RISK	5-6	✓
	UNSEALED LAGGING / SPRAY COATING	3			VERY LOW RISK	1-4	
PRODUCT TYPE	ASBESTOS REINFORCED COMPOSITES	1		RECOMMENDED ACTION	REMOVE		✓
	ASBESTOS INSULATING BOARD, TEXTILES, GASKETS, ROPE, PAPER, FELT	2	✓		REPAIR / SEAL ENCAPSULATE		
	THERMAL INSULATION, SPRAYED ASBESTOS, LOOSE ASBESTOS	3			LABEL AND MANAGE

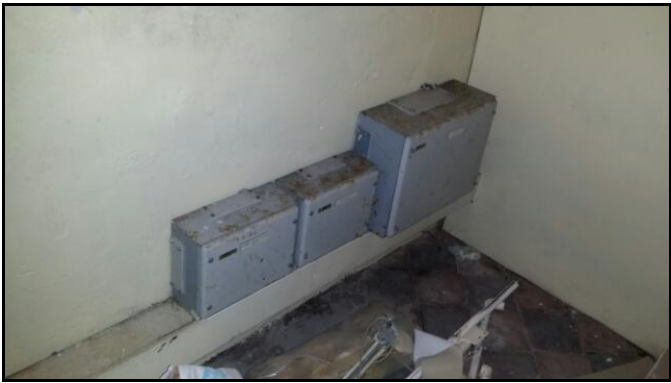
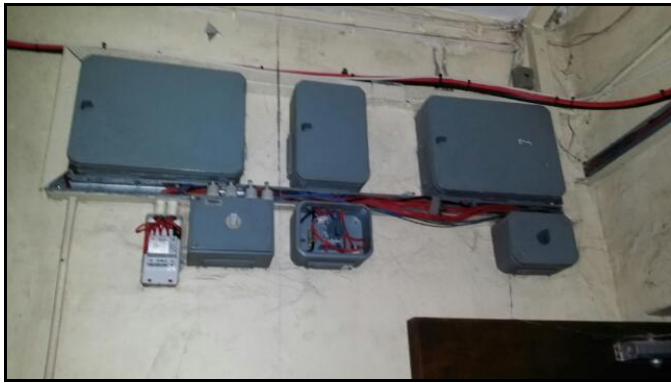
FLOOR:	Basement			SURVEY DATES:	08/05/2018		
ROOM NAME / NO.:	-1-027			SAMPLE REF NO.:	Presumed

USE OF MATERIAL:	Fuse box (Flash Guards)			ACCESSIBILITY:	Difficult		
LOCATION:	Stairwell			EXTENT / QUANTITY:	9 no		
ASBESTOS TYPE	NON ASBESTOS	0		EXTENT OF DAMAGE / DETERIORATION	GOOD CONDITION	0	
	CHRYCOTILE	1	✓		LOW DAMAGE	1	✓
	AMOSITE	2			MEDIUM DAMAGE	2	
	CROCIDOLITE	3			HIGH DAMAGE	3	
	OTHER	2			LOOSE ASBESTOS	3	
SURFACE TREATMENT	COMPOSITE MATERIAL	0		FIBRE RELEASE POTENTIAL	HIGH RISK	10-12	
	ENCLOSED SPRAY / LAGGING, PAINTED / ENCAPSULATED AIB, ASBESTOS CEMENT SHEETS	1	✓		MEDIUM RISK	7-9	
	UNSEALED AIB OR ENCAPSULATED LAGGING AND SPRAYS	2			LOW RISK	5-6	✓
	UNSEALED LAGGING / SPRAY COATING	3			VERY LOW RISK	1-4	
PRODUCT TYPE	ASBESTOS REINFORCED COMPOSITES	1		RECOMMENDED ACTION	REMOVE		✓
	ASBESTOS INSULATING BOARD, TEXTILES, GASKETS, ROPE, PAPER, FELT	2	✓		REPAIR / SEAL ENCAPSULATE

Basement	Same as S9	Hall -1-026 - Pipe Insulation & Cloth & String	Chrysotile in: String	High Damage	Difficult	1 lin m	9	Remove
Basement	Presumed	Stairwell -1-027 - Fuse box (Flash Guards)	Chrysotile	Low Damage	Difficult	9 no	5	Remove
Basement	Presumed	Electrical room -1-028 - Fuse box (Flash Guards)	Chrysotile	Low Damage	Difficult	3 no	5	Remove
Basement	Same as S4	Toilets -1-032 - Cistern (PVC / Reinforced Plastics)	Amosite	Low Damage	Easy	1 no	4	Remove
Basement	S23	Store -1-037 - Cement Board	Chrysotile	Low Damage	Medium	15 m ²	4	Remove
External	S21	Roof area 99-002 - Cement Slates	Chrysotile	Medium Damage	Difficult	350 approx m ²	5	Repair, label & manage

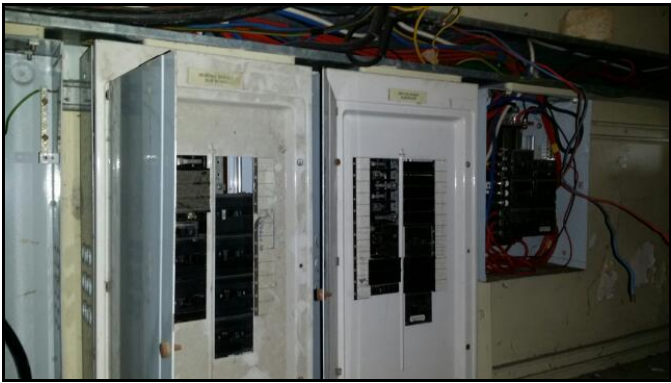
FLOOR:	Basement	SURVEY DATES:	08/05/2018				
ROOM NAME / NO.:	-1-028	SAMPLE REF NO.:	Presumed

No Photo Available					
USE OF MATERIAL:	Fuse box (Flash Guards)	ACCESSIBILITY:	Difficult				
LOCATION:	Electrical room	EXTENT / QUANTITY:	3 no				
ASBESTOS TYPE	NON ASBESTOS	0		EXTENT OF DAMAGE / DETERIORATION	GOOD CONDITION	0	
	CHRYSTOLE	1	✓		LOW DAMAGE	1	✓
	AMOSITE	2			MEDIUM DAMAGE	2	
	CROCIDOLITE	3			HIGH DAMAGE	3	
	OTHER	2			LOOSE ASBESTOS	3	
SURFACE TREATMENT	COMPOSITE MATERIAL	0		FIBRE RELEASE POTENTIAL	HIGH RISK	10-12	
	ENCLOSED SPRAY / LAGGING, PAINTED / ENCAPSULATED AIB, ASBESTOS CEMENT SHEETS	1	✓		MEDIUM RISK	7-9	
	UNSEALED AIB OR ENCAPSULATED LAGGING AND SPRAYS	2			LOW RISK	5-6	✓
	UNSEALED LAGGING / SPRAY COATING	3			VERY LOW RISK	1-4	
PRODUCT TYPE	ASBESTOS REINFORCED COMPOSITES	1		RECOMMENDED ACTION	REMOVE		✓
	ASBESTOS INSULATING BOARD, TEXTILES, GASKETS, ROPE, PAPER, FELT	2	✓		REPAIR / SEAL ENCAPSULATE

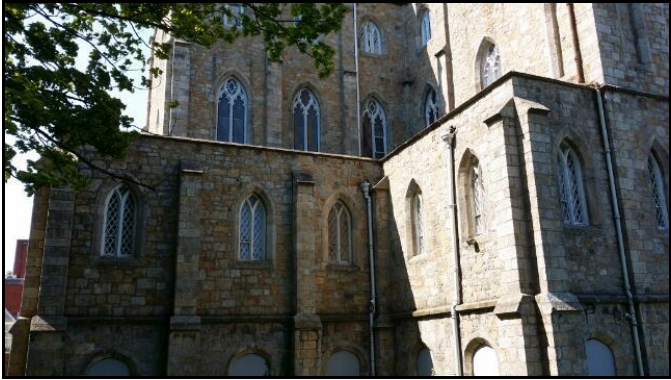
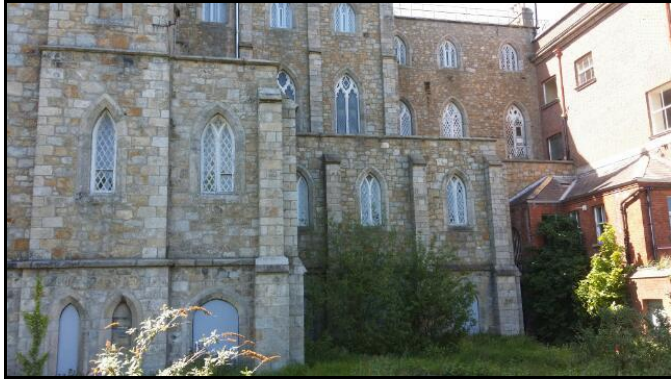
FLOOR:	External	SURVEY DATES:	16/05/2018		
ROOM NAME / NO.:	99-006	SAMPLE REF NO.:	Presumed

USE OF MATERIAL:	Felt (bituminous product) - No Access Gained		ACCESSIBILITY:	No Access	
LOCATION:	Flat roof		EXTENT / QUANTITY:	N/A	
ASBESTOS TYPE	NON ASBESTOS	0	EXTENT OF DAMAGE / DETERIORATION	GOOD CONDITION	0
	CHRYCOTILE	1		LOW DAMAGE	1
	AMOSITE	2		MEDIUM DAMAGE	2
	CROCIDOLITE	3		HIGH DAMAGE	3
	OTHER	2		LOOSE ASBESTOS	3
SURFACE TREATMENT	COMPOSITE MATERIAL	0	FIBRE RELEASE POTENTIAL	HIGH RISK	10-12
	ENCLOSED SPRAY / LAGGING, PAINTED / ENCAPSULATED AIB, ASBESTOS CEMENT SHEETS	1		MEDIUM RISK	7-9
	UNSEALED AIB OR ENCAPSULATED LAGGING AND SPRAYS	2		LOW RISK	5-6
	UNSEALED LAGGING / SPRAY COATING	3		VERY LOW RISK	1-4
PRODUCT TYPE	ASBESTOS REINFORCED COMPOSITES	1	RECOMMENDED ACTION	INVESTIGATE FURTHER FOR NO ACCESS	✓
	ASBESTOS INSULATING BOARD, TEXTILES, GASKETS, ROPE, PAPER, FELT	2		REPAIR / SEAL ENCAPSULATE

THERMAL INSULATION, SPRAYED ASBESTOS, LOOSE ASBESTOS	3		LABEL AND MANAGE	
OTHER RELEVANT INFORMATION:					
No access to flat roof area of old church. Height restriction (over 6m high).					
INVESTIGATE FURTHER FOR NO ACCESS

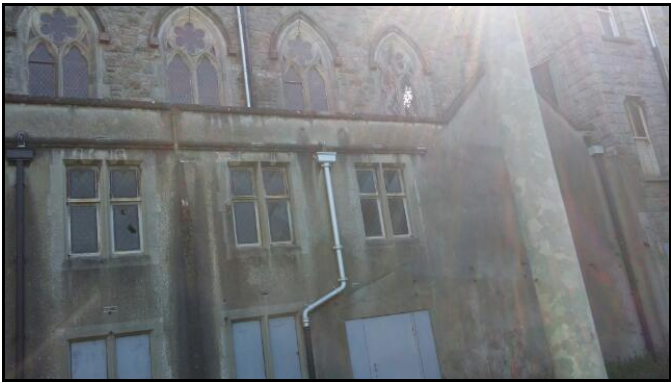
FLOOR:	External			SURVEY DATES:	16/05/2018		
ROOM NAME / NO.:	99-010			SAMPLE REF NO.:	Presumed

No Photo Available			
USE OF MATERIAL:	Felt (bituminous product) - No Access Gained			ACCESSIBILITY:	No Access		
LOCATION:	Flat roof			EXTENT / QUANTITY:	N/A		
ASBESTOS TYPE	NON ASBESTOS	0		EXTENT OF DAMAGE / DETERIORATION	GOOD CONDITION	0	
	CHRYSTOLE	1	✓		LOW DAMAGE	1	
	AMOSITE	2			MEDIUM DAMAGE	2	
	CROCIDOLITE	3			HIGH DAMAGE	3	
	OTHER	2			LOOSE ASBESTOS	3	
SURFACE TREATMENT	COMPOSITE MATERIAL	0		FIBRE RELEASE POTENTIAL	HIGH RISK	10-12	
	ENCLOSED SPRAY / LAGGING, PAINTED / ENCAPSULATED AIB, ASBESTOS CEMENT SHEETS	1			MEDIUM RISK	7-9	
	UNSEALED AIB OR ENCAPSULATED LAGGING AND SPRAYS	2			LOW RISK	5-6	
	UNSEALED LAGGING / SPRAY COATING	3			VERY LOW RISK	1-4	
PRODUCT TYPE	ASBESTOS REINFORCED COMPOSITES	1		RECOMMENDED ACTION	INVESTIGATE FURTHER FOR NO ACCESS		✓
	ASBESTOS INSULATING BOARD, TEXTILES, GASKETS, ROPE, PAPER, FELT	2			REPAIR / SEAL ENCAPSULATE

THERMAL INSULATION, SPRAYED ASBESTOS, LOOSE ASBESTOS	3			LABEL AND MANAGE		
OTHER RELEVANT INFORMATION:							
No access to flat roof area. Height restriction (over 8m high).							
INVESTIGATE FURTHER FOR NO ACCESS

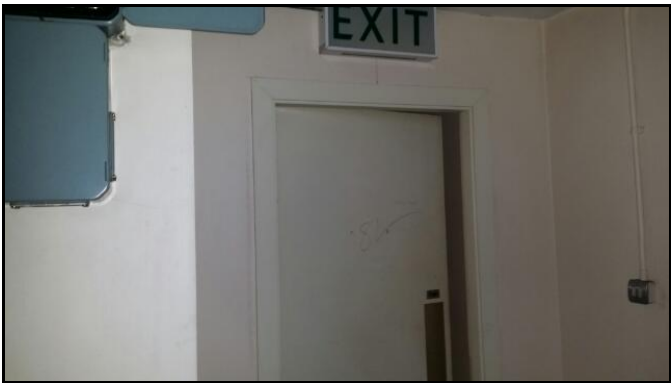
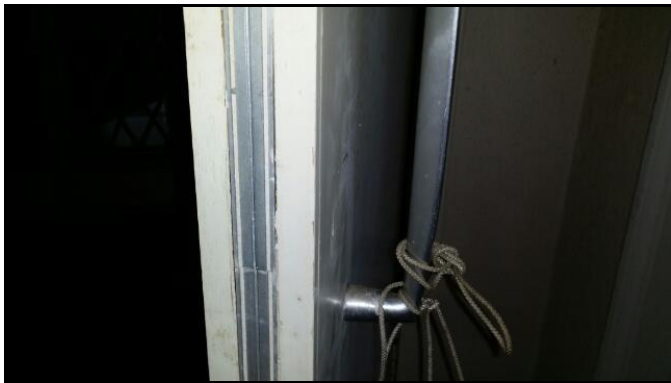
FLOOR:	3rd Floor	SURVEY DATES:	15/05/2018
ROOM NAME / NO.:	3-011	SAMPLE REF NO.:	Same as S18

USE OF MATERIAL:	Insulating Board to fire door	ACCESSIBILITY:	Difficult
LOCATION:	Corridor	EXTENT / QUANTITY:	4 no

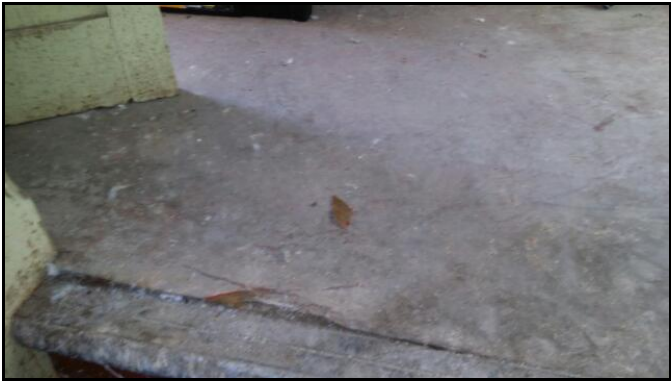
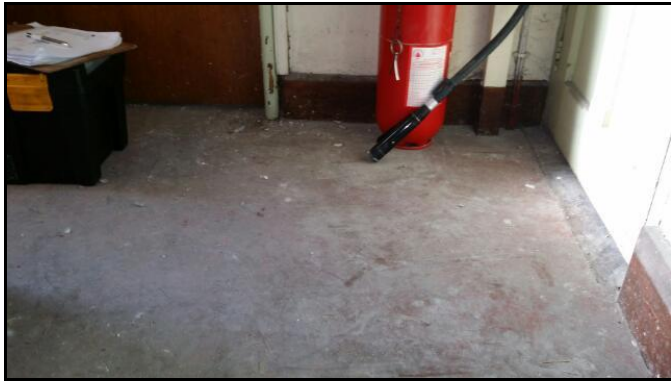
FLOOR:	3rd Floor	SURVEY DATES:	16/05/2018
ROOM NAME / NO.:	3-037	SAMPLE REF NO.:	Same as S7

USE OF MATERIAL:	Vinyl Floor Covering (red) & Adhesive	ACCESSIBILITY:	Easy
LOCATION:	Stairwell	EXTENT / QUANTITY:	5 m ²

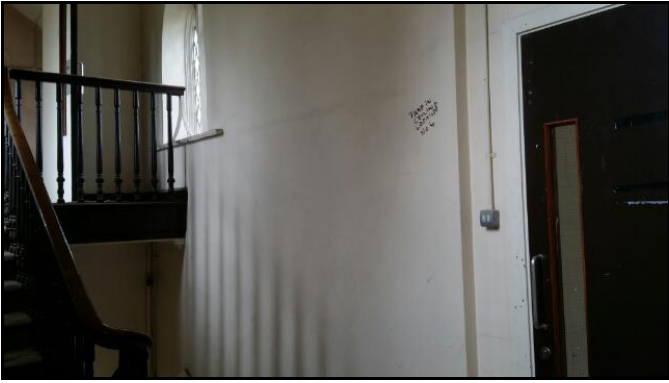
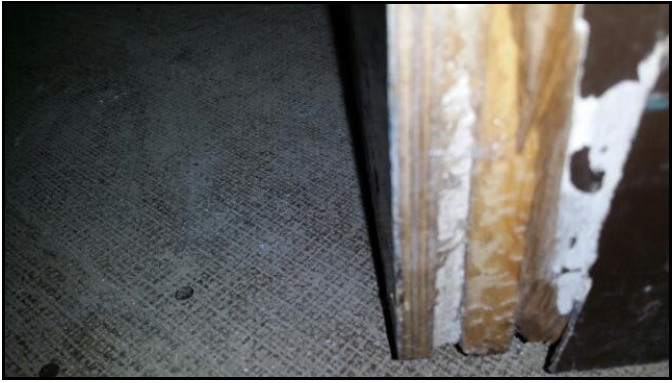
FLOOR:	2nd Floor	SURVEY DATES:	15/05/2018
ROOM NAME / NO.:	2-030	SAMPLE REF NO.:	Same as S20

USE OF MATERIAL:	Insulating Board to fire door	ACCESSIBILITY:	Difficult
LOCATION:	Hall & Stairs	EXTENT / QUANTITY:	2 no

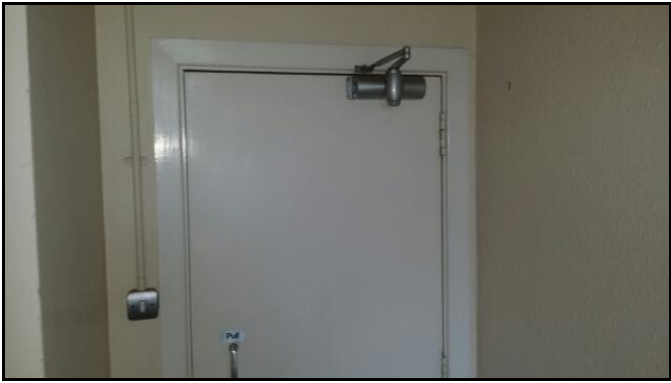
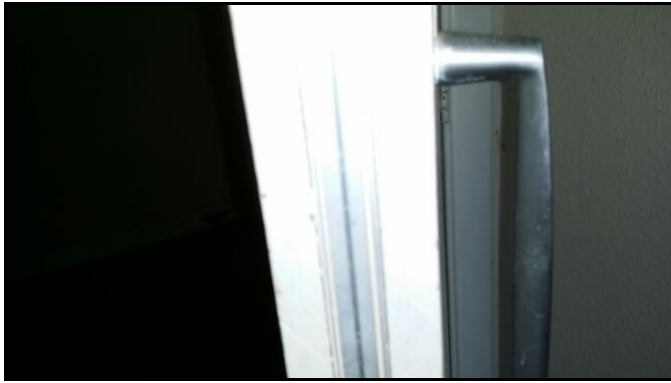
FLOOR:	2nd Floor	SURVEY DATES:	15/05/2018
ROOM NAME / NO.:	2-046	SAMPLE REF NO.:	Same as S18

USE OF MATERIAL:	Insulating Board to fire door	ACCESSIBILITY:	Difficult
LOCATION:	Stairwell	EXTENT / QUANTITY:	2 no

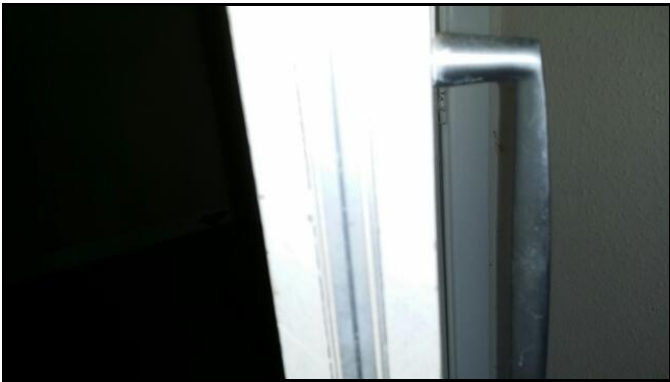
FLOOR:	2nd Floor	SURVEY DATES:	15/05/2018
ROOM NAME / NO.:	2-051	SAMPLE REF NO.:	Same as S18

USE OF MATERIAL:	Insulating Board to fire door	ACCESSIBILITY:	Difficult
LOCATION:	Stairwell	EXTENT / QUANTITY:	2 no

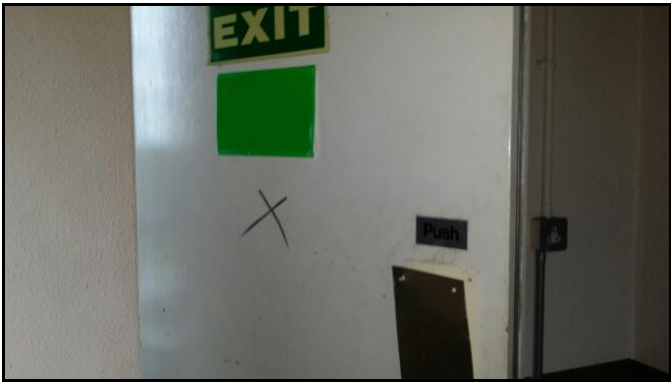
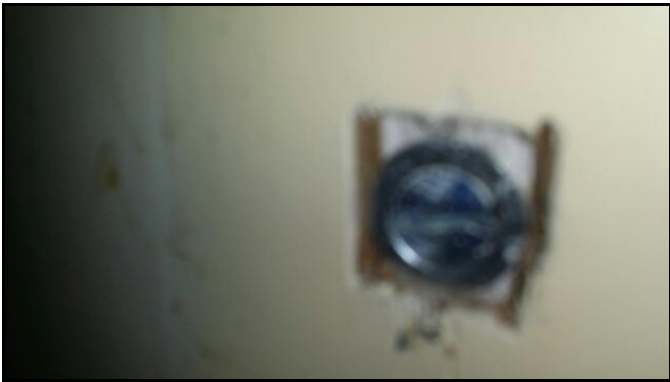
FLOOR:	2nd Floor	SURVEY DATES:	15/05/2018
ROOM NAME / NO.:	2-061	SAMPLE REF NO.:	Same as S18

USE OF MATERIAL:	Insulating Board to fire door	ACCESSIBILITY:	Difficult
LOCATION:	Stairwell	EXTENT / QUANTITY:	2 no

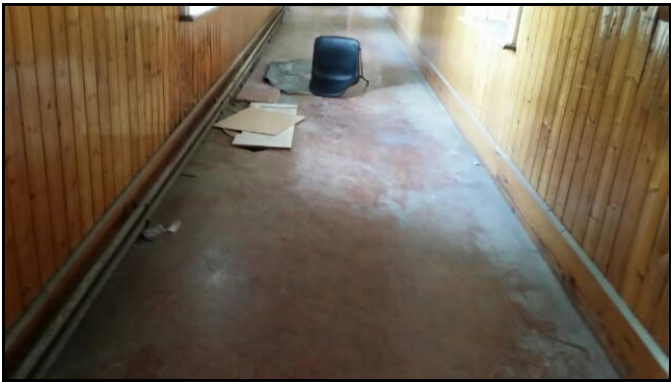
FLOOR:	Ground Floor	SURVEY DATES:	08/05/2018
ROOM NAME / NO.:	0-009	SAMPLE REF NO.:	Same as S7

No Photo Available	
USE OF MATERIAL:	Vinyl Floor Covering (red) & Adhesive	ACCESSIBILITY:	Medium
LOCATION:	Corridor	EXTENT / QUANTITY:	41 m ²

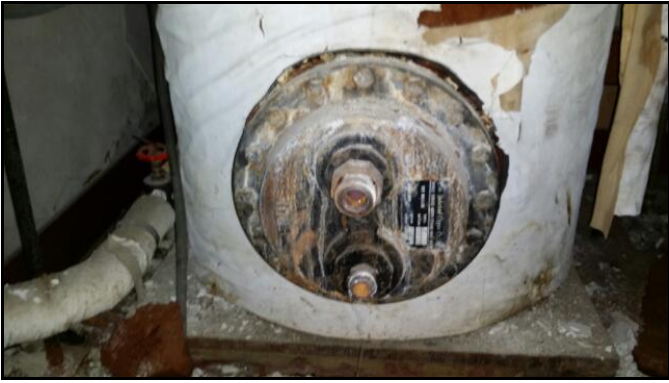
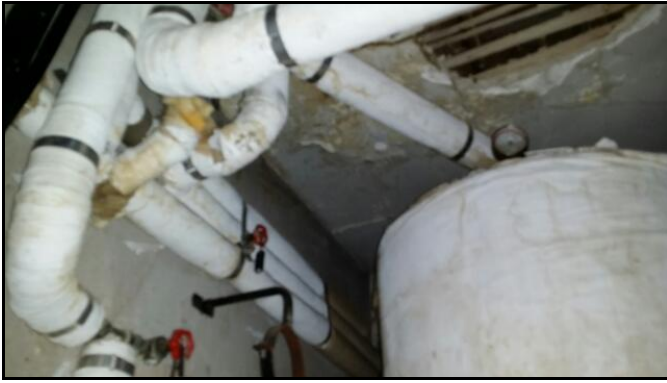
FLOOR:	Ground Floor	SURVEY DATES:	08/05/2018
ROOM NAME / NO.:	0-013	SAMPLE REF NO.:	S12

USE OF MATERIAL:	Pipework (compressed gaskets)	ACCESSIBILITY:	Difficult
LOCATION:	Room	EXTENT / QUANTITY:	2 no

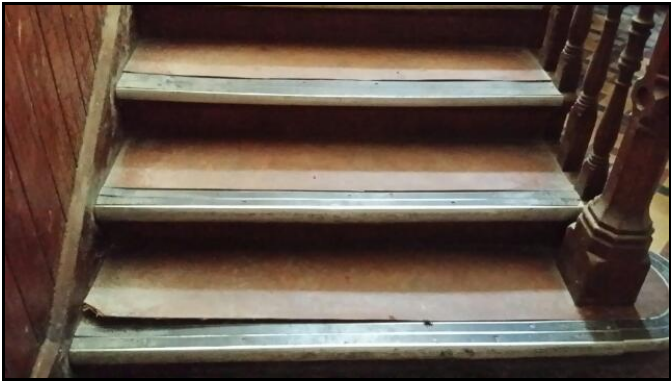
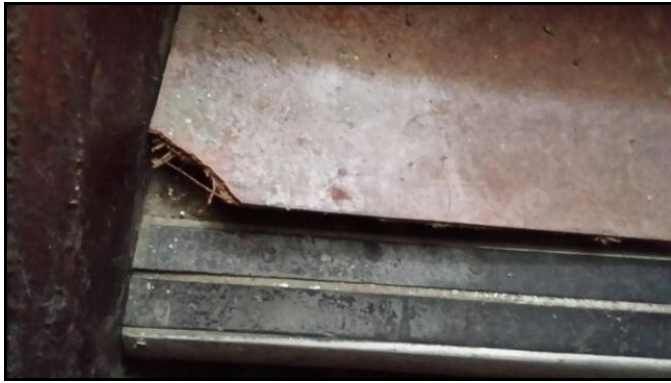
FLOOR:	Basement	SURVEY DATES:	04/05/2018
ROOM NAME / NO.:	-1-022	SAMPLE REF NO.:	S7

USE OF MATERIAL:	Vinyl Floor Covering (red) & Adhesive	ACCESSIBILITY:	Medium
LOCATION:	Stairwell	EXTENT / QUANTITY:	14 m ²
