## SCHEDULE OF MATERIALS AND FINAL DETAILS

Compliance Submission: 26<sup>th</sup> May 2022

**Planning Register Reference: SD21B/0530**

RE: The development consisting of: (i) Partial demolition and reconstruction of a two storey corner extension to the rear, provision of a new flat roof with roof-light to this extension, (ii) Demolition of the two storey extension at the centre of the back (east) of the house and the construction of a new flat roofed two storey extension with roof-light(s), (iii) Repairs to windows with replacements where necessary or appropriate. Construction of single storey bay extension with pitched roof to the south elevation at lower ground floor/basement level, (iv) Minor internal alterations, general refurbishment, provision of maintenance access to centre valley, addition of photovoltaic panels, repairs to plasterwork, increase in height of rear garden boundary wall to the north, (v) Outbuilding to the Rear: internal alterations, roof repairs, new doors and window and general refurbishment, (vi) Minor hard and soft landscaping works including parking area to the North-East and all ancillary site works above and below ground. At **Oak Lodge**, New Road, C

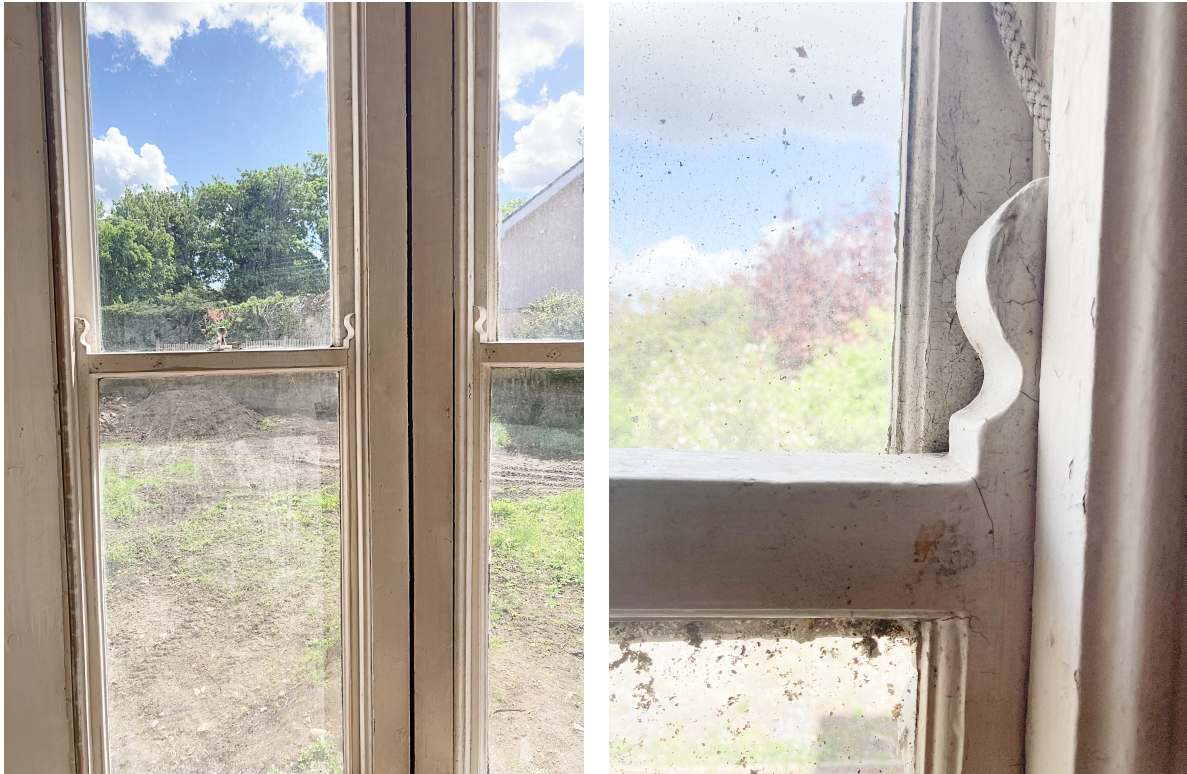
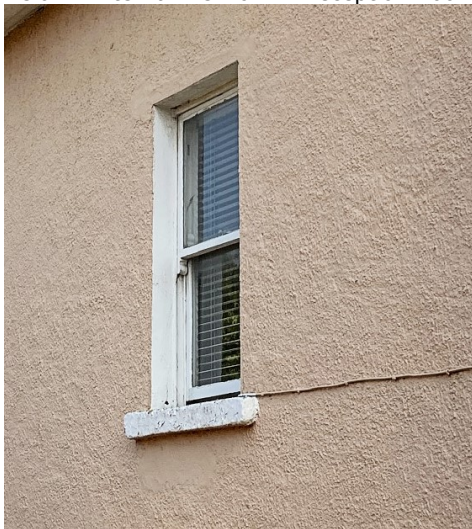
Above Left: Window details bay window sidelight SW Reception Room, Right: window detail NE Reception Room  
 Below: External view of NE Reception Room room window, North Elevation.

It should be noted that the detail and profiles of the new up-and-down sash windows will be almost identical to the existing window in the reception room in the north-west corner of the building.
