**PROSPECT HOUSE
STOCKING LANE
DUBLIN 16**

**ARCHITECTURAL HERITAGE
IMPACT ASSESSMENT**

**Historic Building Consultants
Old Bawn
Old Connaught
Bray**

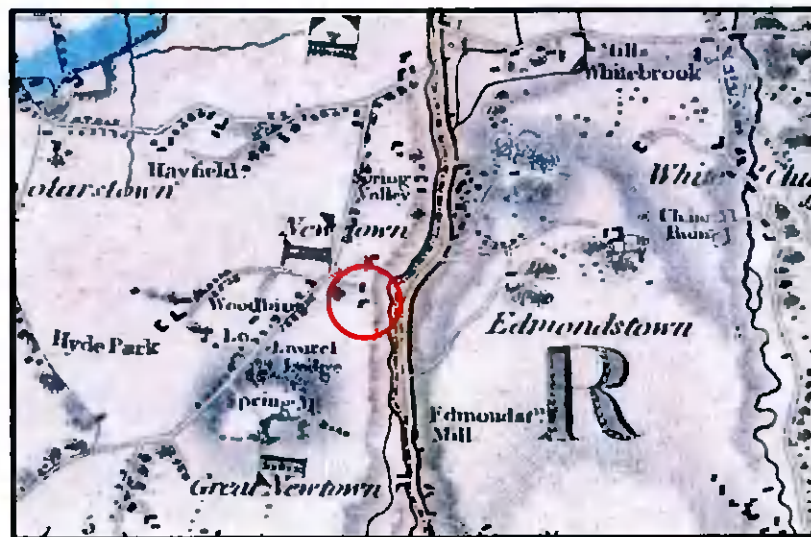
Figure 2: Detail of Duncan's map of 1821, showing Prospect House

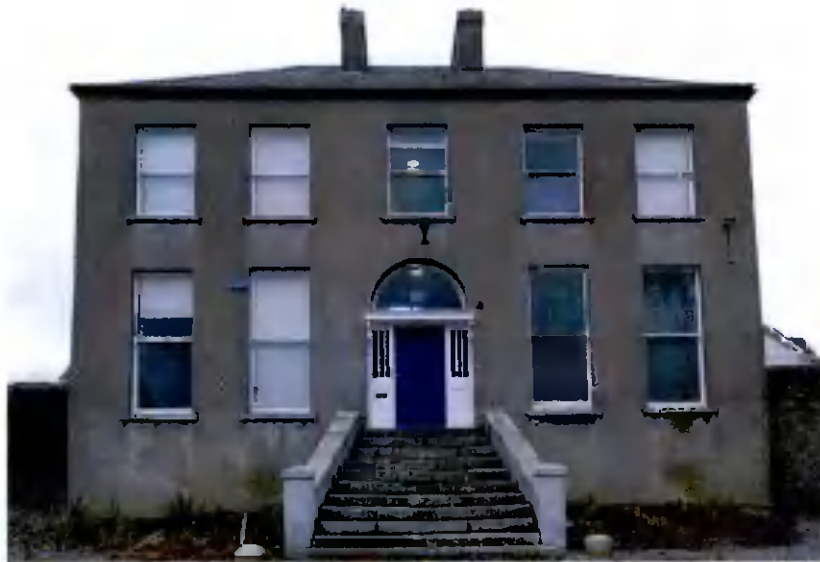
Plate 1: Front elevation

Prospect House is a five-bay, detached, two-storey-over-basement house on the eastern side of Stocking Lane to the north of the M50 motorway. The front door is approached via a large flight of granite steps, leading to the front door, which is four-panelled, flanked by side lights and surmounted by a large semicircular fanlight with plain glass. The house is rendered with sand and cement. The windows on the front elevation are one-over-one timber sashes with obscure-glazed lower sashes. The roof is hipped and there are two chimneystacks rising from the ridge. The western side elevation is slate hung, while the return to the rear, seen at right in the photograph below, is rendered with sand and cement. Two first-floor windows on this elevation are two-over-two sashes with curled horns, while the window on the ground floor of the return is a substantial timber casement suggestive of there being a Wyatt window previously. At basement level there are three windows near ground level, guarded with iron bars.

Externally, the windows have all been replaced, mostly with single-pane sashes and the presence of curled horns suggests an early- to mid-twentieth century timescale. An extraordinary feature of all windows on the ground and first floors is the obscure glazing on the lower sashes. Whether this was done at the time the windows were replaced or later is not certain. Also around the same time the house has been rendered with sand and cement and the fanlight has been replaced with a single pane.

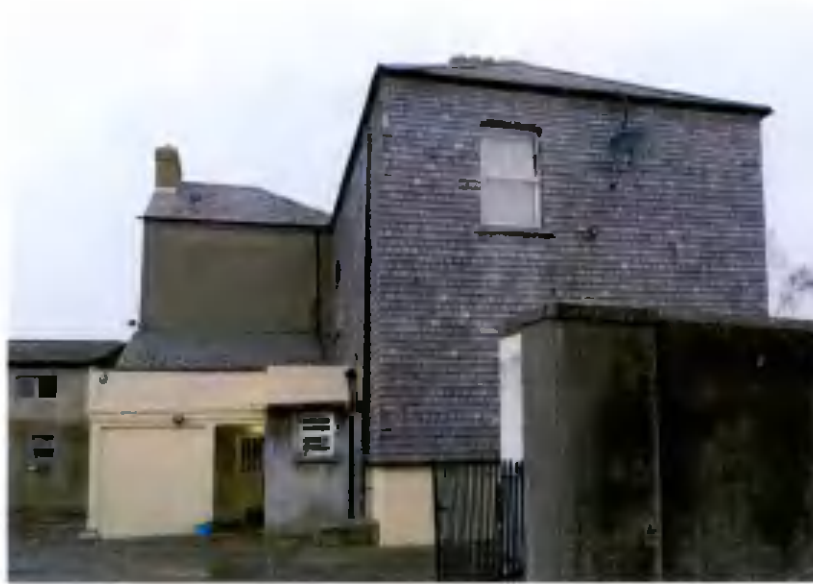
Plate 3: Eastern side elevation

The eastern side of the house and the rear elevation of the main house are slate hung, while the side and rear elevations of the return is rendered with sand and cement. There is a single window on the first floor of the side elevation and another at ground level to light the basement. The former is a one-over-one timber sliding sash, while the latter is a mullioned timber casement. A single window in the rear of the main part of the house is a round-headed sash window lighting the stairs. In the angle between the return and the main house is a lean-to single-storey part of the return, alongside which is a small masonry structure next to the house and a timber-framed and timber-sheeted addition, both of these structures having water tanks on the roof and are later additions to the house. There is a small, enclosed yard at the rear of the house, with a garage, a shed and a stable.

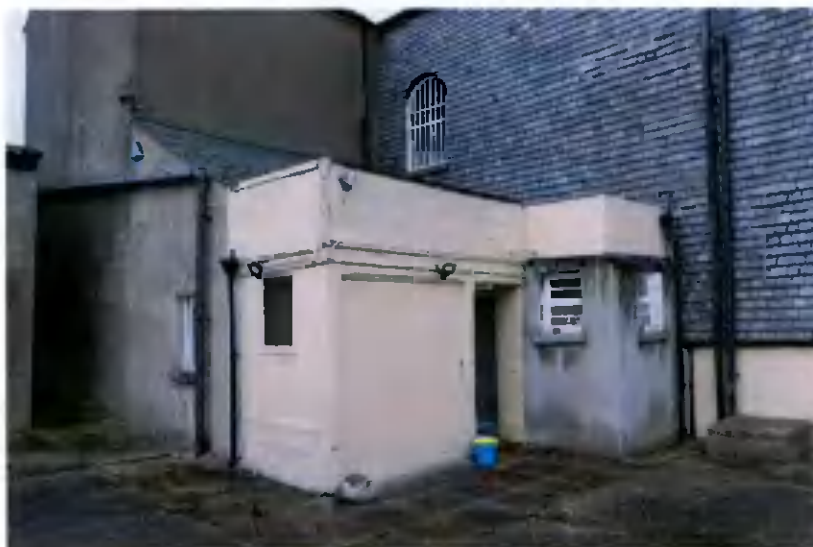
Plate 4: Structures at the rear of the house

The later structures in the rear yard are to be removed, including the flat-roofed porch and WC adjacent to the rear return of the house, a garage and a shed to the east and south-east of the house, and the perimeter wall on the eastern side. These structures are seen in plates 4 and 5 above. These demolitions will facilitate the erection of the extension to the house.

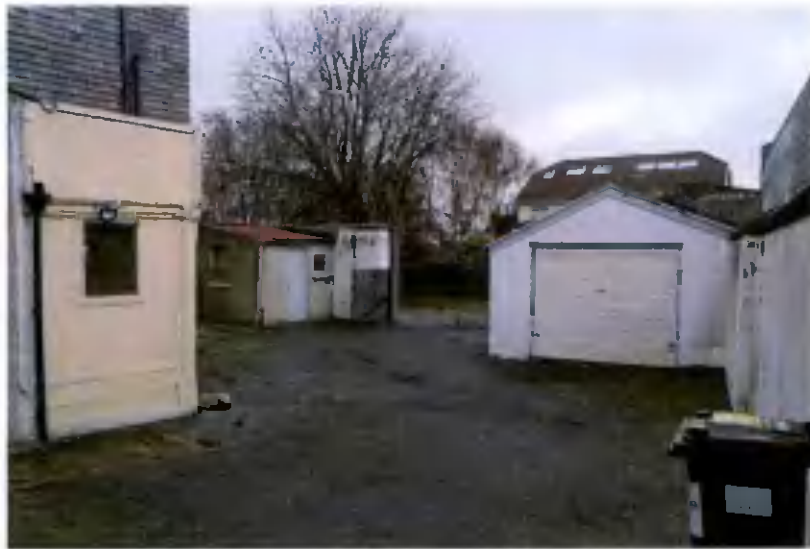
Plate 5: View eastward in the yard

The yard at the rear of the house is paved with concrete. A high wall topped by a wooden fence separates it from a farmyard that is not within the property at present but which was formerly associated with Prospect House. As noted above, there is a small shed in the yard, seen to left of centre in the photograph above, while a garage is seen to the right. To the rear of the rear return is a two-storey stable building, separated from the house by a narrow passageway. The stables are faced with sand and cement render and have a corrugated roof.

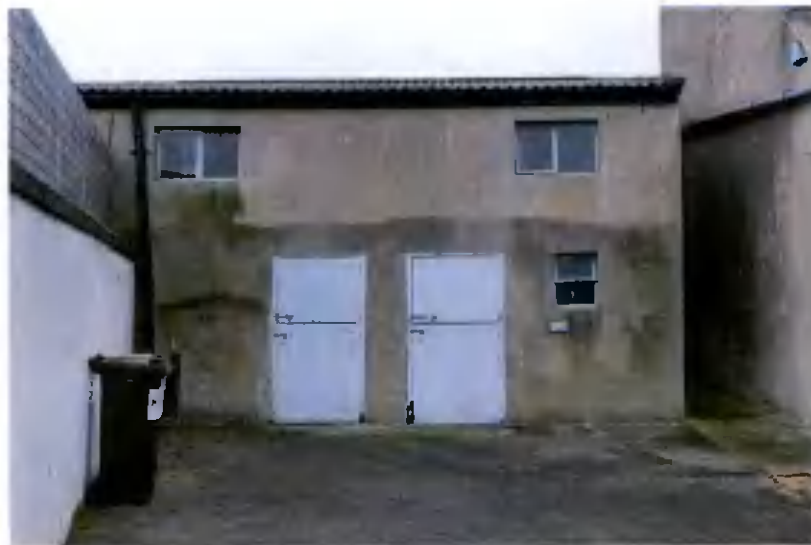
Plate 6: Stables in the yard

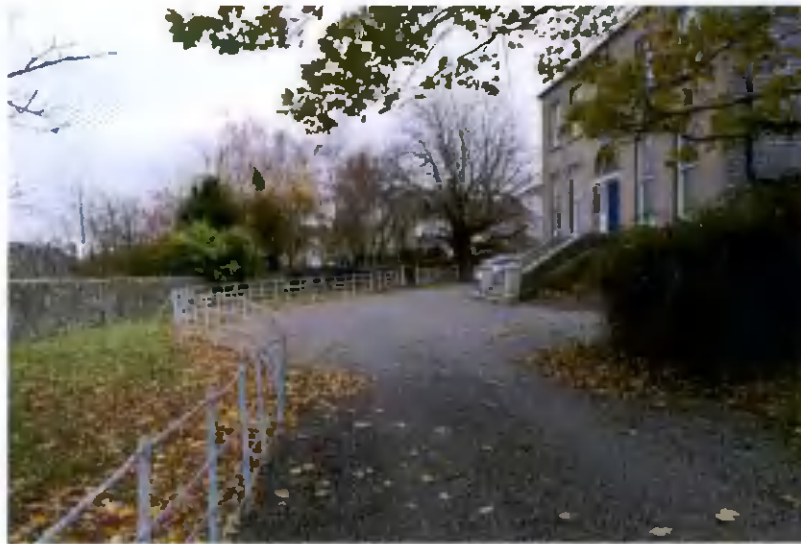
Plate 7: Driveway and railings to front of house

Prospect House is approached via a driveway a hundred metres long, leading from a gateway on Stocking Lane and running past the house to reach the rear yard. On the northern side of this driveway is a wrought-iron railing consisting of vertical flat bars supporting a round-section rail at the top, beneath which are three levels of flat-bar rails. The railing is supported by wrought-iron bracing to the rear. To the east of the house is a wrought-iron farm gateway with diagonal bracing and hung from a cast-iron post.

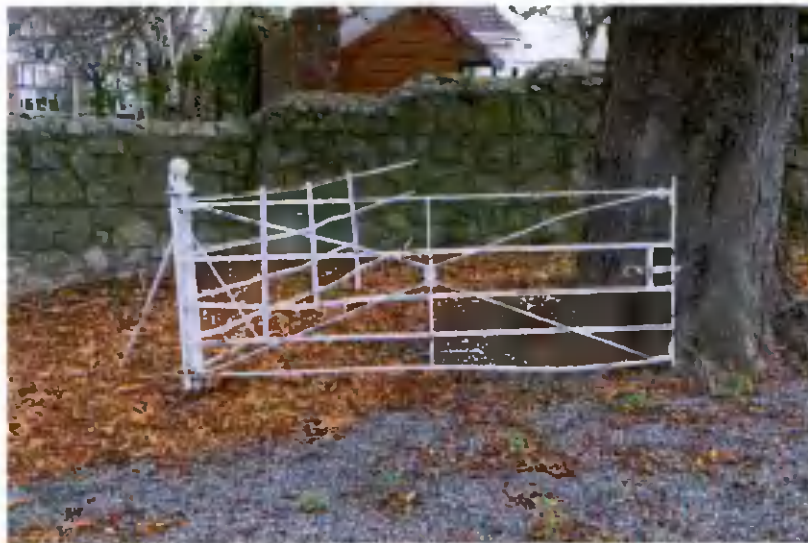
Plate 8: Gateway in railing

Beyond the railing to the north is a narrow strip of grass, while to the north of this is a wall, about 1.5 metres high, of granite rubble and of mid- to late-twentieth century date.

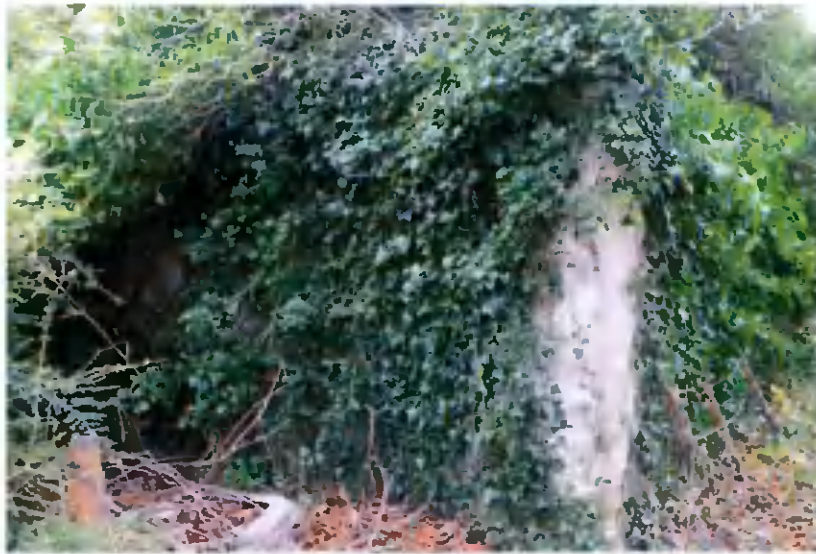
Plate 9: Gate lodge

On the southern side of the driveway inside the gate is the ruin of a gate lodge. This is almost entirely concealed beneath ivy and other vegetation, with just a small area of walling visible and accessible at the north-western corner. It appears that the lodge was of modest size and single-storey.

As was noted in the building survey above, the gate lodge is a ruin, and it has been in this state for a considerable period.

It is proposed to replace the gate lodge with a new building, the principal part of which would incorporate the walls of the original lodge, with an extension placed on the southern side. The original part of the building is to have a monopitch roof, falling toward the driveway, while the extension is to have a hipped roof, with the principal slope running southward, flanked by small hips running to the east and west. The extension will be wider than the original lodge, projecting to the east and west.

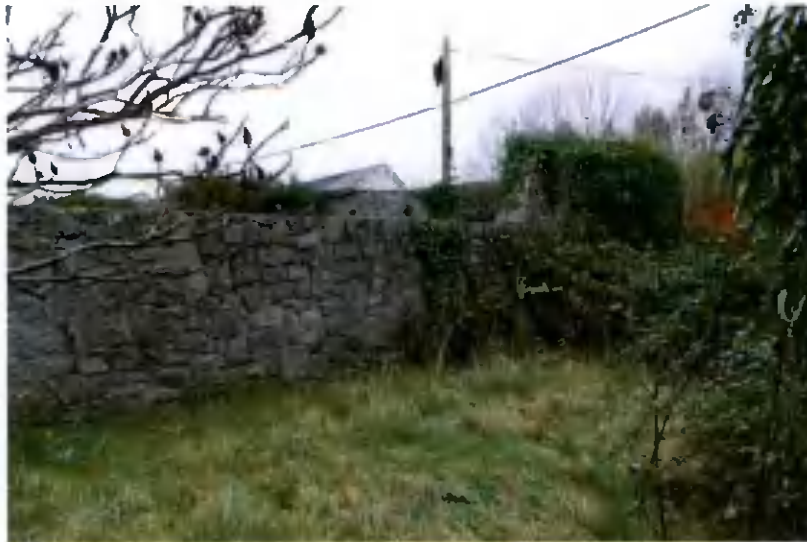
Plate 10: Wall to the south of the gate lodge

The grounds at the rear of Prospect House are separated from the driveway by a stone-faced wall, seen in the photograph above. This wall is of later twentieth-century origin and consists of a concrete-block wall faced on its northern side with granite.

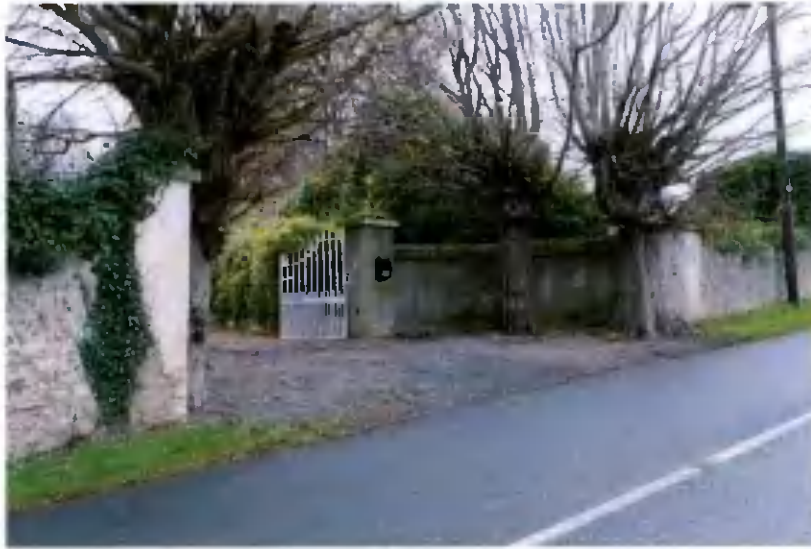
Plate 11: Gateway

The entrance to Prospect House is from Stocking Lane. The wrought-iron gates are set back from the road and are flanked by curved wing walls terminating at stone piers at either end. Adjacent to each wing wall are two trees, heavily pollarded.

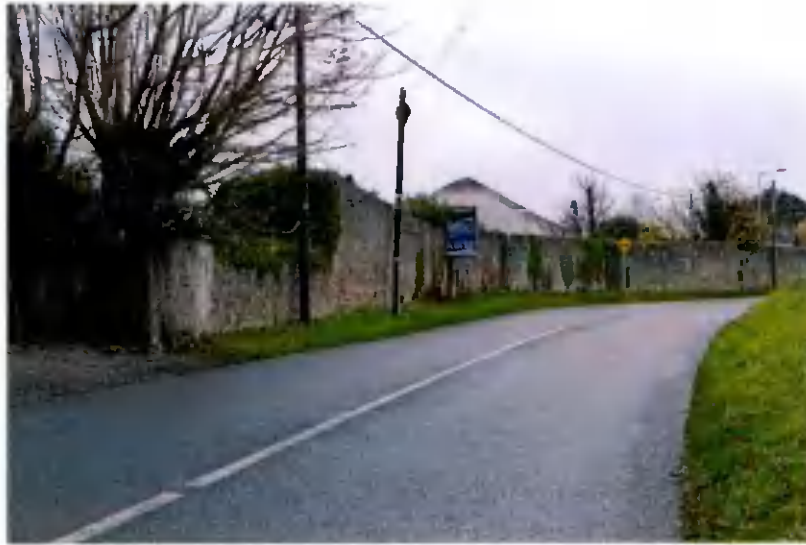
Plate 13: Wall to the south of gateway

Running southward from the gateway is a stone wall, constructed of rubble granite and with the remnants of a render. For a short distance from the gateway the wall is about 1.5 metres high, and it then rises to about 3 metres, continuing to the southern end of the property, where the access to the adjacent property runs from the road. Through this entire length of wall, it runs through a curve, the wall being on the outside of the bend.

As noted above, the choice of access location minimises the disruption to the boundary wall, retaining a long stretch of the wall that is highly visible to those travelling both up and down Stocking Lane.

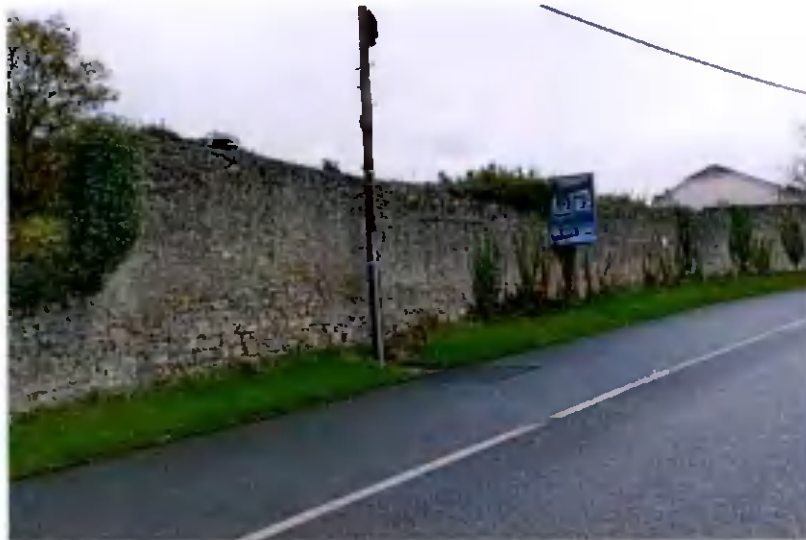
Plate 14: Detail of wall to south of gateway

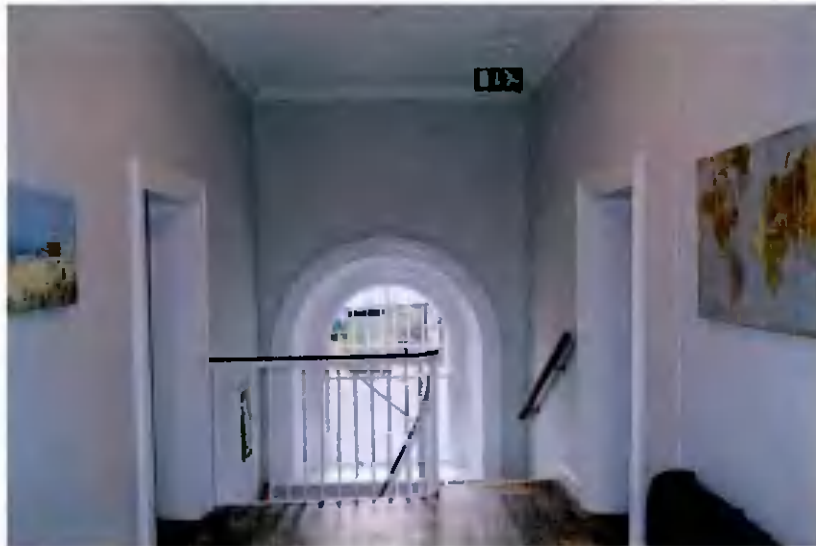
Plate 19: View to rear of first-floor landing

The landing runs from front to rear of the house, with a one-over-one timber sliding sash window at the front, with panelled shutters and a moulded-timber architrave, the lower sash having obscured glass. At the rear of the landing the staircase rises through a series of winders. The staircase is lit by a two-over-two timber sash, the upper sash having a semicircular head and the lower sash has obscured glass.

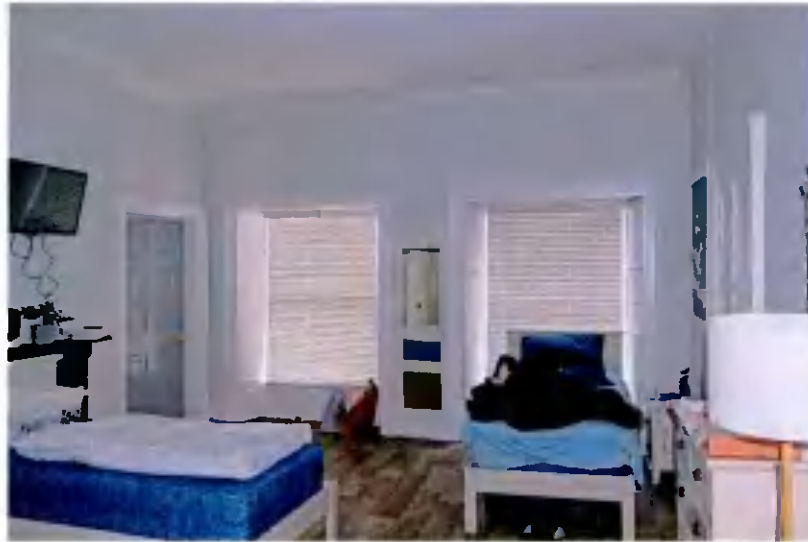
Plate 20: View to the front of the large bedroom

The large bedroom to the east of the first-floor landing is entered via a six-panelled door set in a moulded-timber architrave. A second door near the top of the stairs also leads into this room but is no longer used. The room is lit by two one-over-one timber sliding sashes at the front of the house and another in the side elevation, near the rear. All of these windows have curled horns and obscure-glazed lower sashes and are set in moulded-timber architraves with panelled shutters. A shallow cupboard with a moulded-timber architrave appears to have been a window, now blocked up. The floor has a vinyl covering. The ceiling is plain with a simple run cornice. There is a cast-iron chimneypiece.

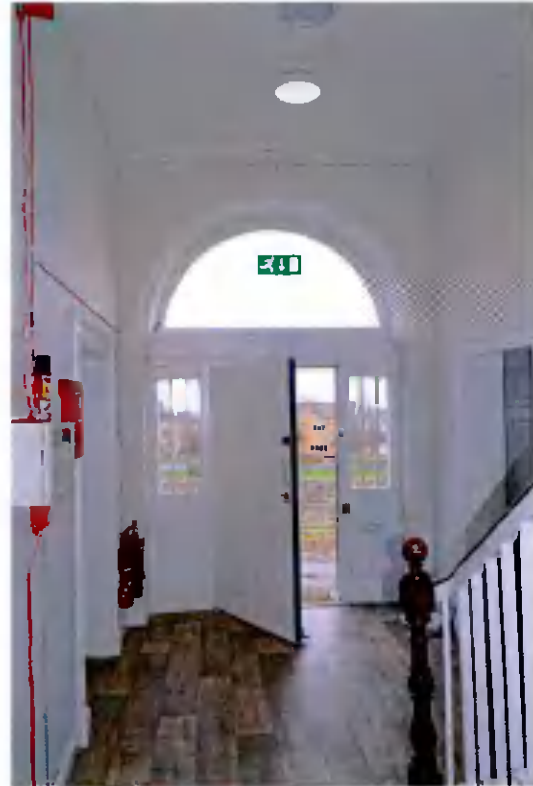
The house is entered via a four-panelled door flanked by plain glass side lights protected internally by iron bars. A large semicircular fanlight with plain glass and a plaster archivolt spans the width of the door and side lights.

The entrance hall is broad and high, with the staircase rising at the rear. The front section is divided from the rear section by a beam standing down from the ceiling. The beam has a facing of plain plaster and to the front the hall ceiling has a decorative cornice, while to the rear, over the staircase, the cornice is plain.

The floor has a vinyl covering. A doorway opens onto either side of the hall, each having a moulded-timber architrave and flanked by pilasters.

Plate 22: View to front of entrance hall

While Prospect House is modest in its decorative elements its appearance would seem to support a date from the 1790s to about 1820. In particular, the scale of its doorway, with its full-width semicircular fanlight seem to suggest a date in that range. The evidence from Taylor's map of 1816 suggests that the house was not in existence at that time. The two houses down the hill from Prospect House are shown – labelled Springvale and Springfield on the first-edition Ordnance Survey map and Spring Mount on Taylor's map. Two houses up the hill were also shown and labelled as Laurel Hill and Spring Mount, which were the same names given on the Ordnance Survey map. The accuracy with which those houses were depicted supports a date for Prospect House as some time after Taylor surveyed the area. The house is clearly seen on William Duncan's map five years later, which provides a narrow timescale in which the house appears to have been built.

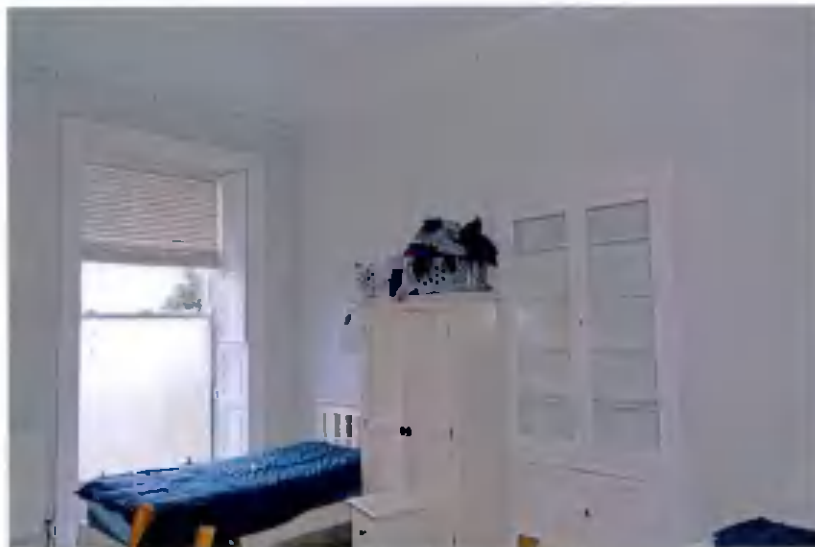
The room to the east of the entrance hall is lit by two windows to the front of the house, each of which is a one-over-one timber sliding sash with curled horns and obscured glass in the lower sash. The windows are set in moulded-timber architraves and have panelled shutters. A shallow cupboard set into the eastern wall may have been a window originally and a similar arrangement is found on the room above. The ceiling is plain, with a decorative cornice. On the western wall there is a reeded grey marble chimneypiece with a tiled insert. The floor has a vinyl covering.

Plate 25: View to north-east in living room

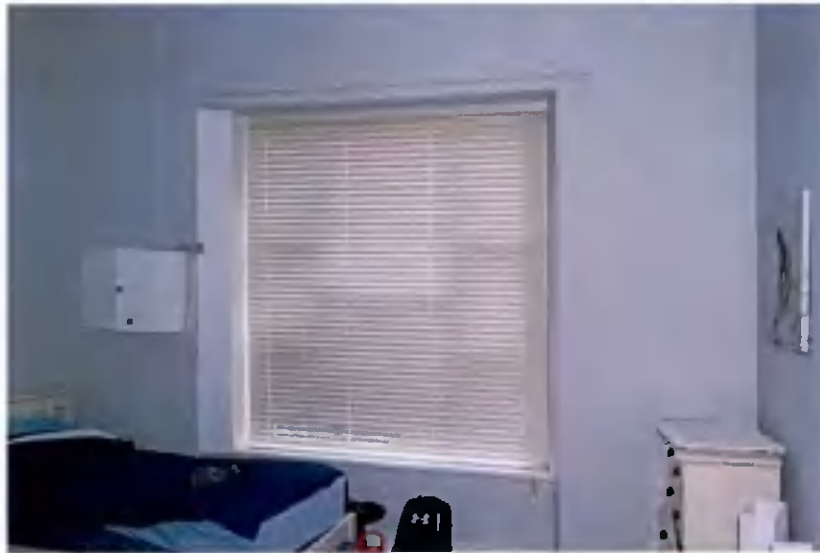
Plate 26: Window in rear bedroom on ground floor

At the rear of the ground floor there is a bedroom in the return. This is lit by a large window that would have been a Wyatt window originally, but which now has a central one-over-one timber sliding sash flanked by three top-hung casements on either side. There are no shutters and no architrave. The window has a steel grille on the outside. The room is entered via a four-panelled door. There is a mid-twentieth-century tiled chimneypiece. The ceiling has coving around the margin, a moulded centrepiece and a narrow decorative border, all of which appear to date from the mid-twentieth century.

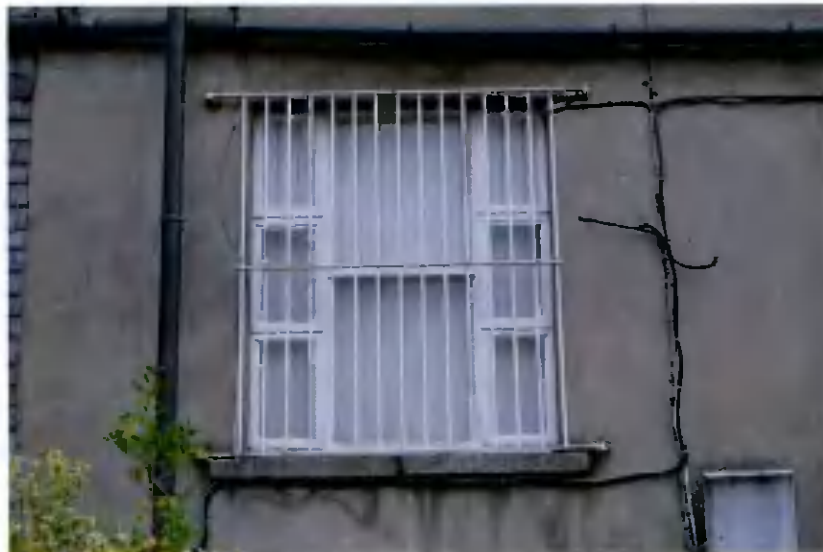
Plate 27: External view of window in rear ground-floor bedroom

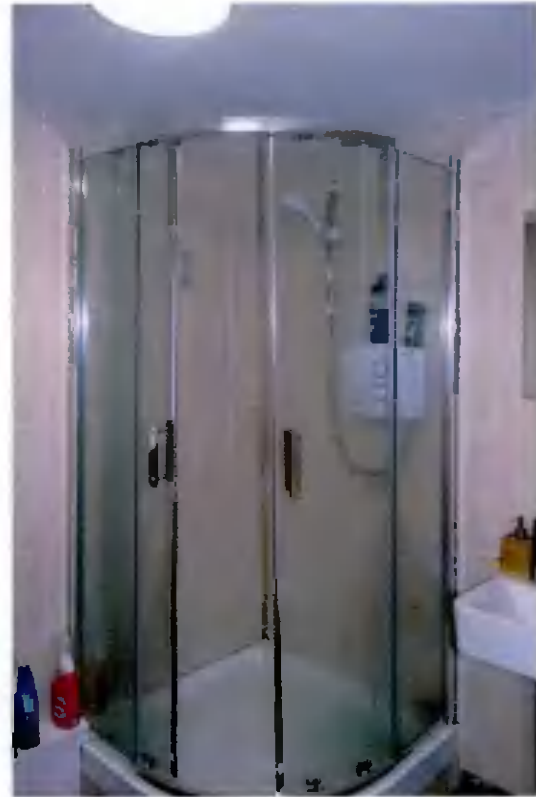
The room is entirely fitted out with contemporary sanitary ware and the walls are tiled from floor to ceiling. The floor has a vinyl covering.

Plate 28: Shower in bathroom

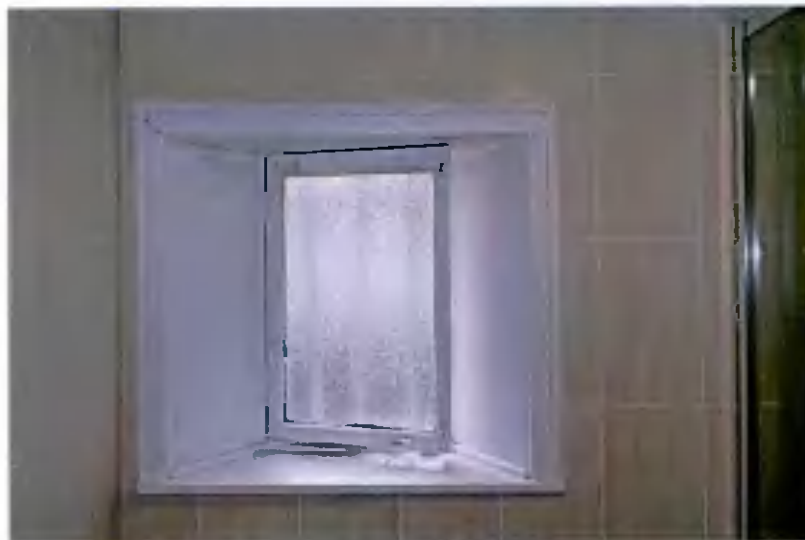
The bathroom is lit by a small timber casement window with obscured glass and set in a splayed opening. The window is protected by iron bars externally.

Plate 29: Bathroom window

The present window on the eastern side of the half landing below the ground floor is to be enlarged to form a doorway. This will necessitate an alteration to the doorway to the bathroom to create sufficient space for the opening of the new door. The bathroom door and part of the adjoining stud wall are to be removed and relocated slightly further back into the bathroom.

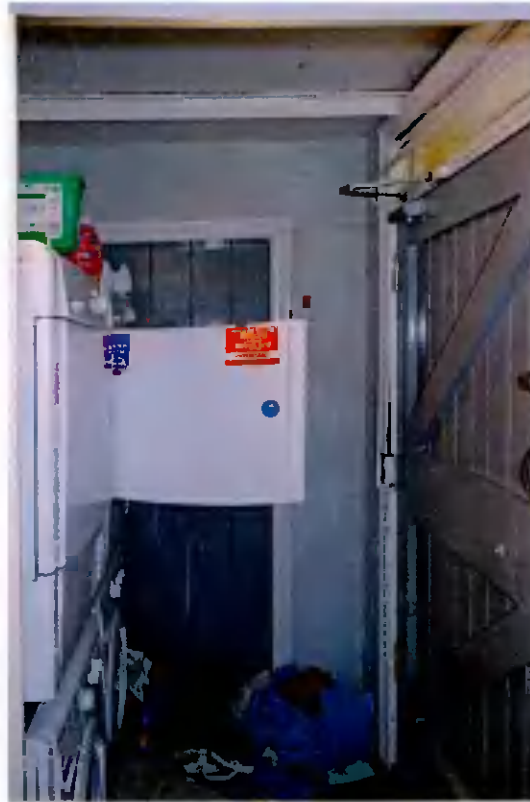
Leading off the mezzanine level at the rear of the house a modern hollow door gives access to a small room that doubles as a utility room and an access to the rear yard.

The ceiling in this room is of mass concrete supported on steel beams. A framed, braced and sheeted door leads to the yard and another timber-sheeted door at the rear leads to a WC.

Plate 30: Utility room

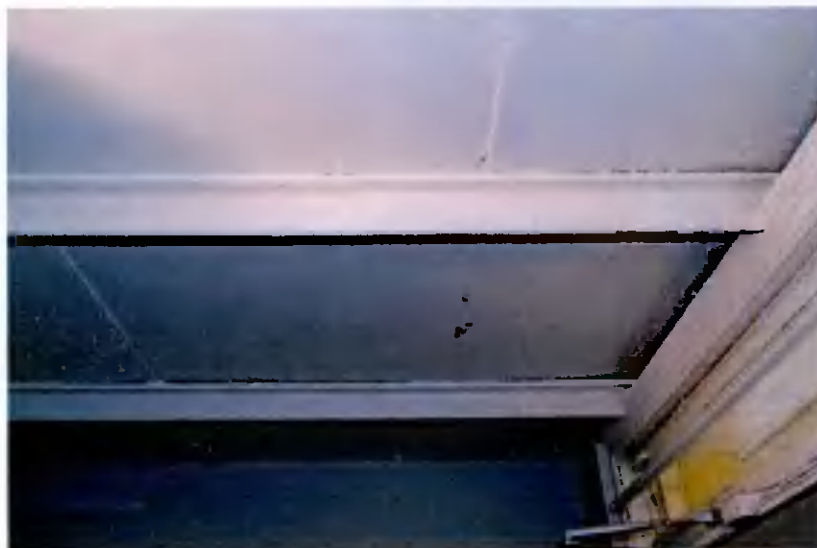
Plate 31: Ceiling in utility room

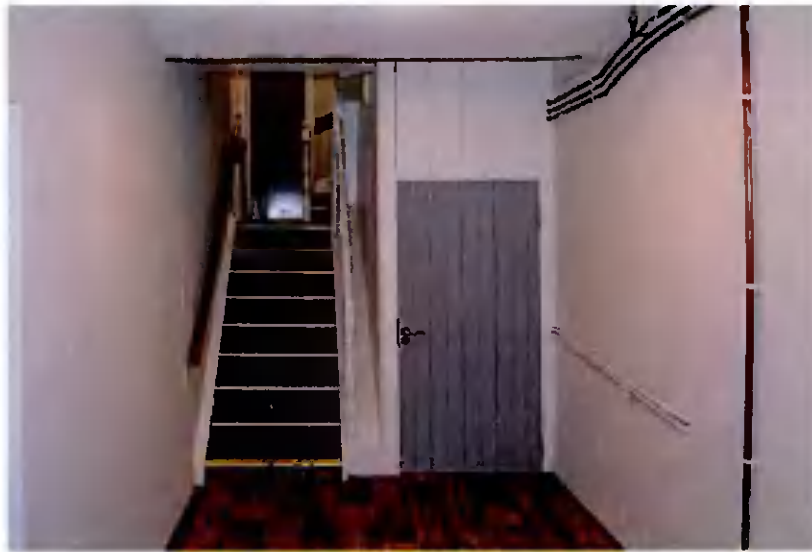
Plate 34: View to south in basement hallway

At the foot of the stairs to the basement is a hallway that corresponds to the extent of the entrance hall above. A small cupboard beneath the stairs is accessed via a timber-sheeted door. Three other doorways lead off the hallway, each with a timber door frame and no architrave. The doors are all modern hollow doors. The ceiling is plain and crossed by services, as are the walls. The floor has a covering of vinyl.

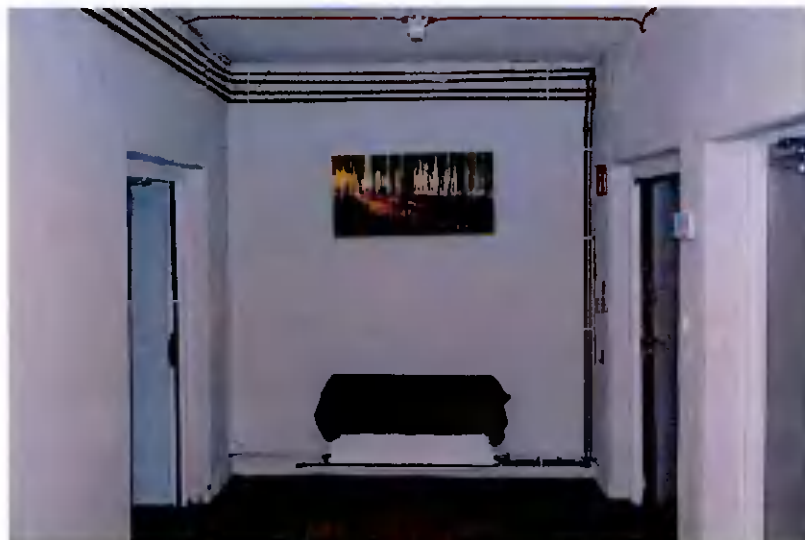
Plate 35: View to north in basement hallway

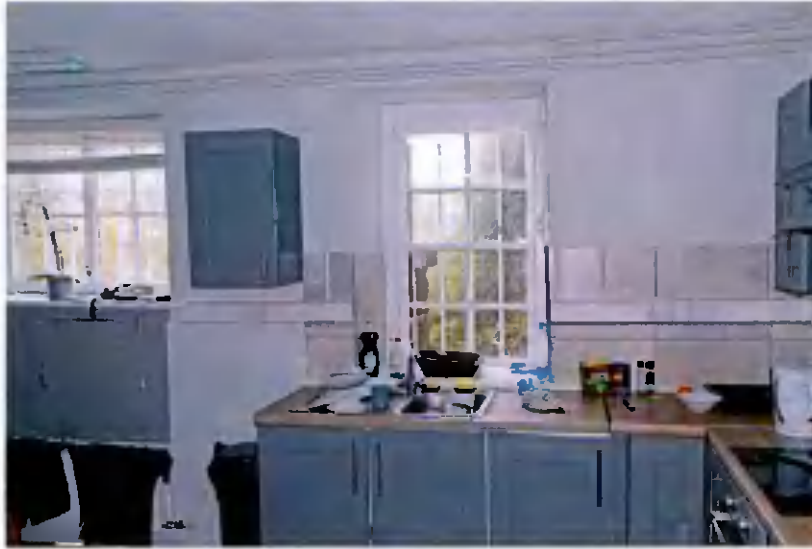
Plate 36: View to the west in kitchen

The kitchen in the basement appears to be located in the room that was originally designed for that purpose. A large recess in the eastern wall probably housed a kitchen range. The room is now fitted out with modern kitchen equipment and has a vinyl floor. The door is a hollow modern door, and another similar door leads to the room in the rear return. The kitchen is lit by two windows in the western wall. The northern of the two, seen in the centre of the photograph above, is a four-over-four timber sliding sash with curled horns and no architrave or shutters. The southern window is a horizontal timber casement with two four-paned sashes and is set in a wide splay with no shutters or architrave. Both windows are protected by iron bars externally.

None of the kitchen fittings are of built heritage significance and their removal will not affect the character of the protected structure.

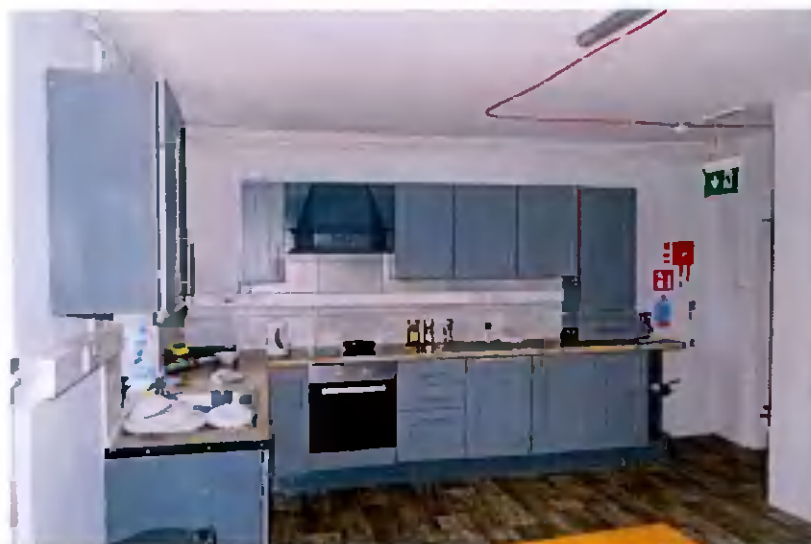
Plate 37: View to the north in kitchen

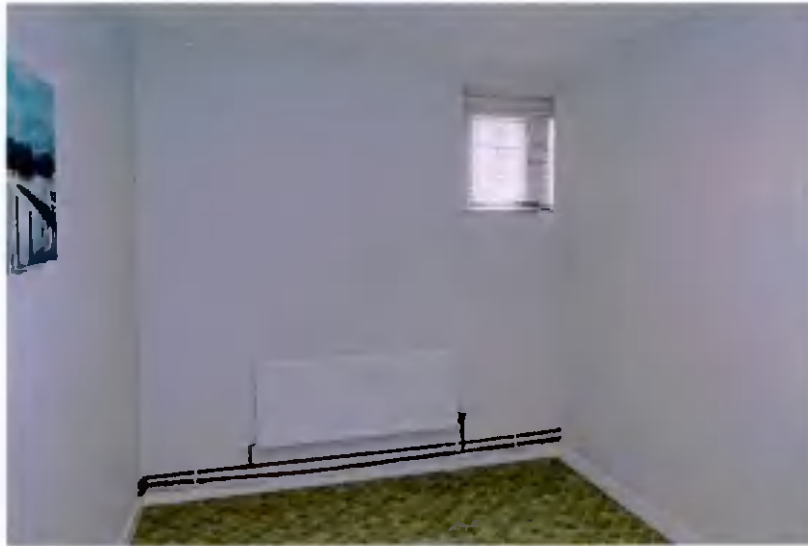
Plate 38: Room on eastern side of basement

On the eastern side of the basement there are two rooms that appear to have been a single room now divided by a partition. The rooms are lit by a single window that consists of two side-hung casements divided by a mullion. The partition runs up to the outer wall and leaves a gap at the window to permit it to light both rooms. At the western end of the room is a chimneybreast, though the hearth has been stopped up and there is no chimneypiece. The floor has a vinyl covering. No access was available to the south-eastern room during the survey. It is accessed only through the first room, via a modern hollow door with a simple architrave.

At basement level a room on the eastern side of the house has been divided into two rooms, with the partition bisecting the window so as to light both rooms.

It is proposed to remove the partition that divides the two rooms on the eastern side of the basement. The window is to be blocked up, leaving the window opening as a niche as a reminder that there was a window here and to facilitate reversal by opening up the window in the future.

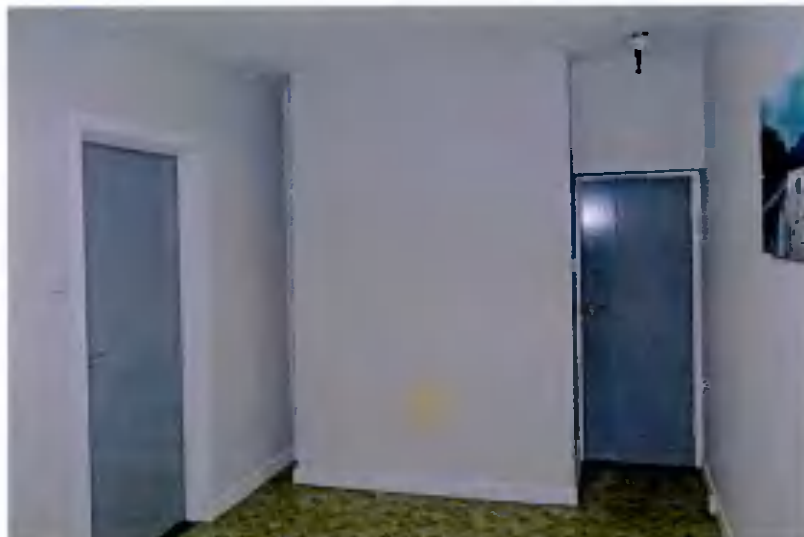
Plate 39: View to west in room on eastern side of basement

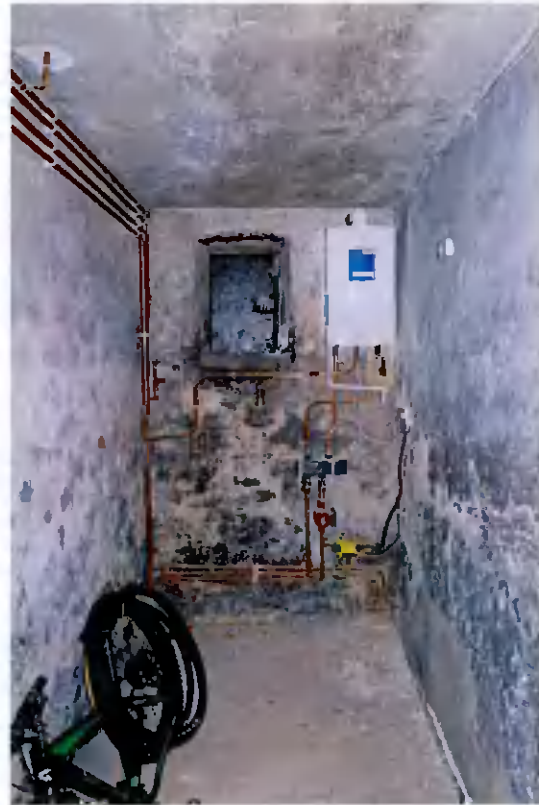
To the east of the hallway, at the front of the building, is a narrow room in use as a boiler house and store. It appears that this may have been a coal store originally, as it has a cast-iron door at the eastern end, providing access to the exterior at the side of the house, probably for tipping coal. There are no windows in this room. The door is a traditional timber-sheeted door, faced with painted hardboard on the side seen from the hallway. The walls in this room are faced with lime-based plaster. The floor is of concrete.

Plate 40: View to east in boiler room

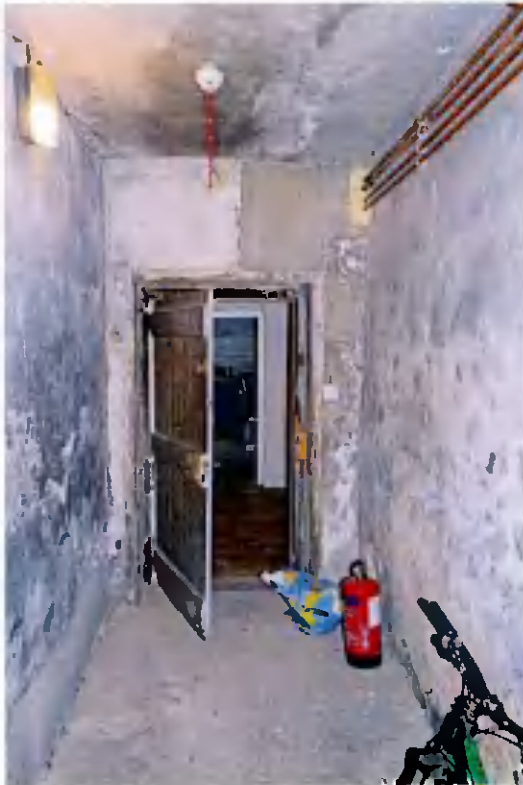
Plate 41: View to west in boiler room
