CONSERVATION REPORT

ARCHITECTURAL ASSESSMENT

Proposed Change of Use and Associated Works

**Presentation Convent ,
Clondalkin, Dublin 22.**

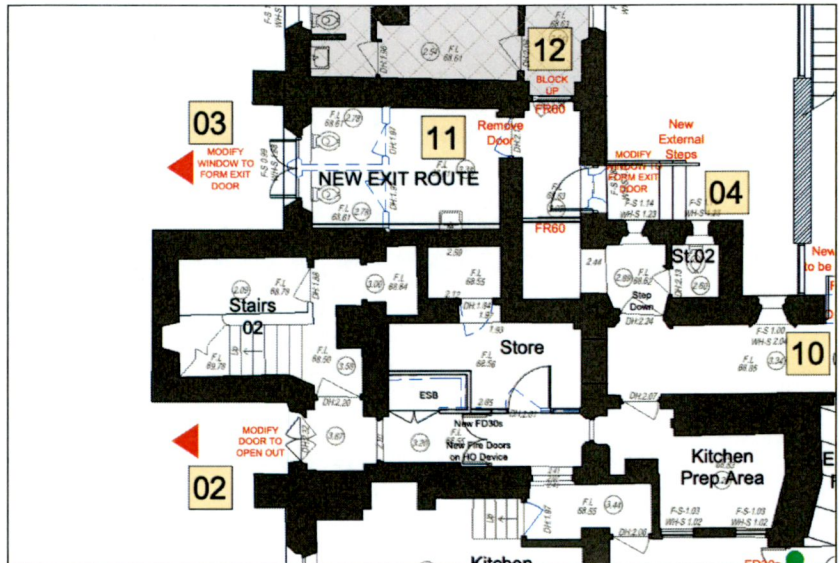
Fig 9 : Existing window indicated at left and proposed new door to open into courtyard at GW 22 (beside '04' on plan at Fig) – new sheeetd timber door and glazed fanlight with dressed stone surround to be retained and modified to form new door opening. New stone steps also to the courtyard.

It is also proposed to form a new access doorway (see Fig.)to the courtyard by adjusting an existing window opening at GW.22 and new stone steps are to be added from this door to the courtyard.

The impact of the proposed new doorway to the courtyard should be minor in that the existing dressed stone will be re-used and modified to create a new doorway. The joinery uses existing sheeted typologies found within the building.

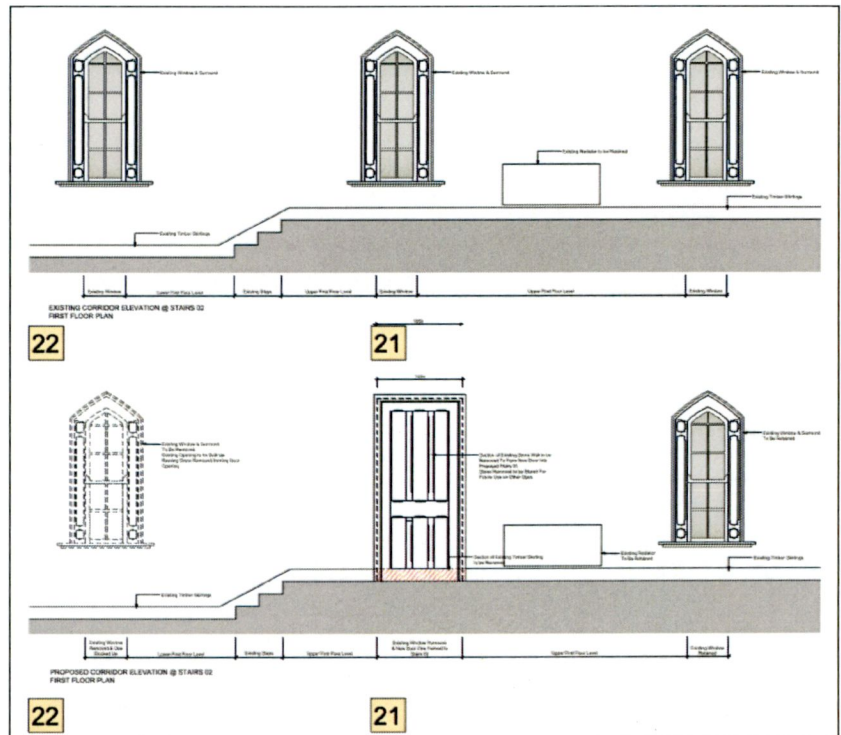
Fig 11: View above of existing window pattern within first floor corridor running at courtyard side alongside Rooms F-14, F-15 and F-19 at the southern range.

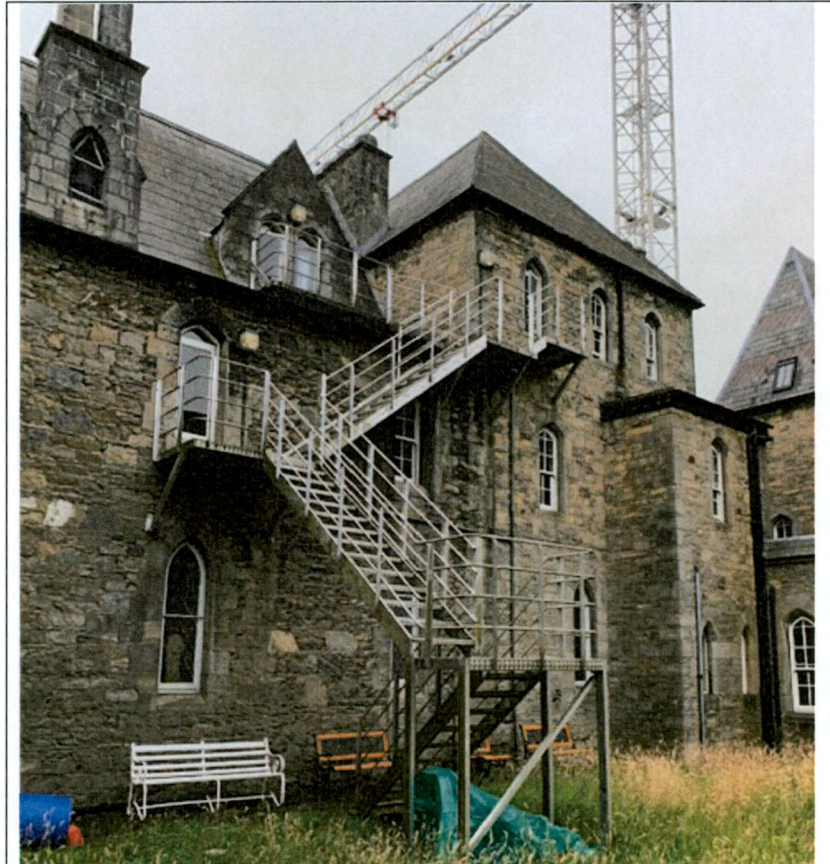
Fig 17: The existing external staircase is to be removed and the new stair tower 02 located on the footprint of the existing metal staircase.

- 5.6.4 Staircase / lift tower 02: This tower is larger than Staircase 1 as it must accommodate both a staircase and replace the existing lift tower located in the southern end of the courtyard adjoining the southern range of the convent structure. It will replace an existing external metal staircase which is no longer safe or compliant with escape requirements.

5.6.5 Impacts: the proposed new Staircase 2 is larger in scale than stair 1 as it must accommodate a lift tower. This element is clearly expressed and the narrative of materials delineates the separate functions of stair and lift. The junction with the existing masonry is separated and managed by the use of a glazed vertical band which allows a lighter junction and allows the stone surface of the original walls to be clearly read. This addition, alongside the introduction of Staircase 01 is clearly a change in scale and form within the internal courtyard. However, in order for the building to be safe and compliant, new access structures for escape and vertical connection are required.

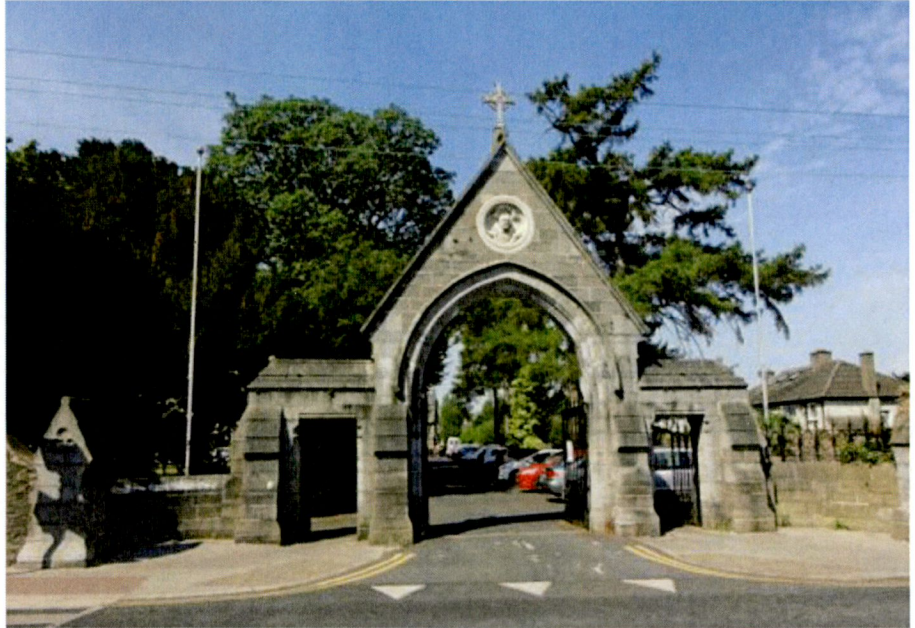
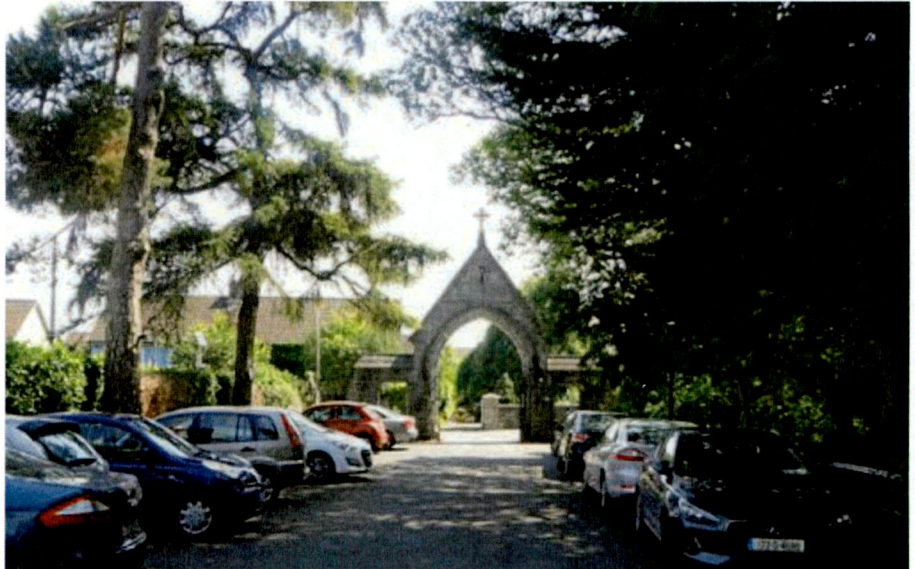
View above and below of the tripartite entrance archway from Convent Road and internally. Although constructed (c. 1892) after the main complex was in place the style and materials are consistent with the original design.

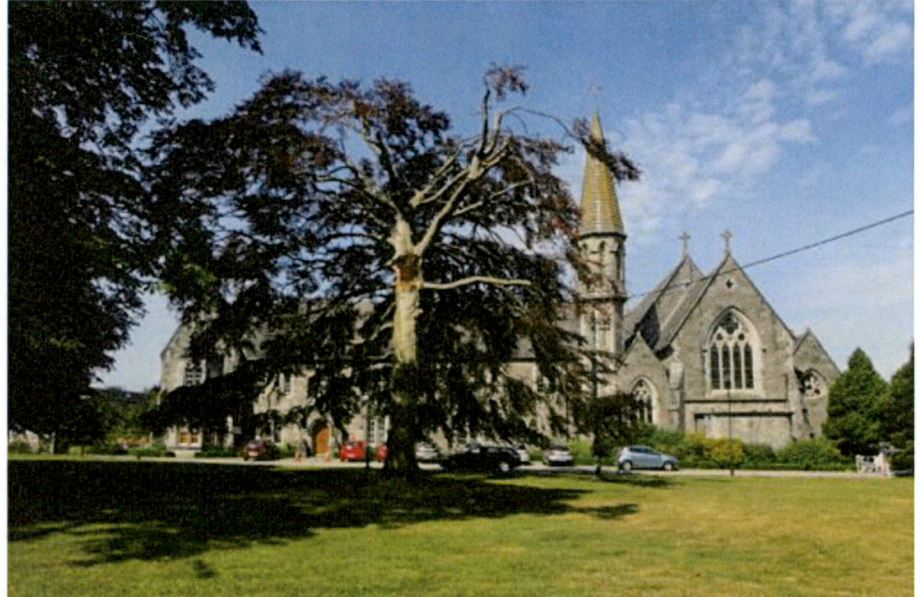
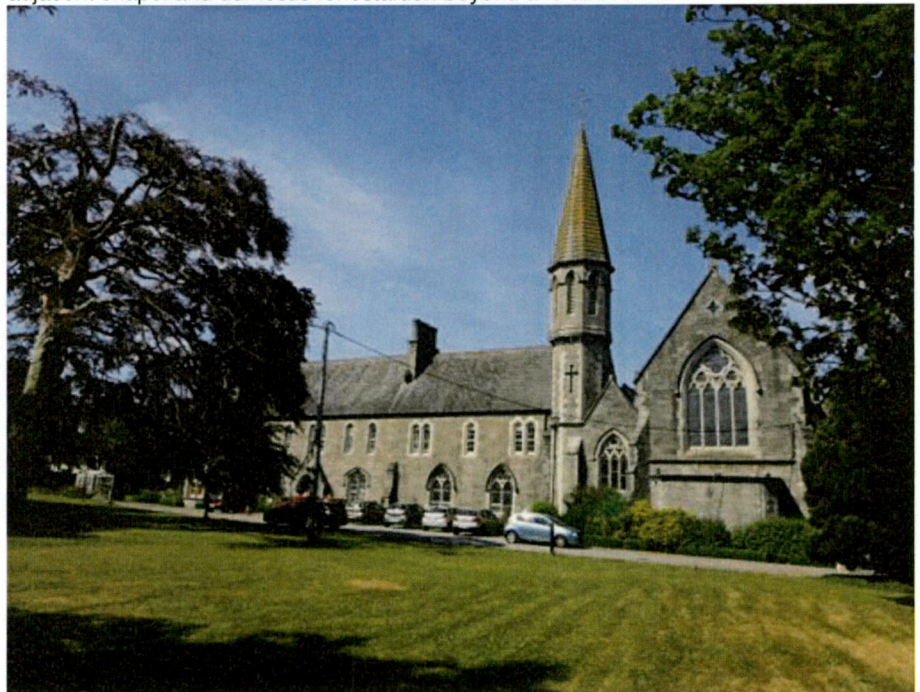
Views (E1 & E2 - above and below) from the eastern landscaped lawns showing the west window of the main parish church and bell tower acting as a pivot and connection point to the two-storey residential convent with elaborate tracery windows to the adjacent chapel and domestic fenestration beyond and above.

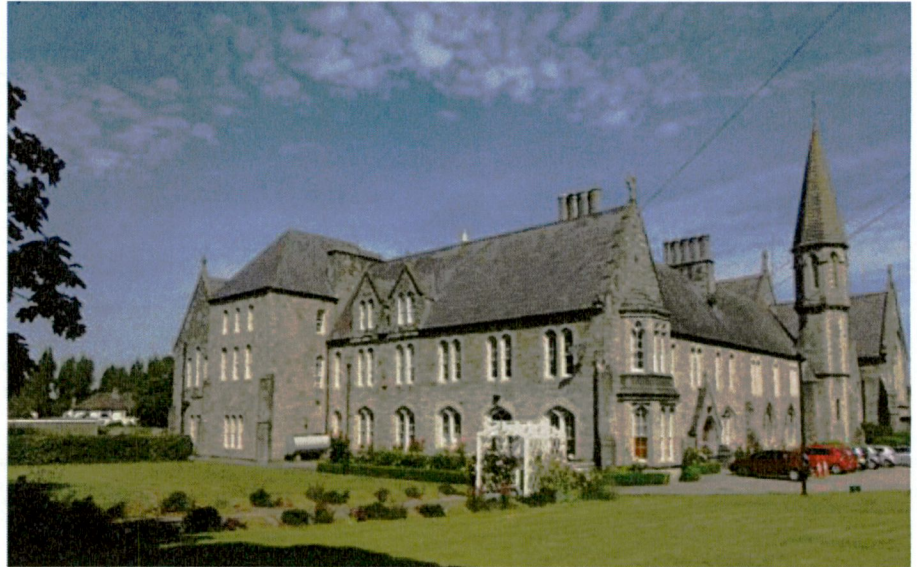
General view from south-east **E3** showing the east facing wing and its conjunction with the south facing wing (composed of two and three storey elements).

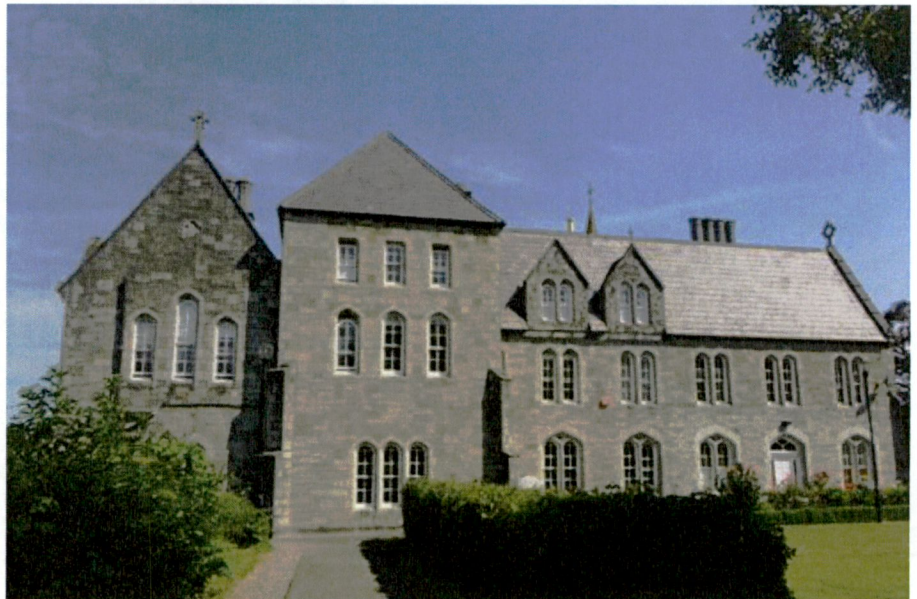
Elevation / view of the south-facing wing **E4** : the more utilitarian nature of the three-storey wing is expressed externally with simpler windows and a greater proportion of masonry. The raised wall dormers with paired windows break up the mass of an otherwise large area of plain slate roof.

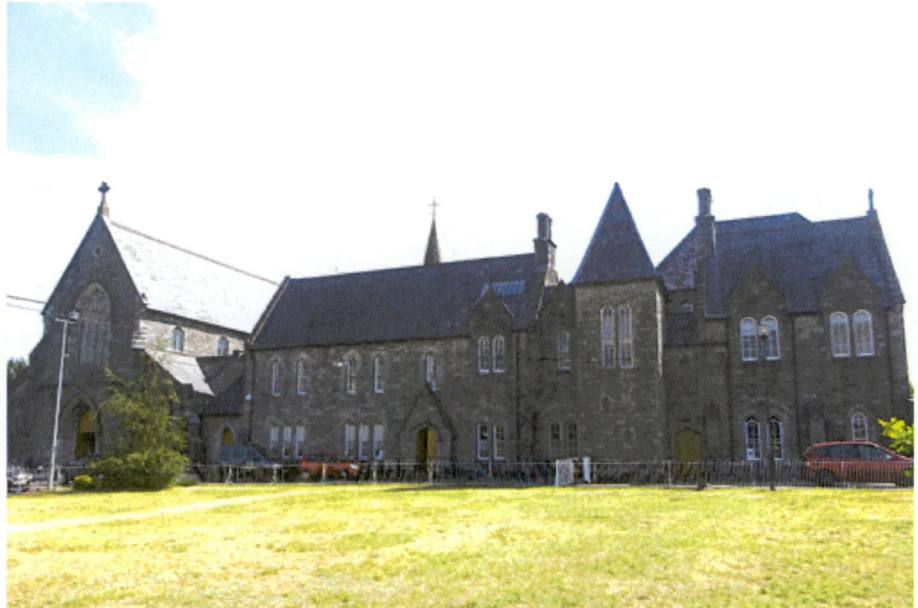
Views (E5 above and E6 below) from the plainer landscape setting on the eastern side of the complex showing the western wing with stair tower and articulation of the junction between the residential section and more public parish meeting rooms.

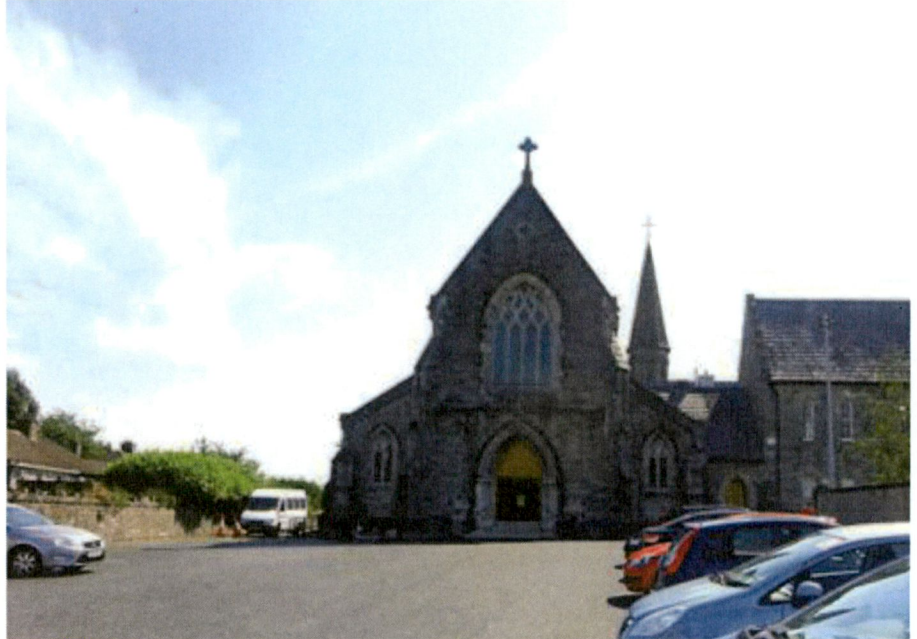
View **E7** of the principle entrance elevation (east facing) of the main parish church and side elevation with side porch of the main parish church **E8**

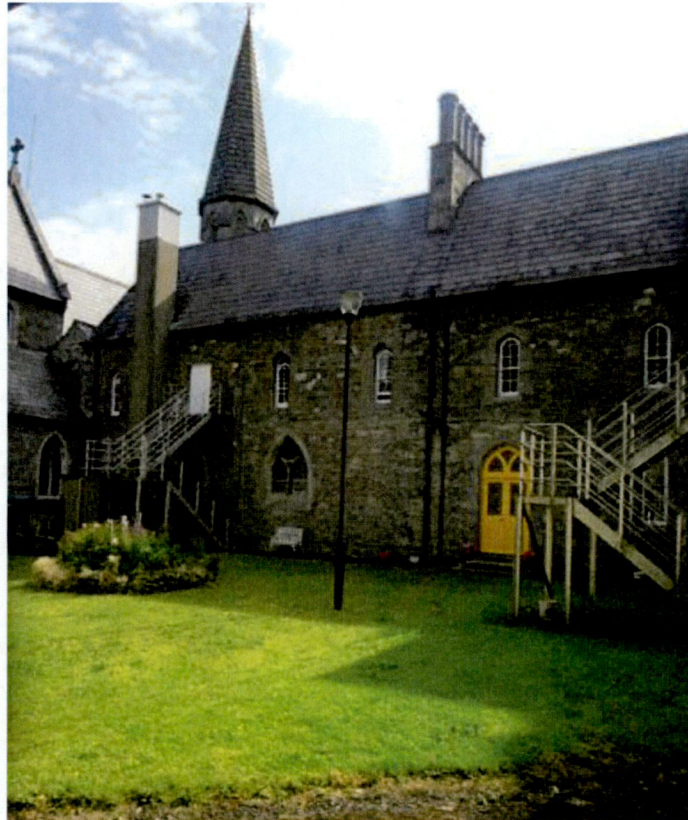
View across the internal courtyard (E9) showing the modern chimney stack and plainer treatment architecturally to the less public internal courtyard facades

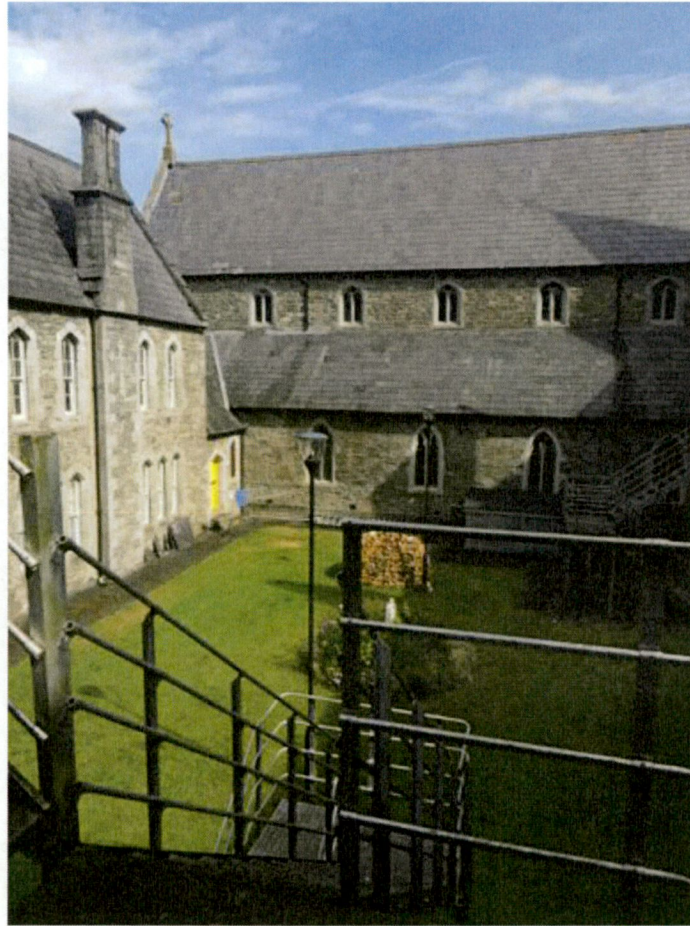
View from fire escape towards north eastern corner of internal courtyard (E10) and view E11 below of internal courtyard façade of western wing.

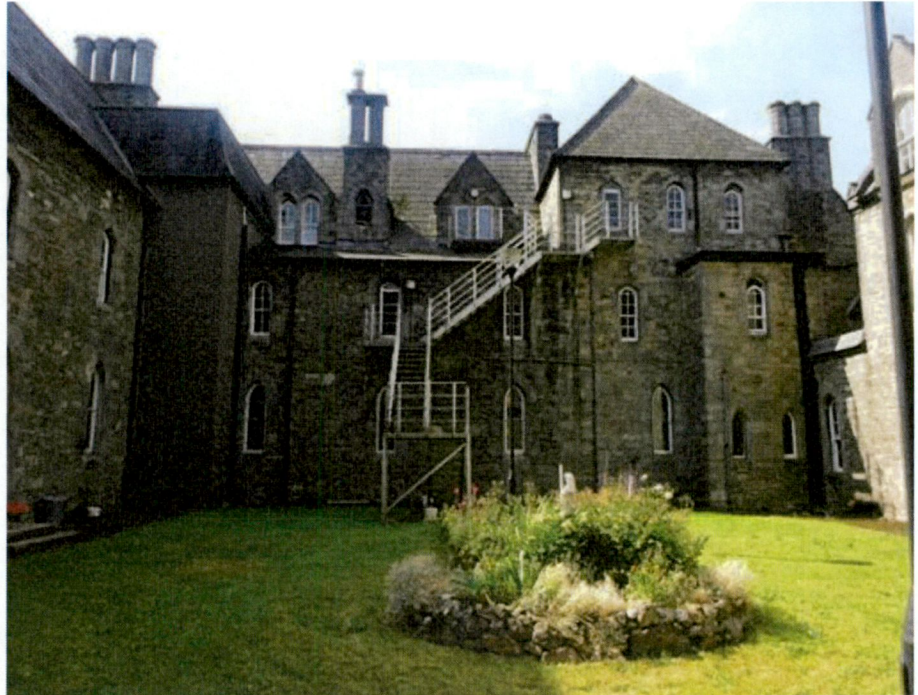
View above (E13) of the three-storey element of the southern wing alongside two-storey wings with attic accommodation.

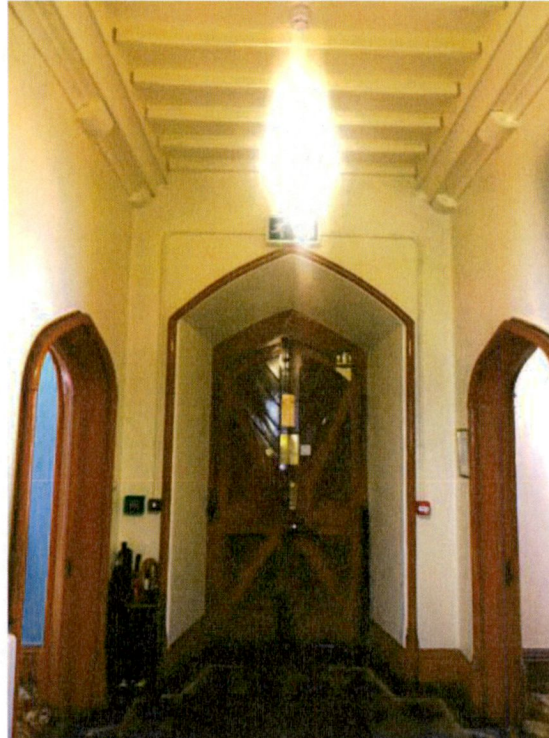
View above G1 and below of entrance hallway from hallway towards arched entry door set in a deep recess with bracketed cornice supporting exposed joisted ceiling and view below G2 of original pierced fanlight screen and paired lancet doors.

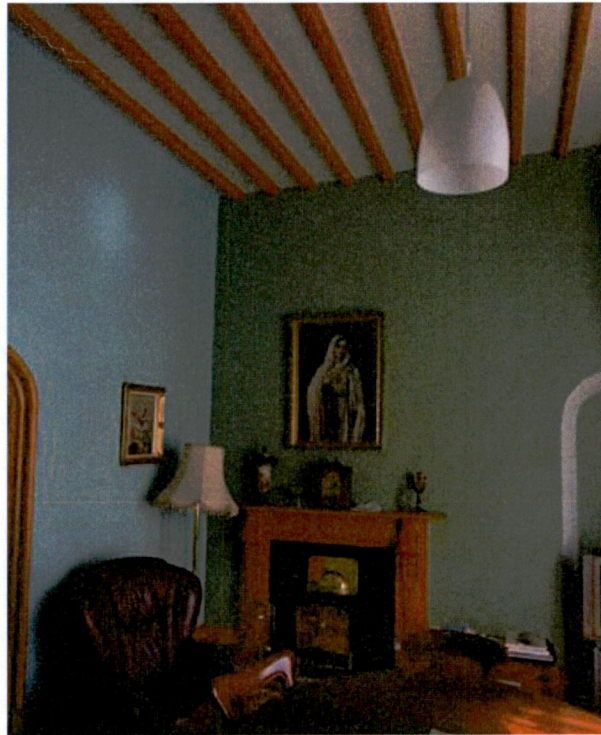
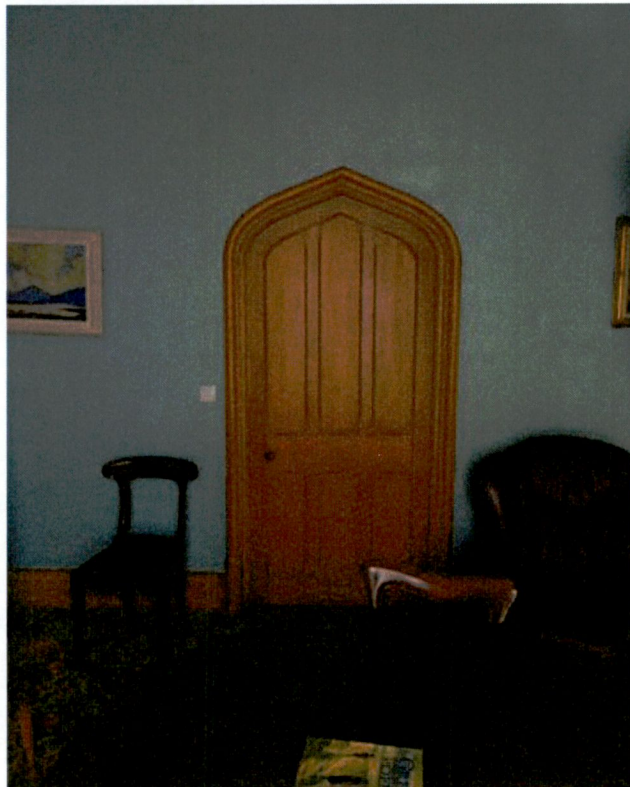
View G3 in reception room of original simple bracketed stone chimneypiece finished to resemble wood with view of G4 original tripartite panelled and arched door-case (Tudor arch form) leading to corridor

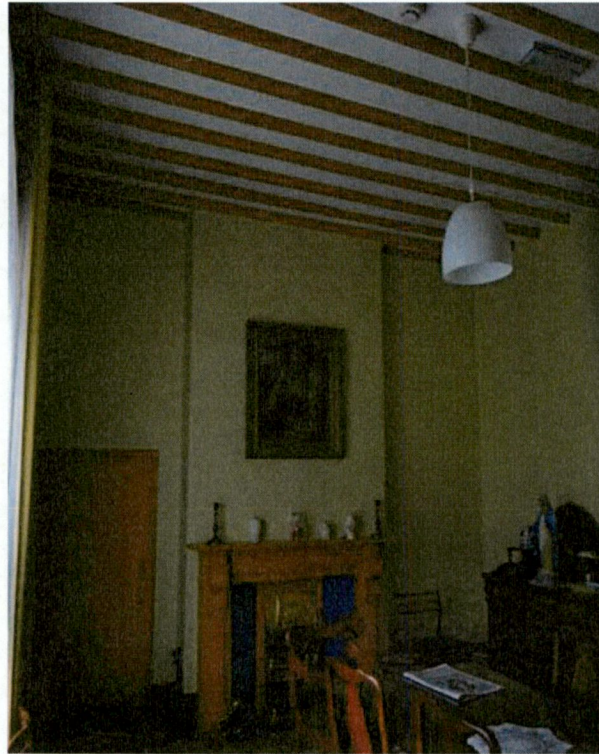
View **G5** above of the second reception or parlour off the entrance hallway with exposed joists and matching chimneypiece. View below **G6** of the original window casing with panelled shutters exhibiting chamfer detail and original sliding sash windows.

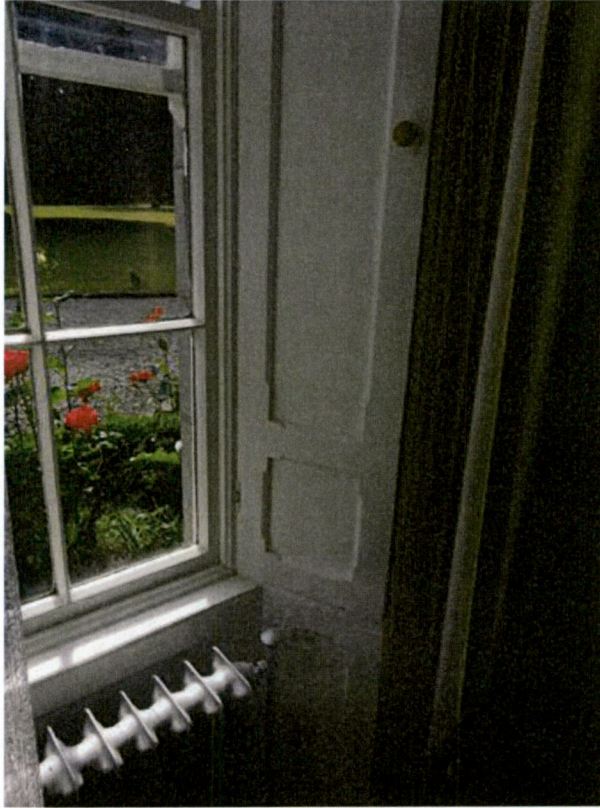
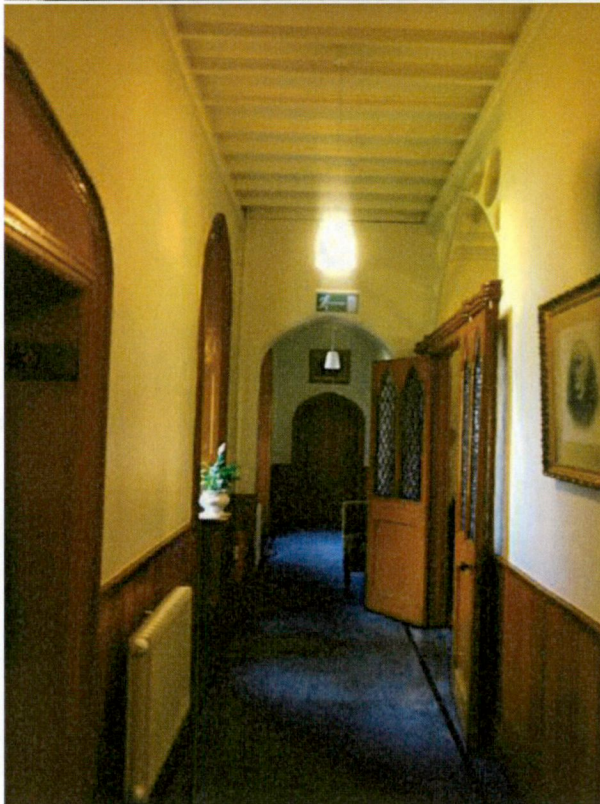
Views above G7 and below G8 of transverse corridor lining alongside courtyard walls and leading from entrance hall to principle rooms. Door at end of corridor above leads to chapel.

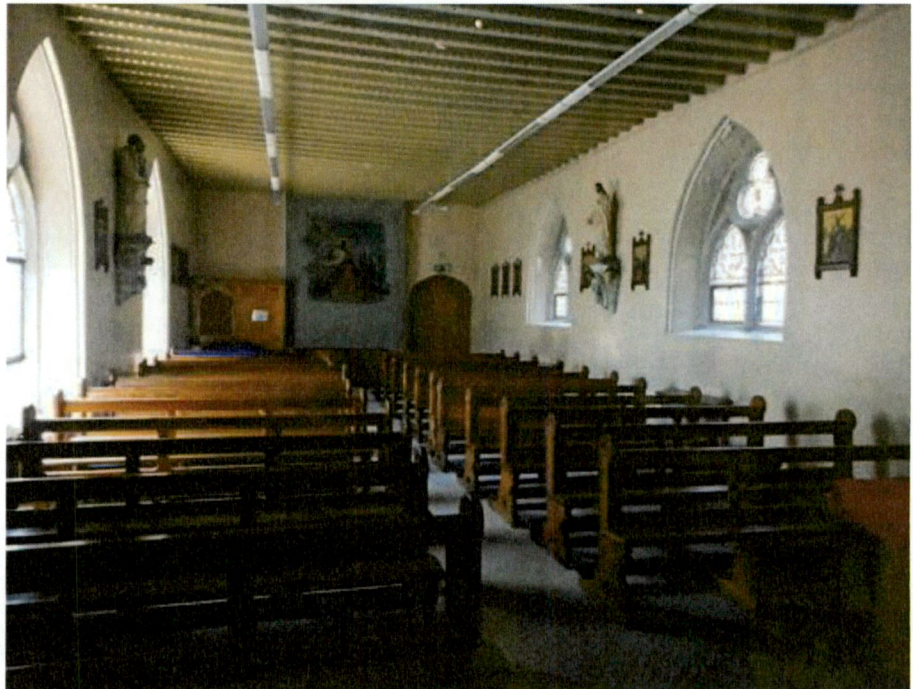
Views above G10 and below G11 of the oratory chapel connected directly to the Parish Church which spans the entire plan with gothic revival stone mullioned windows to either wall, the higher cills affording greater privacy on the side facing the more private and utilitarian courtyard. Exposed joists are stained and decorated with gold squares.

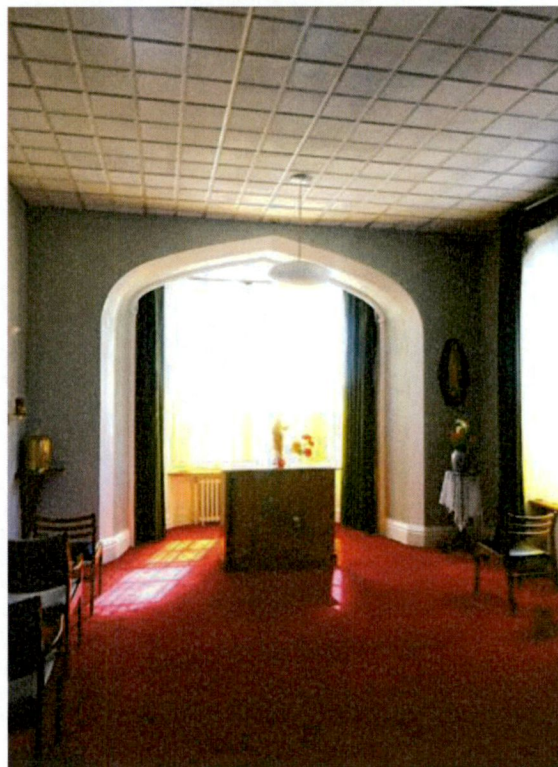
View above **G12** of the former living room located at the junction of the eastern and southern wings with modern dropped ceiling and presently used as a private chapel. The room retains good window joinery, likely cornice-work above dropped ceiling and an original chimneypiece.

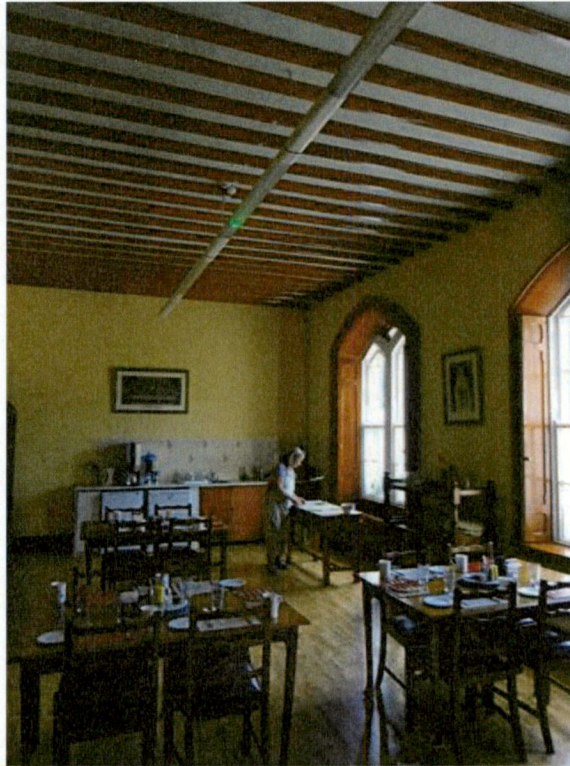
The dining room **G13** is still used for this purpose and retains good original windows and casing, exposed joisted ceiling and an original chimneypiece. View below **G14** of the original paired neo-gothic window and casings in the dining room.

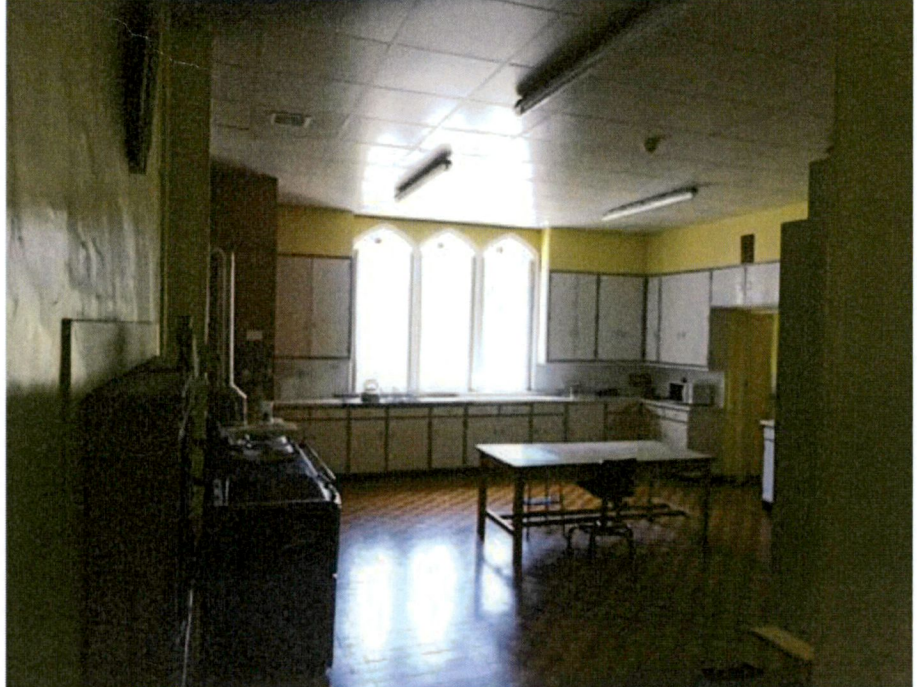
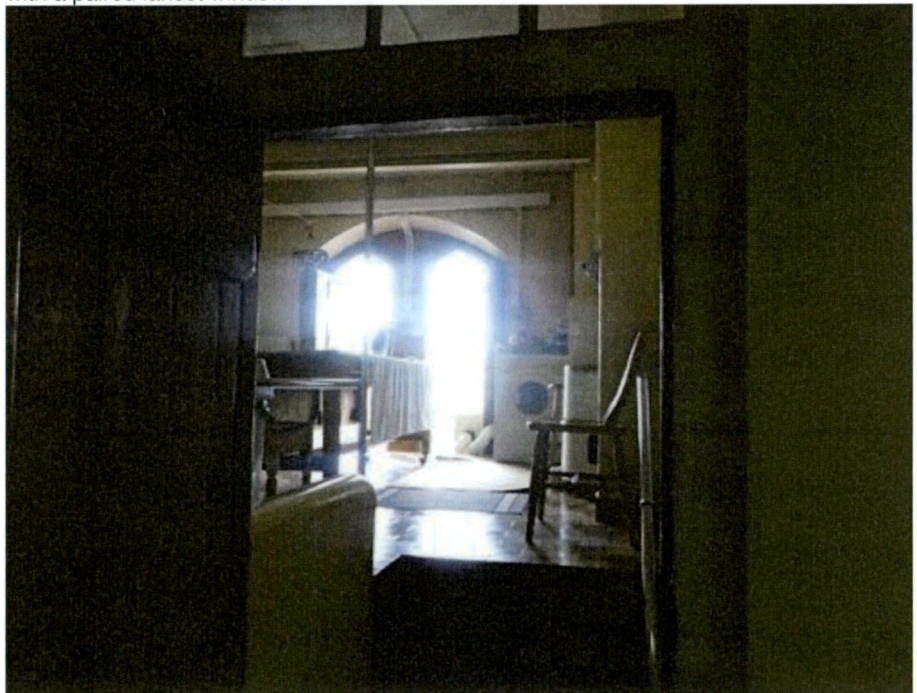
View above G15 of the present kitchen where the ceiling has been dropped but the overall aesthetic and detail is understated and functional with a tripartite window as the principle feature. The laundry (below – G16) is similarly utilitarian in design and finish with a paired lancet window.

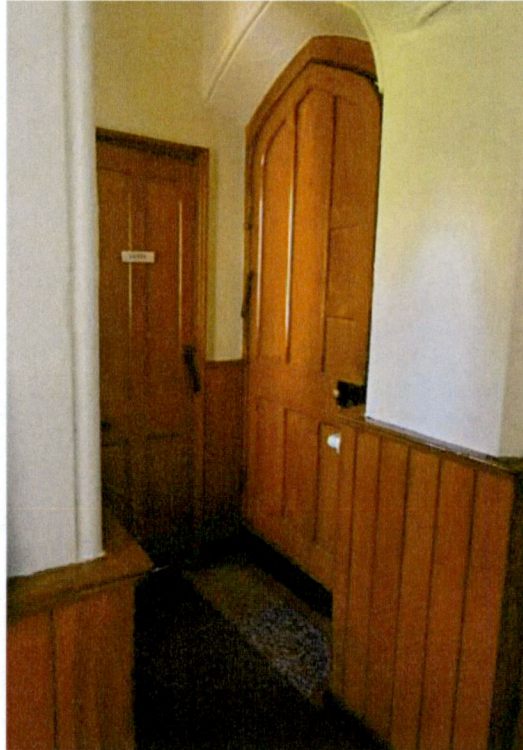
Corridor joinery (above G17) at the junction of the south and east wings is extant, of stained timber and rich and well executed. View (below G18) of the staircase (Stair 01) between the present private chapel and dining room in the south wing with distinctive attenuated finial.

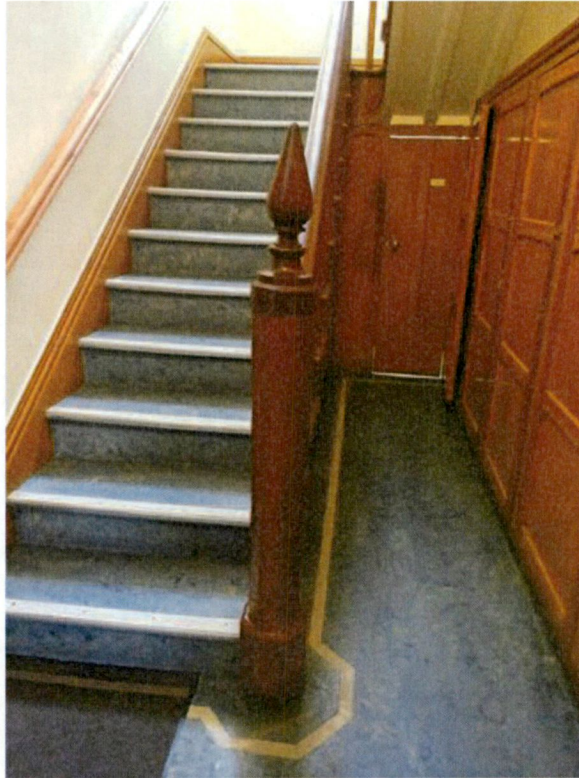
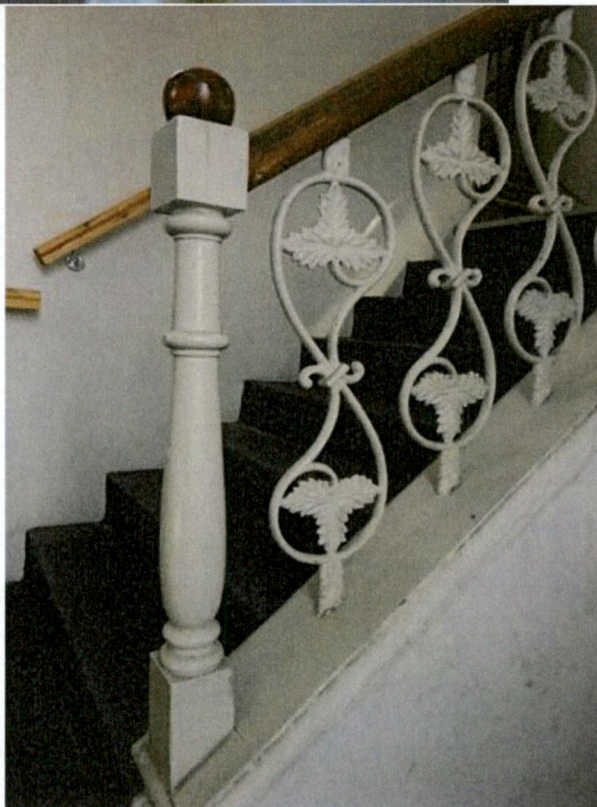
The newel and balustrade to Staircase 02 (above G19) is different from all others within the building, being harder and more robust in design and material with granite treads, and wrought iron balustrade redolent of its more public use on the west side of the complex. It rises G20 below within the projecting stair tower on the west facing façade which acts as a pivot or node point between the more public parish functions and the private residential areas.

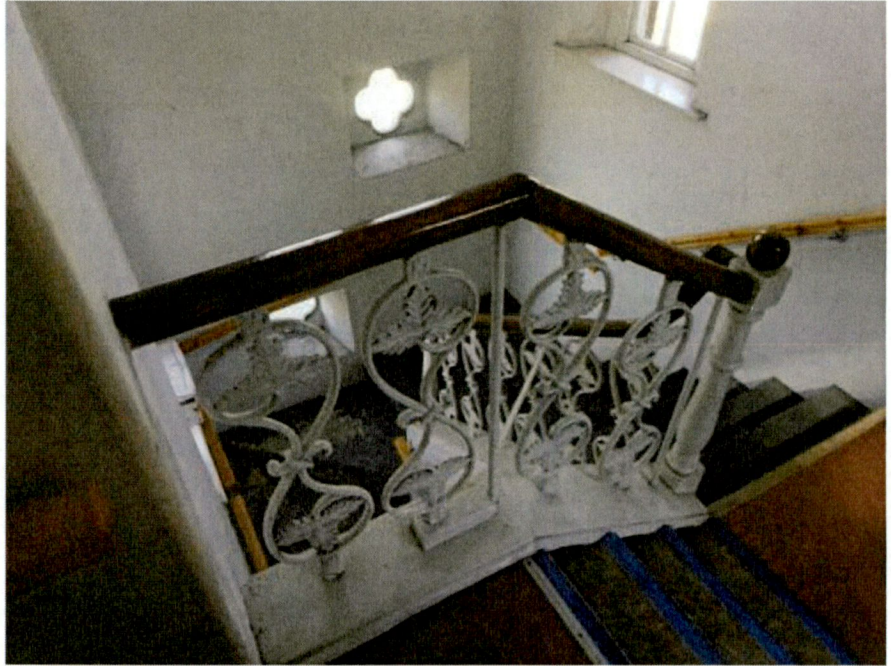
Staircase (03) at G21 within the west wing is more private in function, providing access for parish activities from ground to first floor and the joinery reflects this being more understated than either the robust wrought ironwork of 02 or the more refined joinery within the main convent residential wing at Staircase 01. The parish meeting room G22, now subdivided by later partitions is plain and functional in detail with exposed ceiling joists and finishes but retains original joinery and windows to both sides.

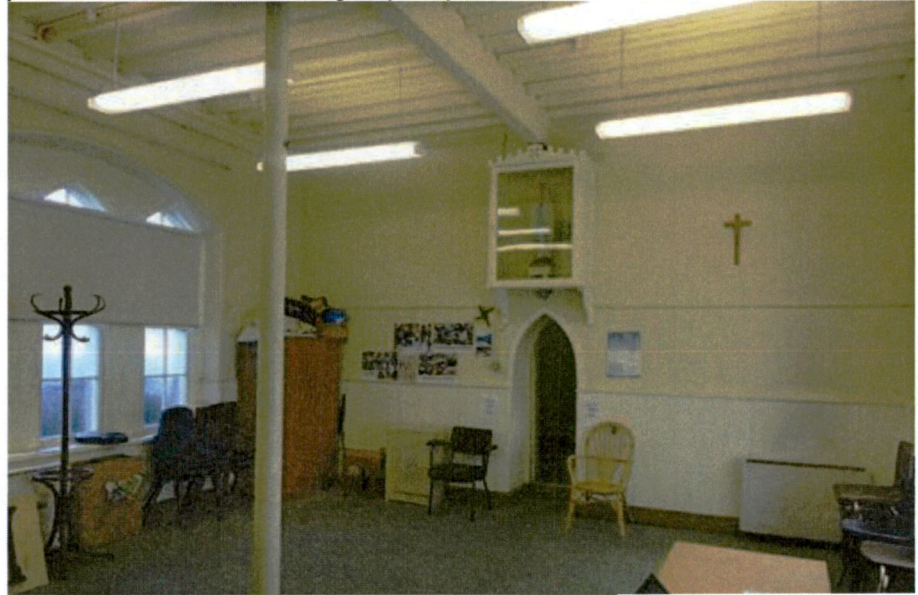
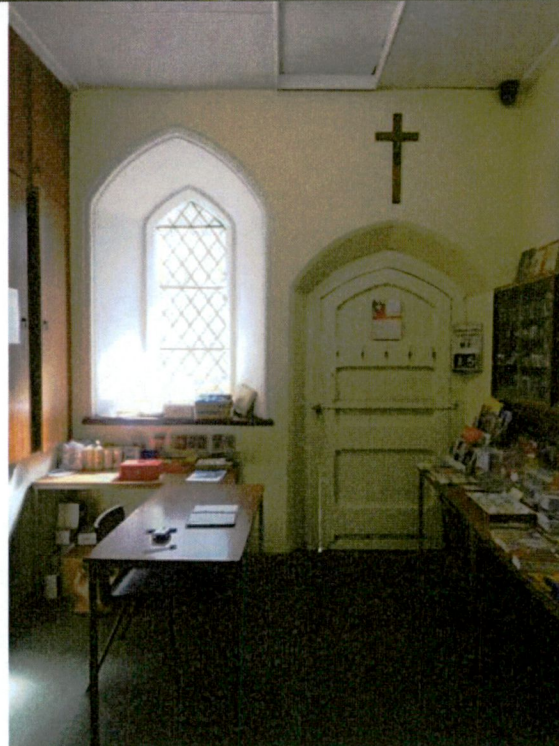
View above G23 and below G24 in single storey parish meeting room which directly adjoins the main body of the church. The dropped ceiling likely conceals exposed joist ceiling and the room retains original door / window joinery and a large gothic arched stone dressed door-case leading to the main body of the church.

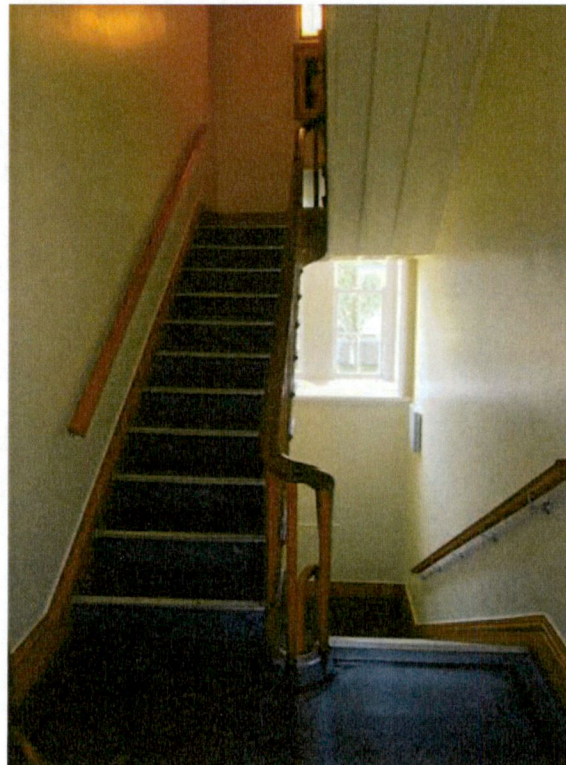
F1 Staircase 01 leads from the ground upwards with the quality of joinery maintained. The view (below **F2**) looks along the access corridor running along the inner side of the southern wing with expressed pitched roof rafters and original window casings.

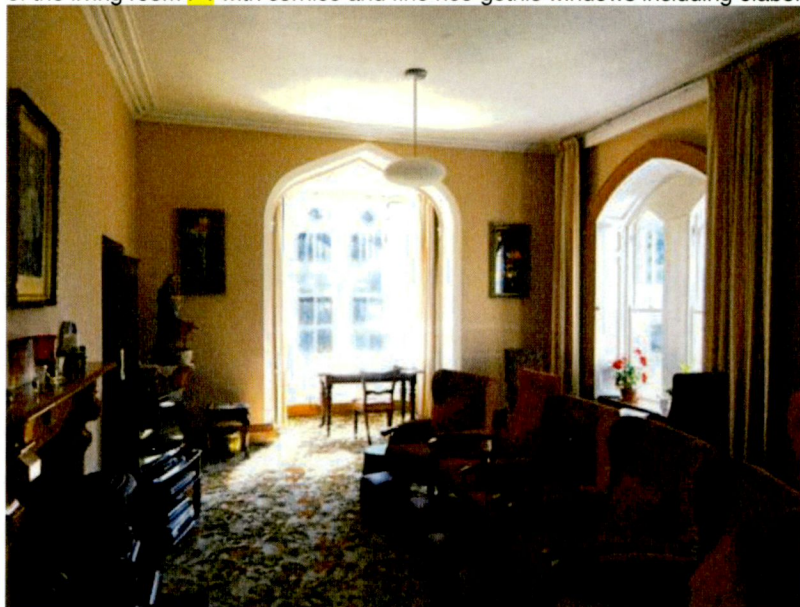
Window F3 (above) with original stained glass to corridor in eastern wing; view (below) of the living room F4 with cornice and fine neo-gothic windows including elaborate bay.

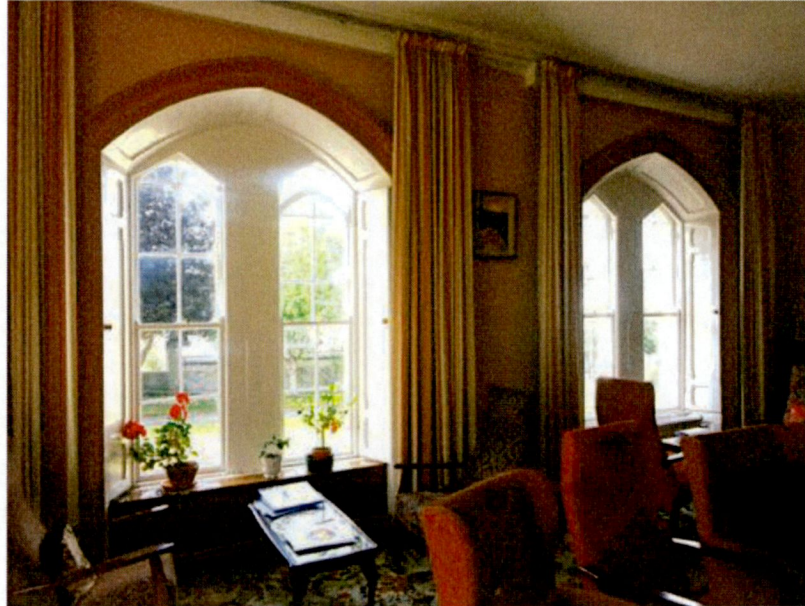
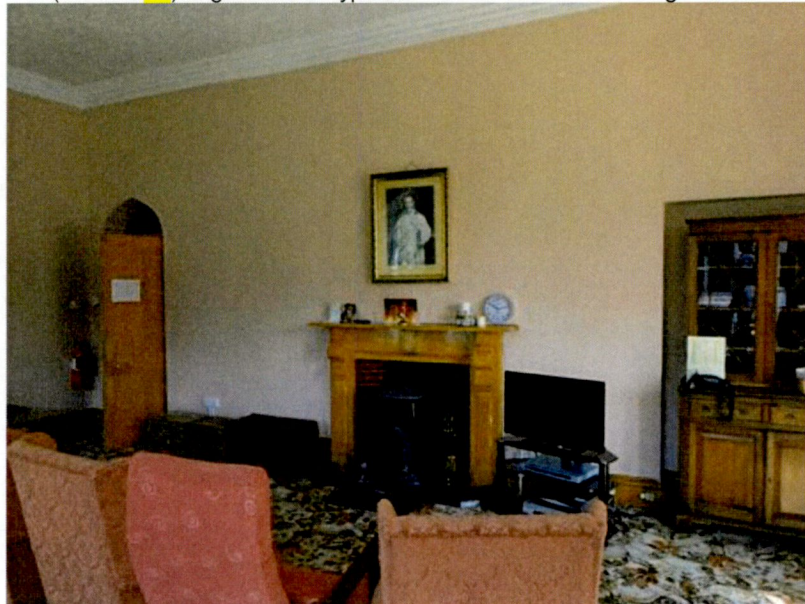
View (above F5) of aired neo-gothic windows within living room and original shutters and (below – F6) original chimneypiece to match others and straight run cornice.

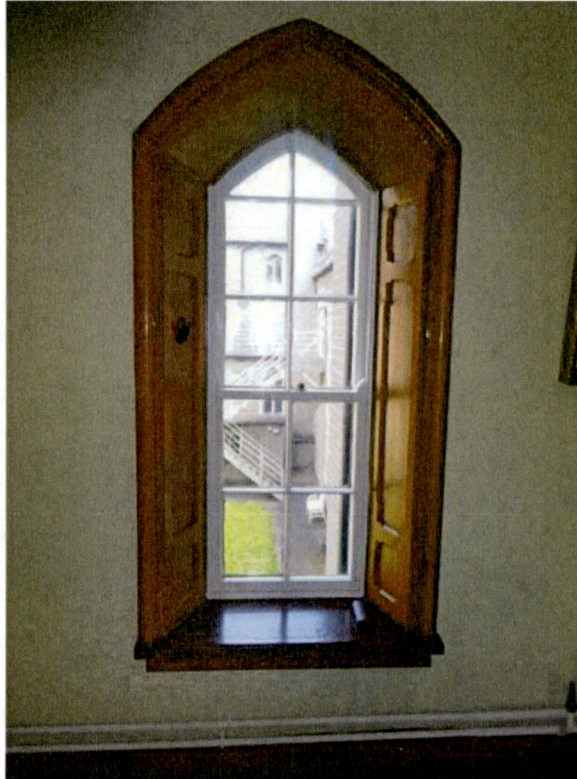
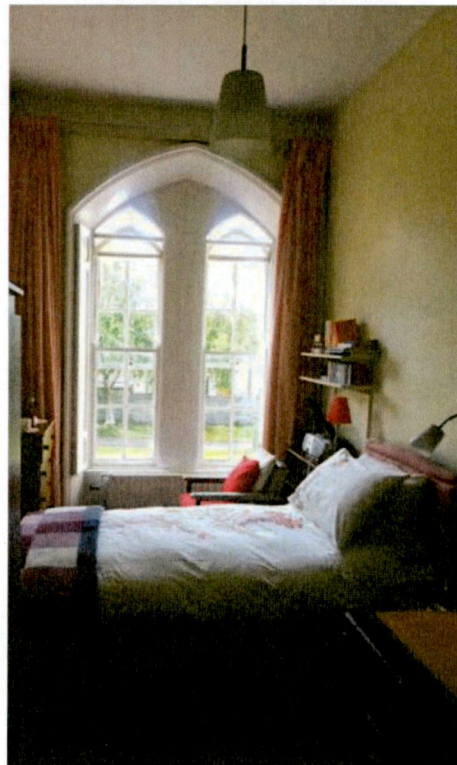
View (above F8) into courtyard with original sliding sash and stained wood window casings in inner corridor within southern wing; View below (F7) within corner bedroom at junction of southern and western wing.

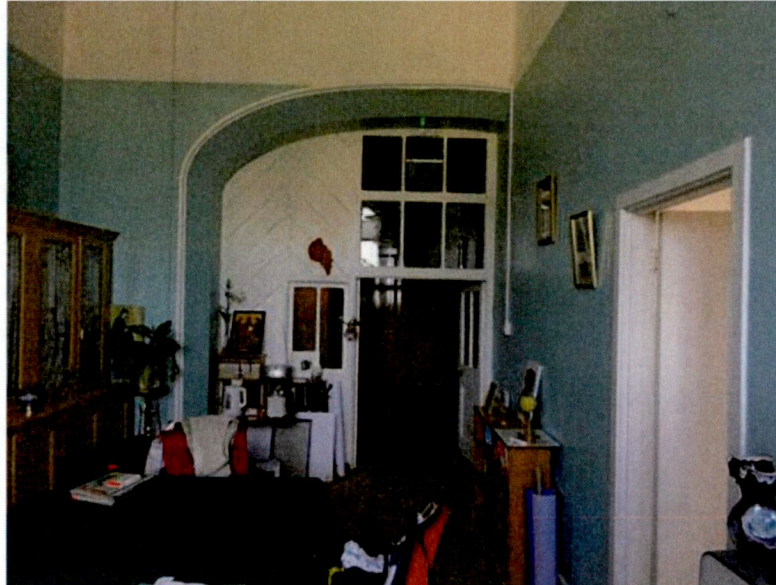
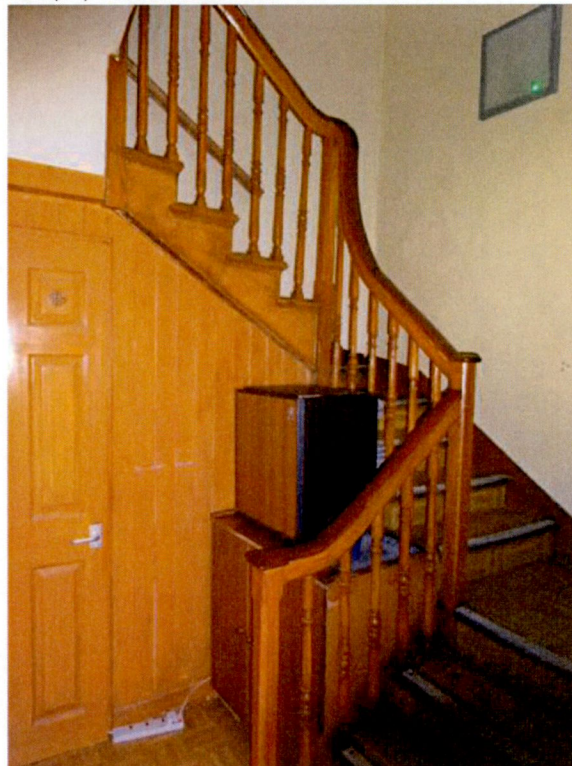
View (above F8) of large arched opening between three storey and two storey sections of southern wing with later partitions cutting across archway. View (below F9) of secondary staircase (04) which allows access to second floor.
