CONSERVATION REPORT

ARCHITECTURAL ASSESSMENT

Proposed Change of Use and Associated Works

**Presentation Convent ,
Clondalkin, Dublin 22.**

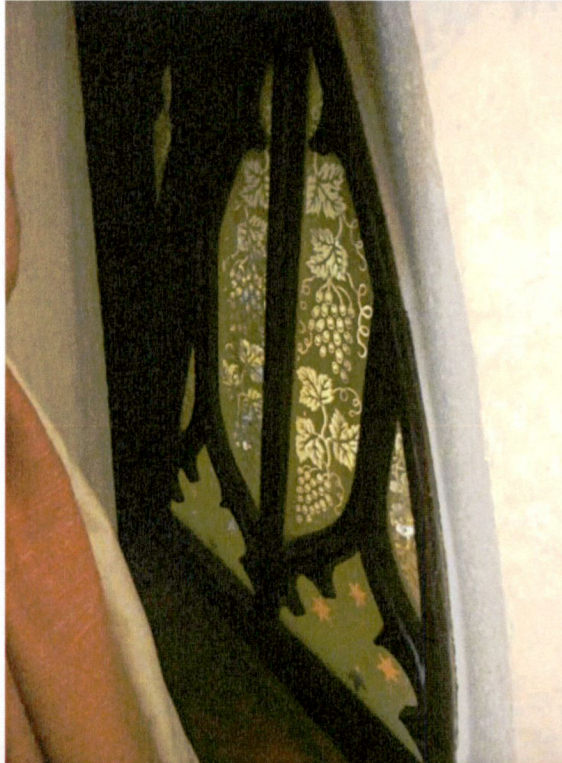
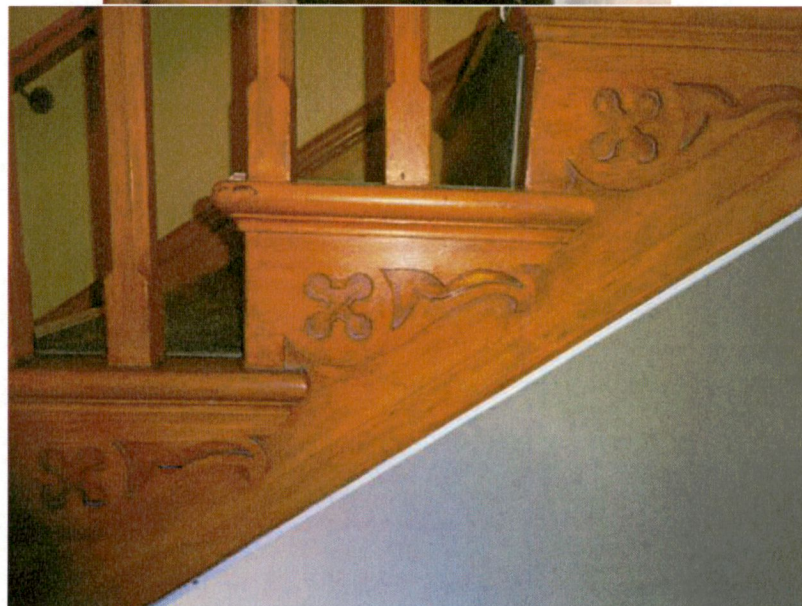
Detail (above **F14**) of decorated stair-end at staircase 03 within western wing and view (below **F15**) to double door to upper parish meeting room with stained glass sidelights in a manner combining Regency influences with neo-gothic forms.

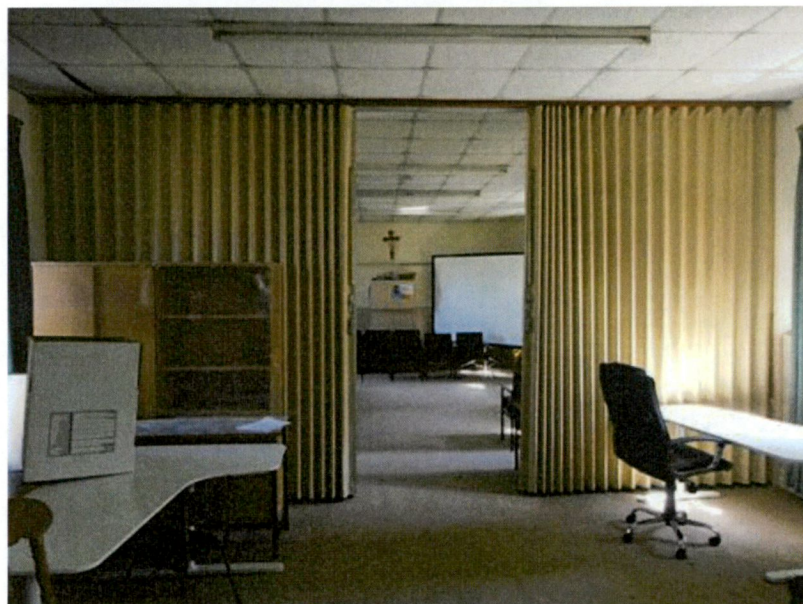
View (above F15 and below F16) of the upper parish meeting room with modern lowered ceiling and original windows and casing extant – otherwise a modernised interior.
