Architectural Design Support Statement

Proposed Apartment Development @
Old Nangor Road, Clondalkin, Dublin 22

Dublin Simon Community.

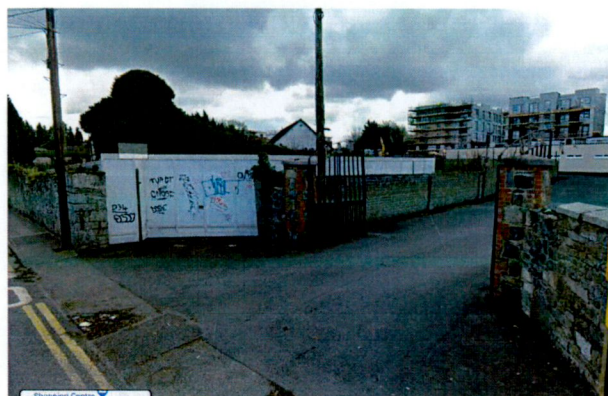
- The area of the site = 1213.32 sqm (0.121 hectares).
- Concrete block walls, approx. 2m high, define the site boundaries to the north, west and south.
- A stone wall defines the boundary to the east (front of site).
- There is an existing vehicular entrance which is angled to the road. It shares a set back with the entrance to the adjoining pitch and putt club.
- The ground level rises by approx. 1m from the road to the rear boundary on the west.
- There is a very narrow footpath along the front boundary of the site.
- Planning Permission has been recently granted for a separate apartment development at the rear (adjacent to our site) on The Mill Lane, Ref. No. SD18A/0271 (followed by SD22A/0038), this development has commenced on site and the buildings well advanced in construction (see in background below).

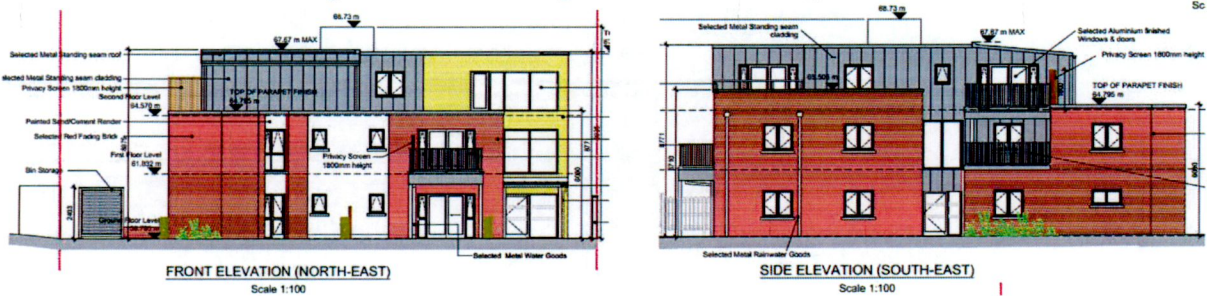
- The building has been modelled to provide a variety of different sized components with varying heights, set-backs and materials to provide a suitable scale and provide visual interest.
- The 3-storey part of the building has been set back from the road to the rear of the site.
- Elements of the building have indents along the sides to break up the facades.
