ARCHITECTURAL HERITAGE IMPACT ASSESSMENT
Of
PRESENTATION CONVENT, CLONDALKIN, DUBLIN 22

For Bartra Property (NH) Ltd.,
MARCH 2023

Presentation Convent, Clondalkin, Dublin 22
PHOTOGRAPHIC REPORT
to accompany
ARCHITECTURAL HERITAGE IMPACT ASSESSMENT

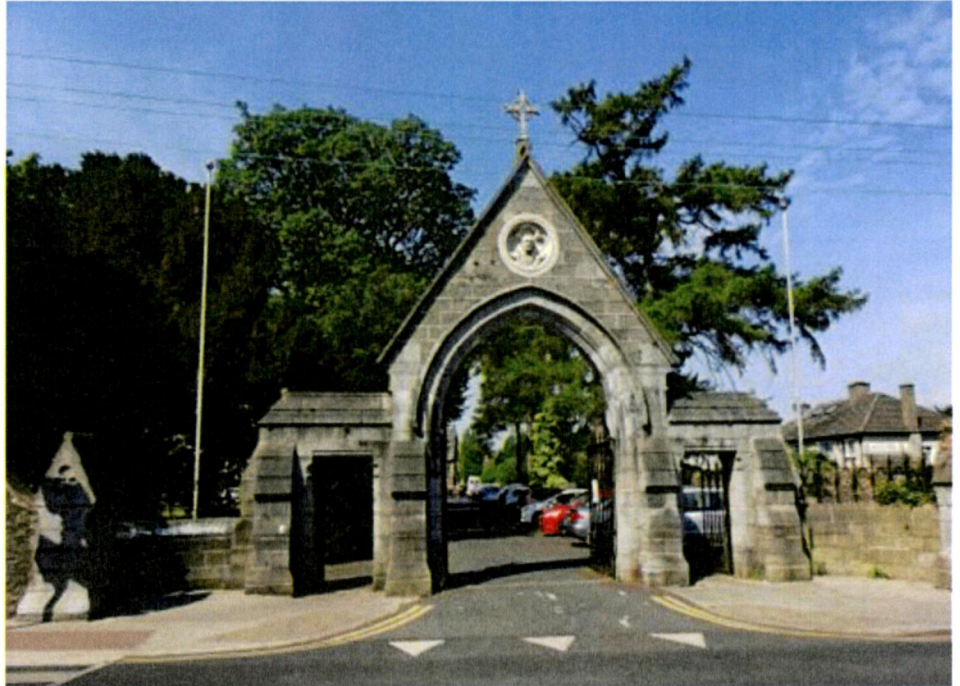
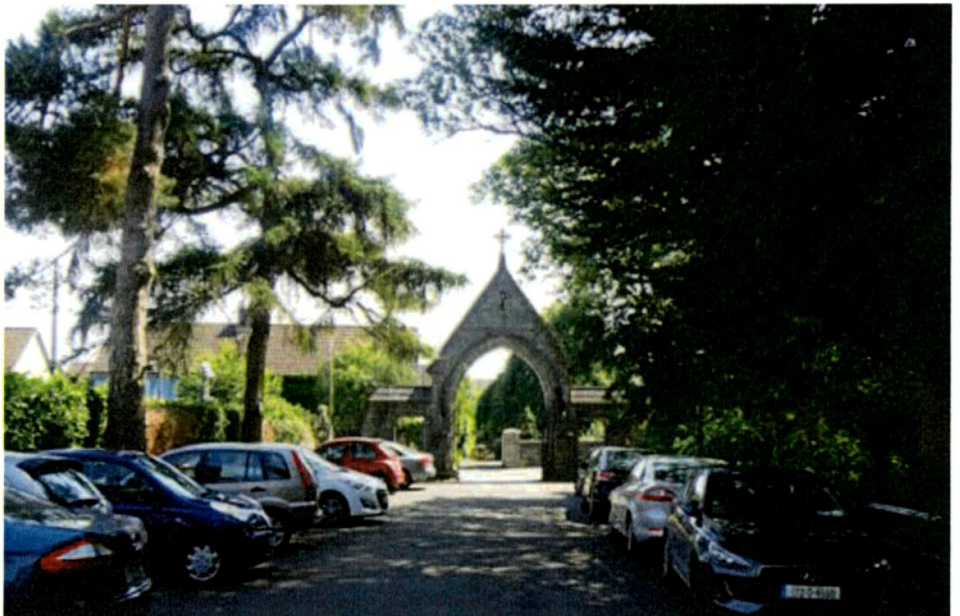
Fig 1: View above and below (Fig 2) of the tripartite entrance archway from Convent Road and internally. Although constructed (c. 1892) after the main complex was in place the style and materials are consistent with the original design.

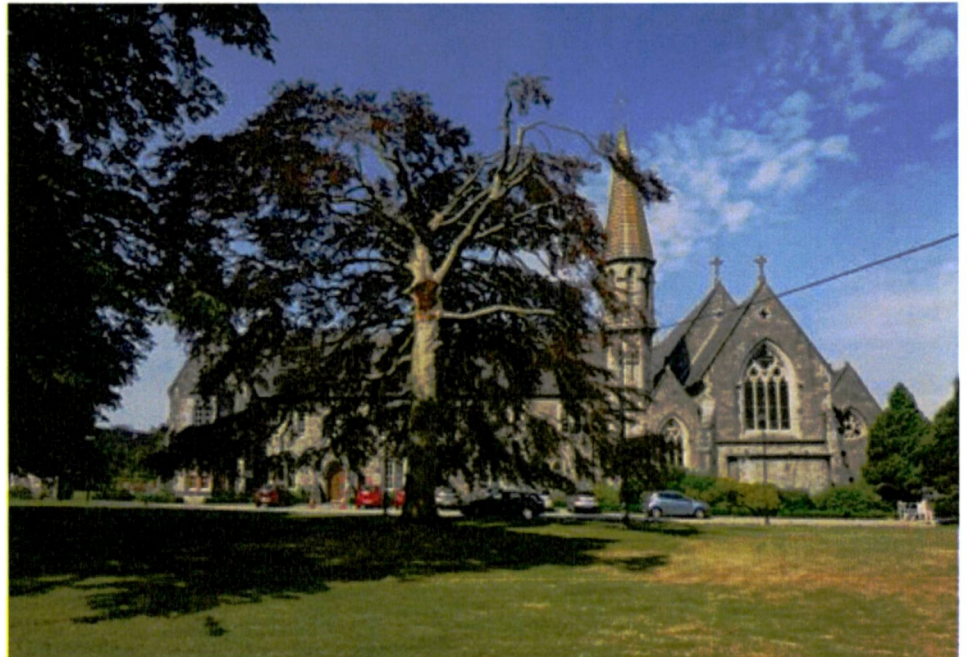
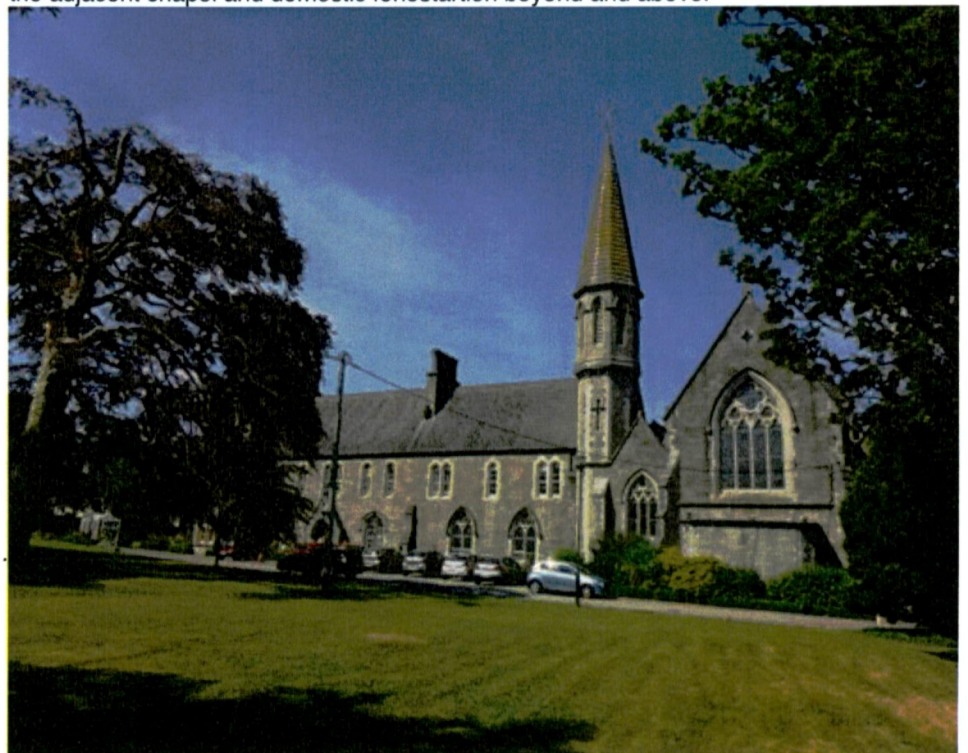
Fig 3 and Fig 4: Views (above and below) from the eastern landscaped lawns showing the west window of the main parish church and bell tower acting as a pivot and connection point to the two-storey residential convent with elaborate tracery windows to the adjacent chapel and domestic fenestration beyond and above.

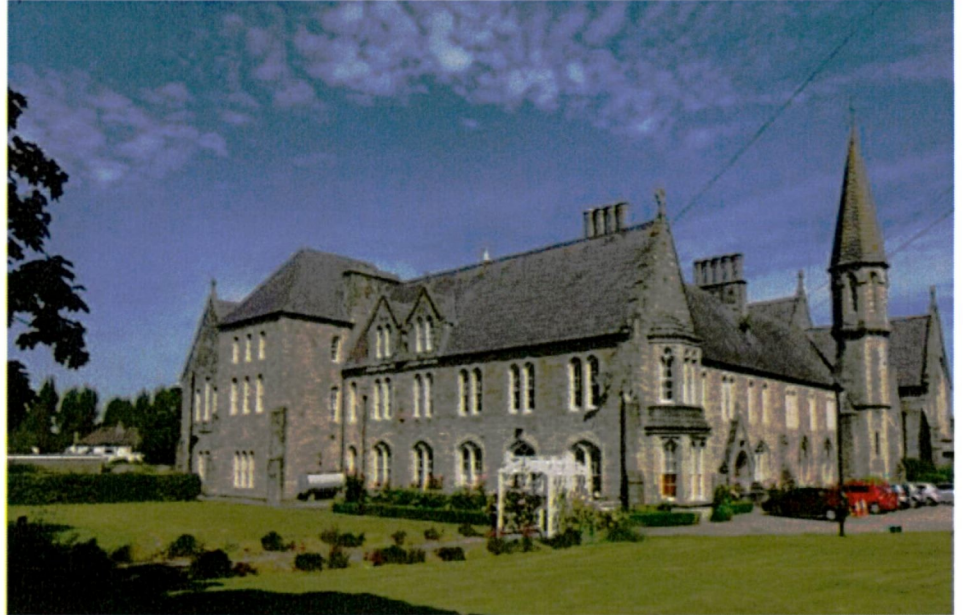
Fig 5: General view from south-east showing the east facing wing and its conjunction with the south facing wing (composed of two and three storey elements).

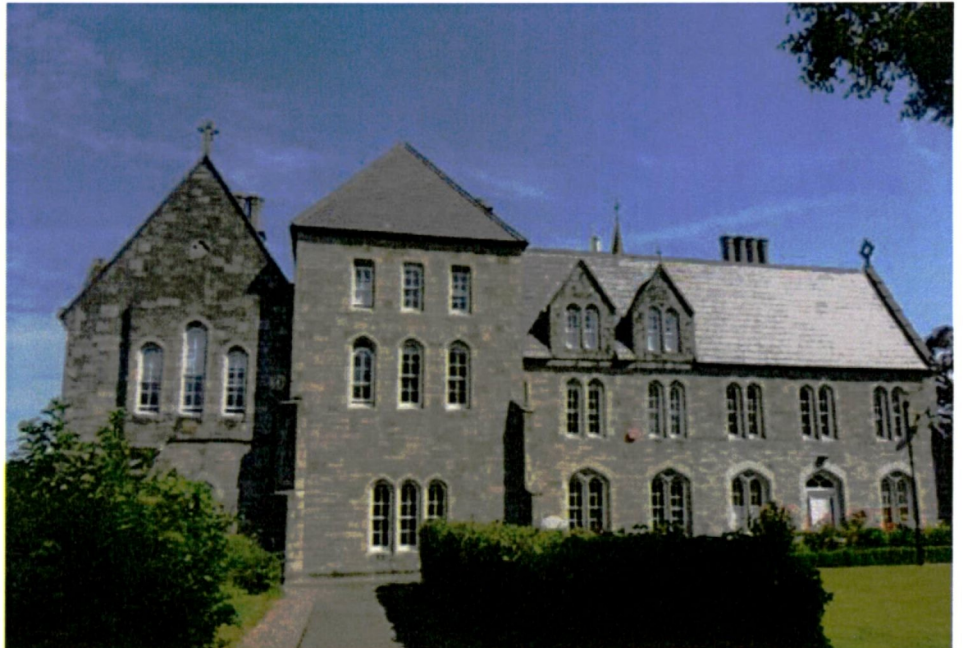
Fig 6: Elevation / view of the south-facing wing : the more utilitarian nature of the three-storey wing is expressed externally with simpler windows and a greater proportion of masonry. The raised wall dormers with paired windows break up the mass of an otherwise large area of plain slate roof.

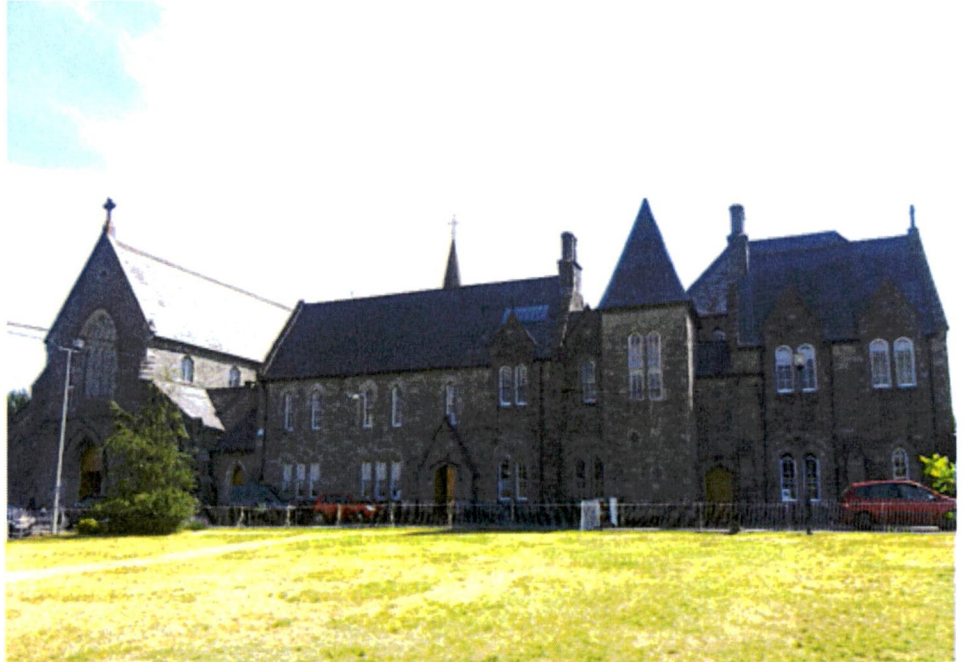
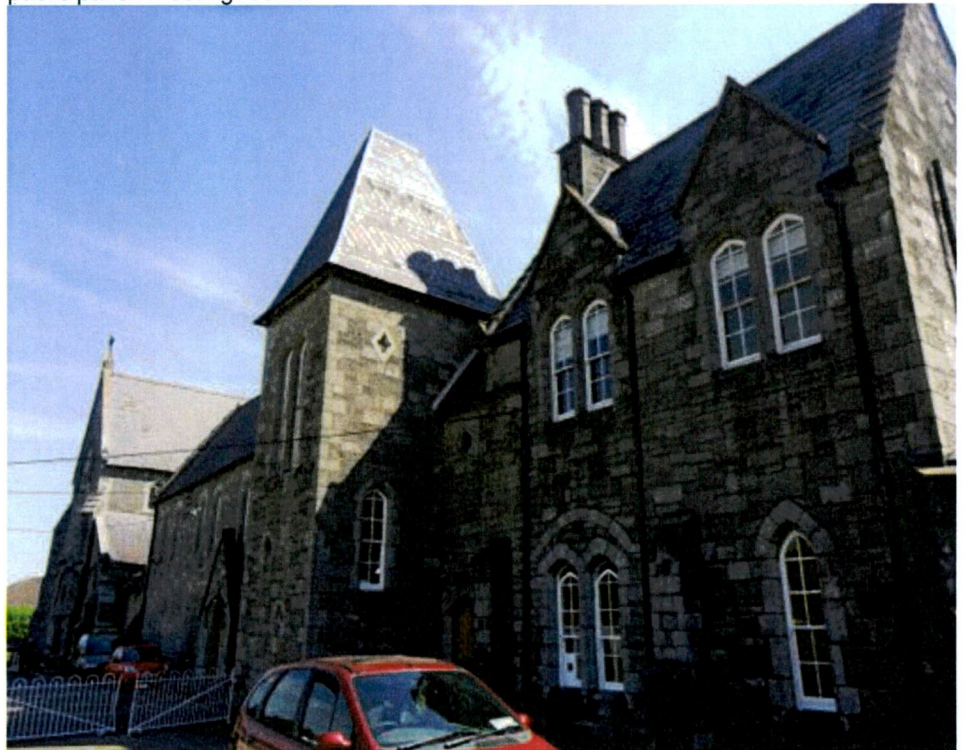
Fig 7 and Fig 8 below: Views (above and below) from the plainer landscape setting on the eastern side of the complex (prior to recent development) showing the western wing with stair tower and articulation of the junction between the residential section and more public parish meeting rooms.

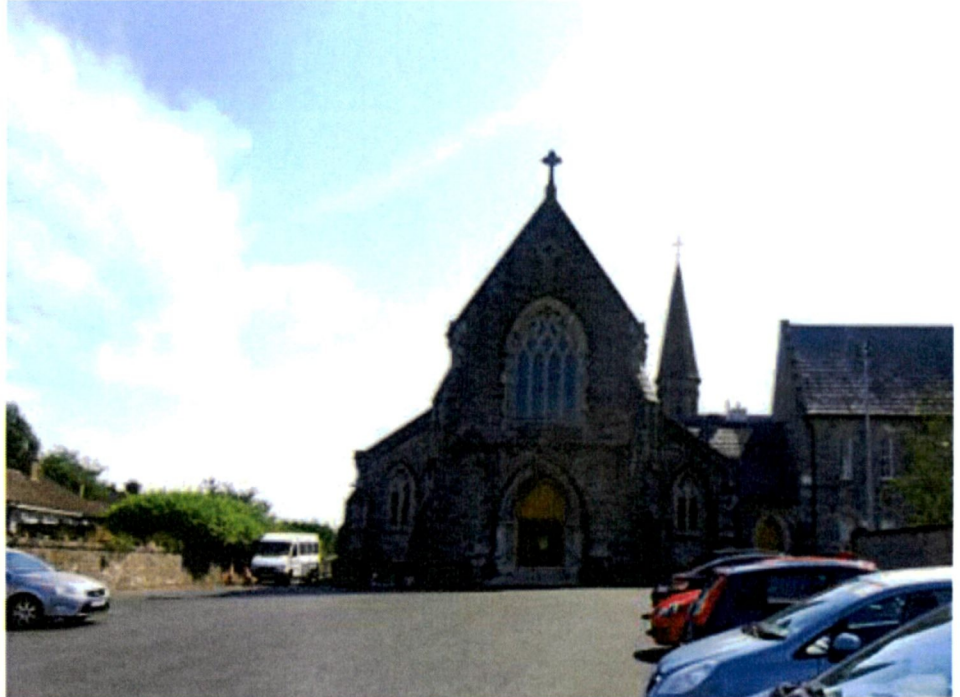
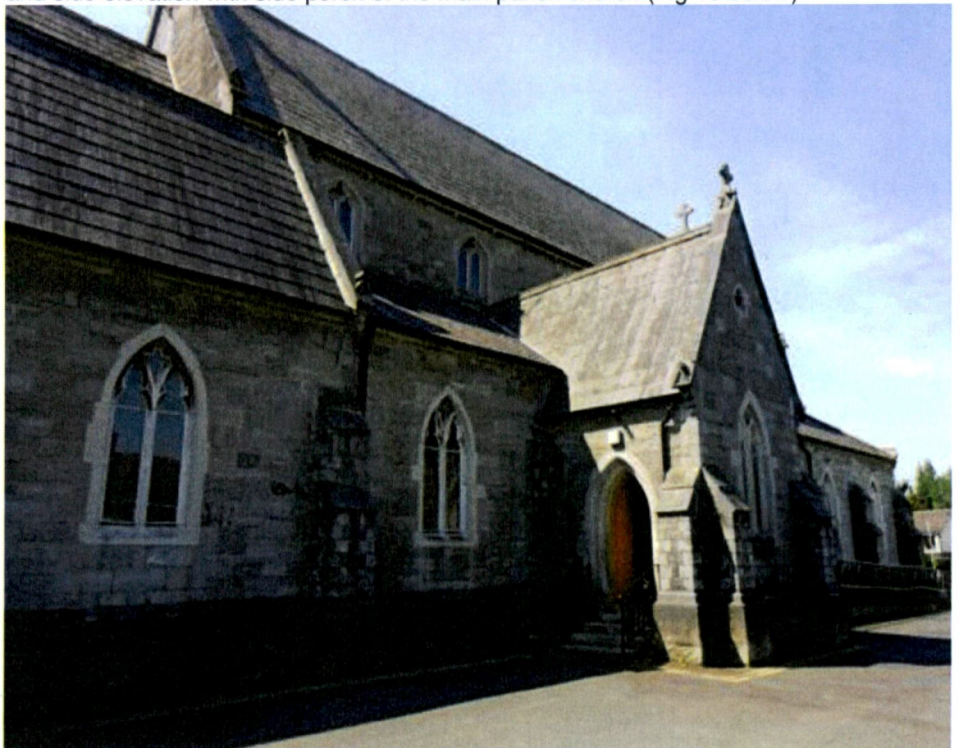
Fig 9: View of the principle entrance elevation (east facing) of the main parish church and side elevation with side porch of the main parish church (Fig 10 below)

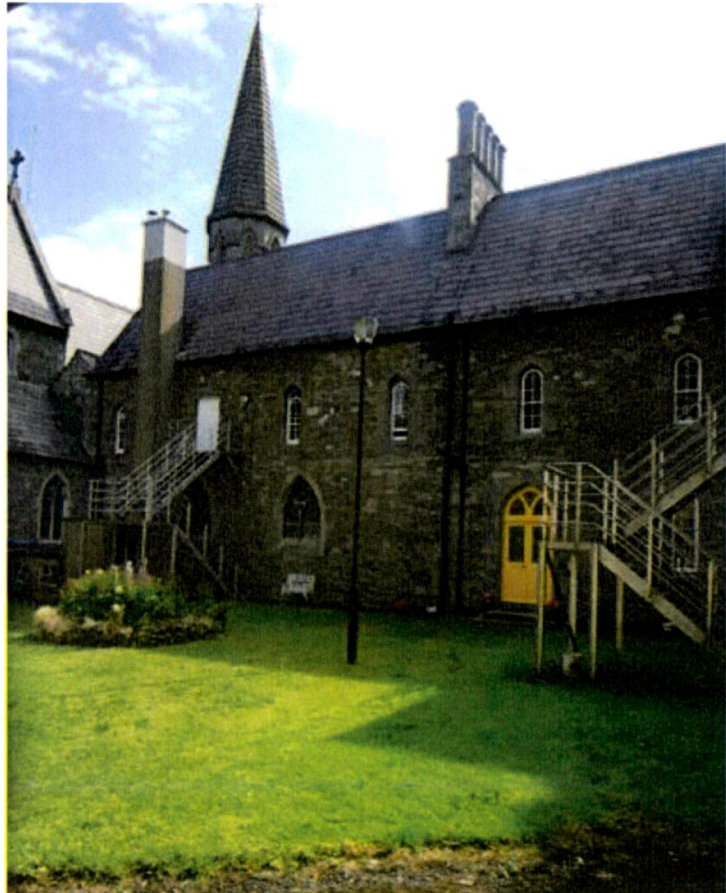
Fig 11: View across the internal courtyard showing the modern chimney stack and plainer treatment architecturally to the less public internal courtyard facades

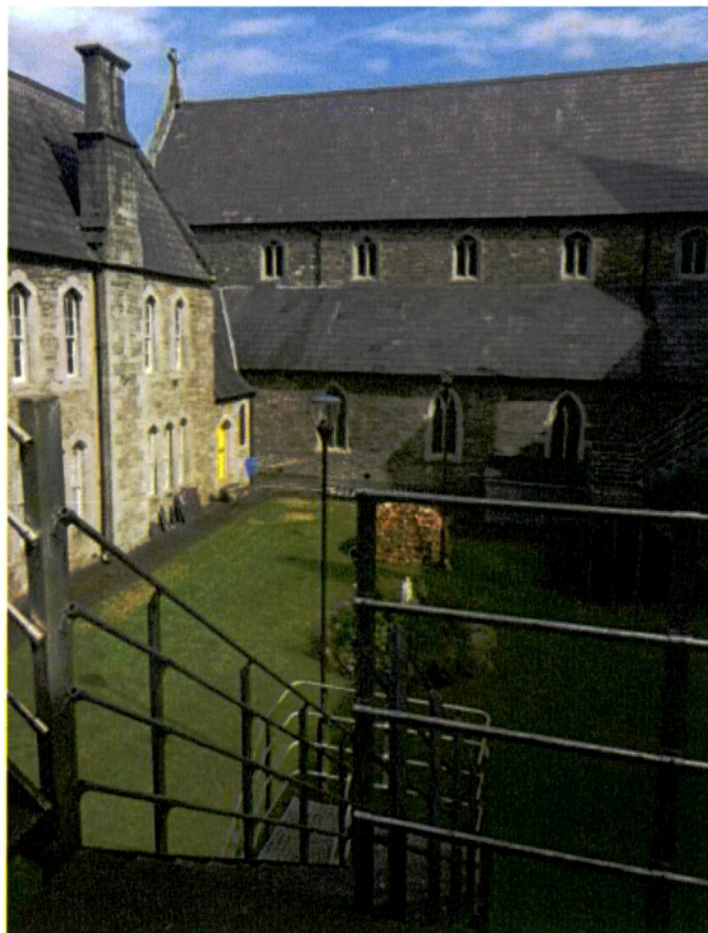
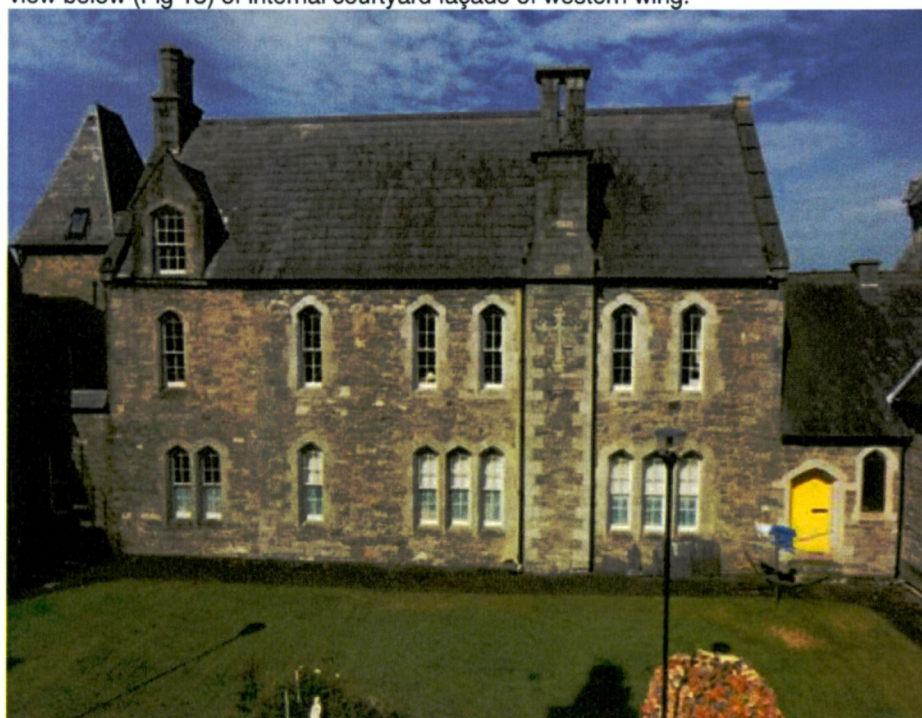
Fig 12: View from fire escape towards north eastern corner of internal courtyard and view below (Fig 13) of internal courtyard façade of western wing.

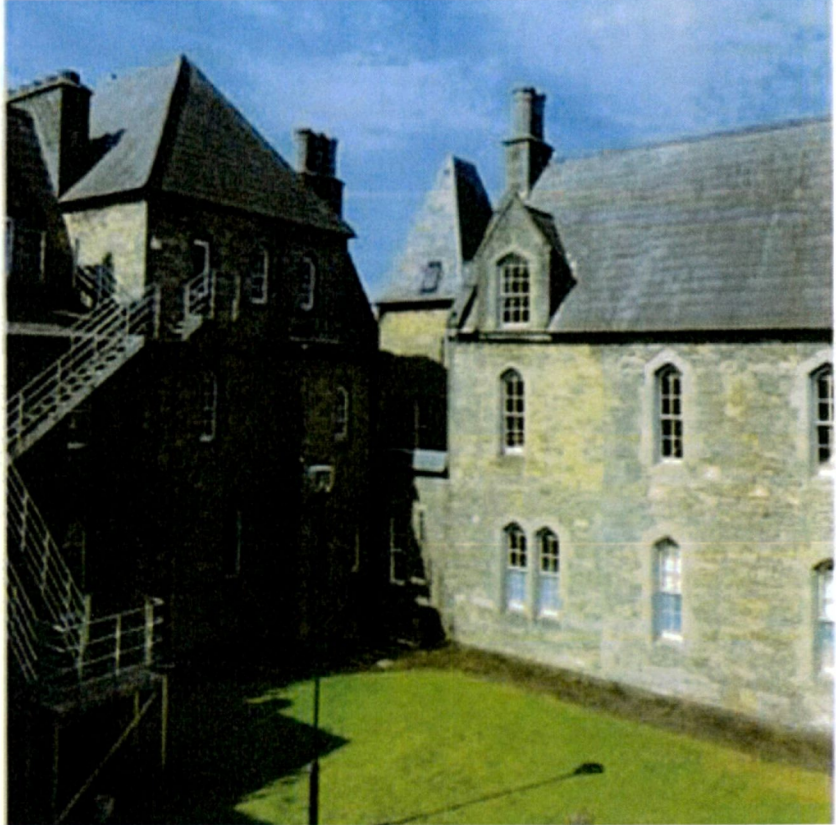
Fig14: View of the internal courtyard junction between the southern and western wings

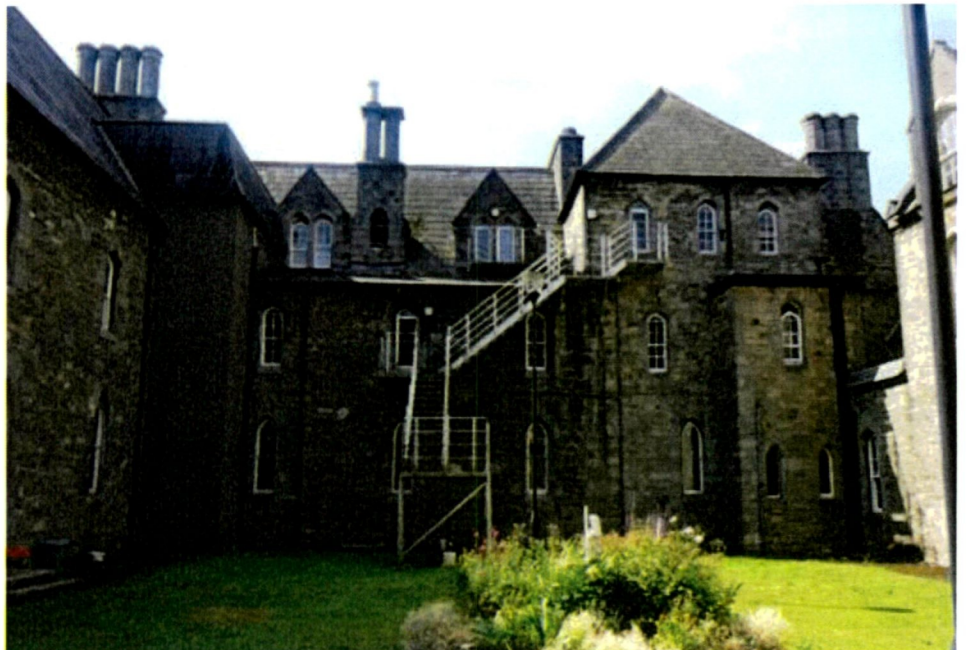
Fig 15: View above of the three-storey element of the southern wing alongside two-storey wings with attic accommodation.

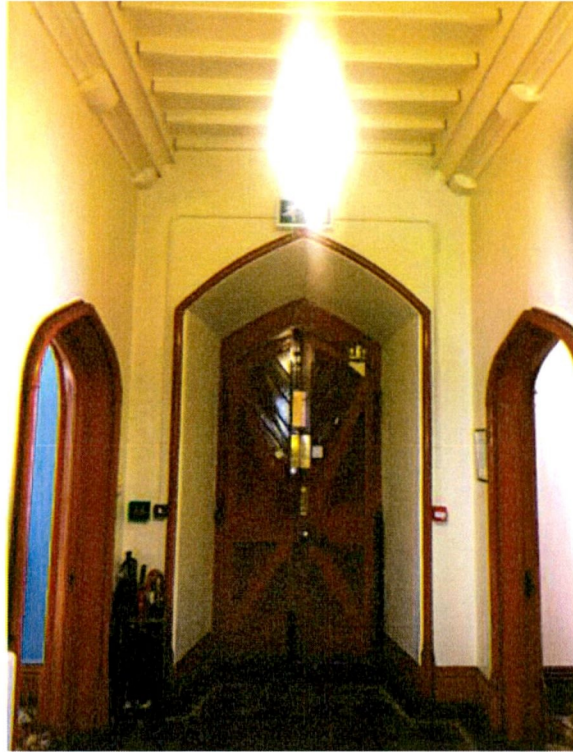
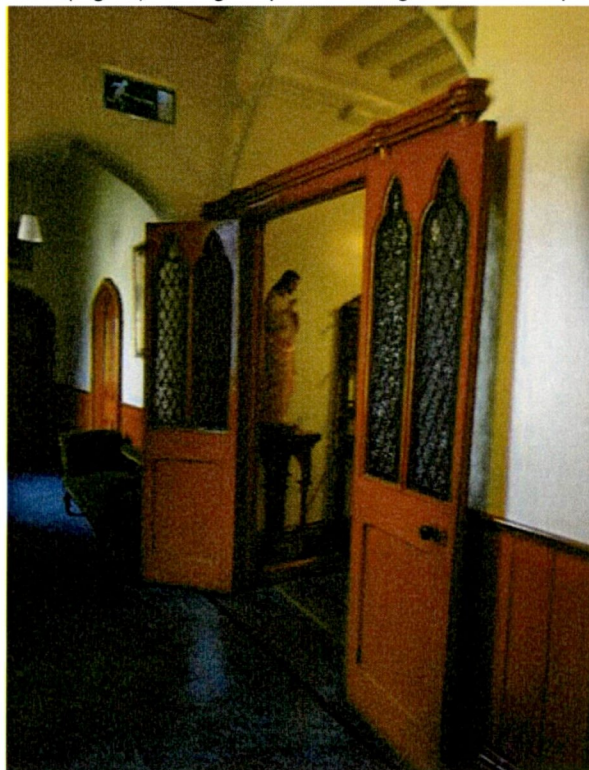
Fig 16: View above and below of entrance hallway from hallway towards arched entry door set in a deep recess with bracketed cornice supporting exposed joisted ceiling and view below (Fig 17) of original pierced fanlight screen and paired lancet doors.

4.2	<p>Entrance Hall (<u>Room G.01</u> – Eastern Range); the rectilinear entrance hall located on the eastern range is expressed externally by a shallow projection externally and features an original double door set within a gothic archway. To right and left arched door cases lead to matching reception rooms or parlours. The ceiling is of simple gothic revival character with expressed beams supporting open joists with quadrant brackets – all painted white. A pair of stained doors are set within a screen featuring paired lancets and obscure glass in leaded settings below a painted pierced timber gothic over-door fanlight reinforcing the consistent and original character of the space.</p> <p>Proposal: To insert a new opening in the between G.01 and adjacent room G.02 to create a working connection between the entrance hallway and the proposed new reception.</p>

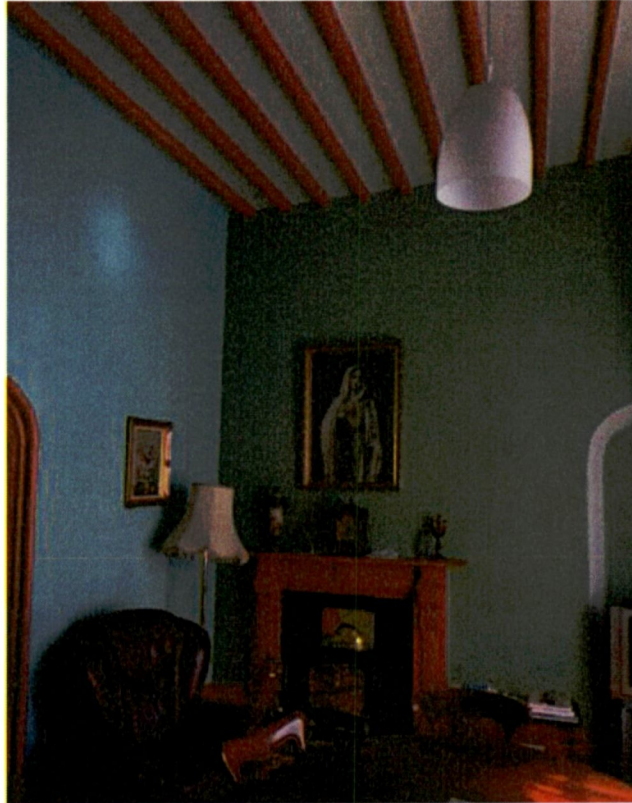
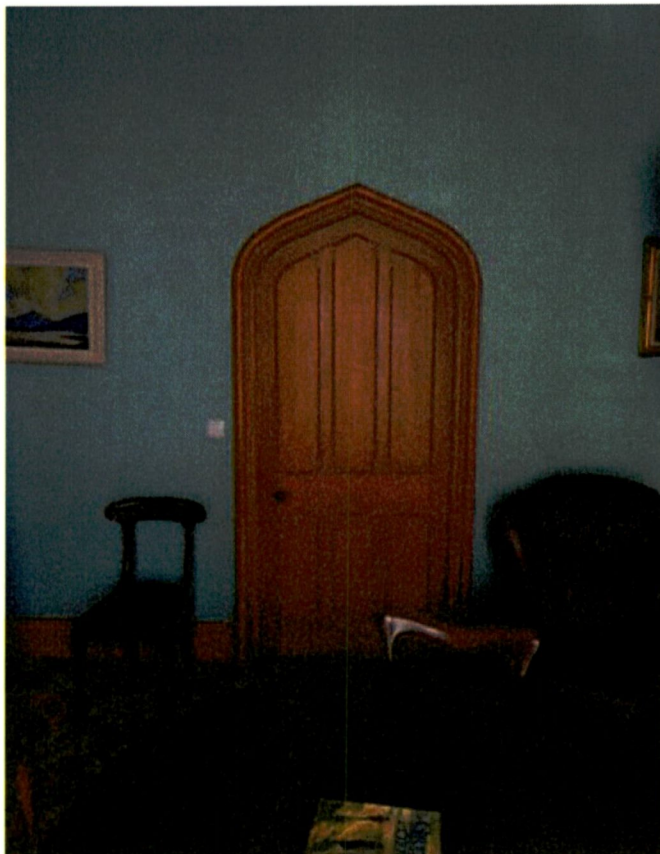
Fig 18: View in reception room of original simple bracketed stone chimneypiece finished to resemble wood with view of (Fig 19 below) original tripartite panelled and arched door-case (Tudor arch form) leading to corridor

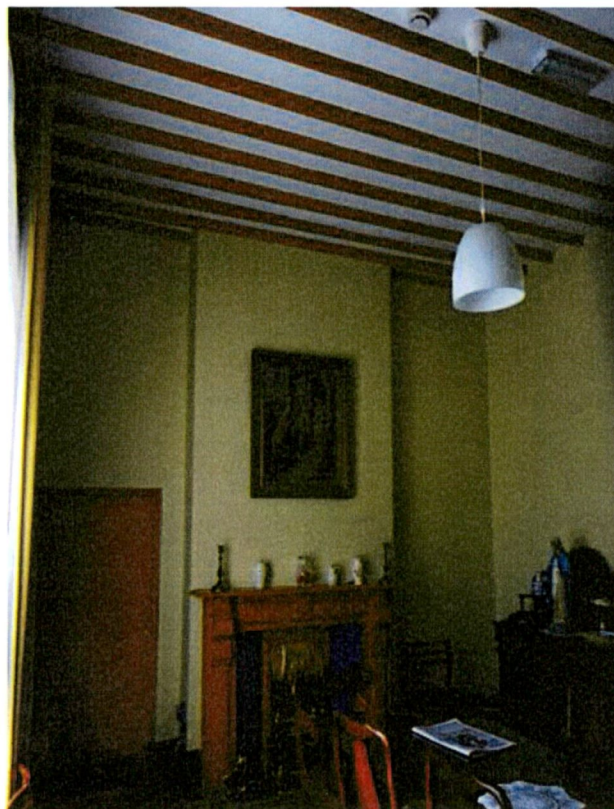
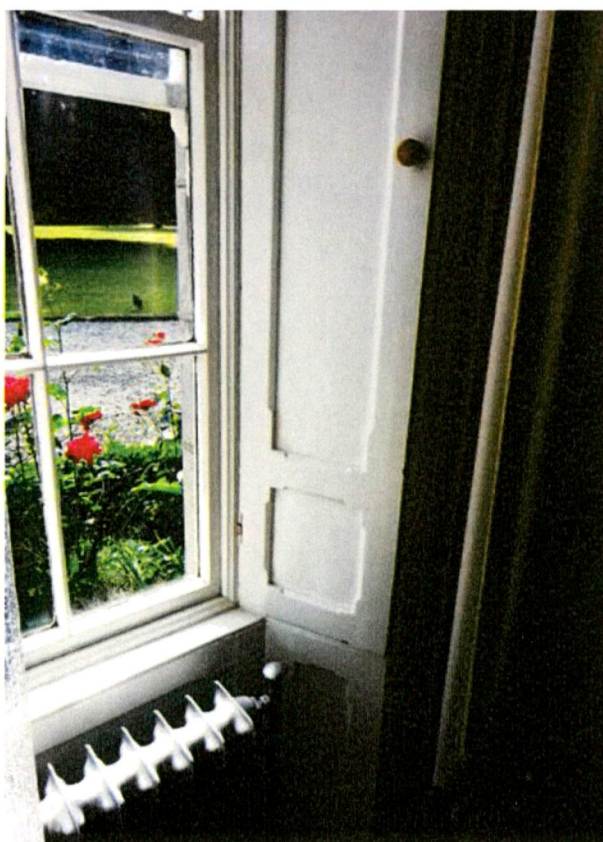
(Fig 20) View above of the second reception or parlour off the entrance hallway with exposed joists and matching chimneypiece. View (Fig 21) below of the original window casing with panelled shutters exhibiting chamfer detail and original sliding sash windows.

4.3	<p>Parlours (now designated as <u>Rooms G02/G03</u> Reception and Reception Office) and <u>Room G.04</u> (now designated as Physio/Therapy Equipment): the restrained interiors of the pair of reception rooms or parlours located to either side of the entrance hallway retain simple and original bracketed stone chimneypieces which have been painted to resemble timber. The ceilings feature expressed joists stained to match the chimneypieces and matching the original window shutters and linings within the arched openings to both rooms – featuring original sliding sash windows and panelled shutters with bevelled mouldings and moulded architraves.</p> <p>Proposal (1): To insert a new separating and free-standing screen between G.02 and adjacent G.03 to create a working reception and a more private but connected reception office.</p> <p>Impacts: This proposal has been designed to be free standing and to avoid dividing this space into two spaces but rather it inserts a screen which will not affect the traditional room integrity. The design does not affect room joinery and any fixings will be light touch and reversible. The impacts should therefore be neutral here allowing for a functioning reception and adjacent office in a reversible manner.</p> <p>Notes on mitigation from previous application: we refer to the previous application SD22A/0336 wherein it was proposed to insert a full height partition dividing this space into two and potentially impacting both the original character and original joinery. a large opening including the loss of the original door and a change in the relationship between G.01 and G.02. This revised design significantly mitigates the previous impacts which were noted in the ACO report as being unacceptable.</p> <p>Proposal (2): To insert a new opening between G.04 and the adjacent G.05; to upgrade both the existing doors to FR 30.</p> <p>Impacts: This proposal has been designed to allow a functioning direct connection between the proposed equipment store (G.04) and the proposed Physio/Therapy Room (G.05). It forms a new opening within the existing arch headed recess to the right of the chimneypiece. This will not affect the room integrity and the use of an existing recess will result in a very modest change in character which should be acceptable. The proposals to upgrade the door openings to FR 30 will be driven by a strategy to retain the maximum number of retained doors and using a proprietary system as specified by the fire consultant and set out in detail in the separate fire strategy documentation. The system proposed (Sealmaster FireFace) is designed to be low impact in conservation impacts while providing for the necessary performance. The overall impacts should therefore be neutral here allowing for a functioning equipment store and adjacent physio / therapy area.</p> <p>Notes on mitigation from previous application: this proposal is as was submitted under SD22A/0336 understanding that this particular proposal was not the cause of significant concern</p>

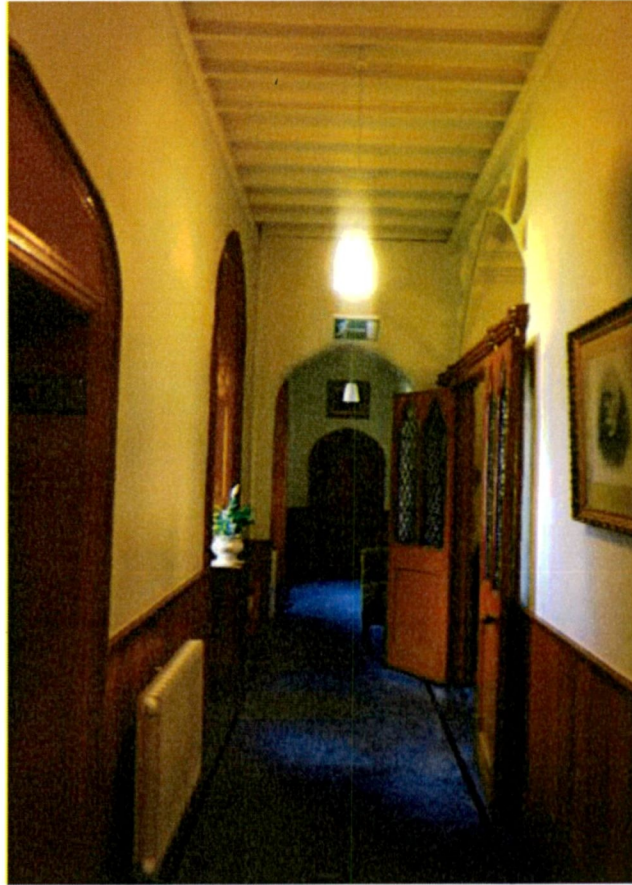
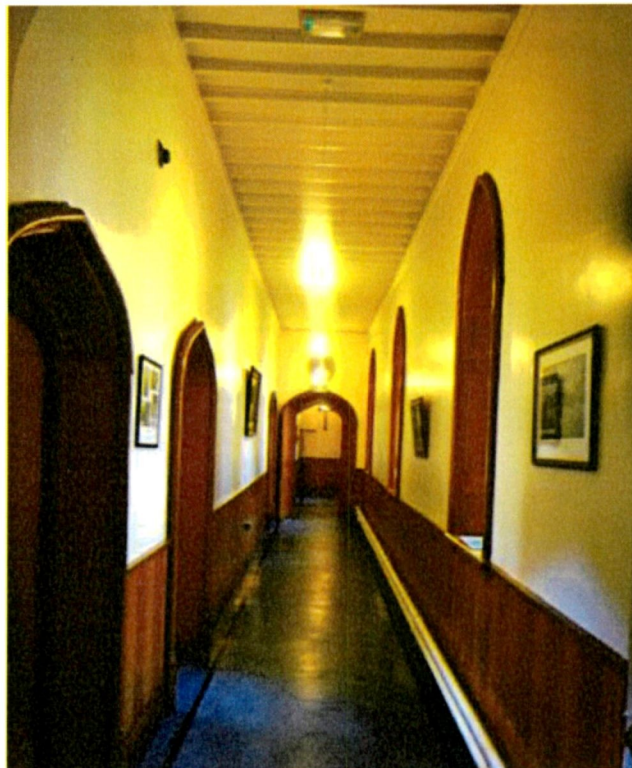
Views above (Fig 22) and below (Fig 23) of transverse corridor lining alongside courtyard walls and leading from entrance hall to principle rooms. Door at end of corridor above leads to chapel.

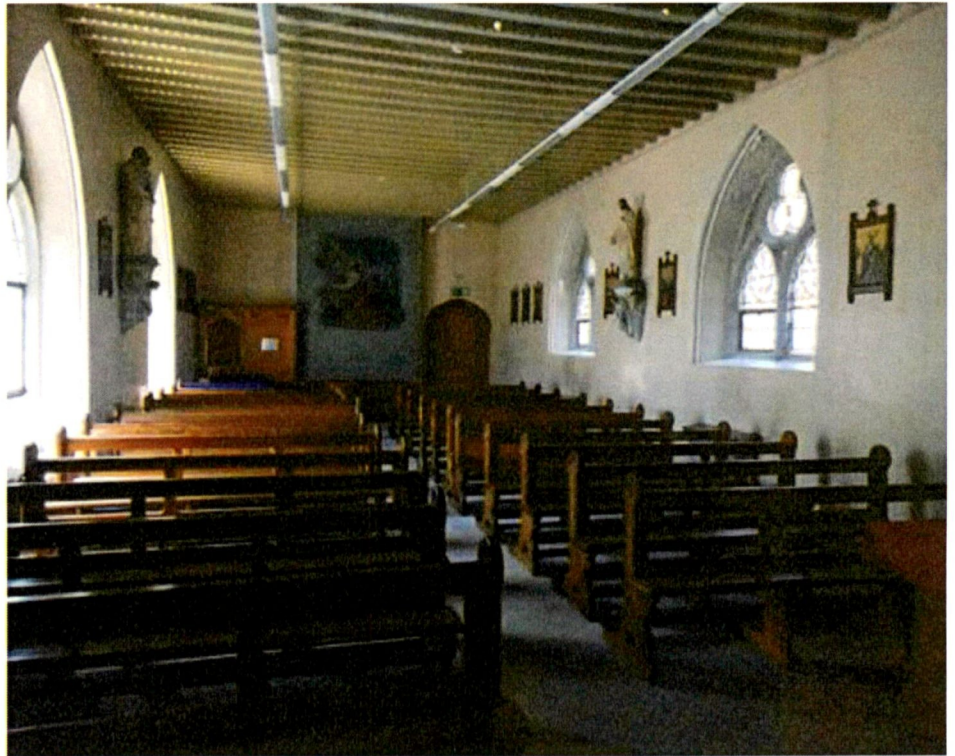
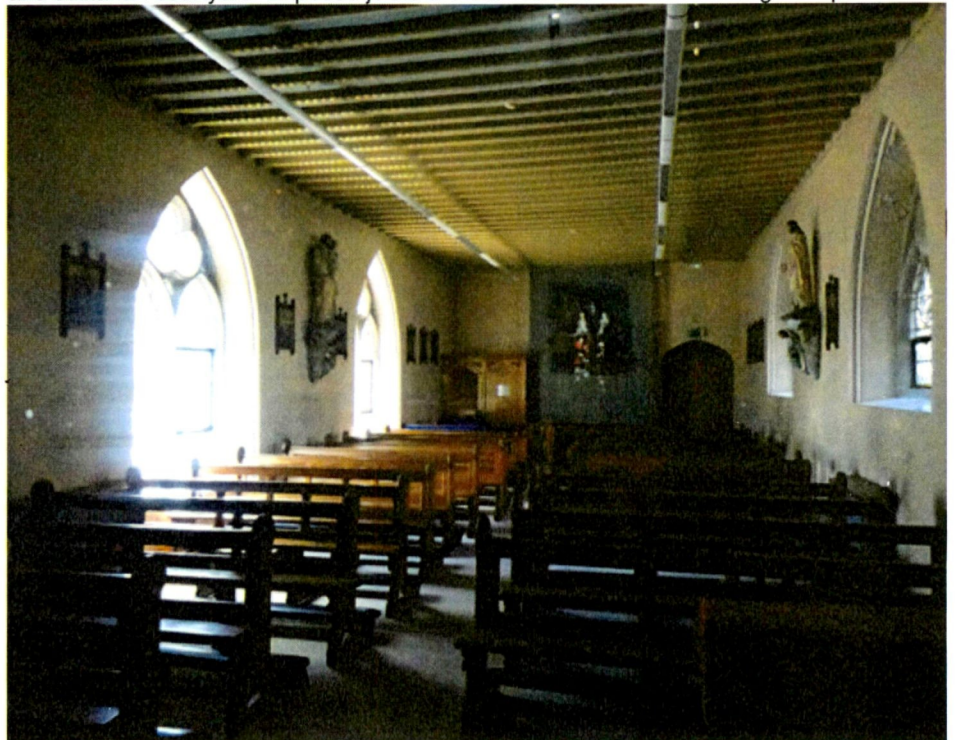
Views above (Fig 24) and below (Fig 25) of the oratory chapel connected directly to the Parish Church which spans the entire plan with gothic revival stone mullioned windows to either wall, the higher cills affording greater privacy on the side facing the more private and utilitarian courtyard. Exposed joists are stained and decorated with gold squares.

The eastern range: as noted above, contains the principle private entrance and adjacent parlours and connects to the large chapel off the parish church. At the southern corner end of the range, a large roof with a canted bay is used as a private oratory for the convent.

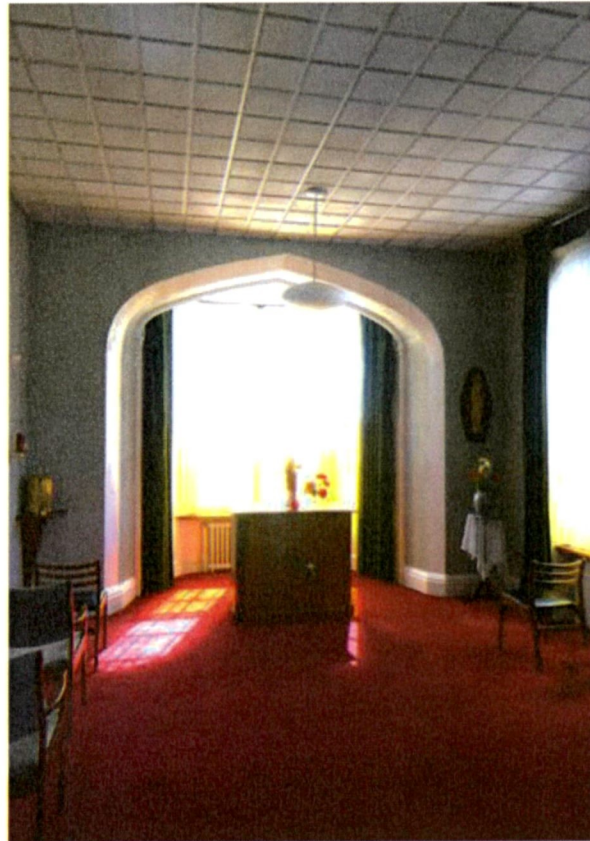
(Fig 26) View above of the former living room located at the junction of the eastern and southern wings with modern dropped ceiling and presently used as a private chapel. The room retains good window joinery, likely cornice-work above dropped ceiling and an original chimneypiece.

4.16	<p>Sitting Room (Proposed Meeting Room): the large corner sitting room located at the junction of the eastern and southern range is clearly a room of status within the plan layout and a communal space for the occupants. The room retains a simple bracketed chimneypiece similar to that found in more important spaces on the ground floor and an original straight run cornice running around but not extending into the canted bay. The room expresses its relative importance within the plan by its scale and detail with three large windows including a deep bay set within a Tudor archway setting off the fine window articulation with scalloped top window panes leading to a pointed trefoil top light. The south facing window are simpler paired sliding sashes with wide weight box mullions and panelled and bevelled panel details. The entire contributes to an intact and fine gothic revival room.</p> <p>Impacts: the room remains as a single volume and will retain existing architectural character. As such there are no negative impacts on this room within the proposal.</p>

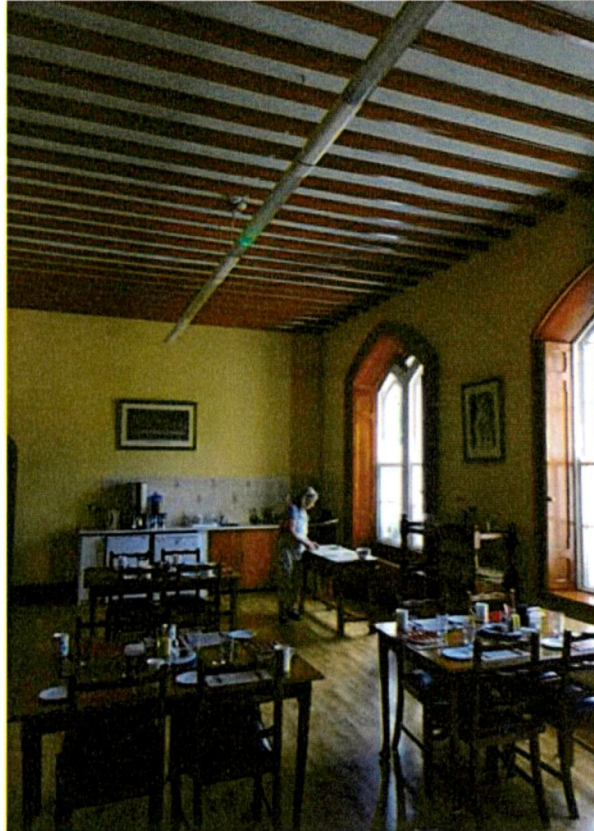
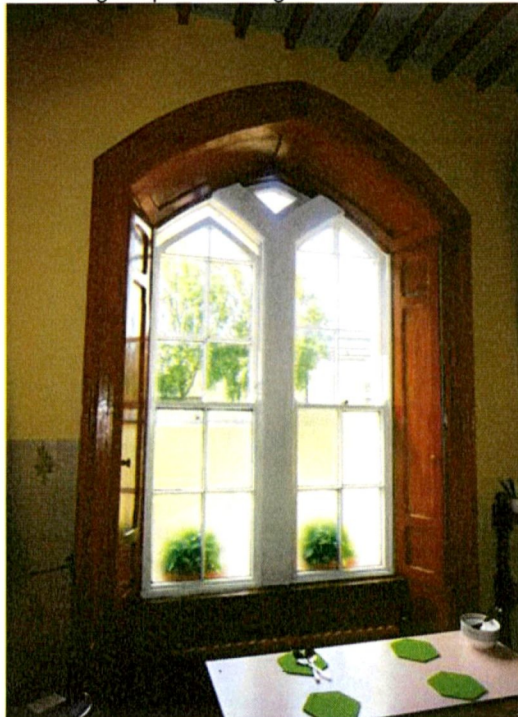
(Fig 27) The dining room is still used for this purpose and retains good original windows and casing, exposed joisted ceiling and an original chimneypiece. View below (Fig 28) of the original paired neo-gothic window and casings in the dining room.

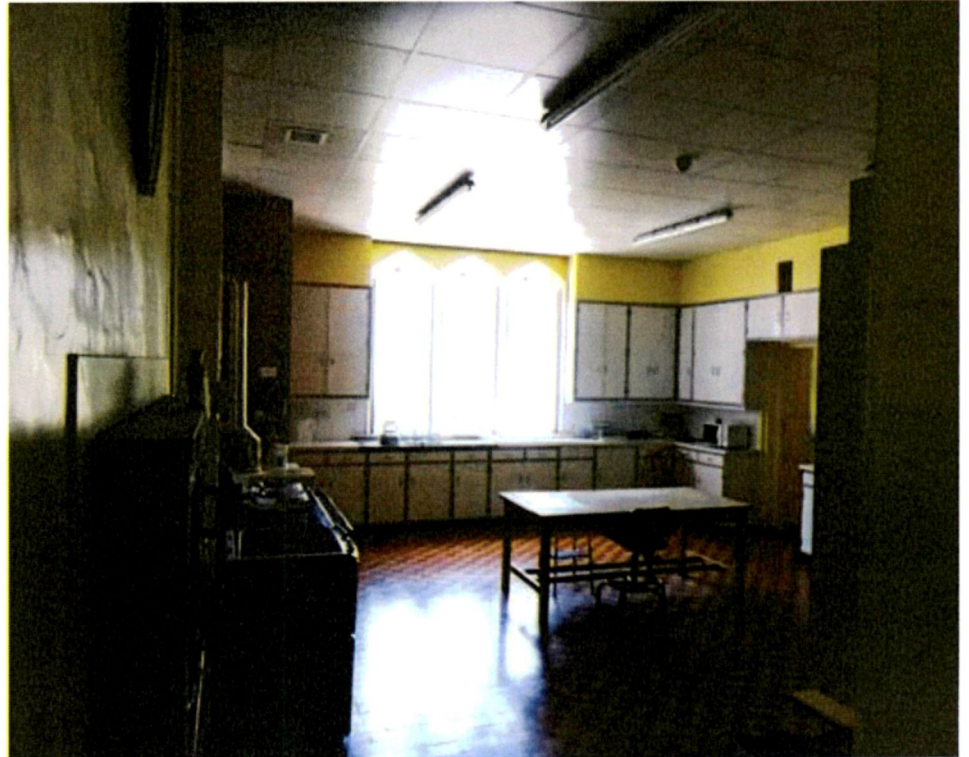
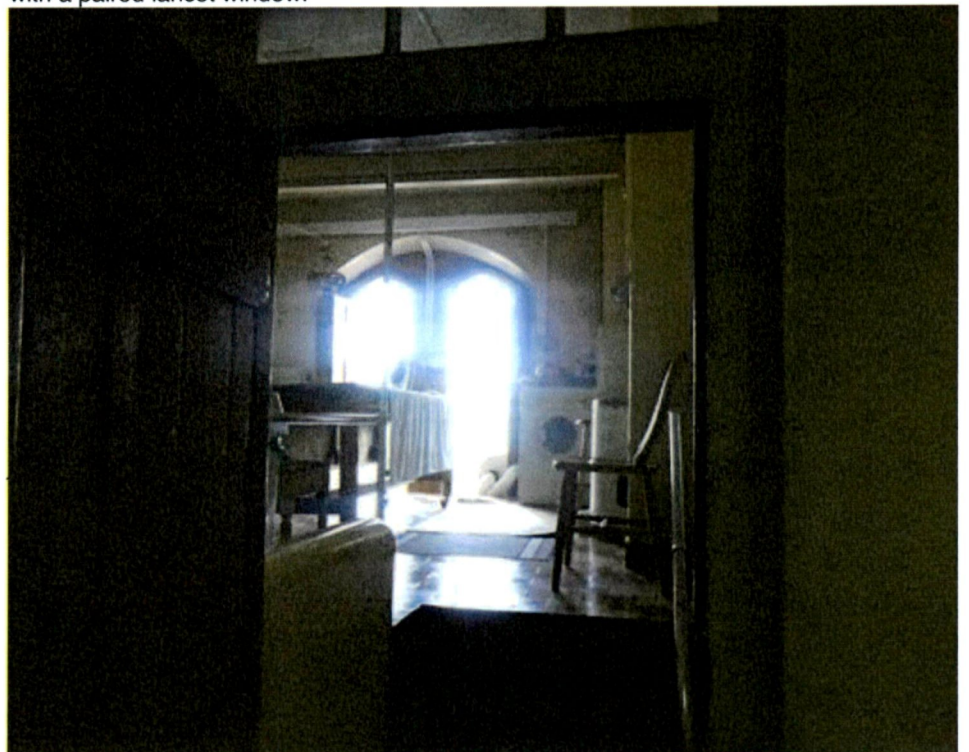
Fig 29: View above of the present kitchen where the ceiling has been dropped but the overall aesthetic and detail is understated and functional with a tripartite window as the principle feature. The laundry (below – Fig 30) is similarly utilitarian in design and finish with a paired lancet window.

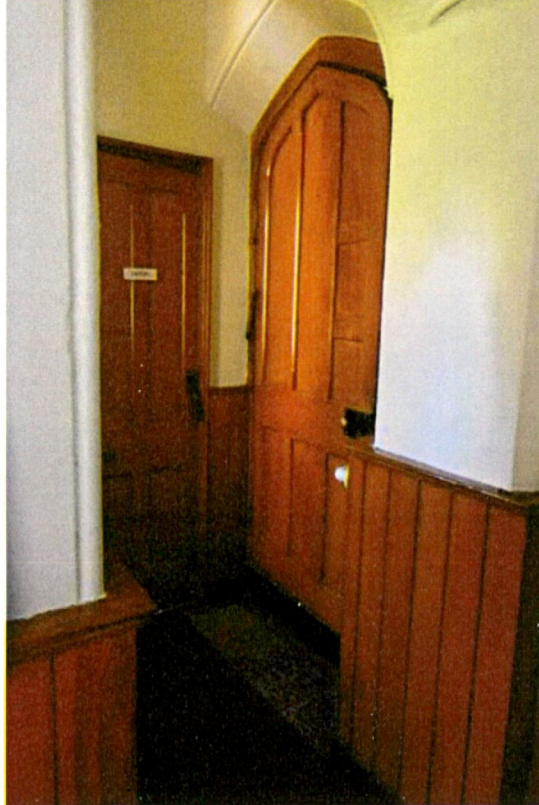
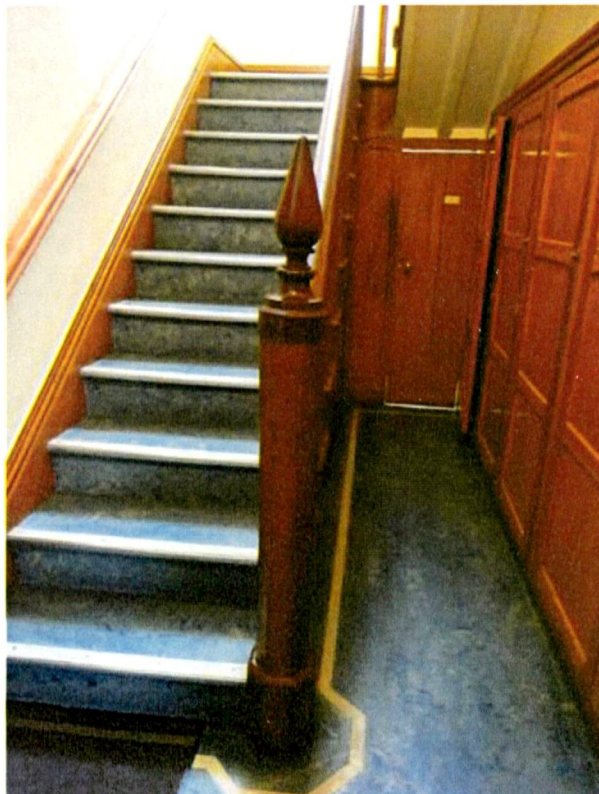
(Fig 31) Corridor joinery (above) at the junction of the south and east wings is extant, of stained timber and rich and well executed. View (below – Fig 32 -) of the staircase (Stair 01) between the present private chapel and dining room in the south wing with distinctive attenuated finial.
