ARCHITECTURAL HERITAGE IMPACT ASSESSMENT
Of
PRESENTATION CONVENT, CLONDALKIN, DUBLIN 22

For Bartra Property (NH) Ltd.,
MARCH 2023

Presentation Convent, Clondalkin, Dublin 22
PHOTOGRAPHIC REPORT
to accompany
ARCHITECTURAL HERITAGE IMPACT ASSESSMENT

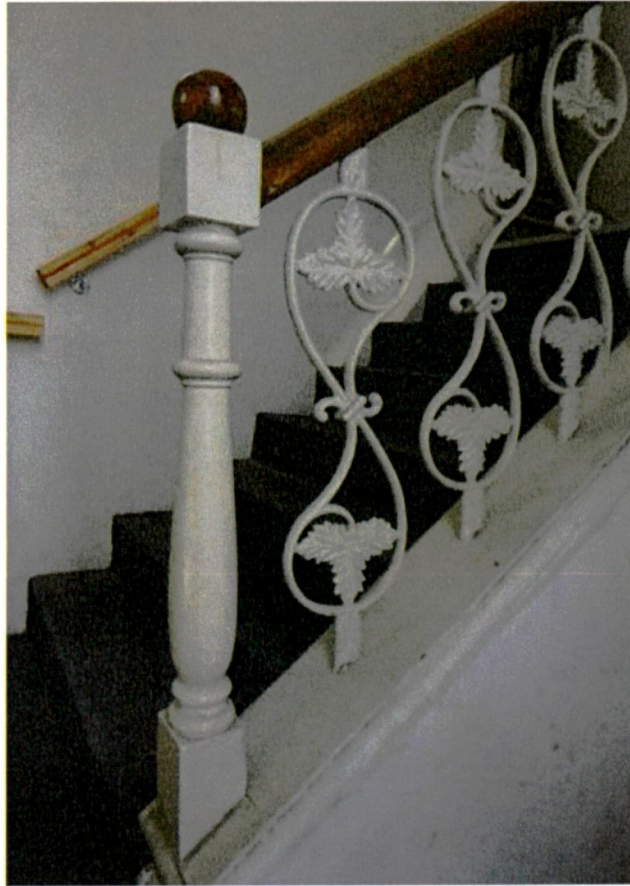
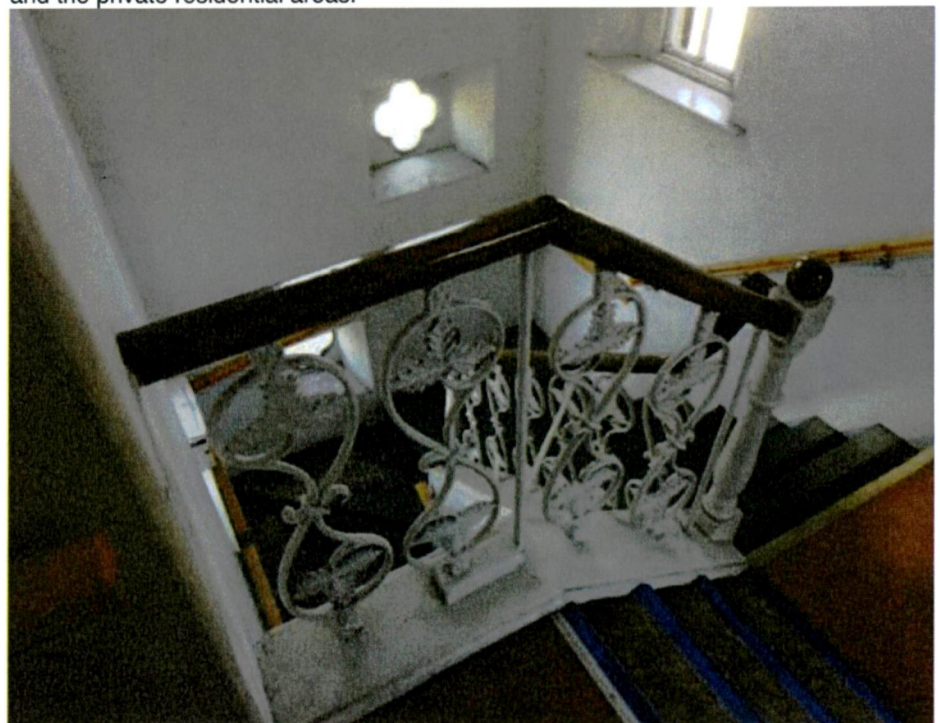
The newel and balustrade to Staircase 02 (Fig 33 above) is different from all others within the building, being harder and more robust in design and material with granite treads, and wrought iron balustrade redolent of its more public use on the west side of the complex. It rises below (Fig 34) within the projecting stair tower on the west facing façade which acts as a pivot or node point between the more public parish functions and the private residential areas.

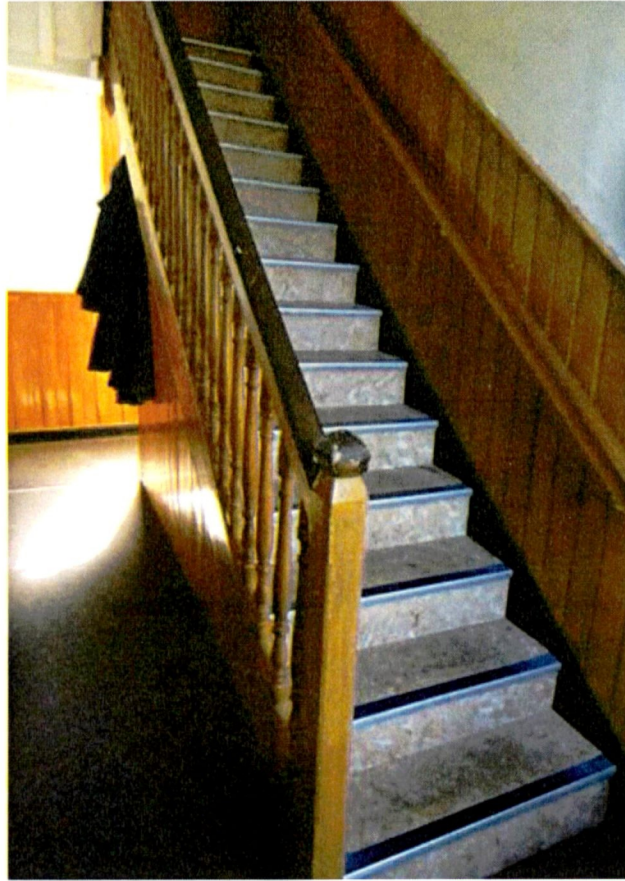
Fig 36: Staircase (03) at within the west wing is more private in function, providing access for parish activities from ground to first floor and the joinery reflects this being more understated than either the robust wrought ironwork of 02 or the more refined joinery within the main convent residential wing at Staircase 01. (Fig 37 below) The parish meeting room, now subdivided by later partitions is plain and functional in detail with exposed ceiling joists and finishes but retains original joinery and windows to both sides.

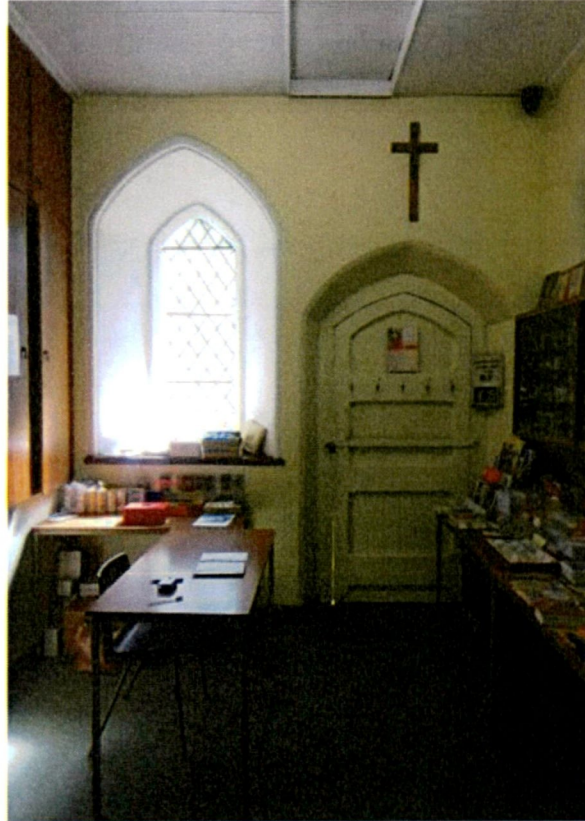
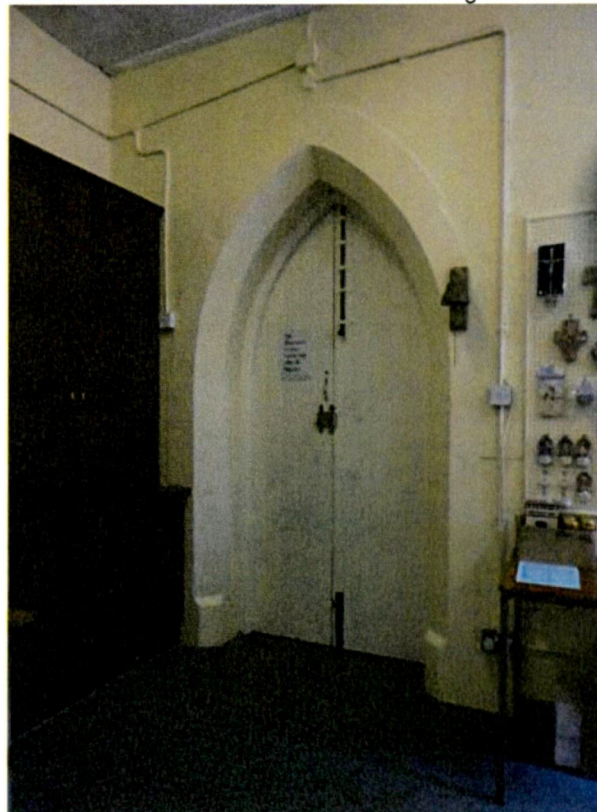
View above (Fig 38) and below (Fig 39) in single storey parish meeting room which directly adjuncts the main body of the church. The dropped ceiling likely conceals exposed joist ceiling and the room retains original door / window joinery and a large gothic arched stone dressed door-case leading to the main body of the church.

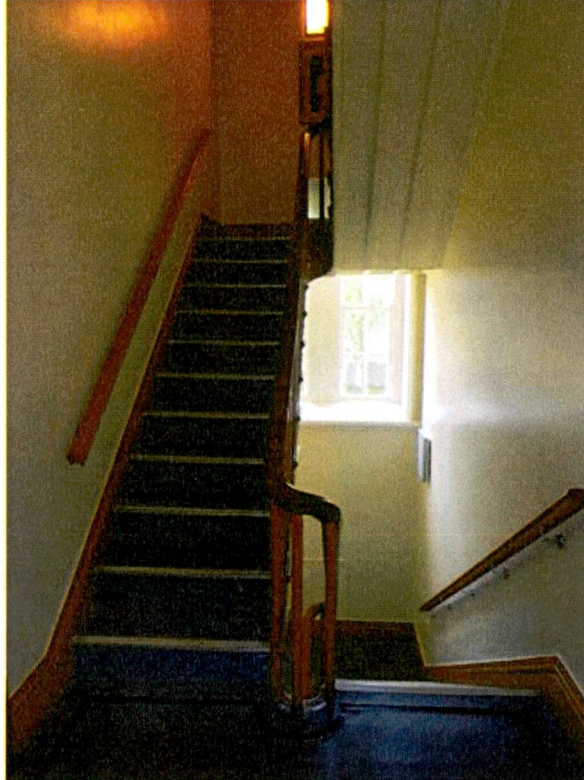
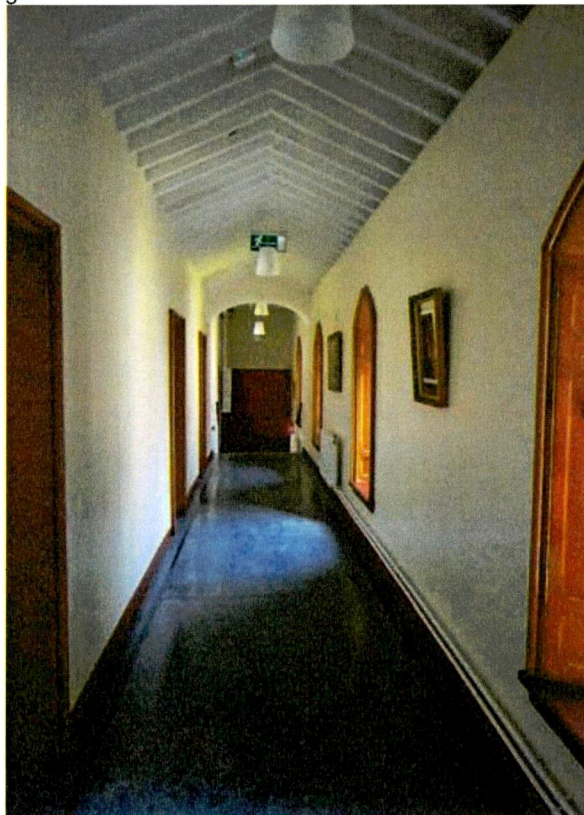
(Fig 40) Staircase 01 leads from the ground upwards with the quality of joinery maintained. The view (below – Fig 41) looks along the access corridor running along the inner side of the southern wing with expressed pitched roof rafters and original window casings.

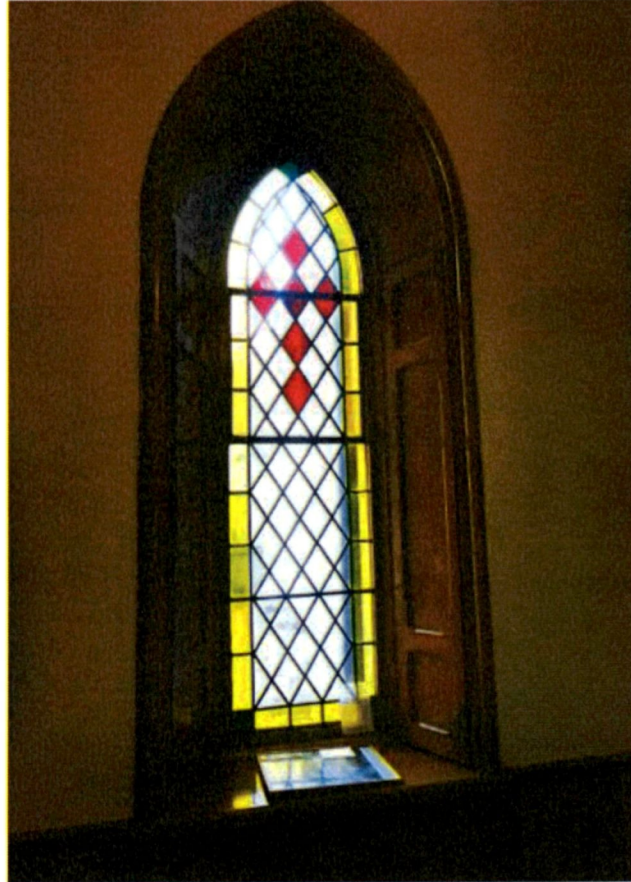
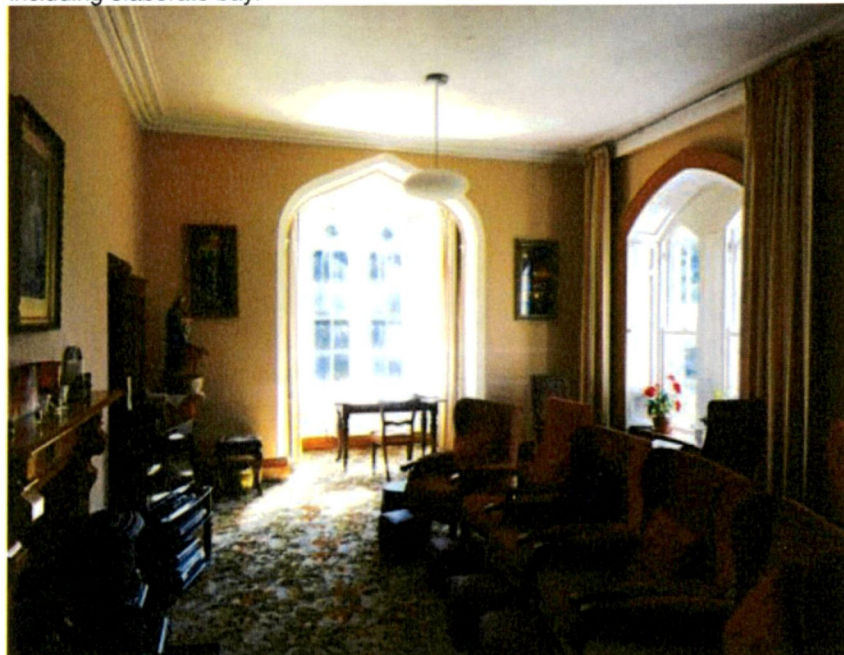
Window (Fig 42 above) with original stained glass to corridor in eastern wing; view (below) of the living room (Fig 43 below) with cornice and fine neo-gothic windows including elaborate bay.

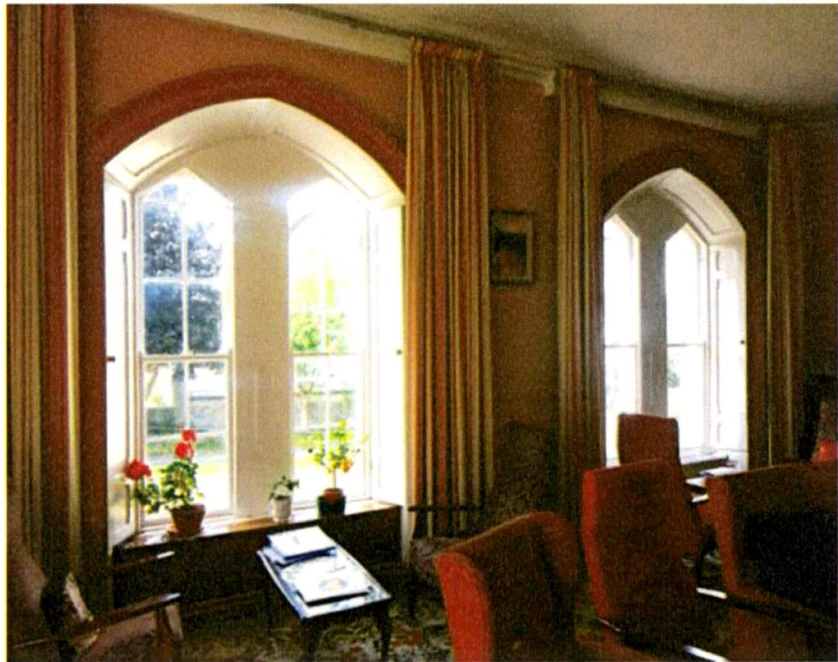
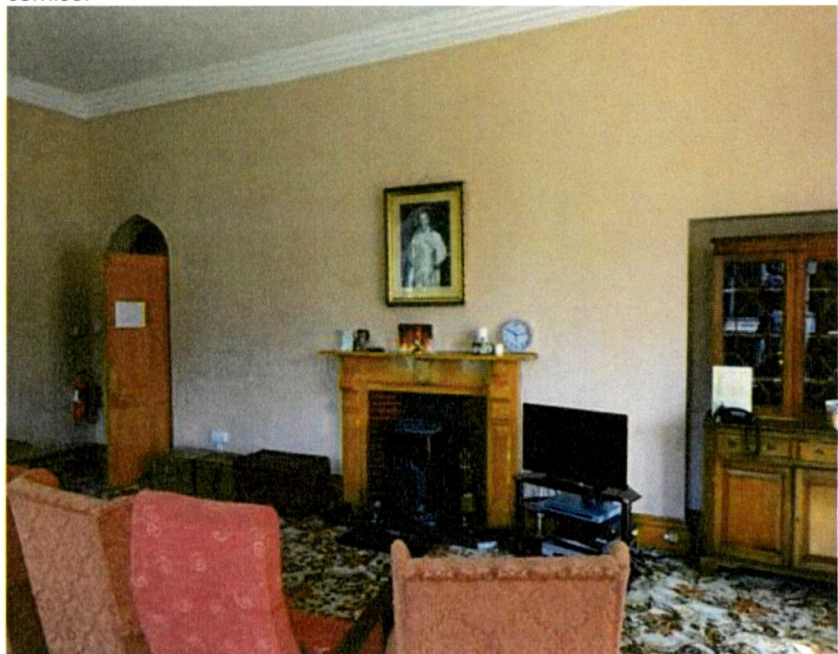
View (Fig 44 - above of paired neo-gothic windows within living room and original shutters and (Fig 45 - below – original chimneypiece to match others and straight run cornice.

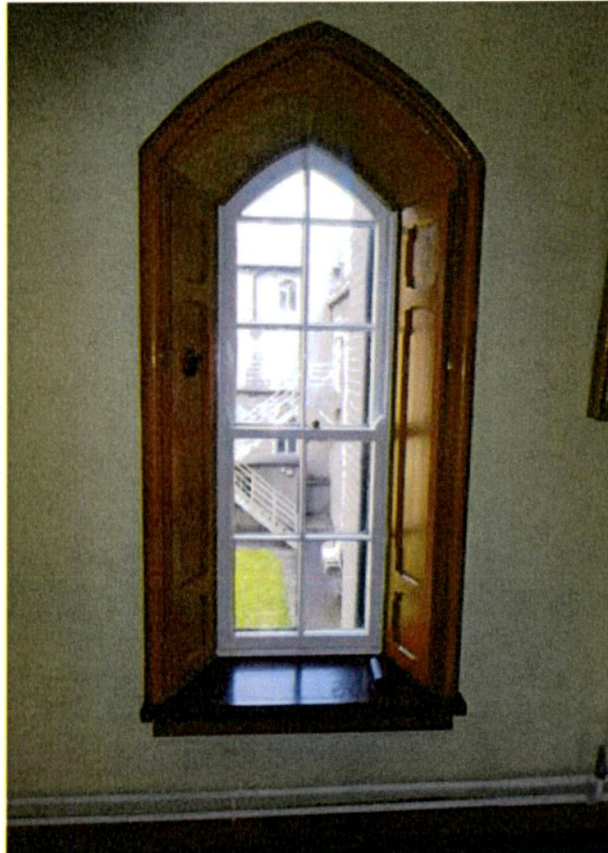
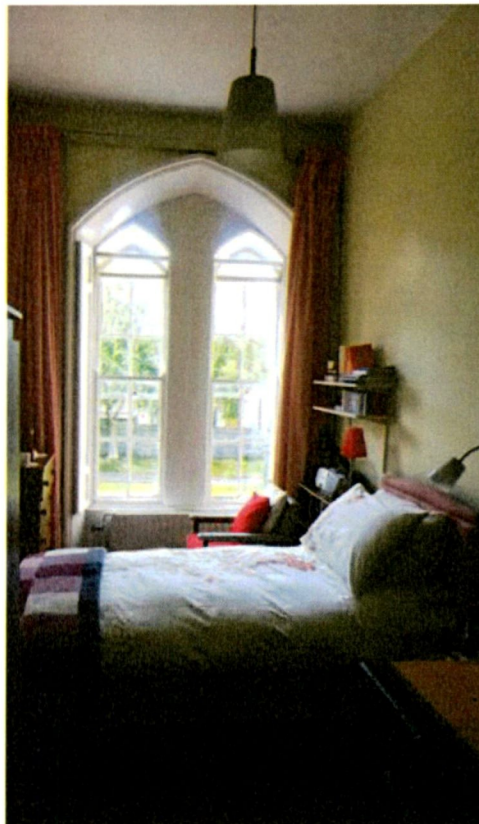
View (Fig 46 above) into courtyard with original sliding sash and stained wood window casings in inner corridor within southern wing; View (Fig 47 below) within corner bedroom at junction of southern and western wing.

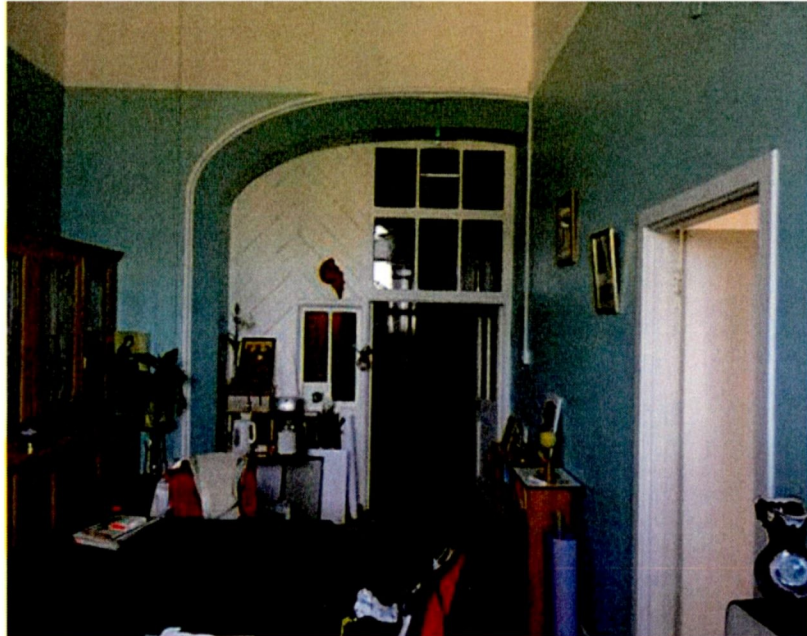
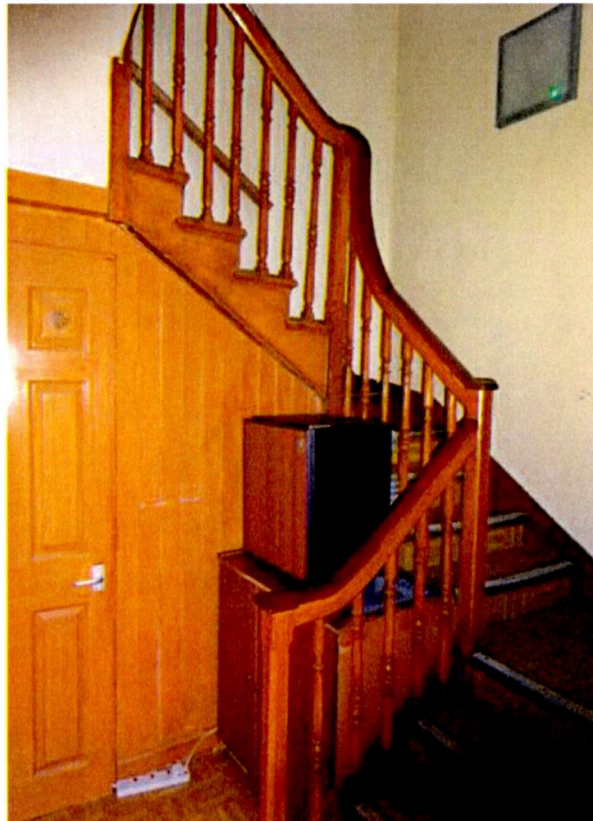
Fig 48 : View (above) of large arched opening between three storey and two storey sections of southern wing with later partitions cutting across archway. Fig 49: View (below) of secondary staircase (04) which allows access to second floor.

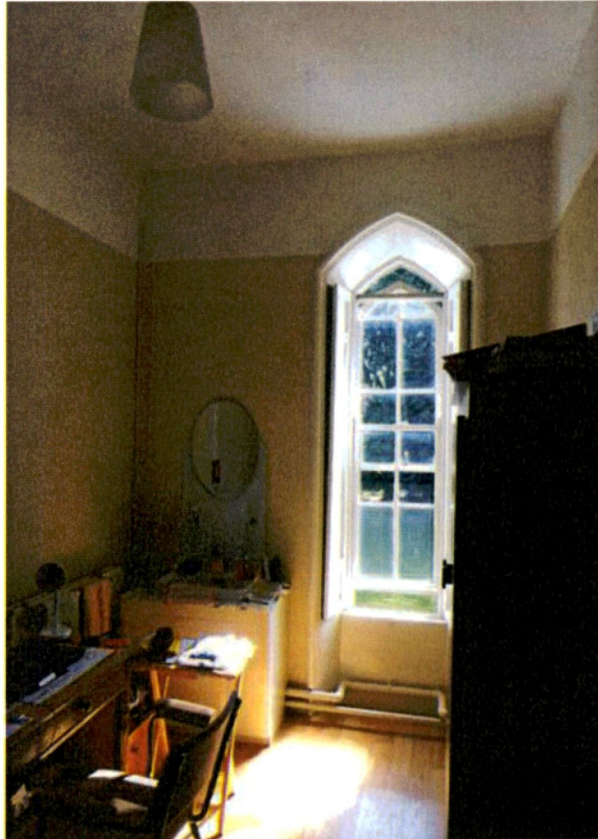
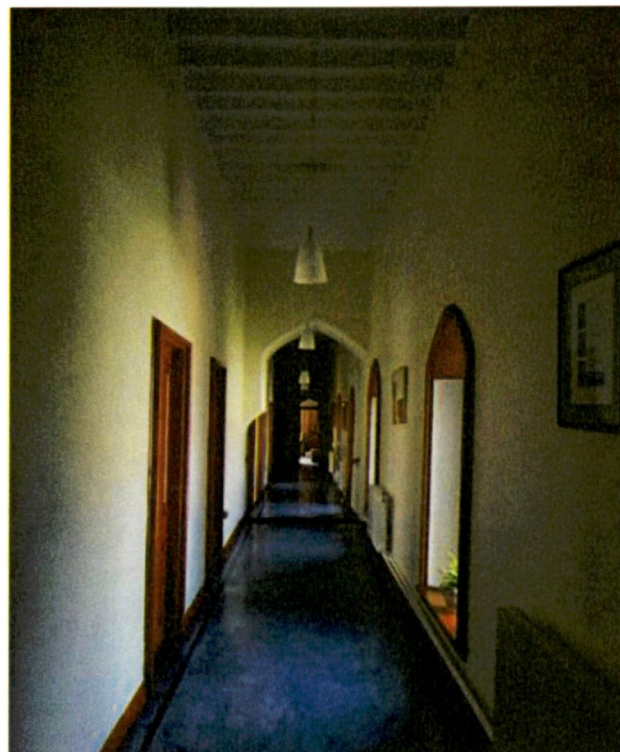
View (Fig 50 above) within first floor room noting plain interiors without embellishment retaining original window casings. View (Fig 51 below) with stepped archway breaking length of corridor and exposed ceiling joisted ceiling.

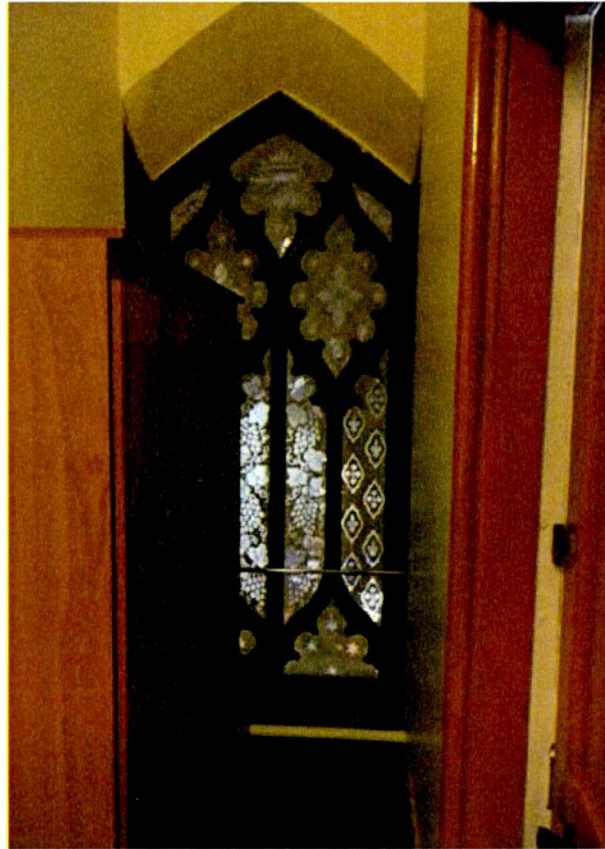
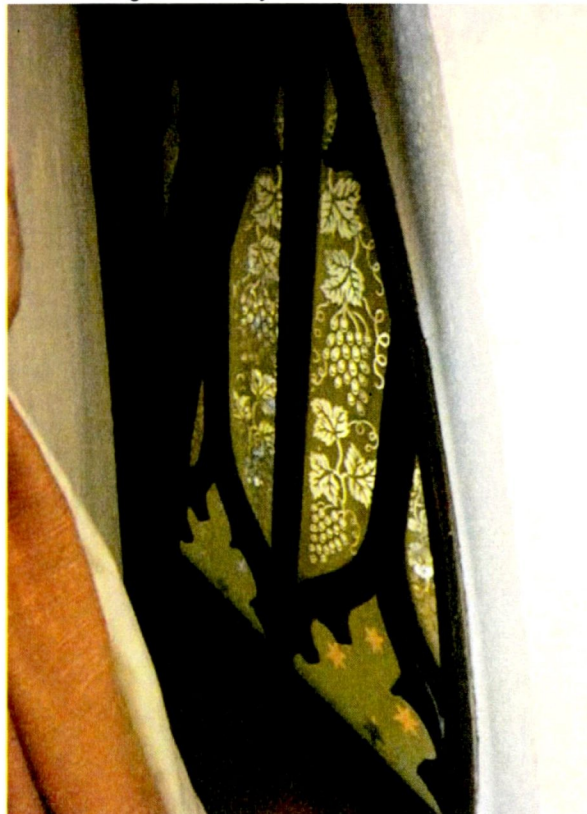
View (Fig 52 above and Fig 53 below) at termination of corridor running along eastern wing with partially obscured window overlooking main body of the parish church with etched glass and neo-gothic tracery

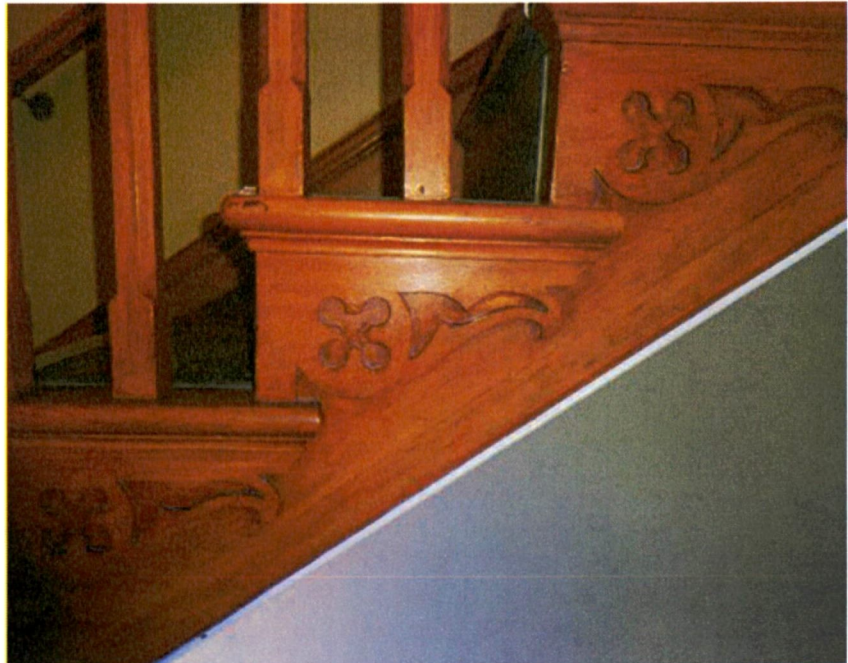
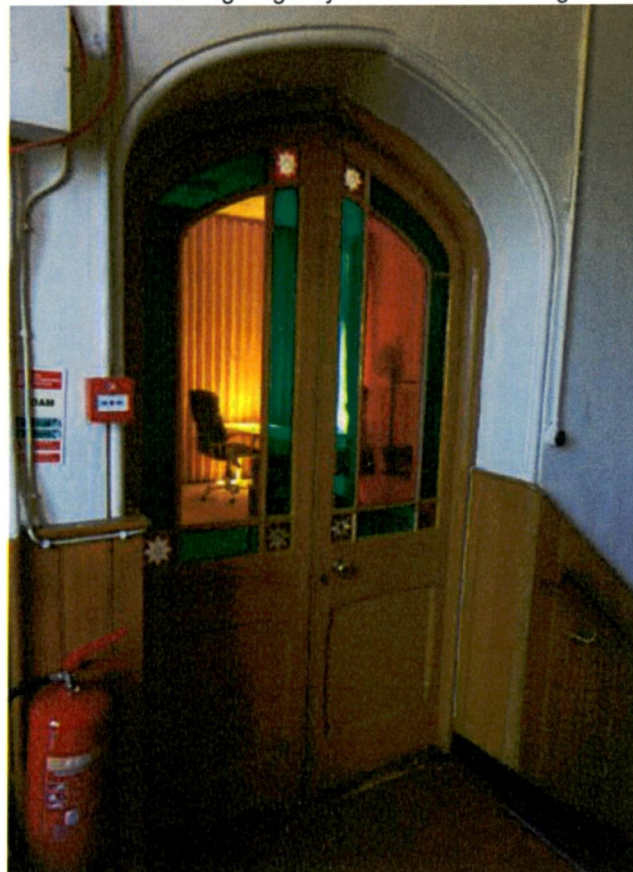
Detail (Fig 54 above) of decorated stair-end at staircase 03 within western wing and view (Fig 55 below) to double door to upper parish meeting room with stained glass sidelights in a manner combining Regency influences with neo-gothic forms.

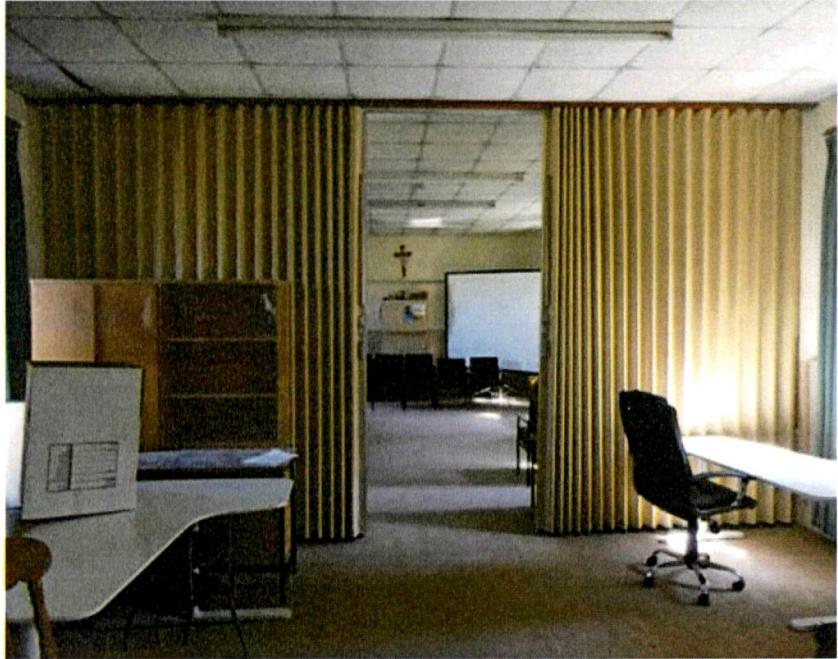
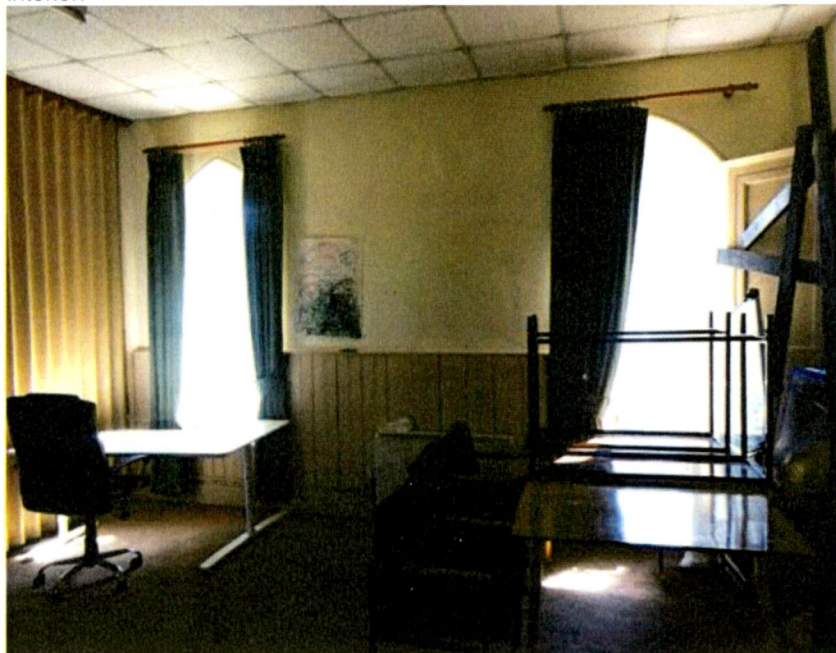
View (Fig 56 above and Fig 57 below) of the upper parish meeting room with modern lowered ceiling and original windows and casing extant – otherwise a modernised interior.

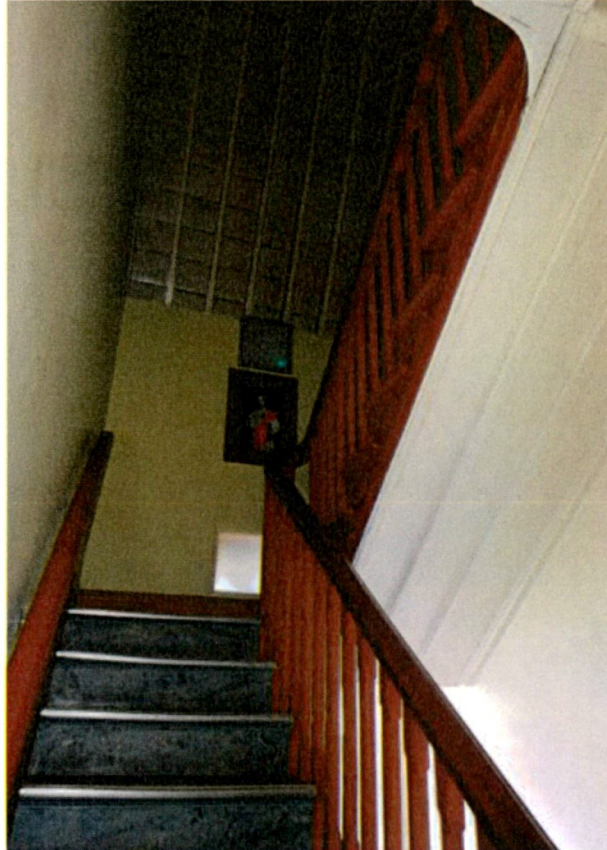
Fig 58: Staircase (01) continues to the second floor landing with continuous handrail and consistent standard and quality of joinery. Expressed joisting to underside of staircase.

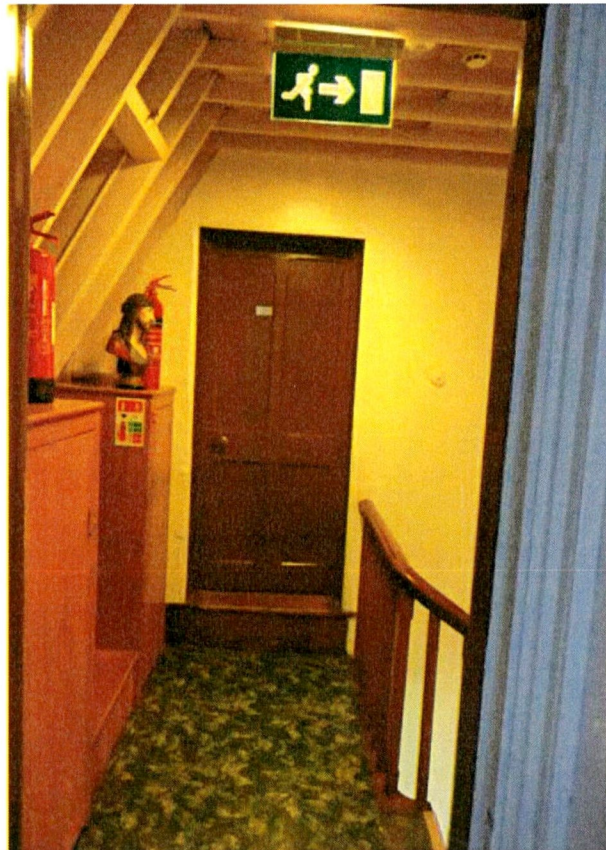
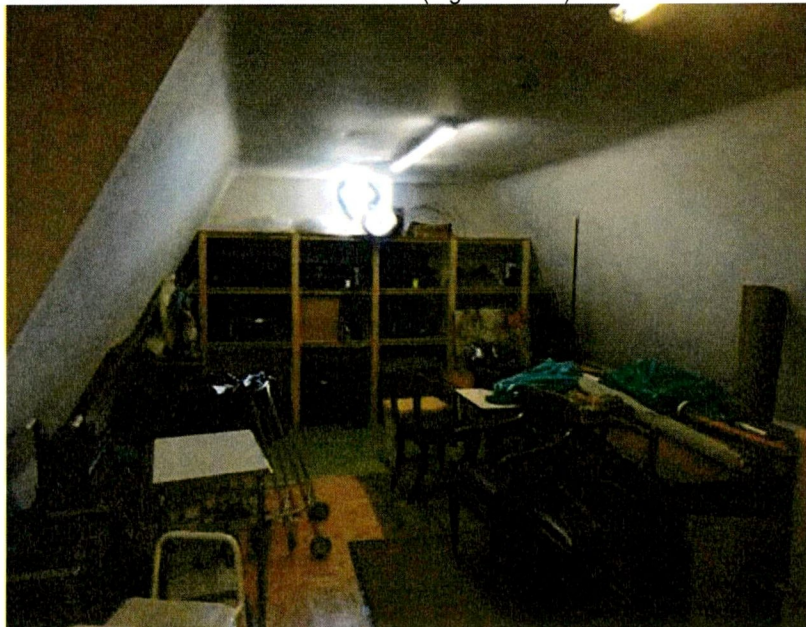
View (Fig 59 above) of top landing with robust utilitarian detailing and otherwise plain and functional interiors as at attic room (Fig 60 below).

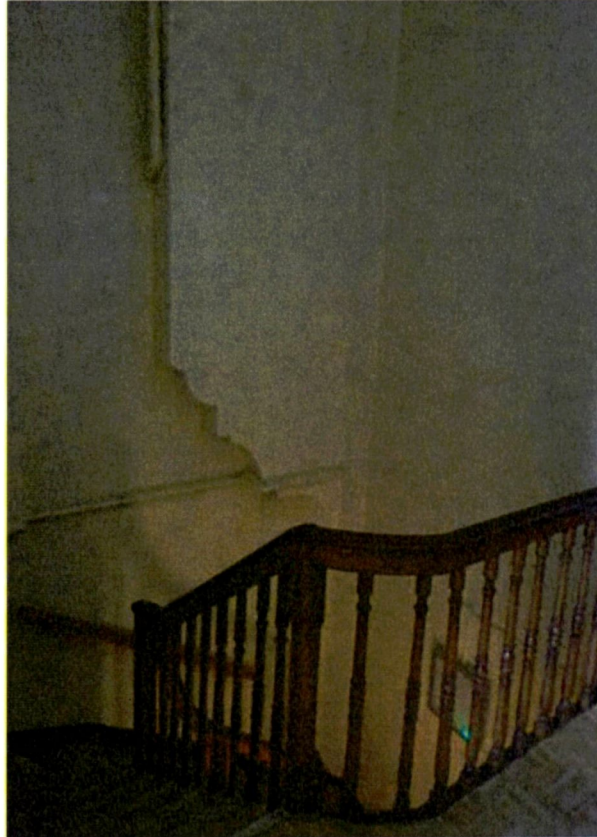
Fig 61 above: Top second floor landing of secondary staircase (04) with unusual expressed moulded corbel supporting chimney stack above and captured within the staircase suggesting possible phasing of construction.

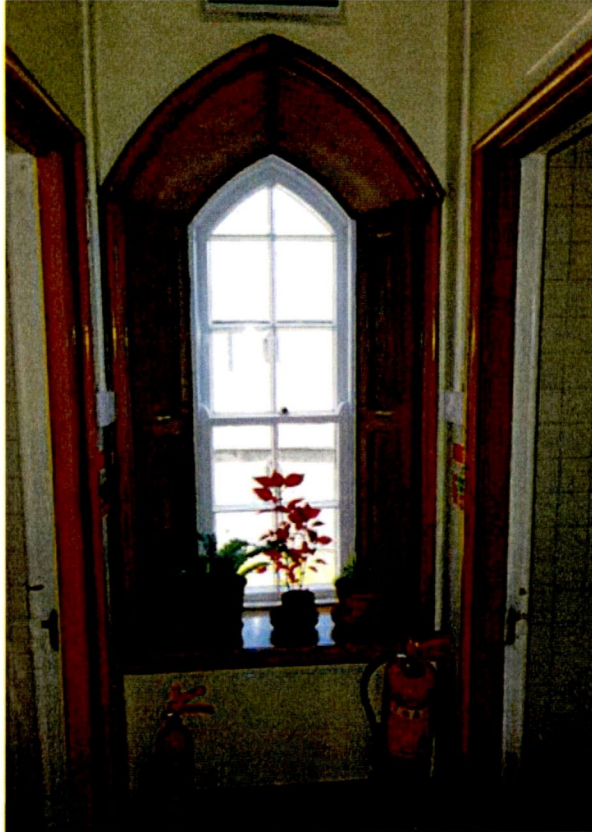
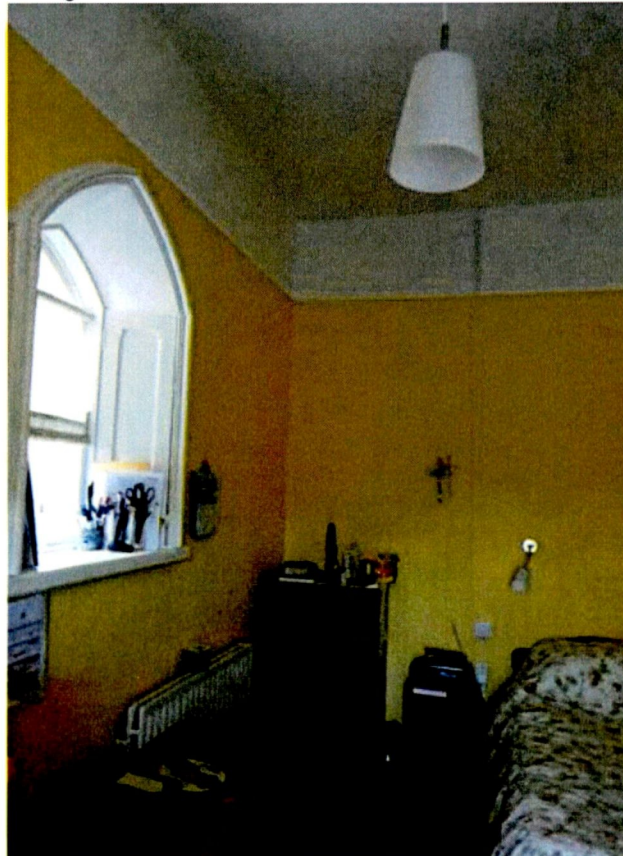
Views (Fig 62 above and Fig 63 below) of second floor windows within this portion of the southern wing.

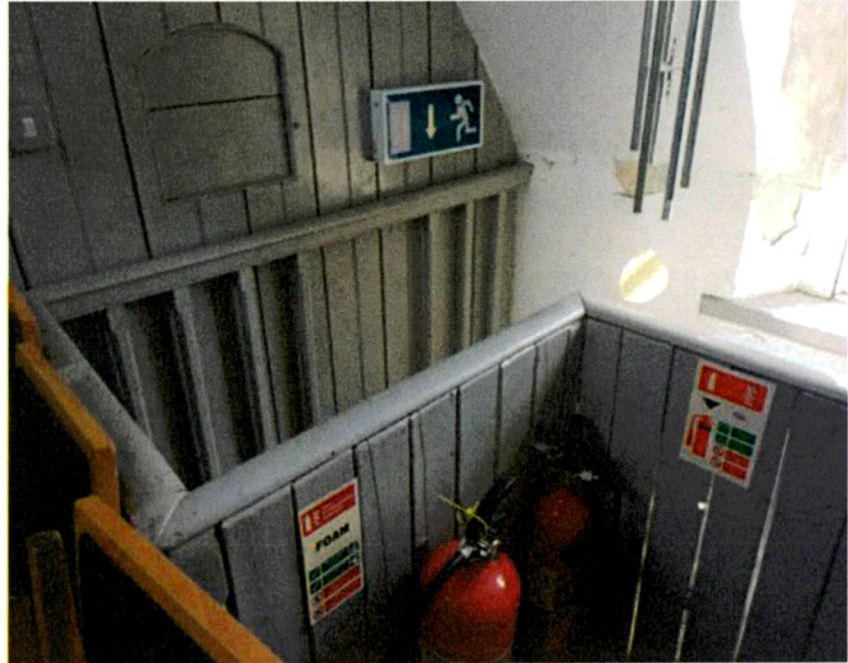
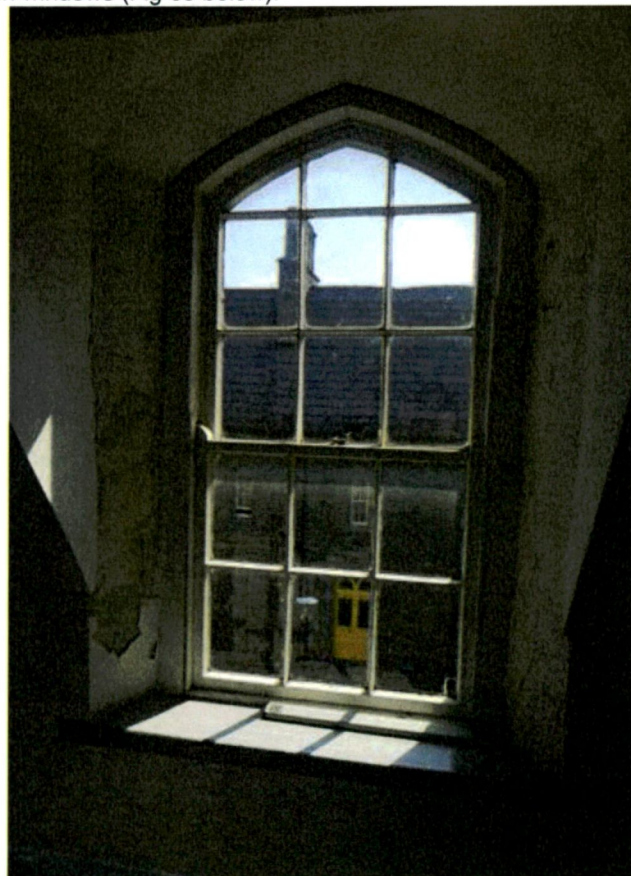
(Fig 64) Second floor portion of western wing with later sheeted timber partitions inserted along balustrades with top landing window with plainer reveals but original sliding sash windows (Fig 65 below).

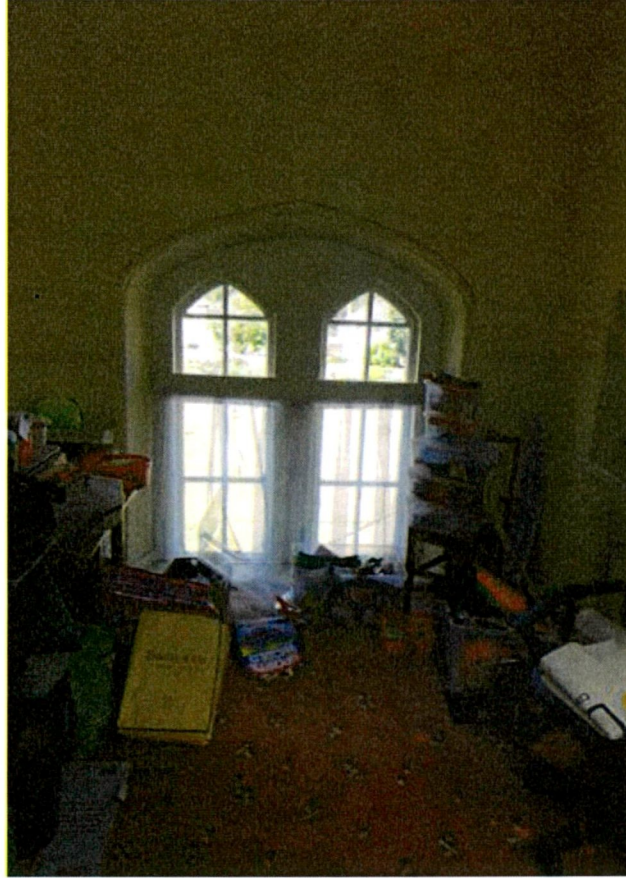
(Fig 66) - Paired neo-gothic windows within second floor of staircase tower (staircase 02) noting inserted floor cutting across windows.
