SuDS Management Plan

Unit 1, M50 Business Park

Client: Creighton Properties LLC

Job Number: 22_112

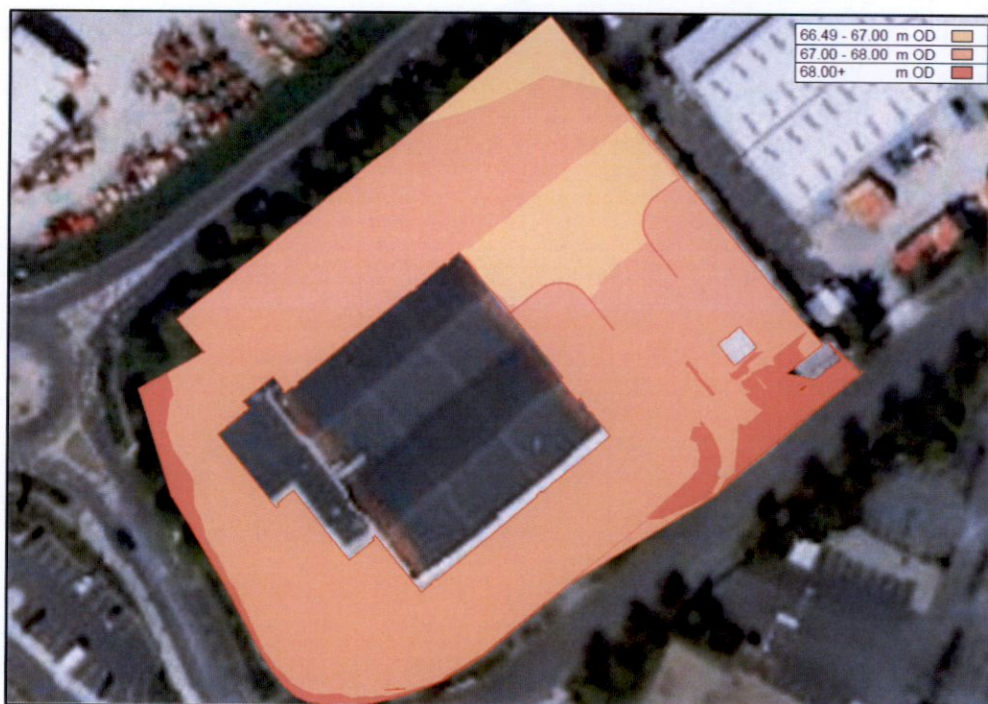
The site generally falls from southwestern boundary to northeastern boundary with existing ground levels varying between 68.14 m OD to 66.49 m OD. The existing site topography is shown in Figure 2.

Figure 2 Existing Site Topography.

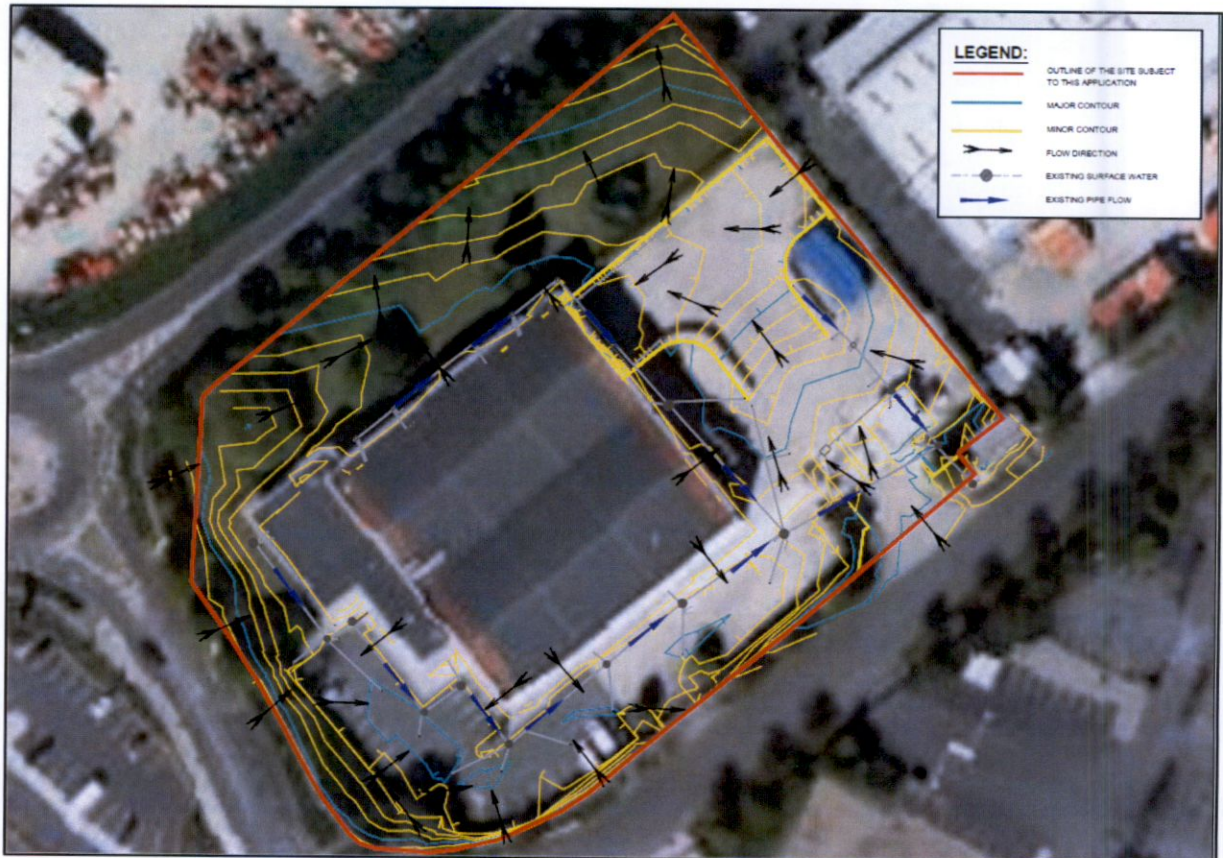
The existing flow route analysis is shown in Figure 3 below, which demonstrates how the existing site behaves. It depicts the existing flow conveyance, overflow arrangements and exceedance routes.

Figure 3 Existing Flow Route Analysis.

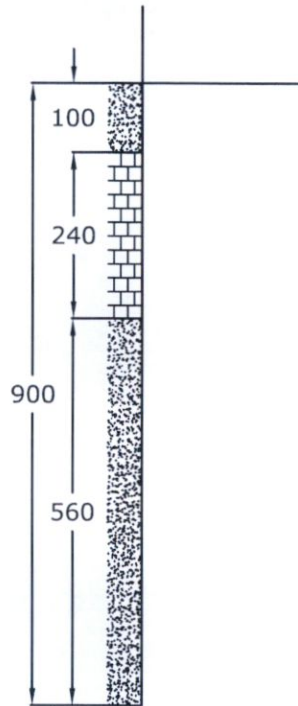
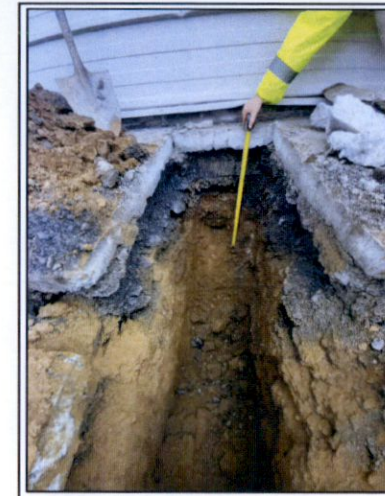
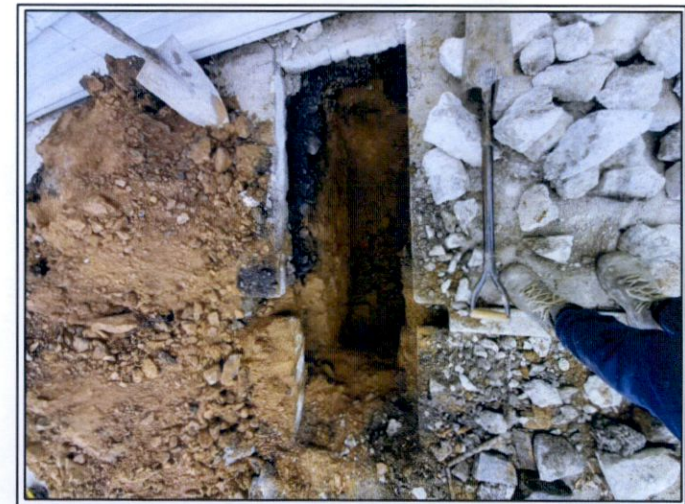
FIP01

100mm concrete overlying 240mm blocks overlying 560mm concrete. No extension from building wall.

- 0.00m:** MADE GROUND: concrete.
- 0.10m:** MADE GROUND: grey silty sandy gravel (mixed CL.804 and Cl. 6F2).
- 0.54m:** Firm brown slightly sandy gravelly silty CLAY with medium cobble content.
- 1.40m:** Pit terminated.

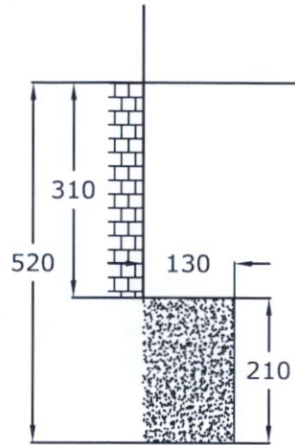
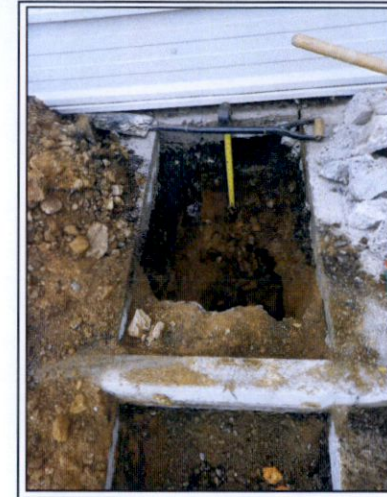
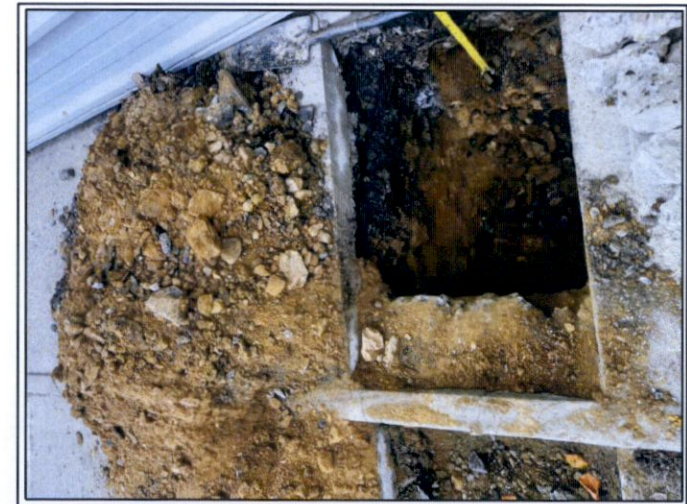
FIP02

310mm concrete blocks overlying 210mm concrete foundation, extends 130mm from wall.

- 0.00m:** MADE GROUND: concrete.
- 0.10m:** MADE GROUND: grey silty sandy gravel (mixed CL.804 and Cl. 6F2).
- 0.35m:** Firm brown slightly sandy gravelly silty CLAY with medium cobble content.
- 1.20m:** Pit terminated.

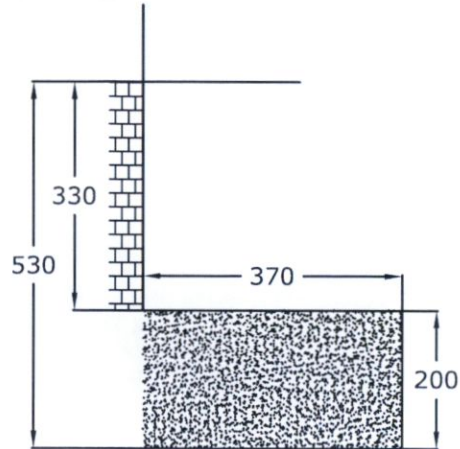
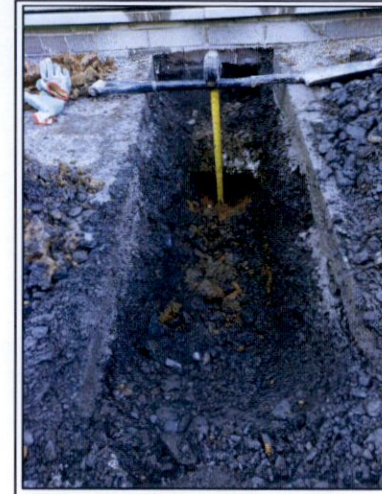
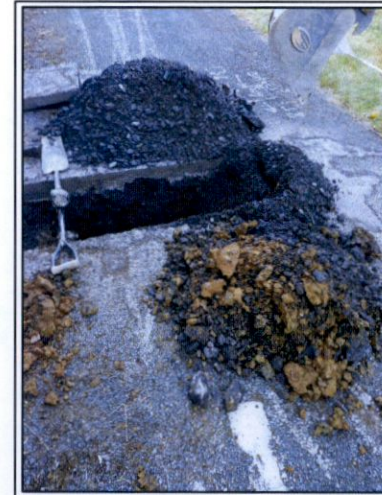
FIP03

330mm concrete blocks overlying 200mm concrete foundation, extends 370mm from wall.

- 0.00m:** MADE GROUND: tarmacadam.
- 0.06m:** MADE GROUND: grey silty sandy gravel (CL.804).
- 0.44m:** Firm brown slightly sandy slightly gravelly silty CLAY with medium cobble content.
- 0.60m:** Pit terminated.

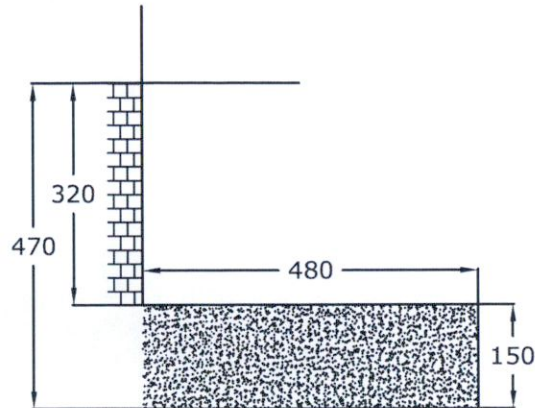
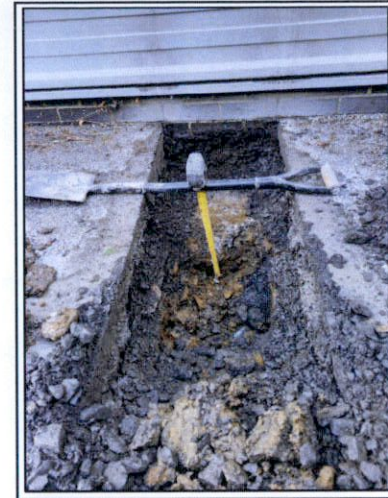
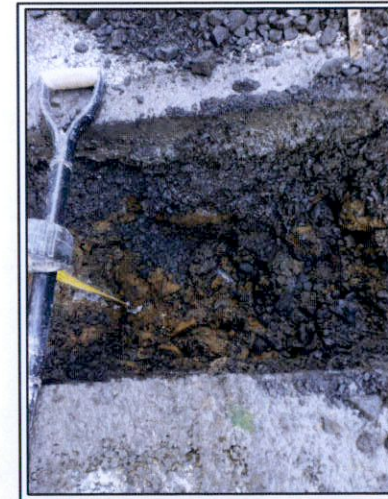
FIP04

320mm concrete blocks overlying 150mm concrete foundation, extends 480mm from wall.

- 0.00m:** MADE GROUND: tarmacadam.
- 0.06m:** MADE GROUND: grey silty sandy gravel (CL.804).
- 0.36m:** Firm brown sandy gravelly silty CLAY with medium cobble content.
- 0.55m:** Pit terminated.

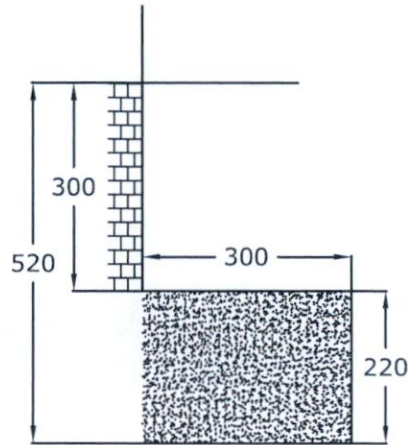
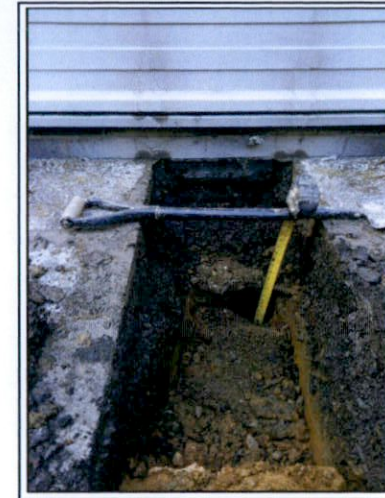
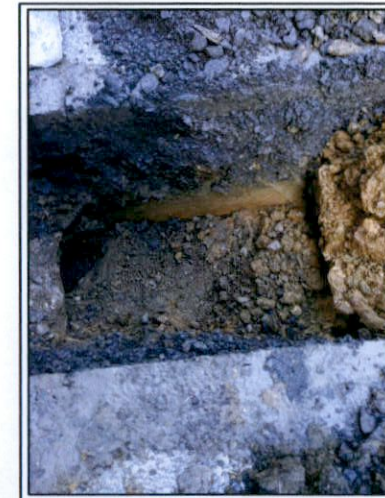
FIP05

300mm concrete blocks overlying 220mm concrete foundation, extends 300mm from wall.

- 0.00m:** MADE GROUND: tarmacadam.
- 0.06m:** MADE GROUND: grey silty sandy gravel (CL.804).
- 0.18m:** Firm brown slightly sandy slightly gravelly silty CLAY with medium cobble content.
- 0.60m:** Pit terminated.

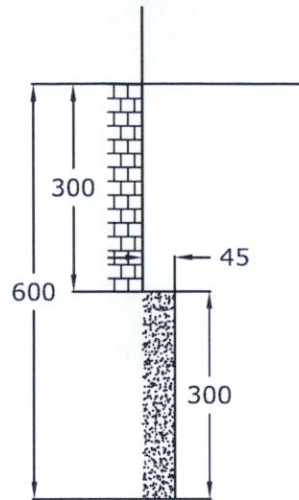
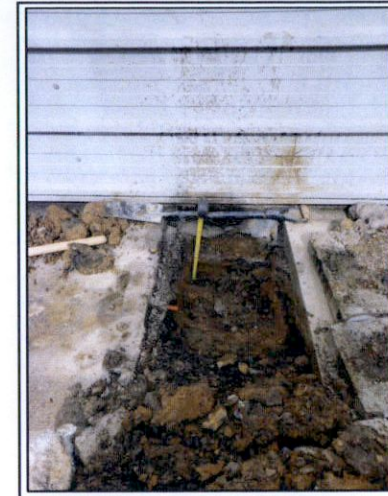
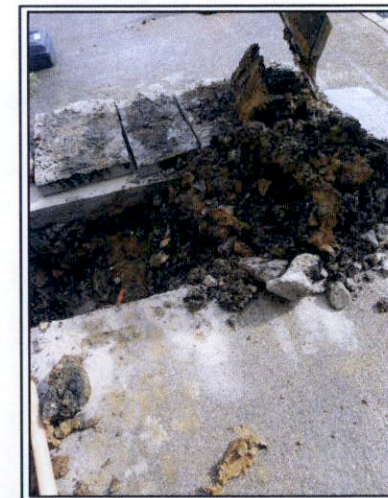
FIP06

300mm concrete blocks overlying 300mm concrete foundation, extends 45mm from wall.

0.20m: Firm brown slightly sandy slightly gravelly silty CLAY with medium cobble content.

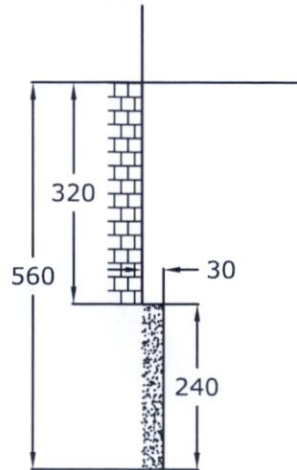
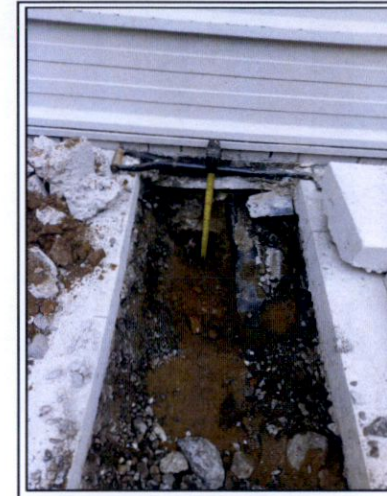
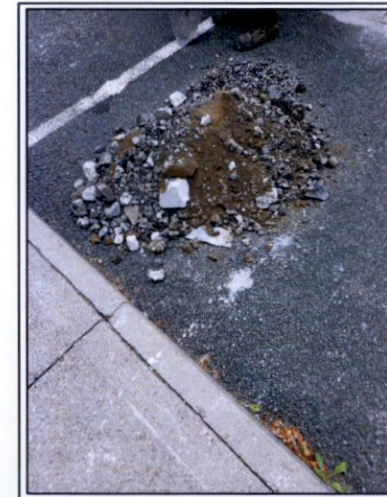
FIP07

320mm concrete blocks overlying 240mm concrete foundation, extends 30mm from wall.

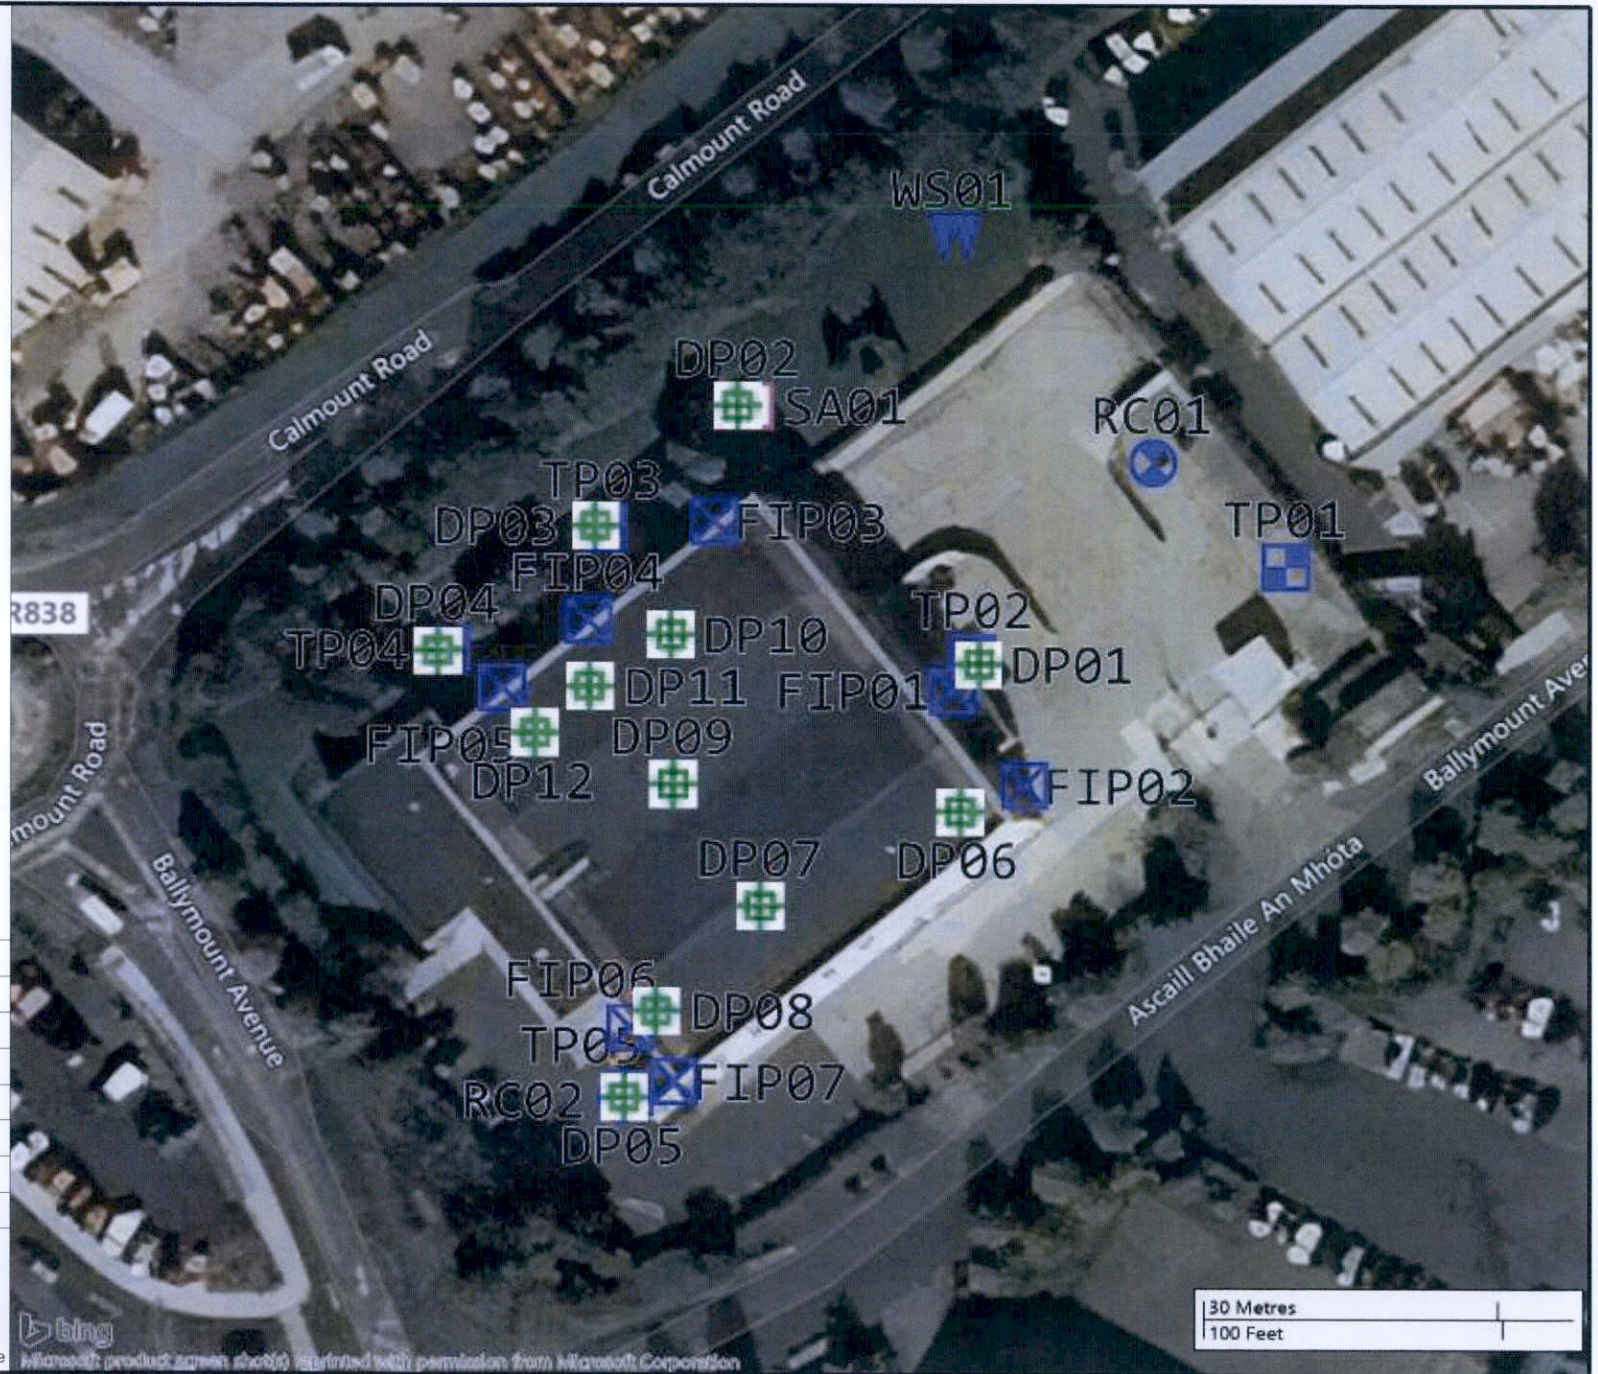
Contract No:	6032
Contract Name:	DUB602 - Ski Lodge
Location:	Ballymount, Dublin 12
Client:	-
Engineer:	Arup
Title:	Site Plan
Scale:	1:750
Drawn By:	SL

Location	Irish Transverse Mercator		Elevation	Irish National Grid	
	Easting	Northing		Easting	Northing
Trial Pits					
TP01	709884.685	730169.540	67.76	309957.823	230142.364
TP02	709852.288	730159.299	67.51	309925.419	230132.121
TP03	709813.662	730171.918	67.59	309886.784	230144.742
TP04	709797.689	730158.896	67.76	309870.808	230131.717
TP05	709817.922	730113.294	67.60	309891.046	230086.106
Window Samples					
WS01	709849.232	730203.113	67.26	309922.362	230175.944
Dynamic Probes					
DP01	709852.888	730158.629	67.55	309926.019	230131.451
DP02	709827.424	730184.945	67.47	309900.549	230157.772
DP03	709812.865	730172.133	67.56	309885.987	230144.957
DP04	709796.966	730158.727	67.77	309870.085	230131.548
DP05	709817.329	730112.769	67.58	309890.453	230085.580
Soakaway Tests					
SA01	709828.569	730184.944	67.56	309901.694	230157.771
Foundation Inspection Pits					
FIP1	709850.117	730155.804	67.68	309923.247	230128.625

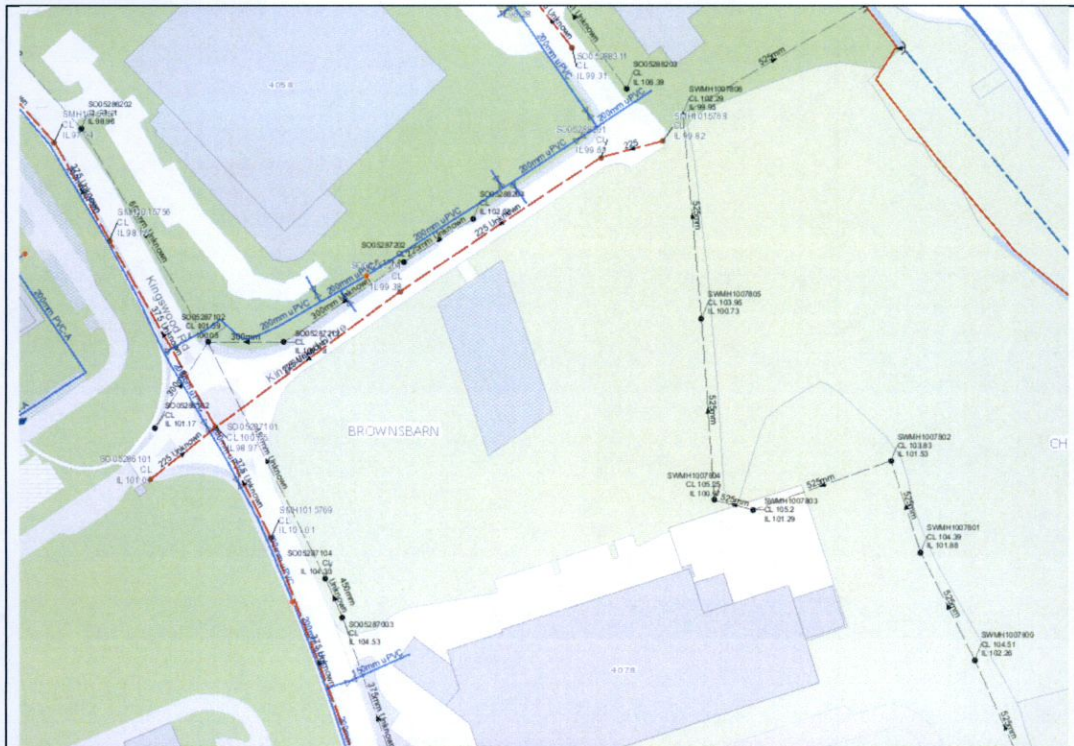
The map included below outlines the current Irish Water infrastructure adjacent the Development: To access Irish Water Maps email datarequests@water.ie

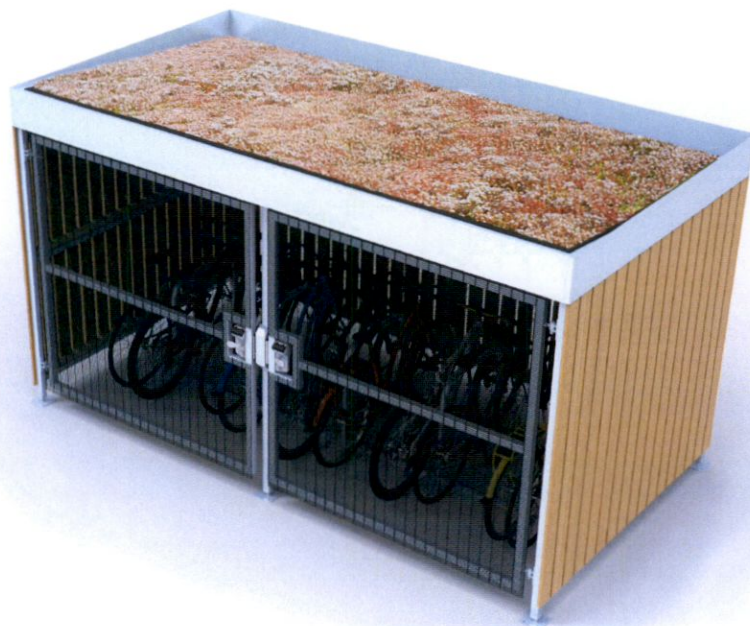
Wooden, Mesh & Green Roof Bike Shelters

The Wooden & Mesh Bike Shelter are an attractive cycle parking solution that is perfect for those seeking an environmentally sustainable solution. They can be fitted with a CO2 capturing sedum Green Roof.

The shelters are ideal with Toast Racks or Semi Vertical Bike Rack, enabling users to lock their bikes up securely inside the unit. This product comes with swing or sliding gates.
