1078/D2/Trees Preservation & Protection Note 00123 03.2022.pptx

Site Trees Preservation & Protection

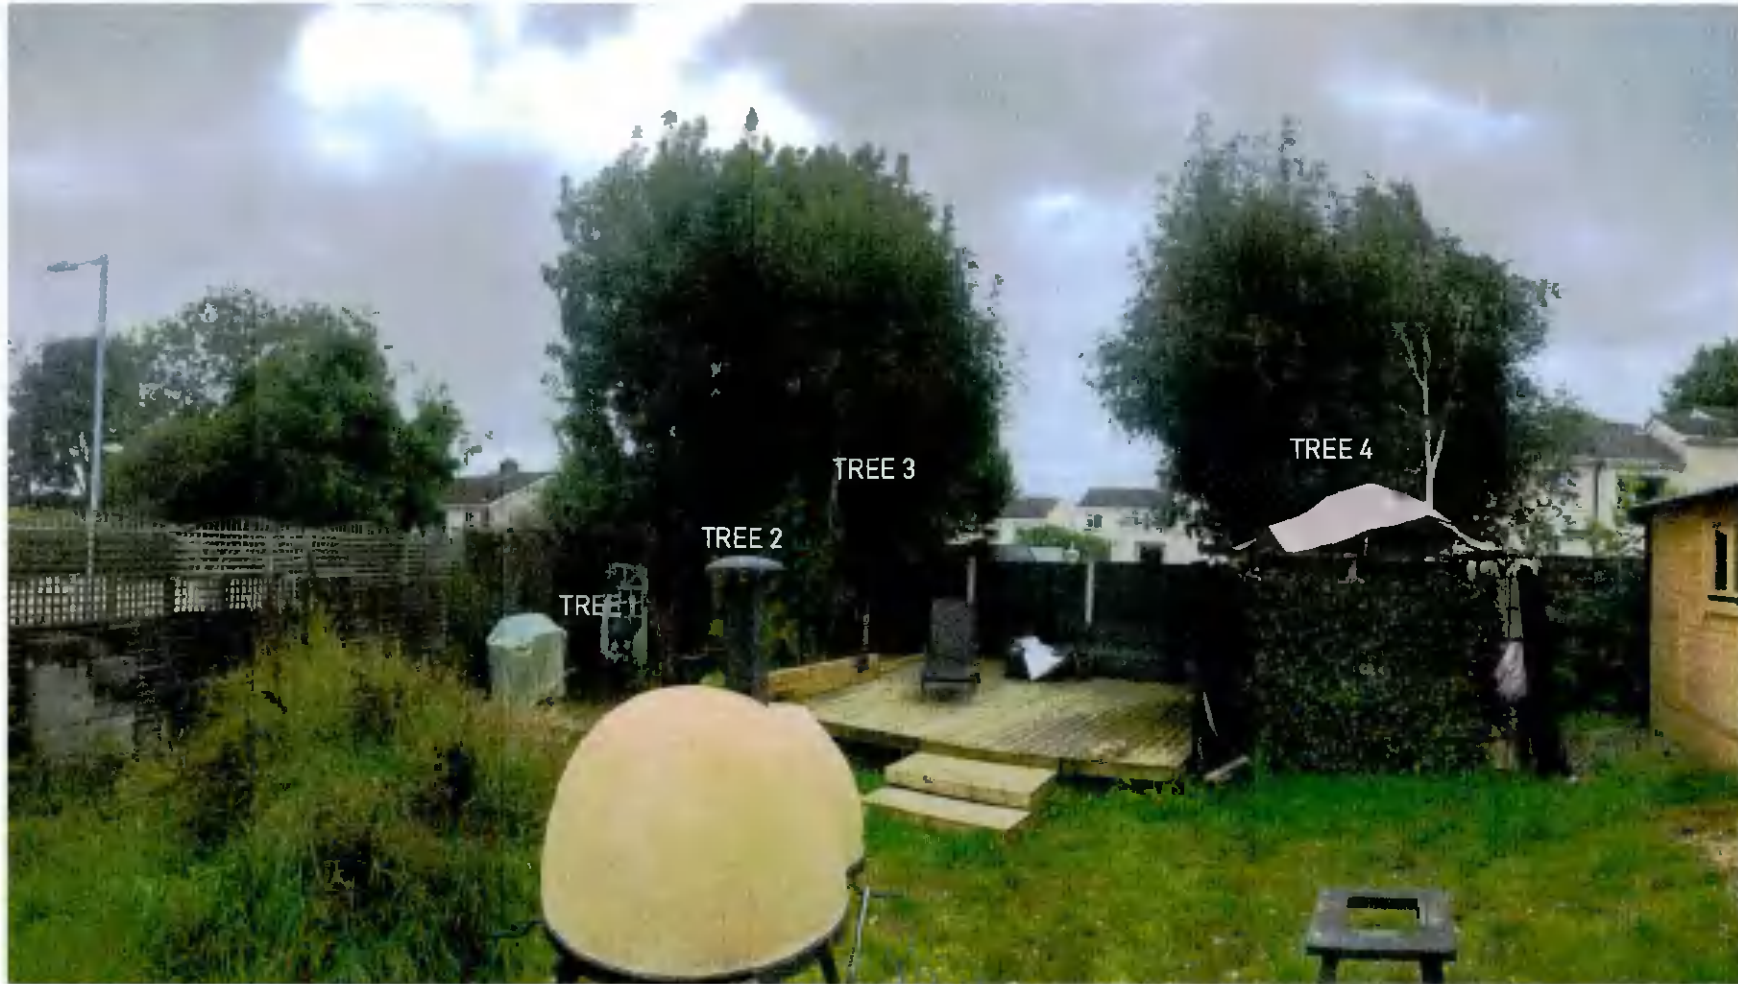
All the existing mature tree clusters on the site marked TREE 1 - 4 on the site layout plan have been identified & located on the drawings, they form a cluster of 3 trees (marked TREE 1 - 3) to the north east corner of the site located 1.2m within the existing boundary, and a single tree (marked TREE 4) further south along the eastern or rear boundary 0.85m within the boundary

Fig 1. View to east/rear boundary from within site

Existing Trees to be retained & protected all tree works to be carried out in accordance with BS3998:2010 Tree Work Recommendations

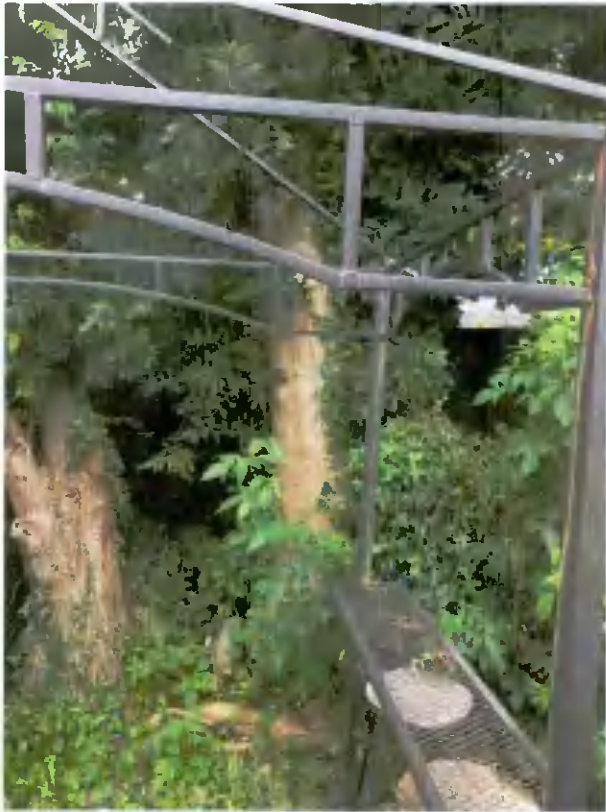
The trees based on initial inspection consist of native Ash *Fraxinus Excelsior* species of mixed mature and recent offshoots and overall are 8m+ in height with a spread of 6m approximately, and have not had recent care & maintenance, & with some metal boundary wires embedded/attached to TREE 2

Fig 2. TREE 1 & 2

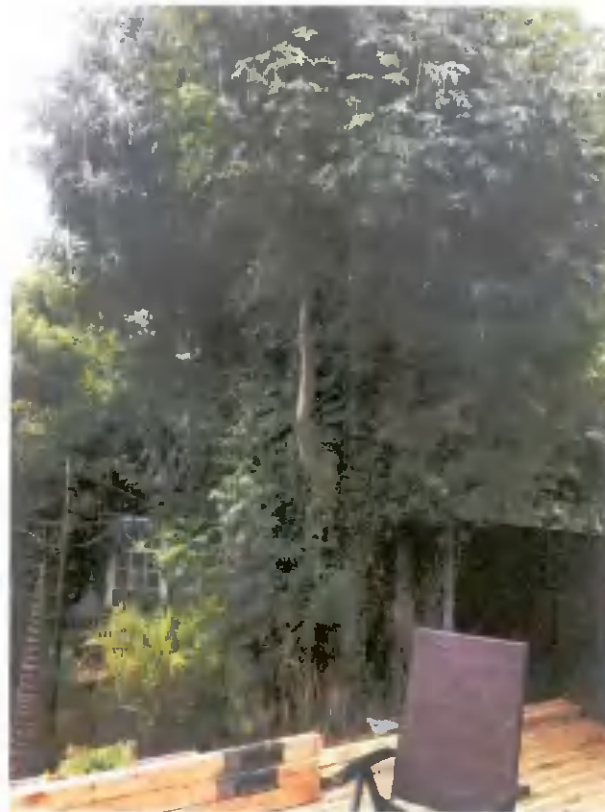
Fig 3. TREE 3

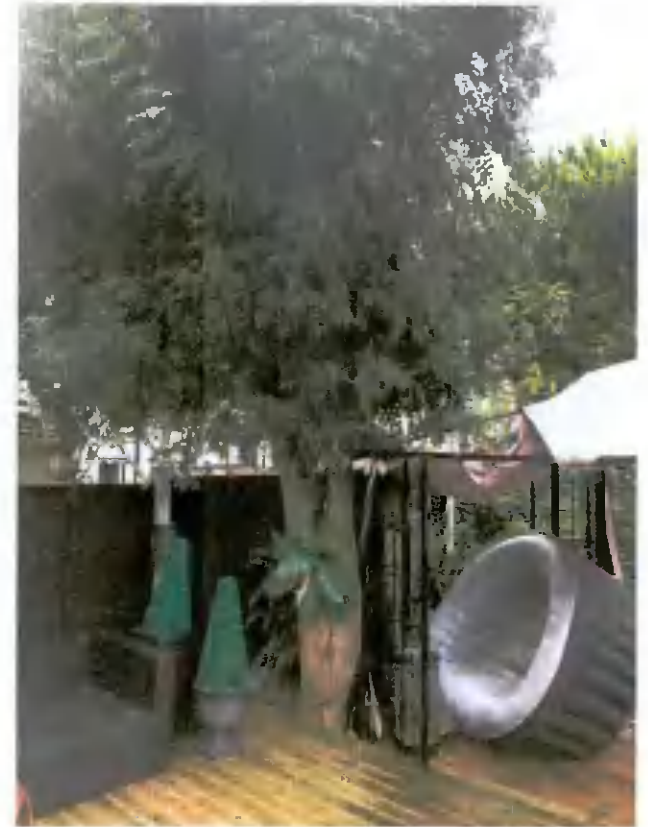
Fig 4. TREE 4
