Client: Quintain Developments Ireland Ltd.

Project: Tree Survey, Tandys Lane Village, Adamstown, Co Dublin

Description: Tree Impacts Plan

Drawing Title: Tandys Lane Village Tree Impacts Plan

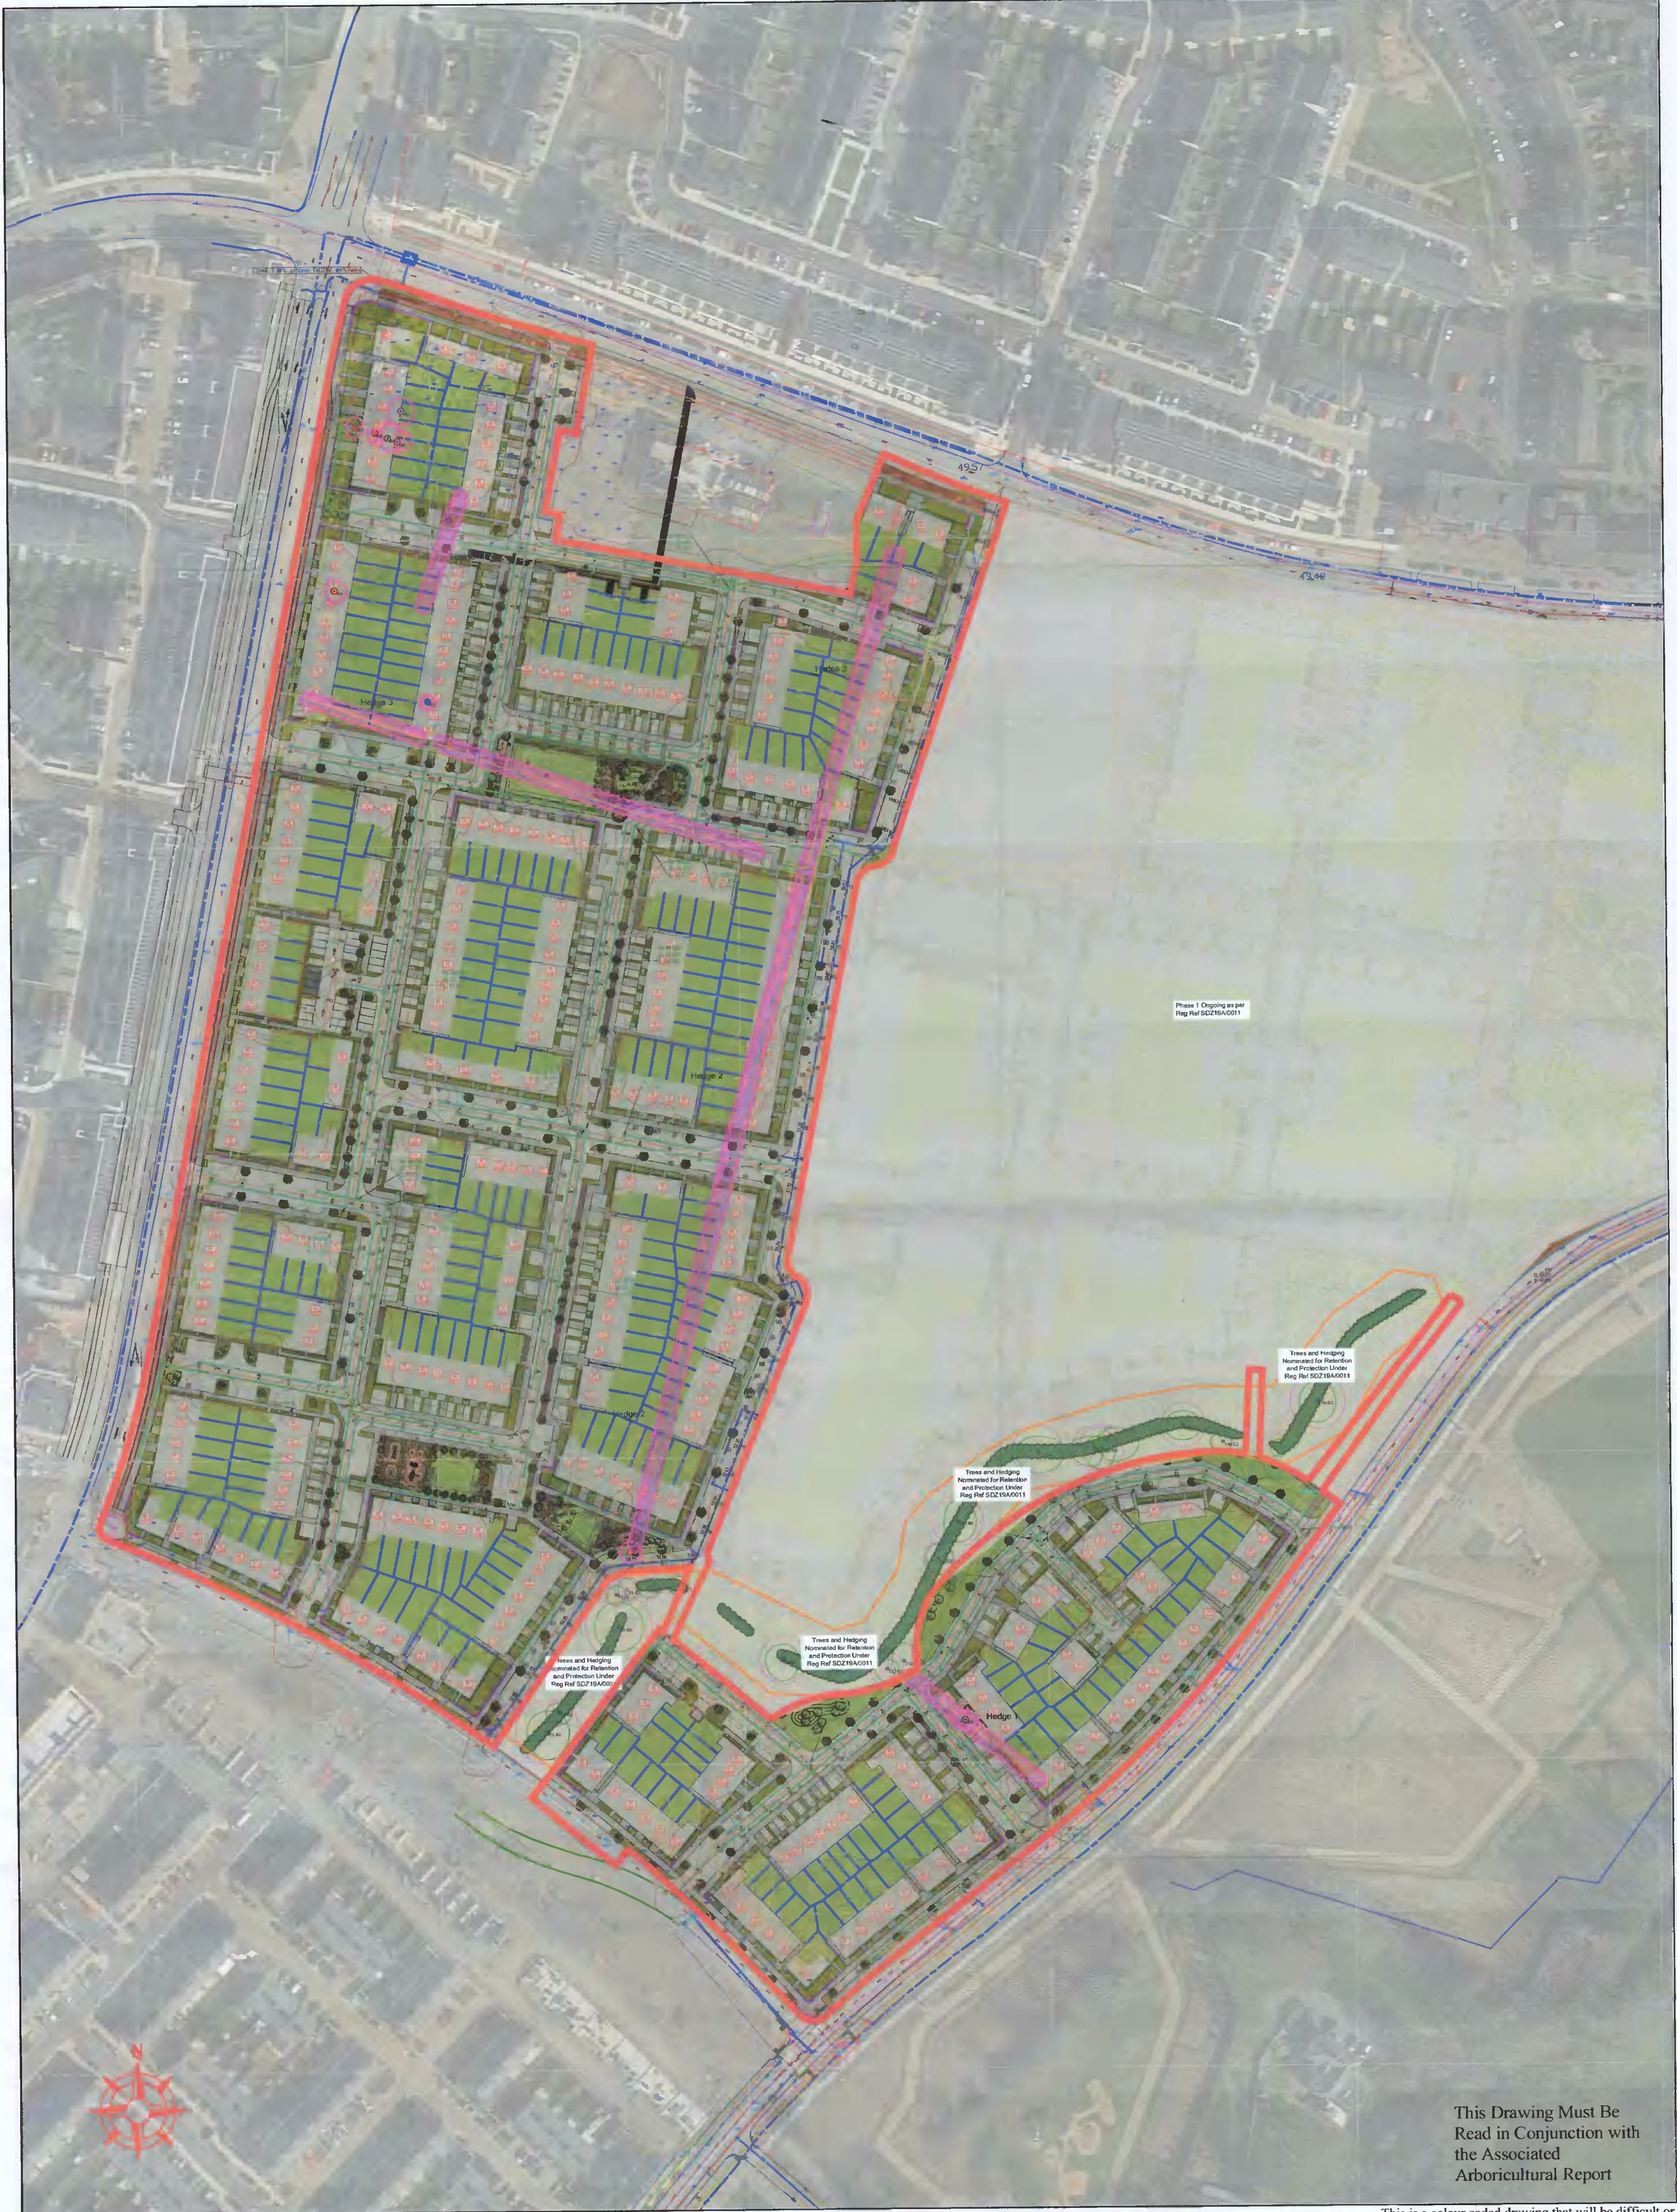
Tandys Lane Village Tree Impacts Plan 1/1 Scale 1:500 @ A1

- Trees Intended for Retention - Solid Green Crown Outline
- Trees Intended for Removal in Conjunction With Development Works - Broken Pink Crown Outline
- Hedge or Group Intended for Retention - Solid Green Crown Outline
- Hedge or Group Intended for Removal in Conjunction With Development Works - Broken Pink Crown Outline

- Category "A" Trees (Green Button) Excellent Quality Trees
- Category "B" Trees (Blue Button) Good Quality Trees
- Category "C" Trees (Grey Button) Mediocre to Poor Quality Trees
- Category "U" Trees (Red Button) Dead, Dying or Otherwise Compromised Trees that are Unsustainable.

- Canopy Extent
  - Cardinal Radii
  - Category Code
  - Stem Circumference
  - Root Protection Area (RPA)
- Canopy is drawn to account for any natural asymmetry or imbalance. Crown Representation is scaled to account for north, east, west and south radii.
- Root Protection Area (RPA)  
This area relates the "RPA" radius as defined in the Tree Survey Table and is measured from the tree centre. This area defines the preliminary Construction Exclusion Zone (CEZ) that must be protected by fencing from the potentially damaging affects of construction activity.
