Drainage Layout scale 1:100.

Drainage Plans By Applicant
ARE INCORRECT.!

Proposed Drainage Layout scale 1:50.

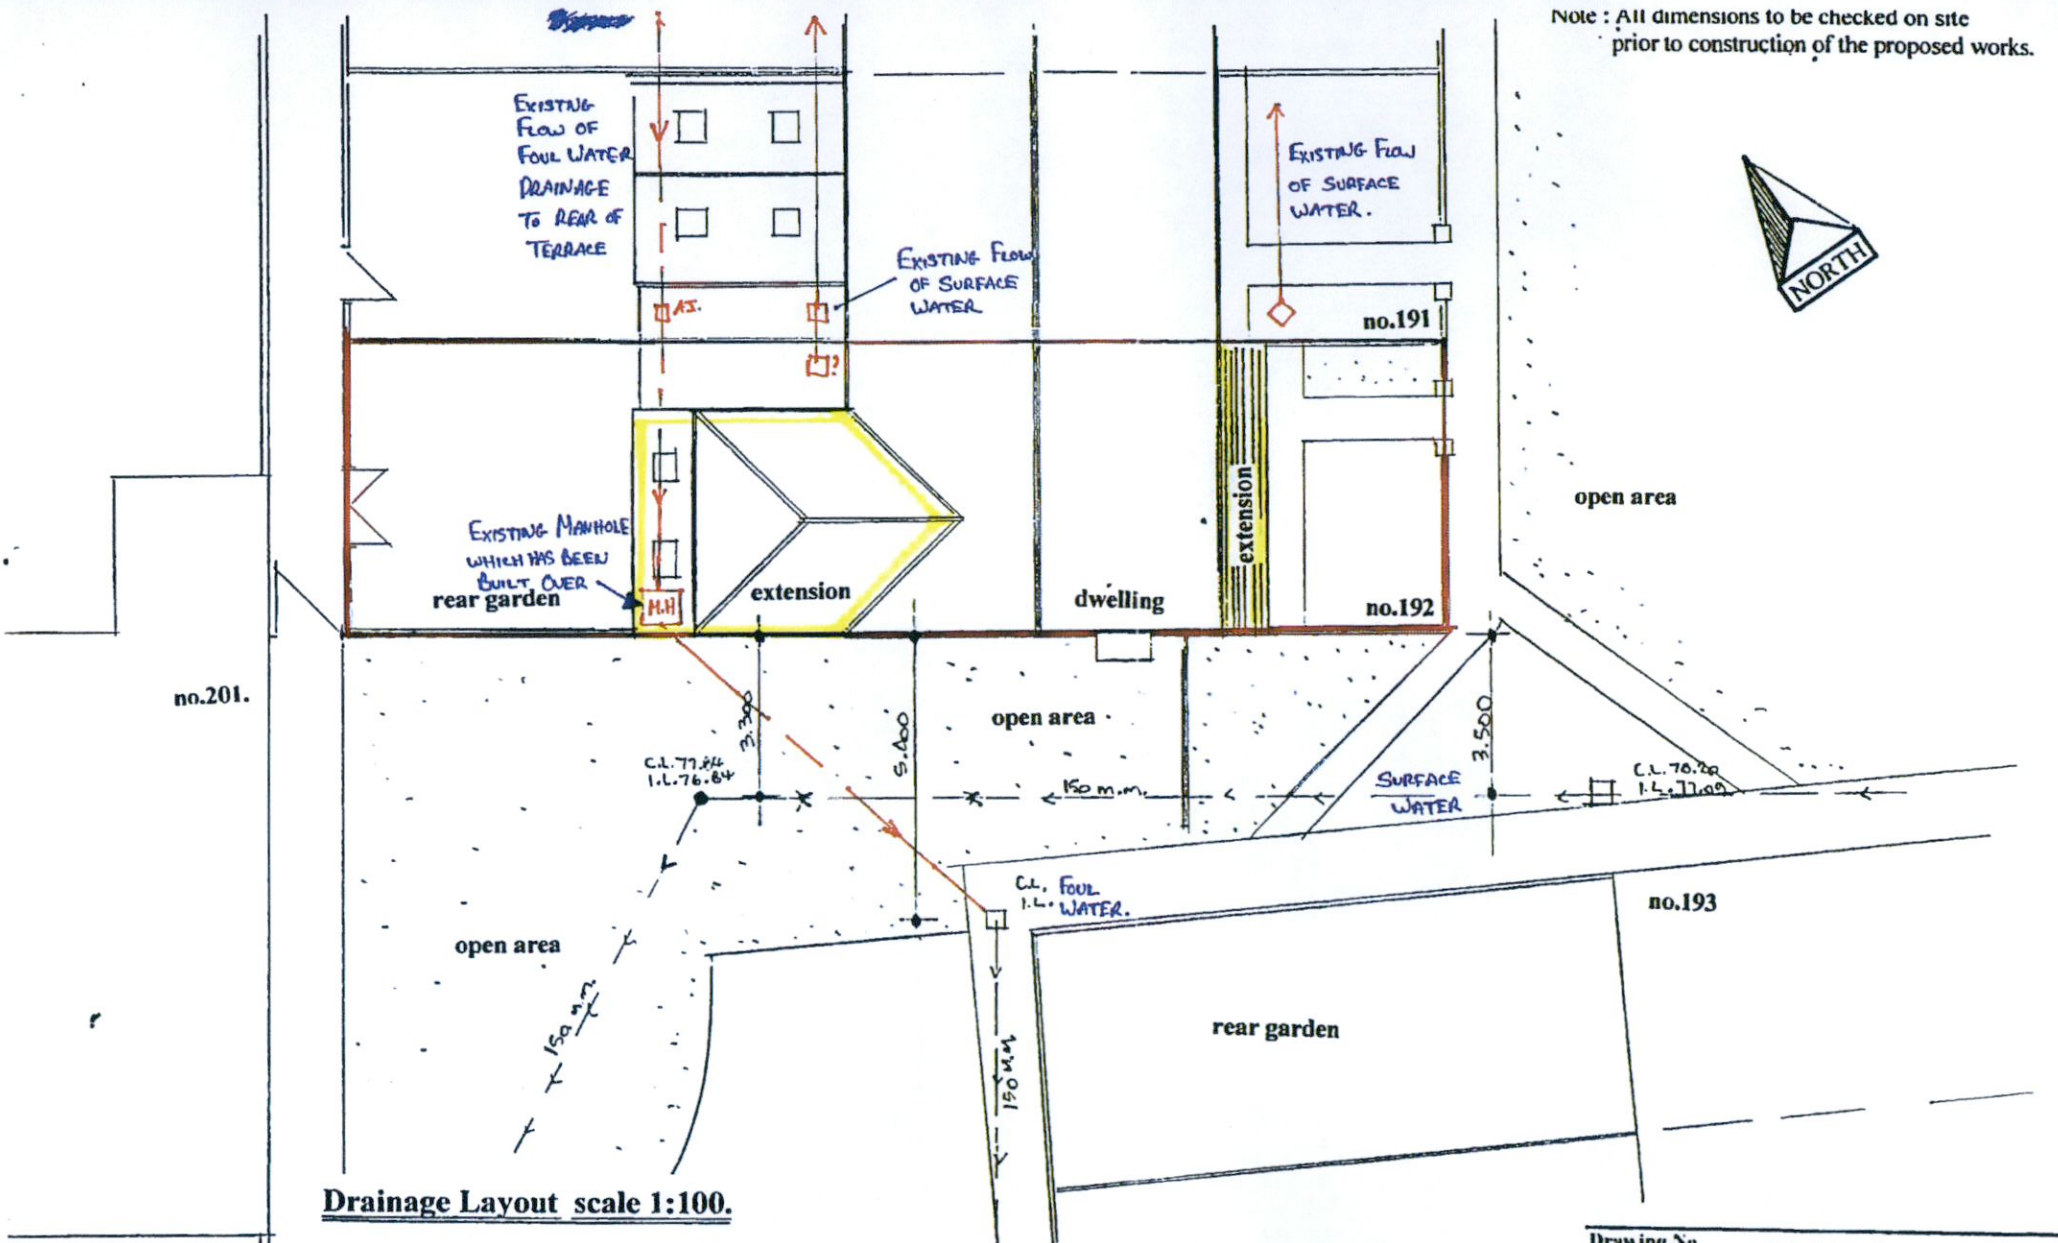
CONNECTS TO ADJACENT FOUL M.H. FLOW IS EASILY ESTABLISHED.
EXISTING FOUL WATER MAINHOLE HAS BEEN BUILT OVER.

No Details Provided For Location Distances To Boundaries.

REAR GARDEN FLOODING.

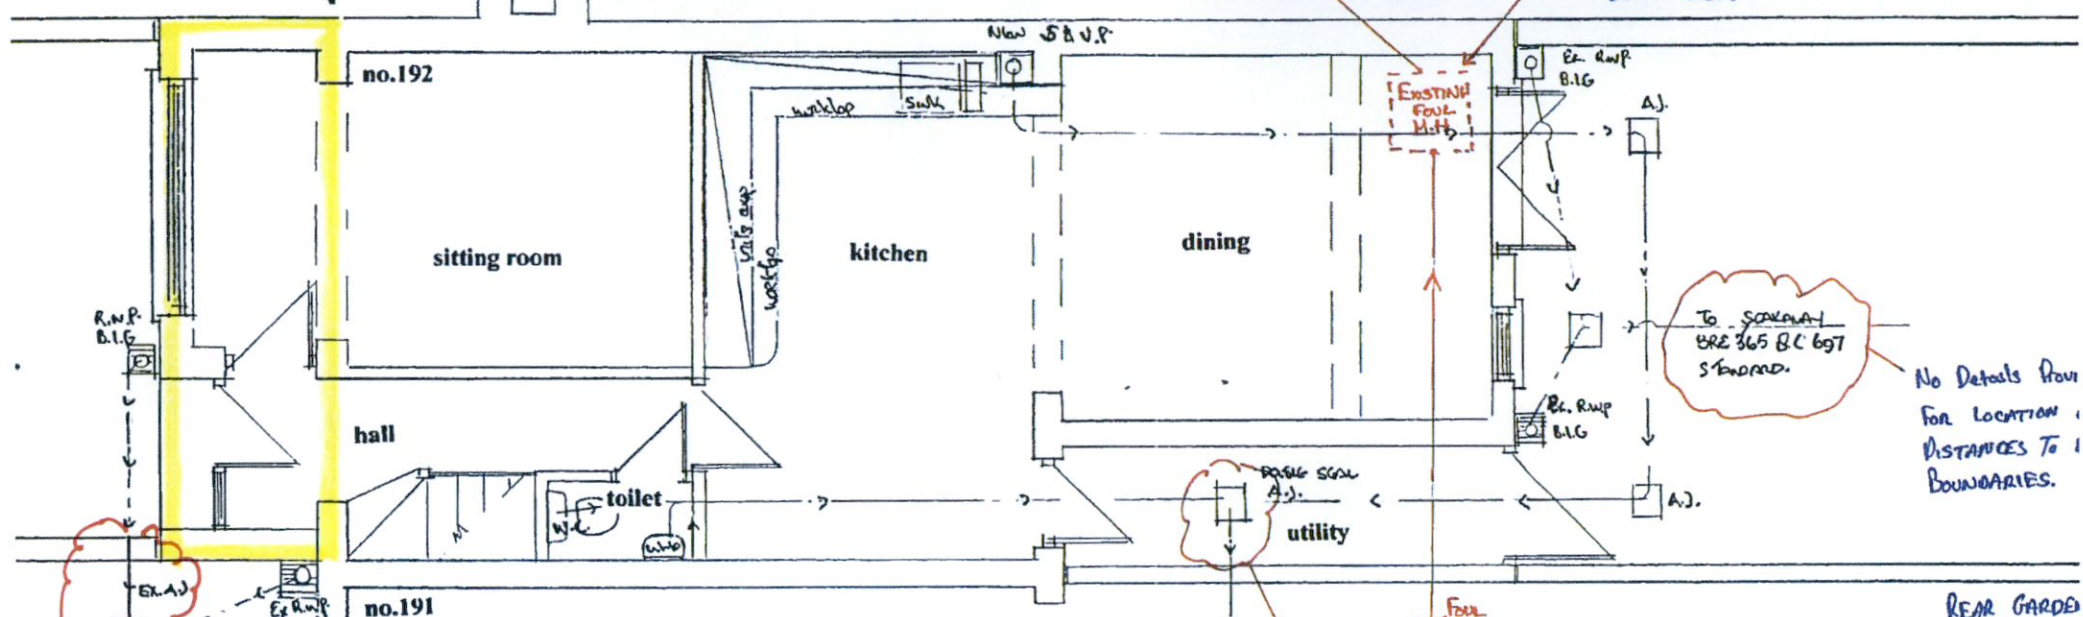
To SOAKAWAY BRE 365 B.C. 697 STANDARD.

A survey of the existing drainage system to be carried out prior to the commencement of the proposed works.
The existing drainage system is a separate drainage system
-all existing & new rainwater drains discharges into the existing separate rainwater system
-all existing & new foul drains discharges into the existing separate foul drain system .
-all disused drain runs ; bigs ; gullies ; gullies ; ajs to be filled with sand & backfilled with hardcore & concrete finish.
-all new drains ; bigs ; gullies ; ajs to be encased in 150 weak mortar
- all drain runs passing under new structure to have precast concrete lintols over.
The rainwater from new extension to discharge into a b.i.g & discharge into a soakaway to BRE365 & C697

GROUND WORKS REQUIRED ON PRIVATE (OURS) PROPERTY OUTSIDE THE APPLICATION BOUNDARY.

SURFACE WATER PIPE??

SEEMS TO BE THE SAME LINE AS EXISTING SURFACE WATER DRAINAGE.

EXISTING LINE AND DIRECTION OF FOUL WATER PIPE DRAINAGE.
