Contiguous Elevation - View A-A

Contiguous Elevation - View B-B

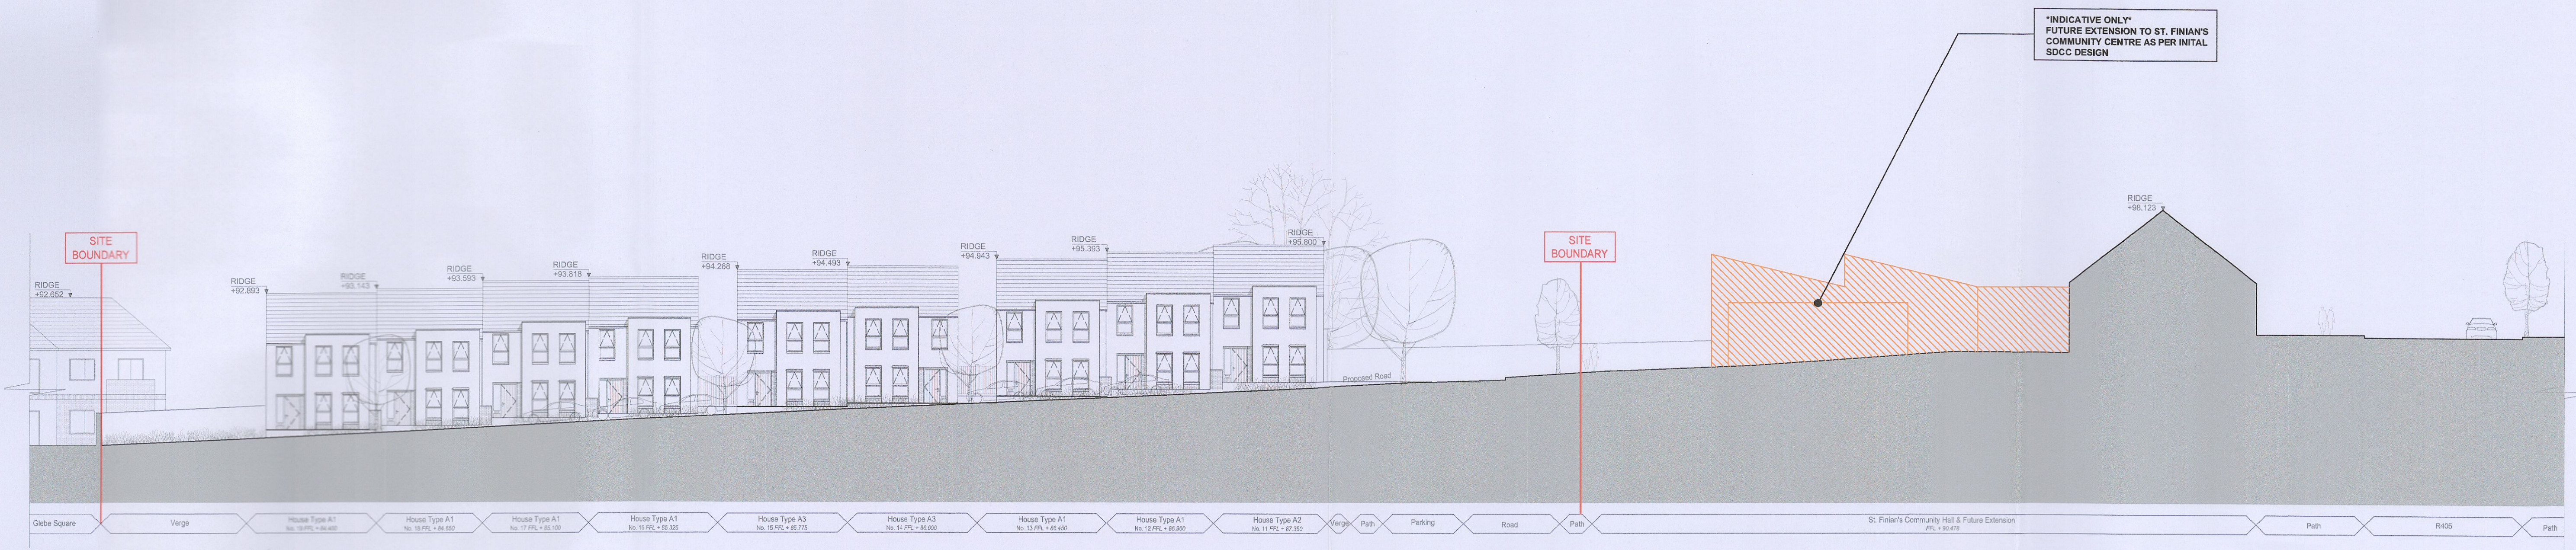
MATERIALS:
 ALL HOUSE TYPES IN THE SCHEME ARE FINISHED WITH A CEMENT RENDER. CEMENT RENDER IS A COMMON MATERIAL USED IN THE AREA FOR ITS LOW MAINTENANCE REQUIREMENTS AND LONG LIFE SPAN.

ALL UNIT TYPES HAVE A BRICK DETAIL AT THE ENTRANCE WAY. THE BRICK PROVIDES A MORE ROBUST SURFACE WHERE CONTACT IS MORE LIKELY TO OCCUR.

ALL UNITS FEATURE SELECTED SLATE ROOF TILES WITH LOW PROFILE GUTTER DETAILS.

ALL UNITS FEATURE UPVC/ALUMINIUM WINDOWS WITH BLACK FRAMES.

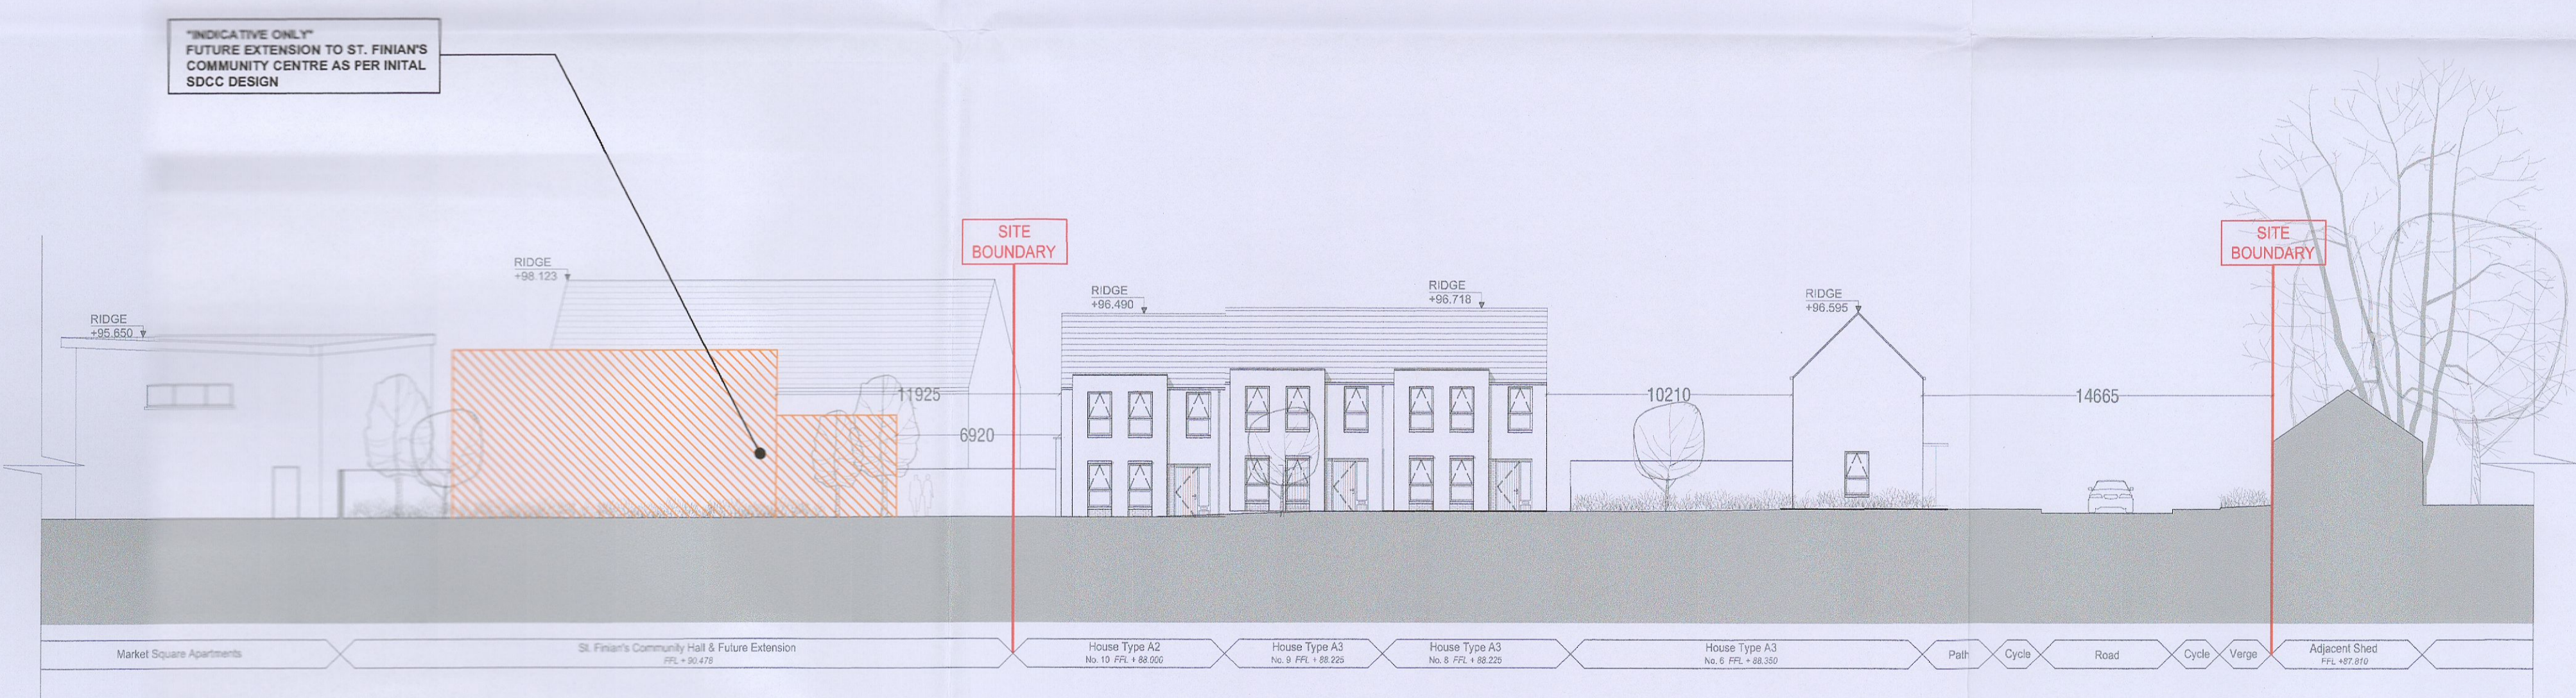
***NOTE:**
 HOUSE NO. 1-7 HAVE NO OPPOSING REAR WINDOWS. PLEASE REFER TO DESIGN STATEMENT FOR MORE INFORMATION.
