Drainage & Water Supply
Report

No. 1 Fonthill Park,
Rathfarnham,
Dublin 14

22736-Drainage & Water
Supply Report

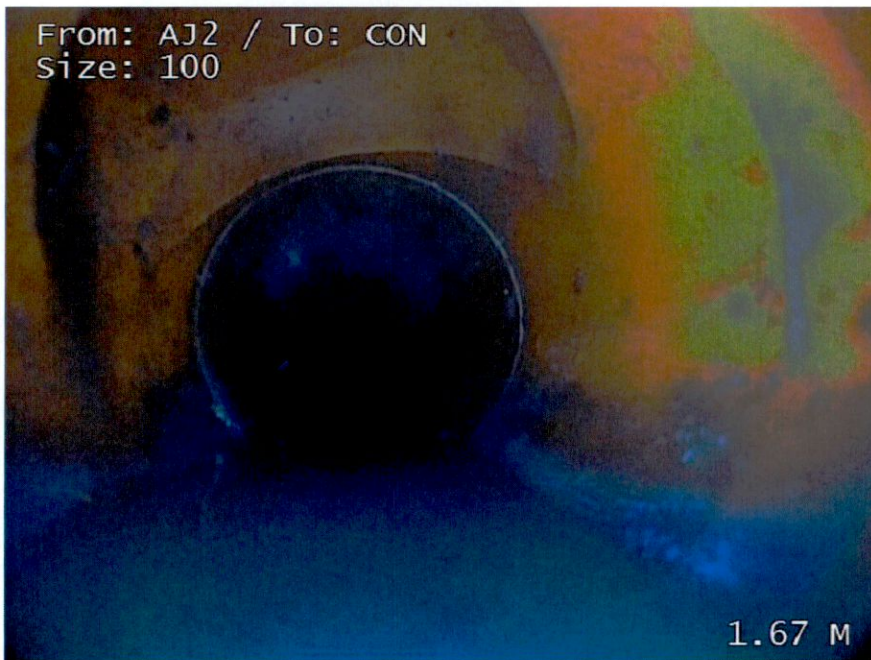
S3C4

Junction at 11 o'clock, diameter 100mm

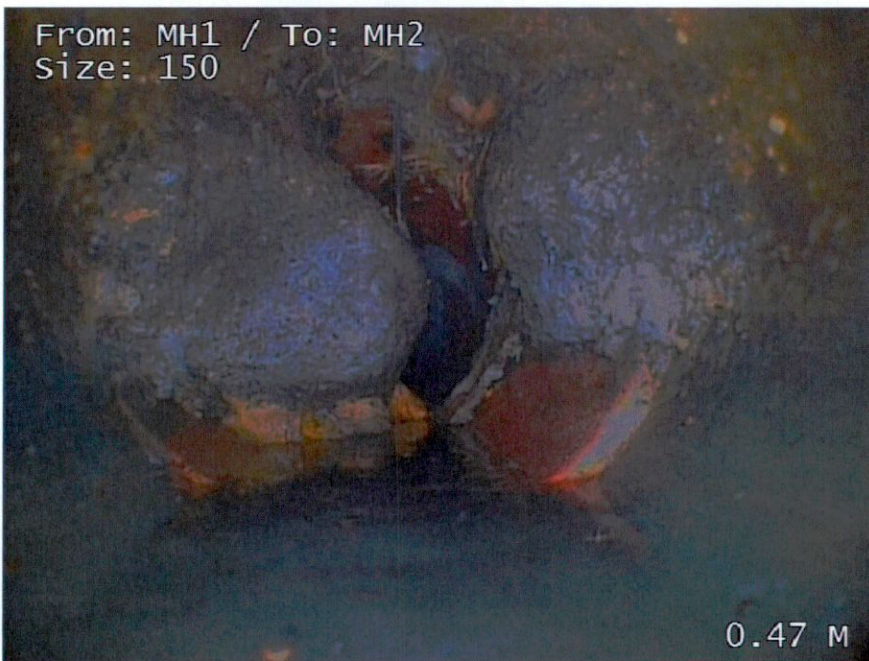
S6C5

00:00:20 - 0.47 m

Open joint large

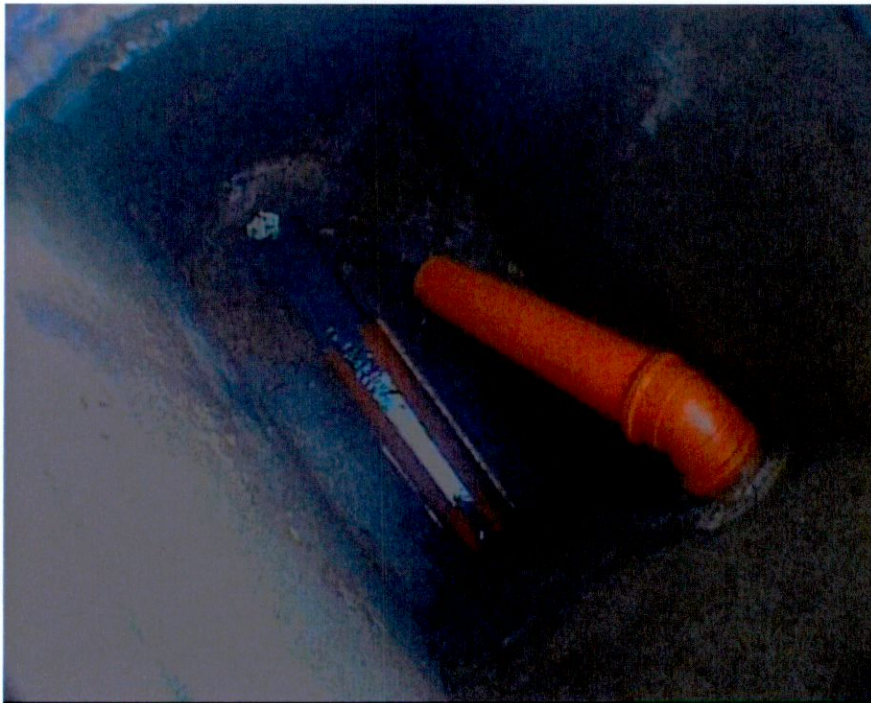
S7 Manhole Internal

MH1 Internal
