CCTV Inspection Report

**DAVID WHITSON
5 LIMEKILN DRIVE,
D12 AP60.**

Job Number: 00037

Greenday Environmental

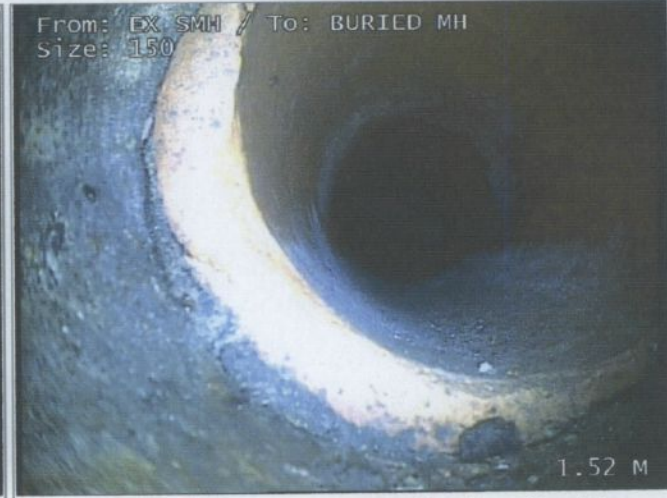
Material of drain/sewer changes to vitrified clay at this point

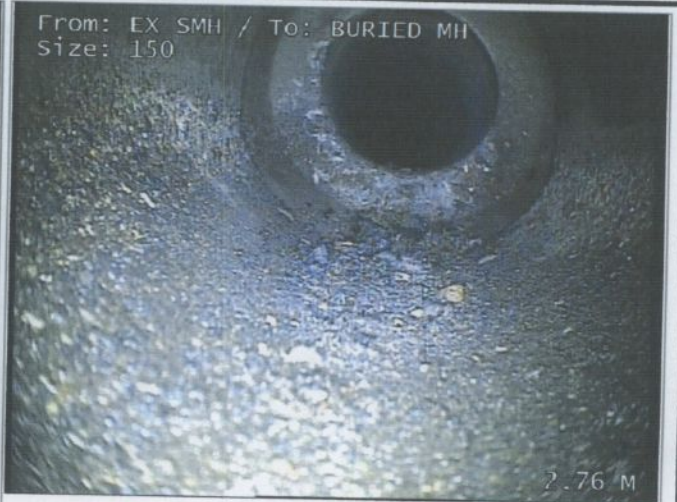
Dimensions of drain/sewer changes to 100mm

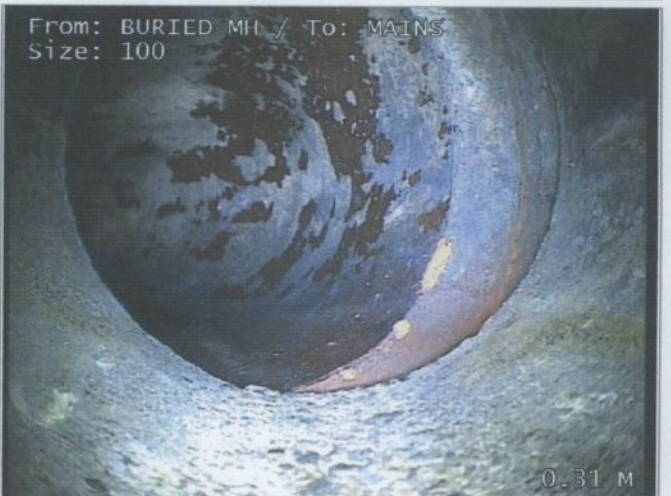
Material of drain/sewer changes to vitrified clay at this point

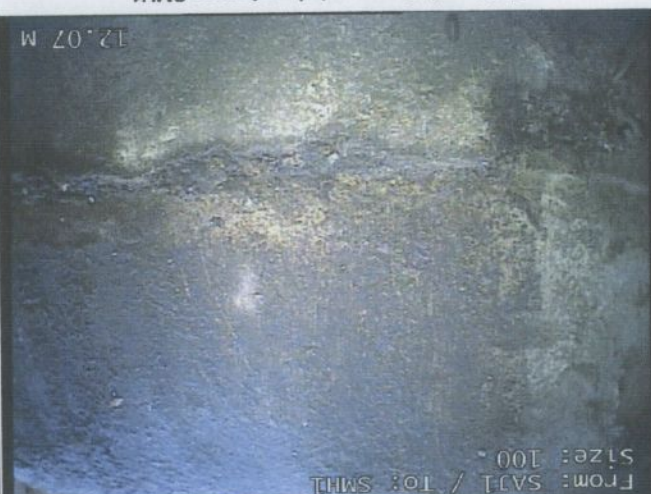
Finish node type, manhole, reference SMH1

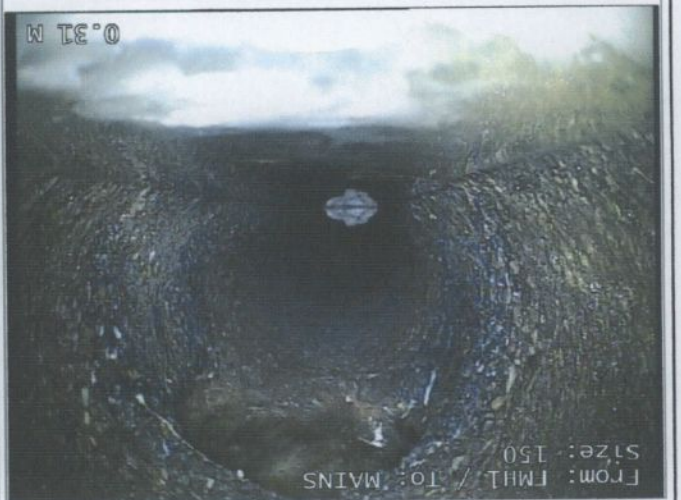
0.31 M

Connection other than junction at 12 o'clock, diameter 100mm

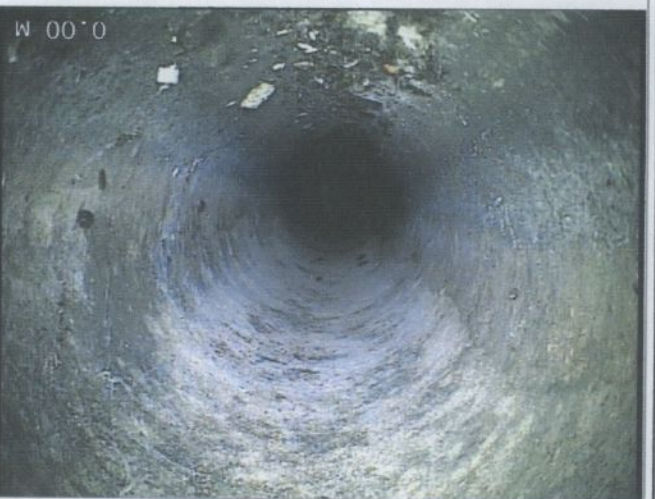
Water level 0% height/diameter

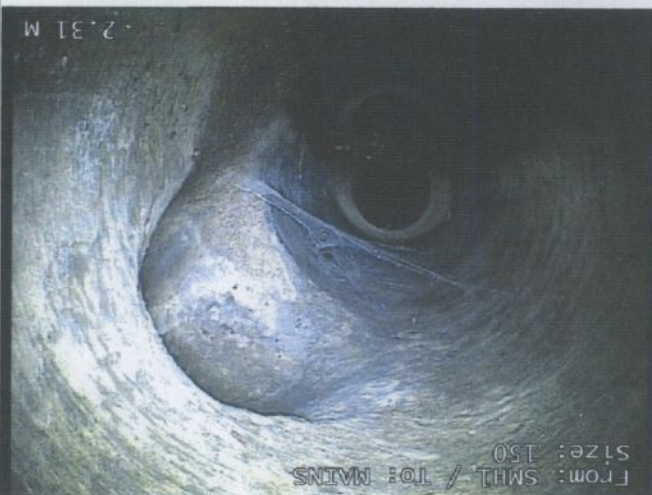
Material of drain/sewer changes to concrete at this point

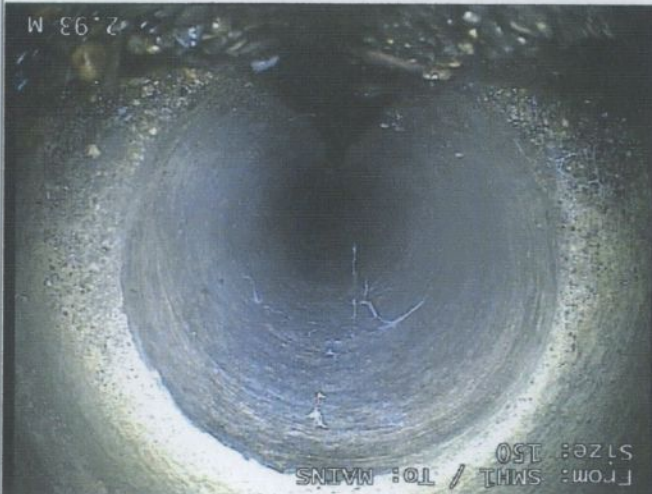
Dimensions of drain/sewer changes to 100mm

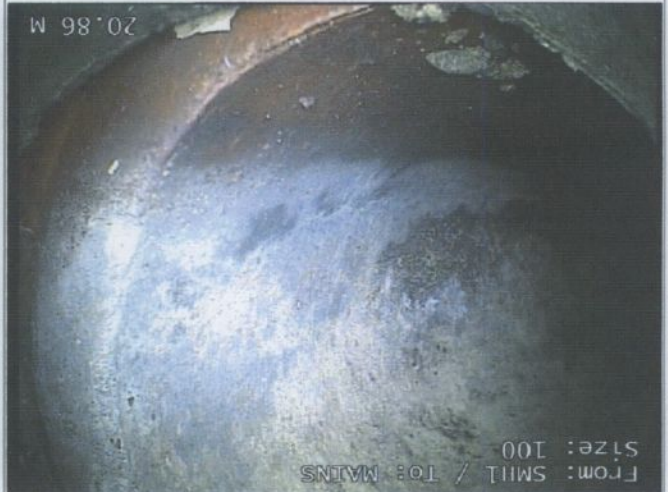
Material of drain/ sewer changes to vitrified clay at this point
